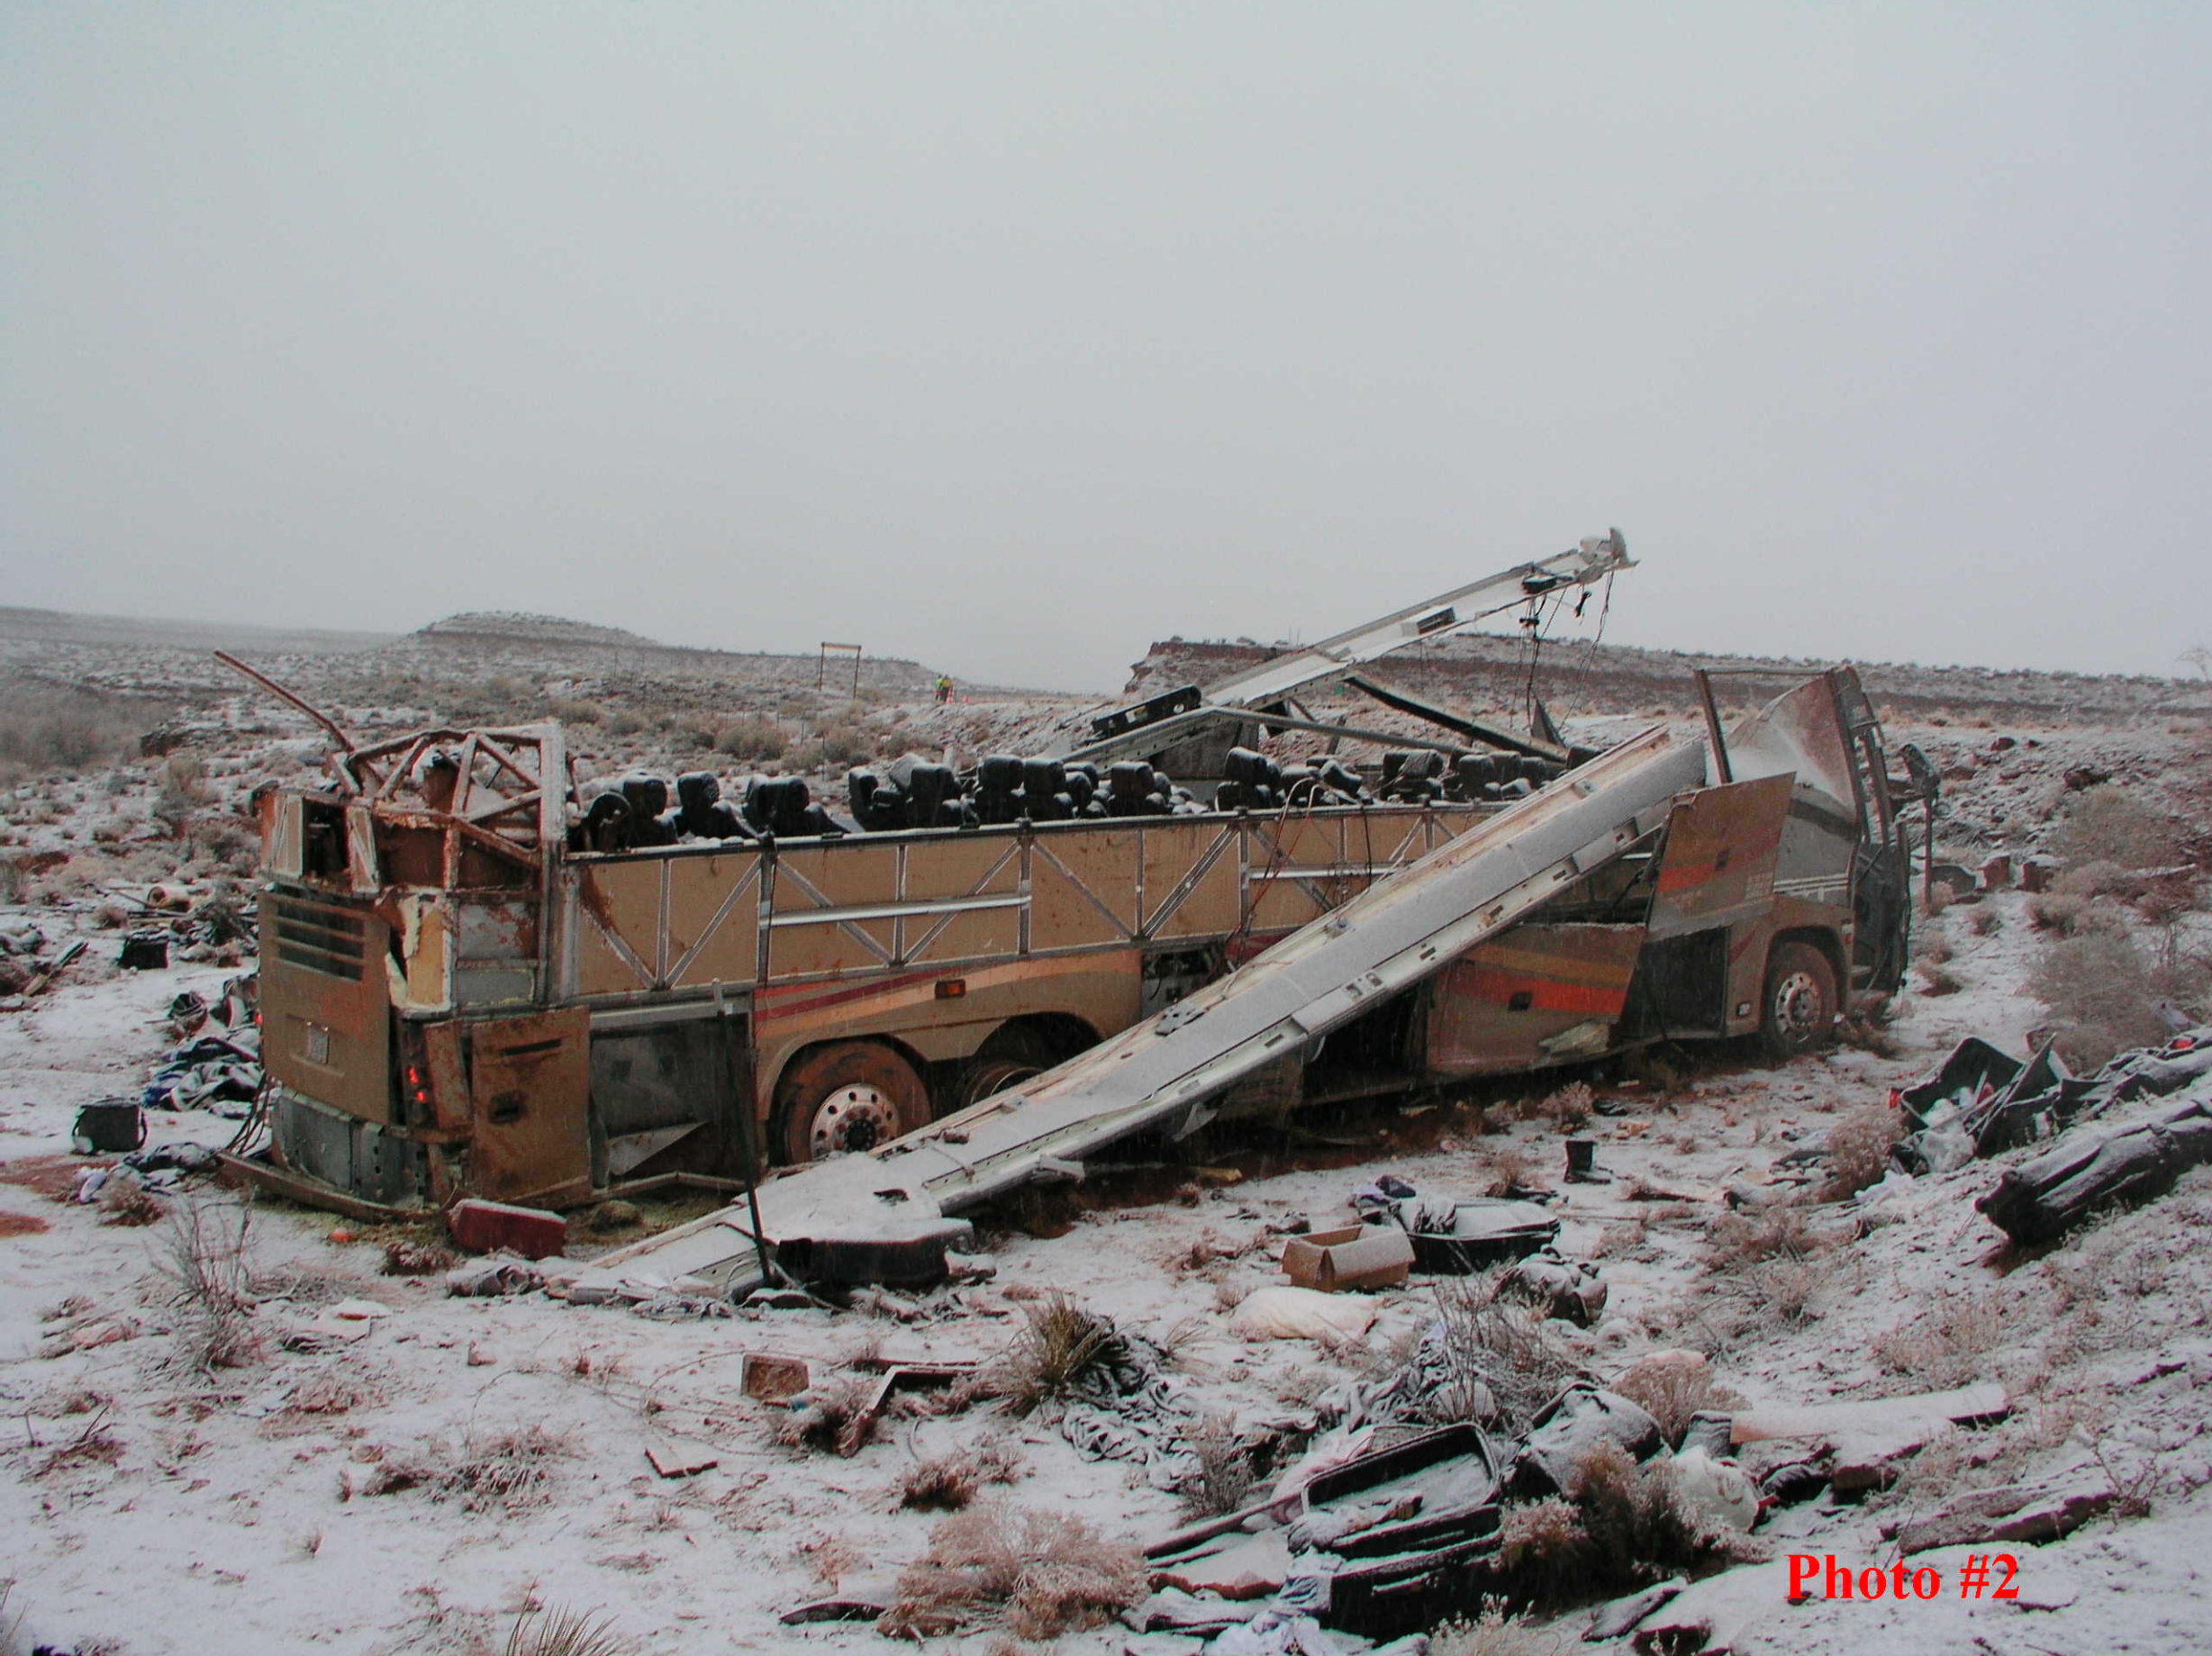
Photo #2

Veh. Photo #02 - Right side of MCI bus in final resting position
