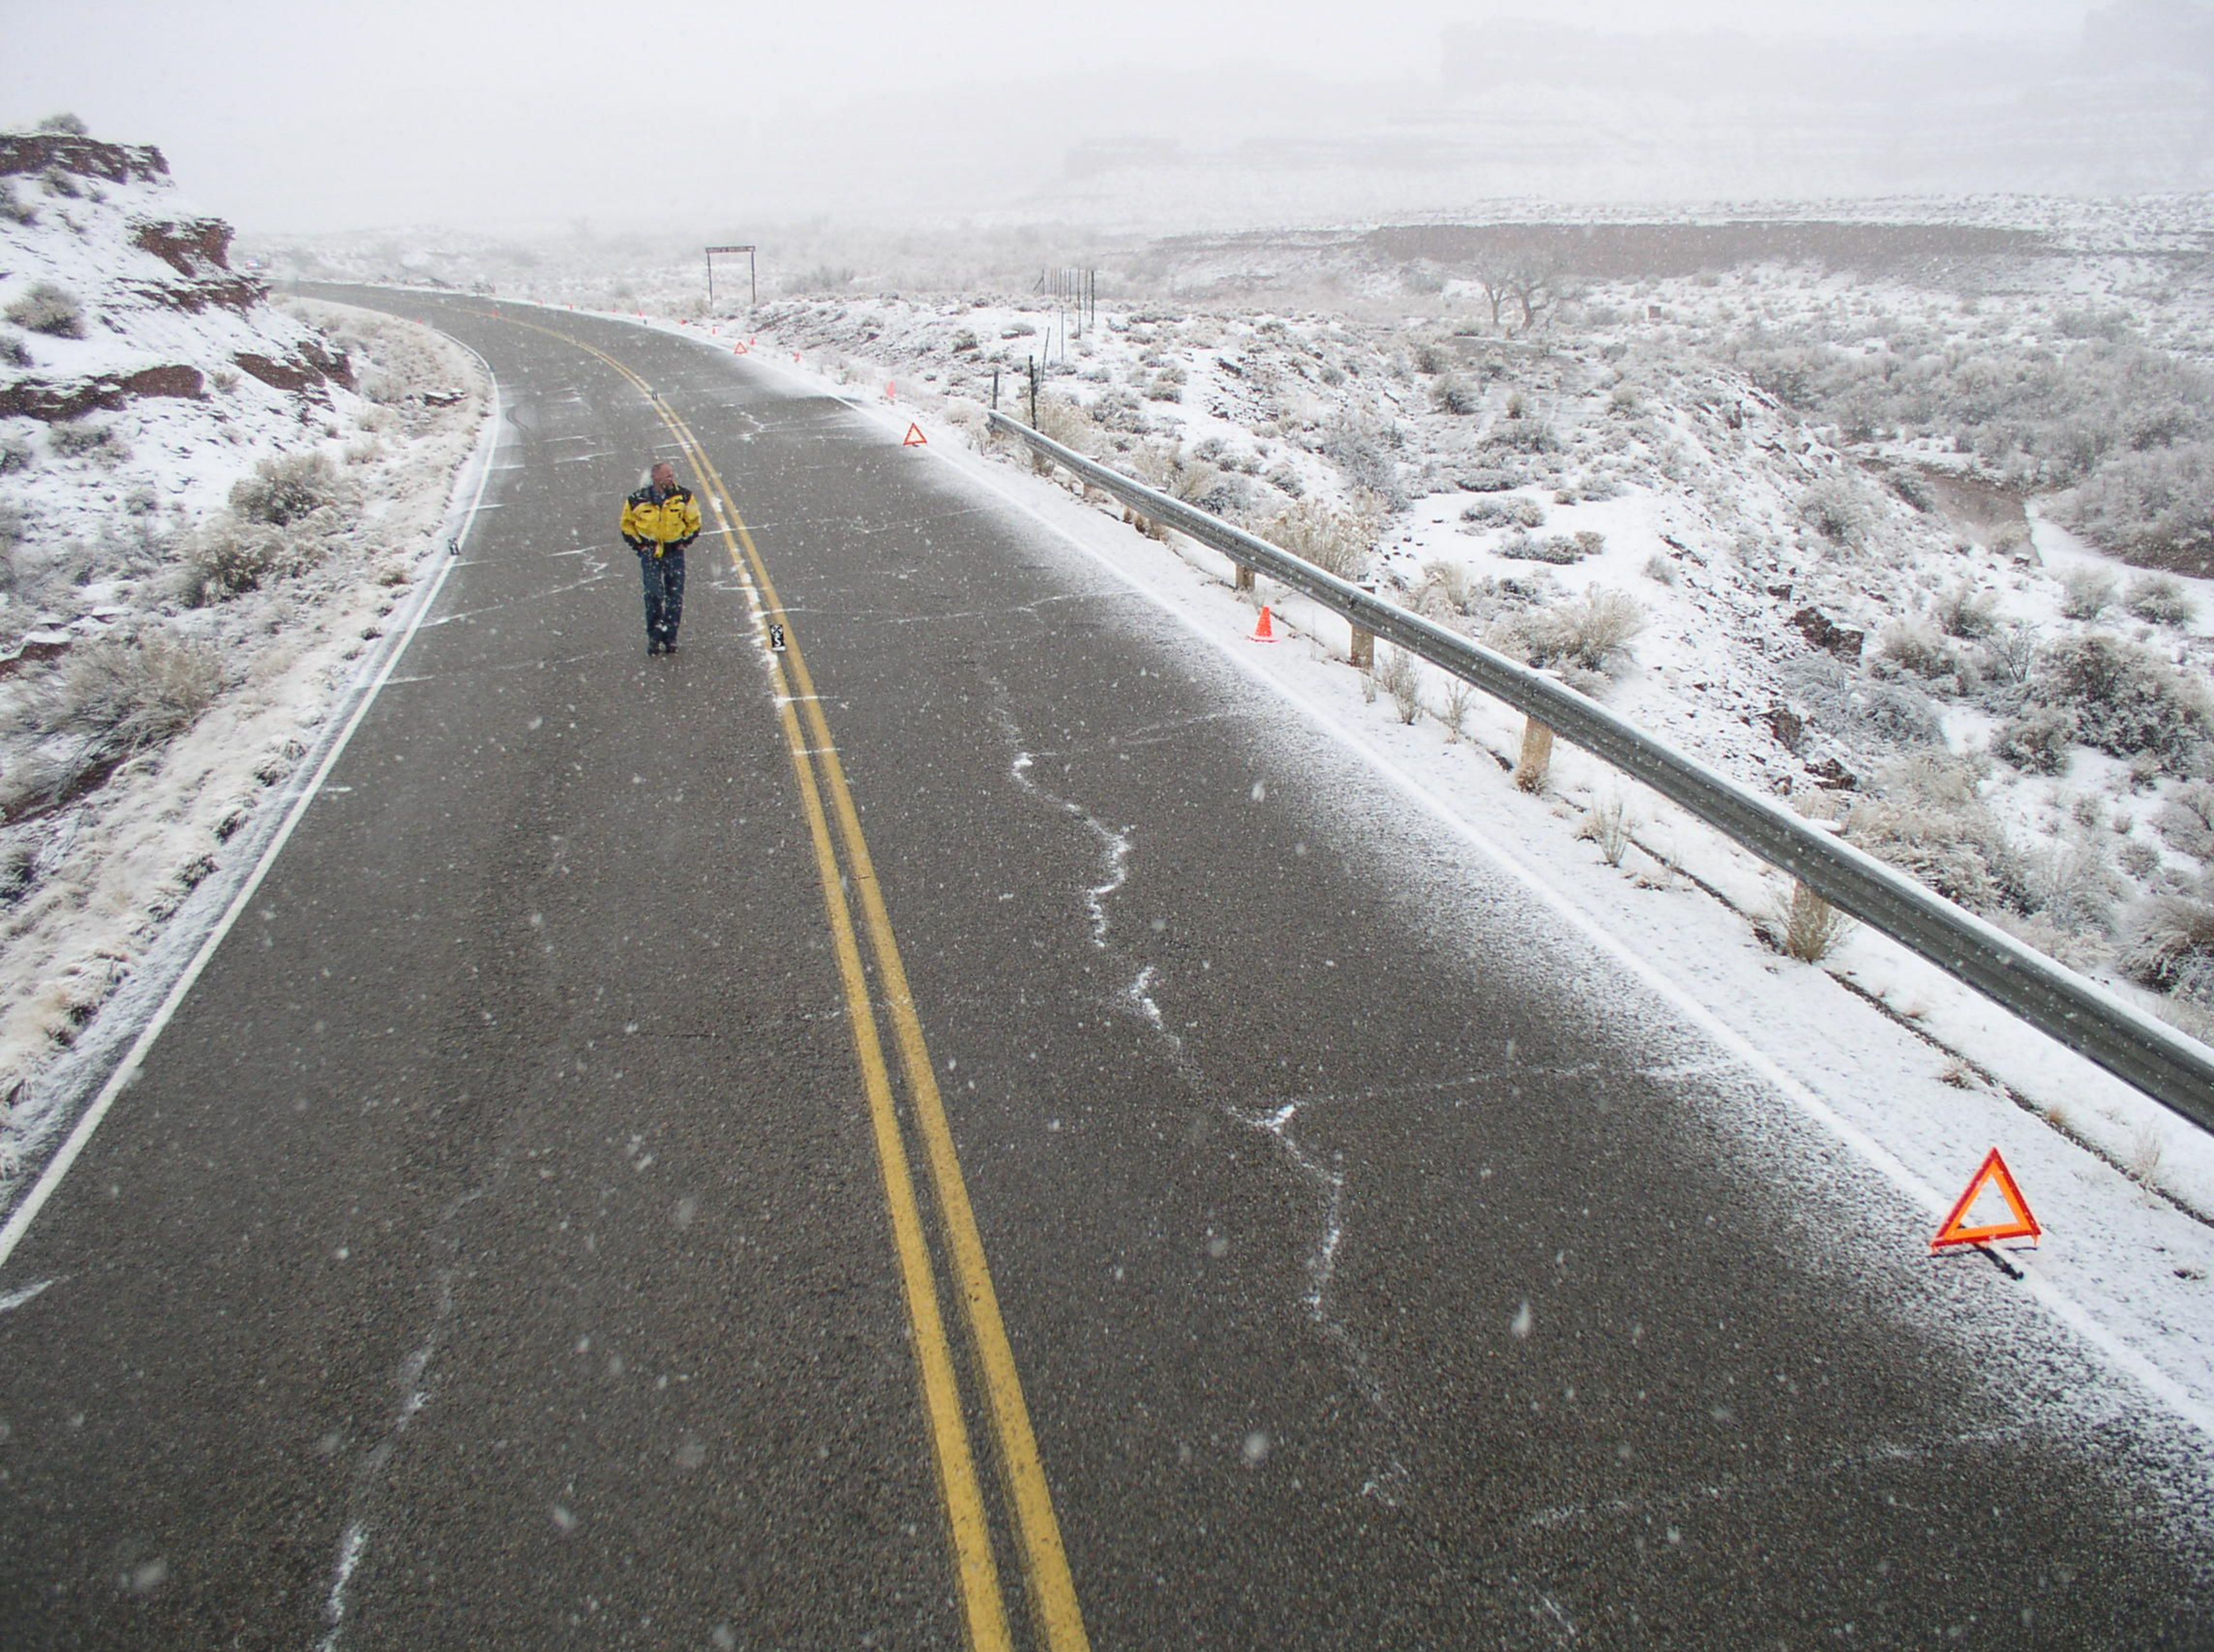
Hwy. Photo #40 - View of guardrail, curve, and first embankment that had a 2:1 slope
