NATIONAL TRANSPORTATION SAFETY BOARD

Vehicle Dynamics Study

HWY-08-MH012

Location: Mexican Hat, UT
Date: January 6, 2008
Time: 8:02 PM MST
Vehicle: 2007 MCI Model J4500, 56-Passenger Motorcoach

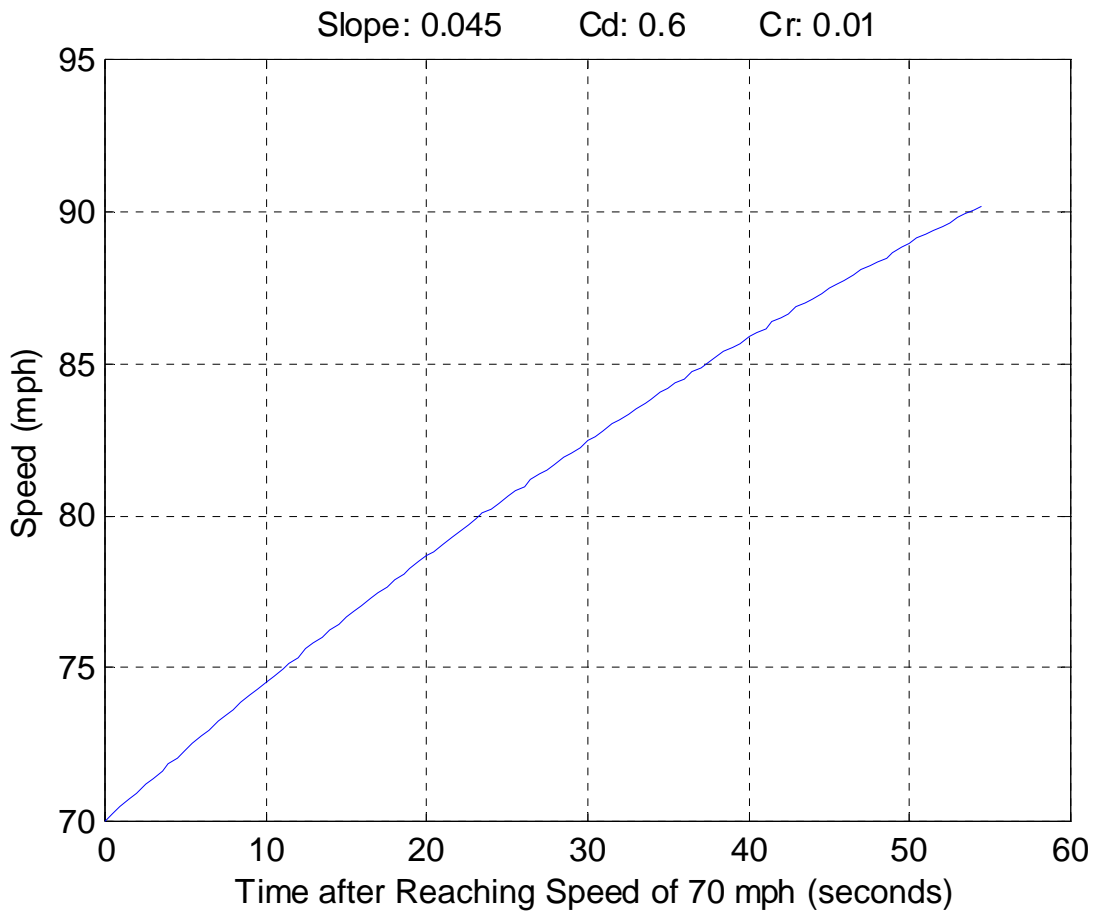
Figure 1 Speed Increase from 70 mph vs. Time (with fuel shut off)

Figure 1 shows that the motorcoach reached the speed of 90 mph in 54 seconds when started at 70 mph on a 4.5% downgrade. Figure 2 shows that the distance traveled when the speed reached 90 mph was 6400 ft. These results indicate that the motorcoach can reach speeds significantly higher than the fuel cut-off speed when traveling on a 4.5% downgrade.

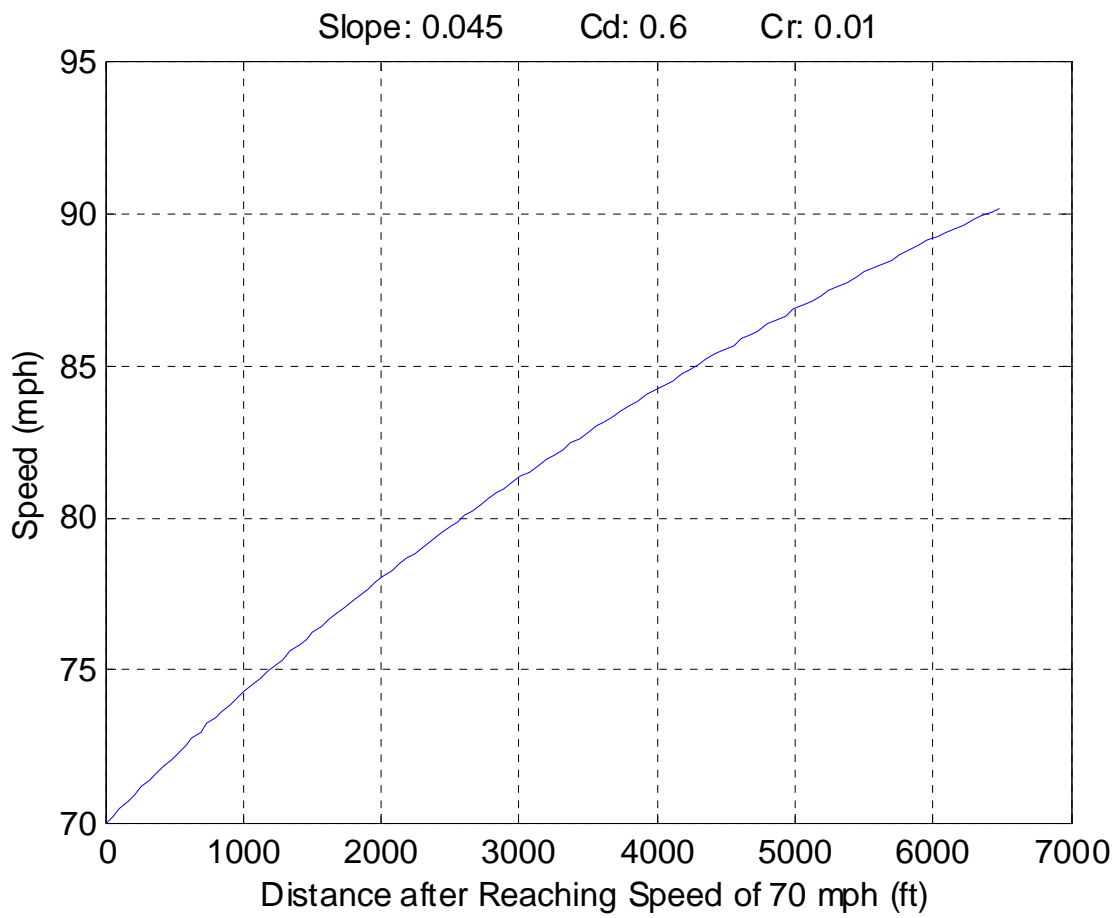
Figure 2 Speed Increase from 70 mph vs. Distance (with fuel shut off)

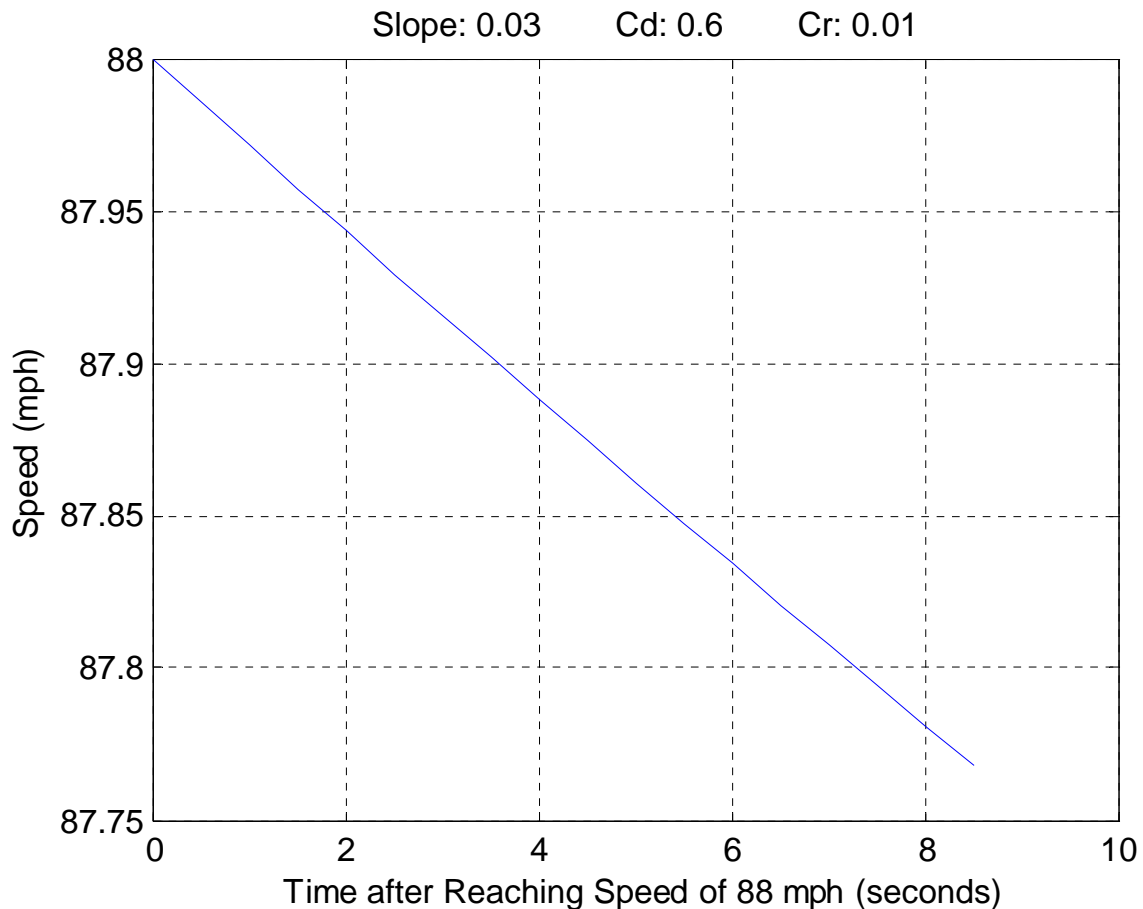
Figure 3 Speed Decrease from 88 mph vs. Time (on a 3% downgrade)

Figure 3 shows that in 1000 ft on a 3% downgrade, the motorcoach will slow down by less than 0.2 mph when started at 88 mph. The simulation assumed a constant 3% downgrade. On a downgrade where the slope is reduced gradually from 5% to 3%, the deceleration would have been even lower. This agrees with the DriveCam vehicle-mounted camera longitudinal accelerometer that did not show a measurable deceleration.
