**Submission of BUSCO to the
National Transportation Safety Board**

**Mexican Hat, UT
HWY-08-MH-012**

Alternative Crash Theory – Mexican Hat, UT.

By Kimball Kinnersley, Corporate Director of Safety
Busco, Inc. (dba Arrow Stage Lines & Corporate Transportation 'N Tours)

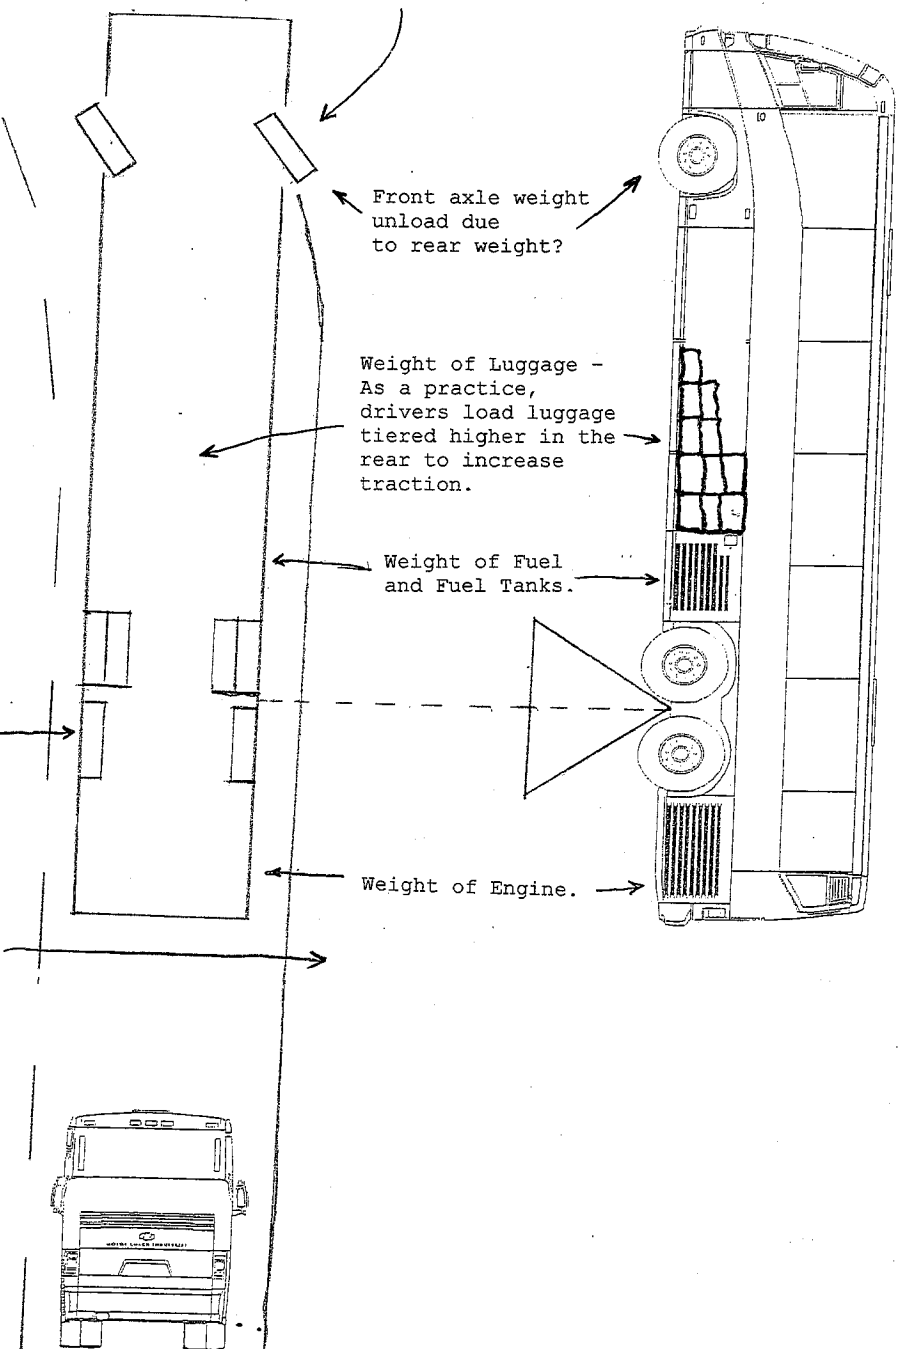
A

Front tire slip angles exceeded?

Front axle weight unload due to rear weight?

Weight of Luggage - As a practice, drivers load luggage tiered higher in the rear to increase traction.

Weight of Fuel and Fuel Tanks.

Weight of Engine.

Tag Axle Pressure?

Pendulum Effect - Once the driver made a correction in the front, the rear weight gained momentum like a clock pendulum and pulled the entire vehicle from the road.

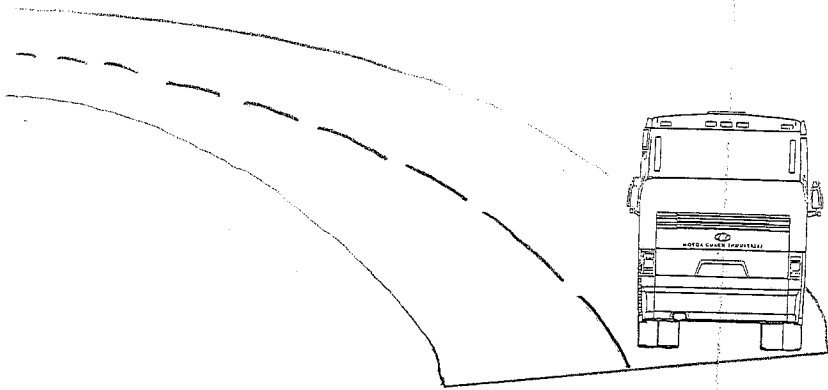
B

Horizontal c.g. shift to right.
Vertical c.g. is obviously higher
in a motorcoach due to the height
of the vehicle.

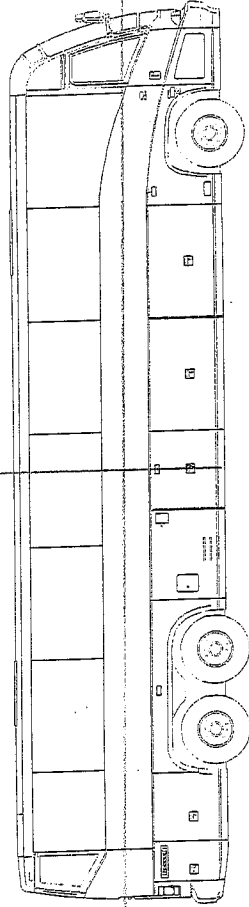
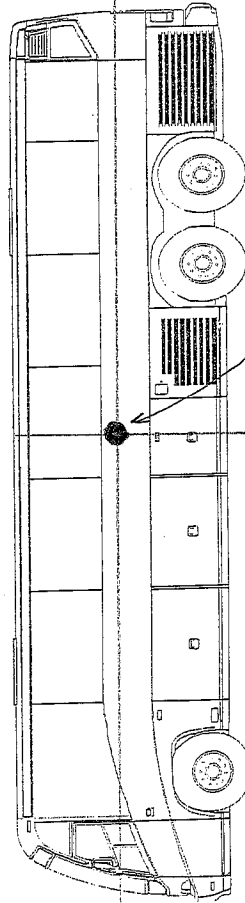
C

Sample centers
of gravity.
Vertical &
Longitudinal.

Sample c.g. of entire
vehicle where all three
meet.

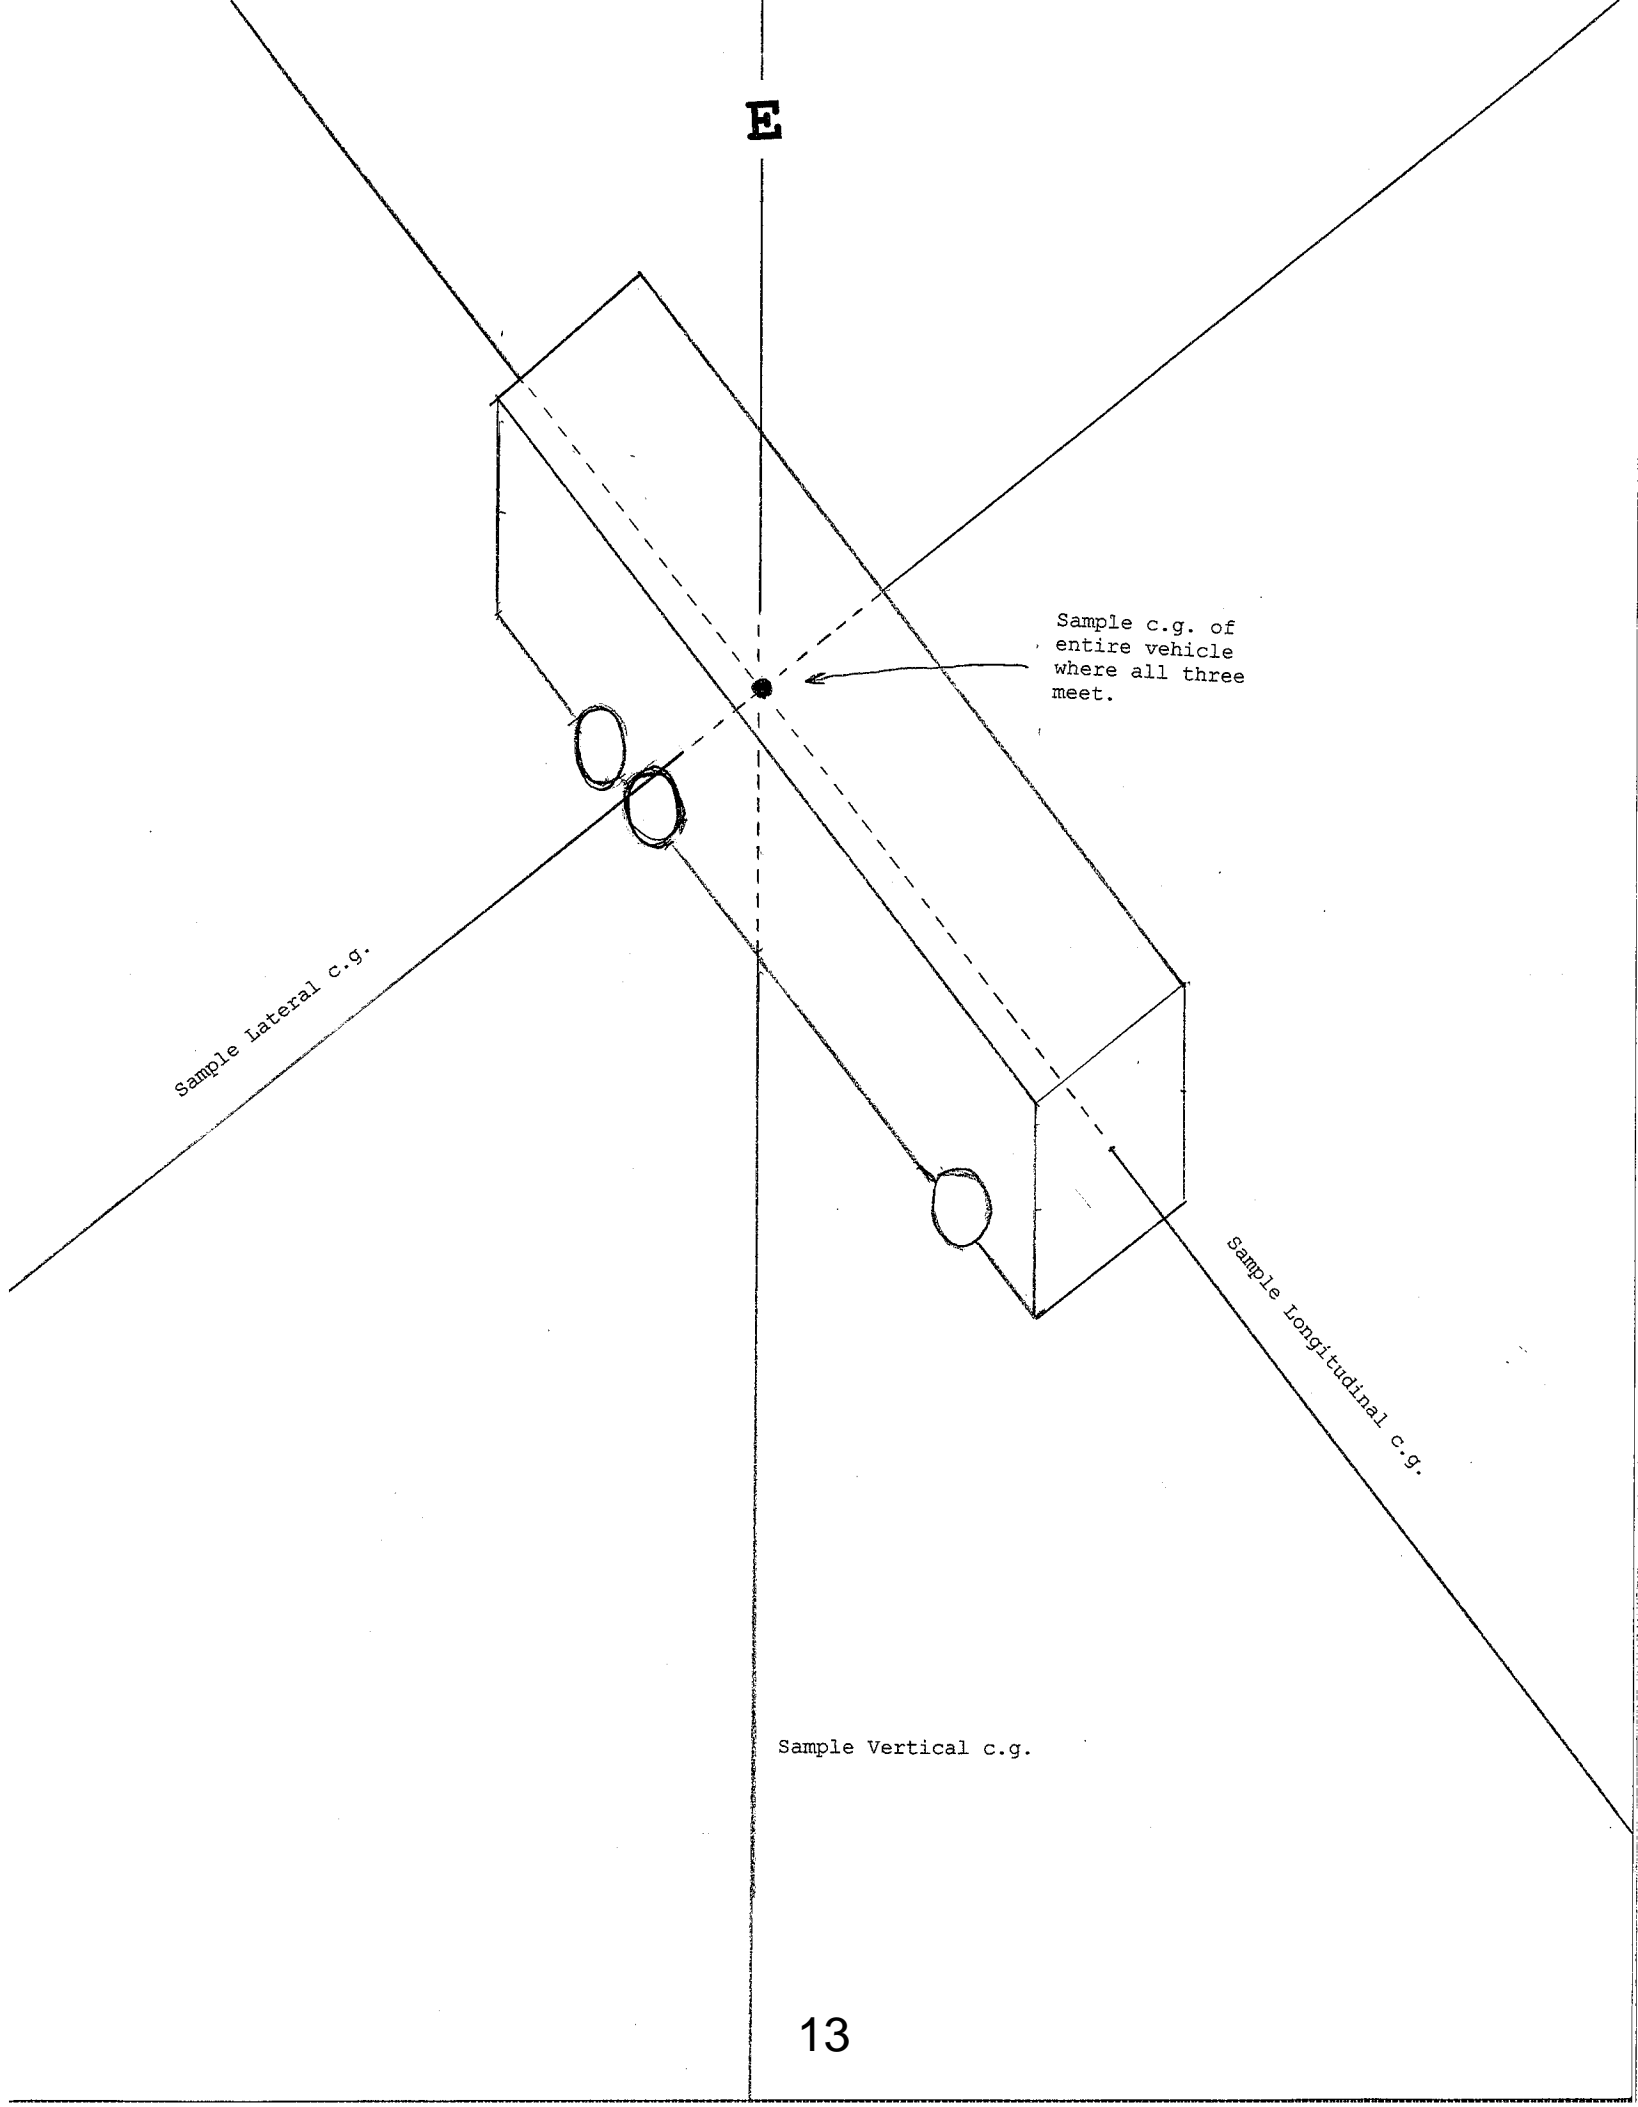
E

Computer animation could possibly pinpoint the vehicles c.g. as depicted in Exhibit E. The height of the bus and the affect of having a high c.g. or top weight (and its lateral affect) could be simulated. The road surface could be simulated. All the simulations, including the speed of the bus could be re-enacted.

Sample Lateral c.g.

Sample c.g. of
entire vehicle
where all three
meet.

Sample Longitudinal c.g.

Sample Vertical c.g.
