RAILROAD ACCIDENT REPORT

COLLISION OF NATIONAL RAILROAD PASSENGER CORPORATION (AMTRAK)
TRAIN 59 WITH A LOADED TRUCK-SEMITRAILER COMBINATION AT A
HIGHWAY/RAIL GRADE CROSSING IN
BOURBONNAIS, ILLINOIS, MARCH 15, 1999

**NTSB/RAR-02/01
PB2002-916301
Notation 7168A
Adopted February 5, 2002**

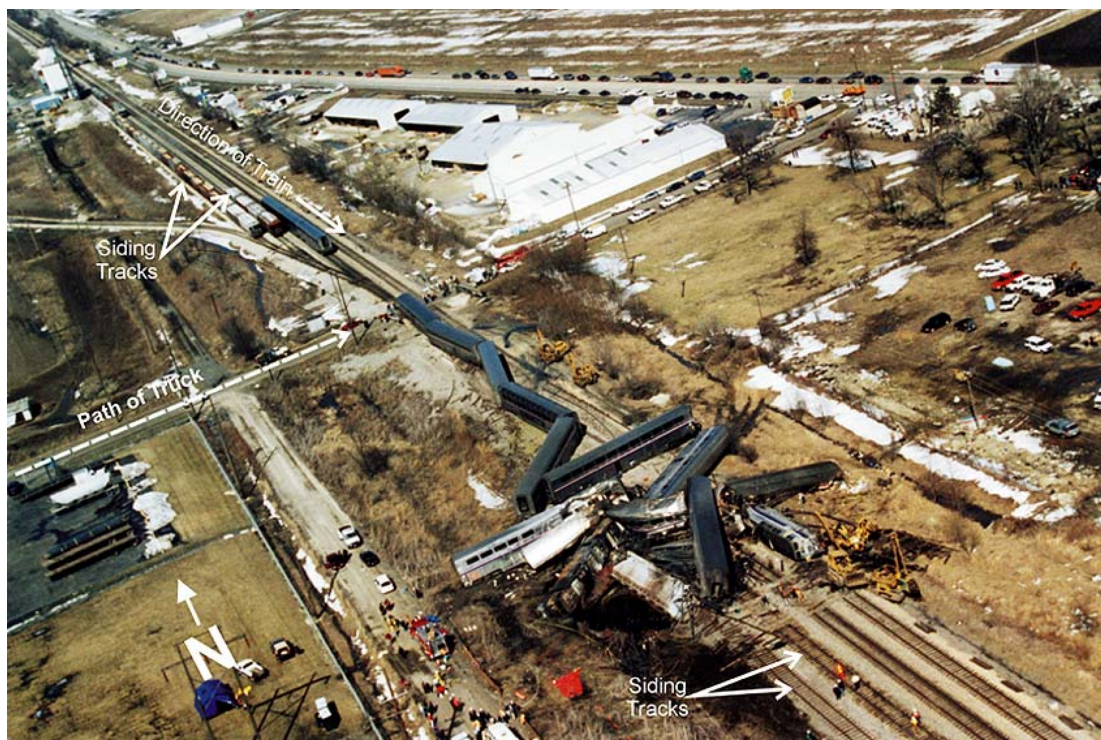
The train 59 engineer, who was the only person in the locomotive cab at the time, stated that he saw the truck slowly moving over the crossing, and he sounded the train horn to warn the truckdriver. He said that when he realized that the truck would not clear the crossing before the train arrived, he initiated emergency braking.² Traveling at 79 mph, the train did not have sufficient distance to stop and struck the left rear of the semitrailer. (See figure 2.) The time was about 9:47 p.m.

Figure 2. Aerial view of crash scene.

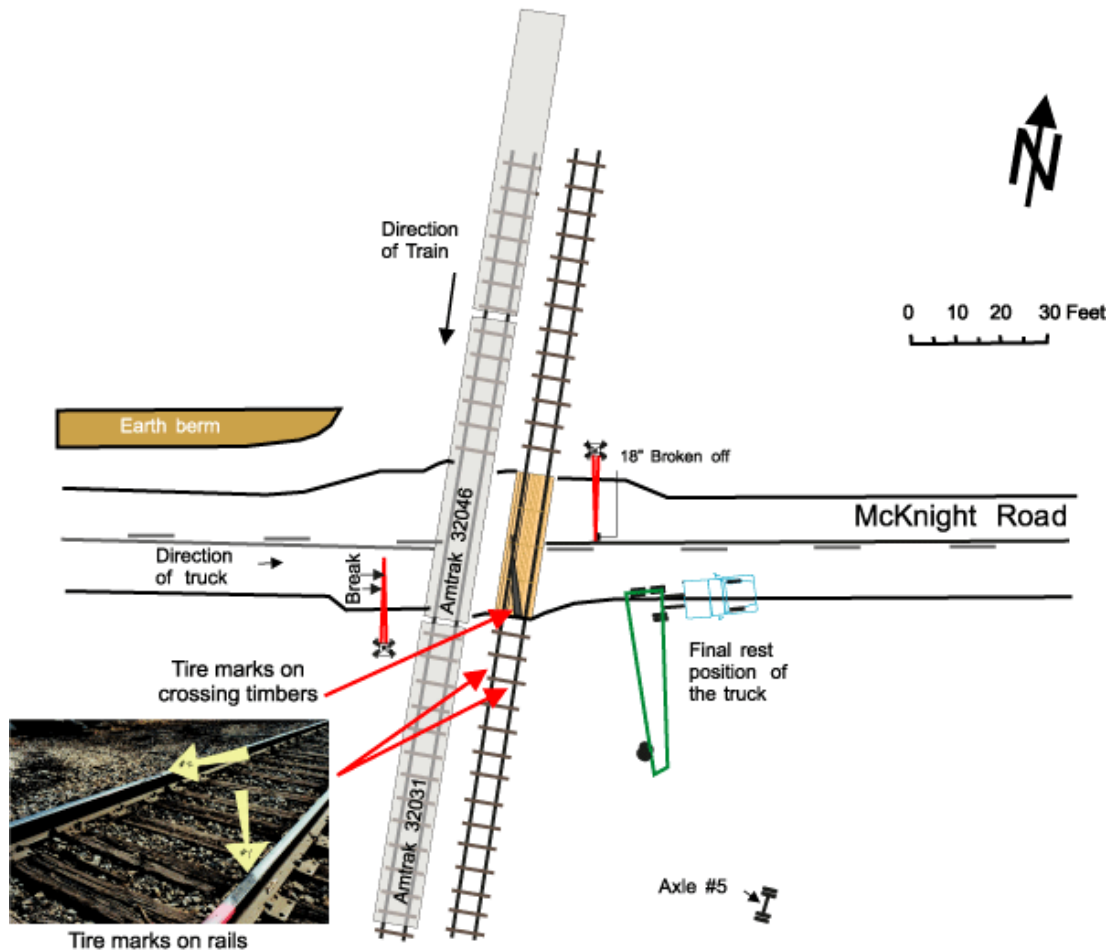
track. (See figure 5.) One end of the tire mark began just west of the west rail north of the centerline of the roadway. It ran over the west rail and continued diagonally between the rails to the edge of the crossing timbers near the east rail and ended on the east rail, about 4 feet from the edge of the timbers.

Figure 5. McKnight Road grade crossing showing damage features and tire marks.

Two additional tire marks were found on the passing siding track rails south of the crossing timbers. The first of these was found on the west rail about 12 feet from the timbers. The second mark was found on the east rail about 18 feet from the timbers.

The northerly end of the black tire mark on the timbers of the easterly track indicates the position of the tires when the truck was hit by the train. The only tires showing sideways sliding were those on the left side of the fourth axle. It was therefore concluded that the marks were made from the left tires of the fourth axle. A 10-foot measurement (distance between the fourth and fifth axles) indicated that the fifth axle had to be at the center of the southbound tracks at impact. This was confirmed by noting the damage to the left outside wheel of the fifth axle, which was consistent with the geometry of the locomotive's front coupler. (See figure 6.)

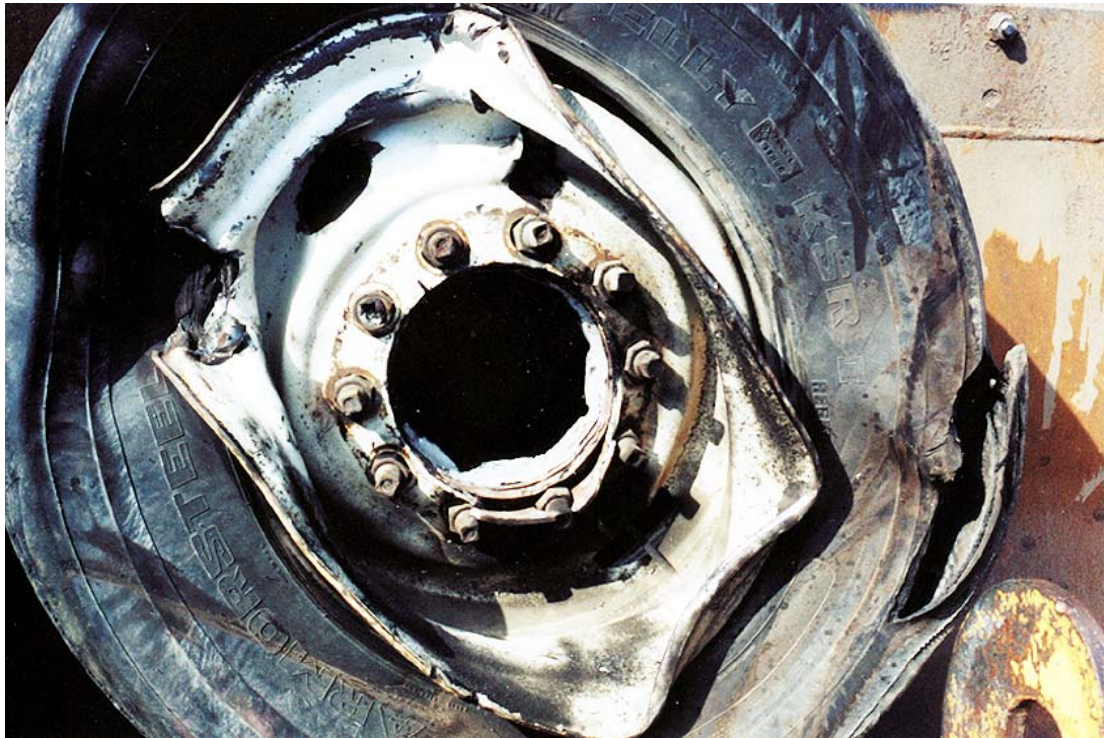
Figure 6. Left-side fifth axle of semitrailer at point of impact.

The left wheel rim and drum assembly of the semitrailer's No. 5 axle had heavy impact damage that matched the Amtrak locomotive's coupler in size and conformation. The hub was destroyed, and the brake shoes and air chamber were dislodged. This was the only wheel assembly on the semitrailer that showed evidence of impact damage. The left side dual tires on axle No. 4 showed surface abrasions in one section of the tread area, with striations perpendicular to the tread.

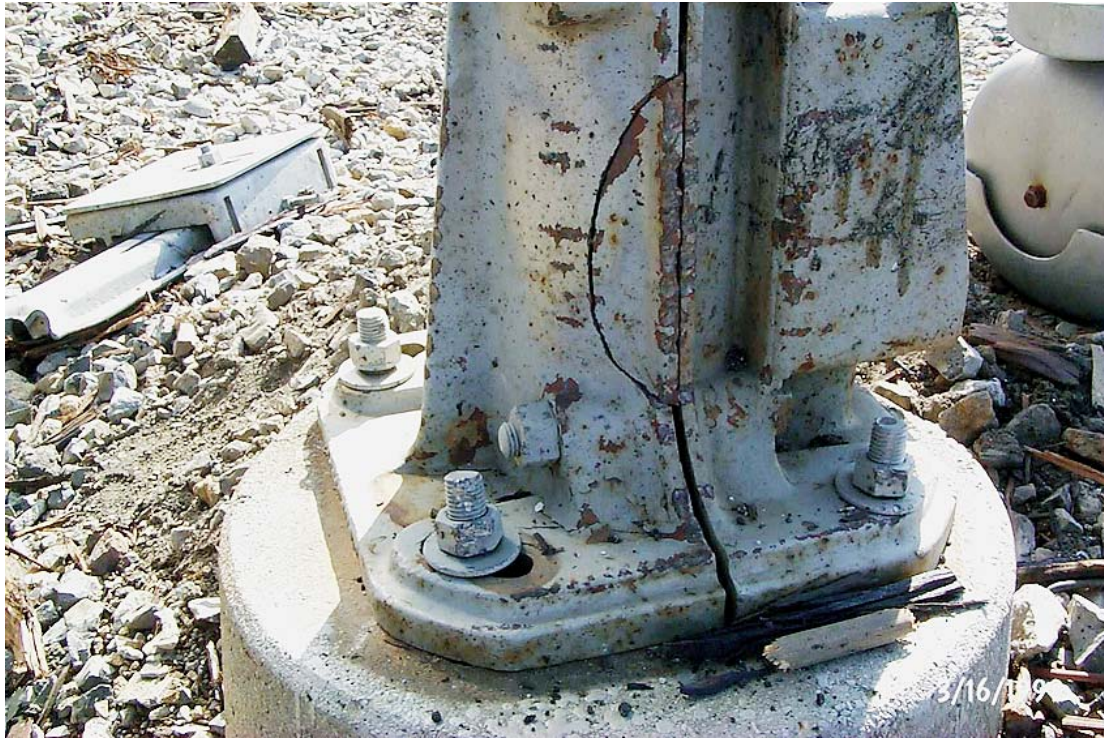
The base of the west crossing gate signal mast was cracked. This was the gate that was on the approach side of the crossing from the perspective of the accident truckdriver. The front edge of a flange on the case metal base and a section of the base itself bore a series of indentations. Witness marks on the concrete under the base of the crossing signal mast indicated that the cast-metal gate mast base had been moved about 1 inch to the west and south of its original position. (See figure 7).

Figure 7. Cracked cast metal base of the west-side crossing gate.

The base of the crossing gate mast consisted of two castings fastened together around the mast. Four fasteners screwed the two base castings onto anchor bolts embedded in a concrete foundation.

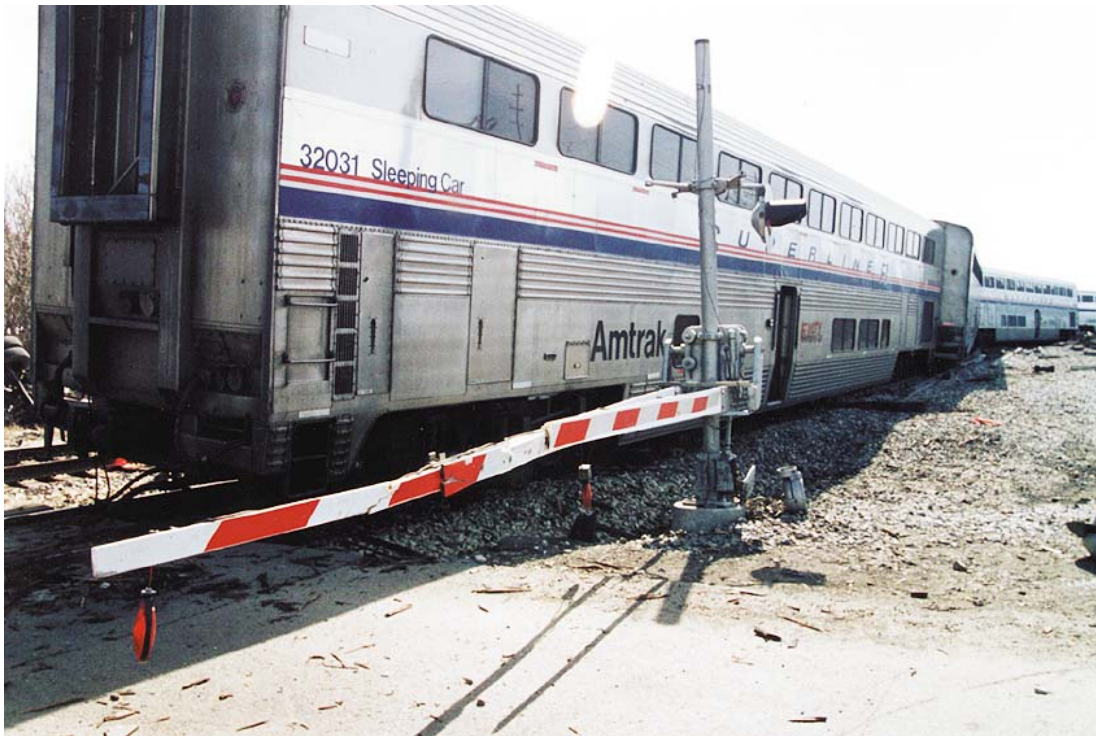
An area of missing paint, where the outer coat was removed while the base or primer coat was left, was found on the west face of the gate at the tip. The gate counterweight, three of the four large signal lights, and the bell had broken off the signal mast. In addition, the gate arm was fractured but not broken off; the mountings for the three lights on the gate arm were broken; and the tip light and base light remained hanging from the gate arm. (See figure 8.) Safety Board investigators were unable to locate the lens for the gate arm center light. The east crossing gate was broken off, in an inward and downward direction, at a point 19 inches from the tip.

Figure 8. West (approach) crossing gate.

As a part of the accident scene cleanup, the IC replaced the damaged west gate arm mechanism. The gate mechanism was discarded and remained in outside storage in Gilman, Illinois, until September 15, 1999, when the Safety Board asked that it be sent to Washington, D.C., for testing. The Safety Board received the mechanism on October 5, 1999. Details of the initial testing and examination of the gate arm mechanism are discussed in further detail in the “Tests and Research” section of this report.

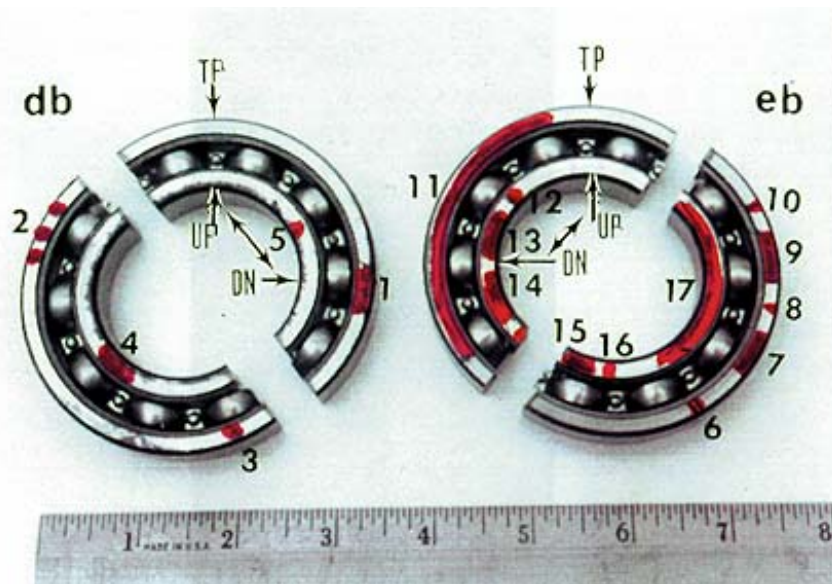
Figure 10. West crossing gate arm mechanism main shaft bearings. Numbered markings on inner and outer races indicate location of Brinell marks.

To determine whether the Brinell marks on the bearing surfaces might have resulted from normal operations, investigators examined a set of bearings from another, similar gate arm mechanism. The ball grooves of the inner and outer races of the comparison bearings bore signs of the balls' rotation in the grooves and of minor surface corrosion. The comparison bearings did not show evidence of Brinell marks on any surface. The rotational signs in the grooves of the inner and outer race aligned to indicate the range of the gate's movement; these were more prominent on the bearing that supported the counterweight arm.
