**Collision of Union Pacific Railroad Train  
MHOTU-23 With BNSF Railway Company  
Train MEAP-TUL-126-D With Subsequent  
Derailment and Hazardous Materials Release  
Macdona, Texas  
June 28, 2004**

**NTSB/RAR-06/03**

**NTSB/RAR-06/03  
PB2006-916303  
Notation 7675D  
Adopted July 6, 2006**

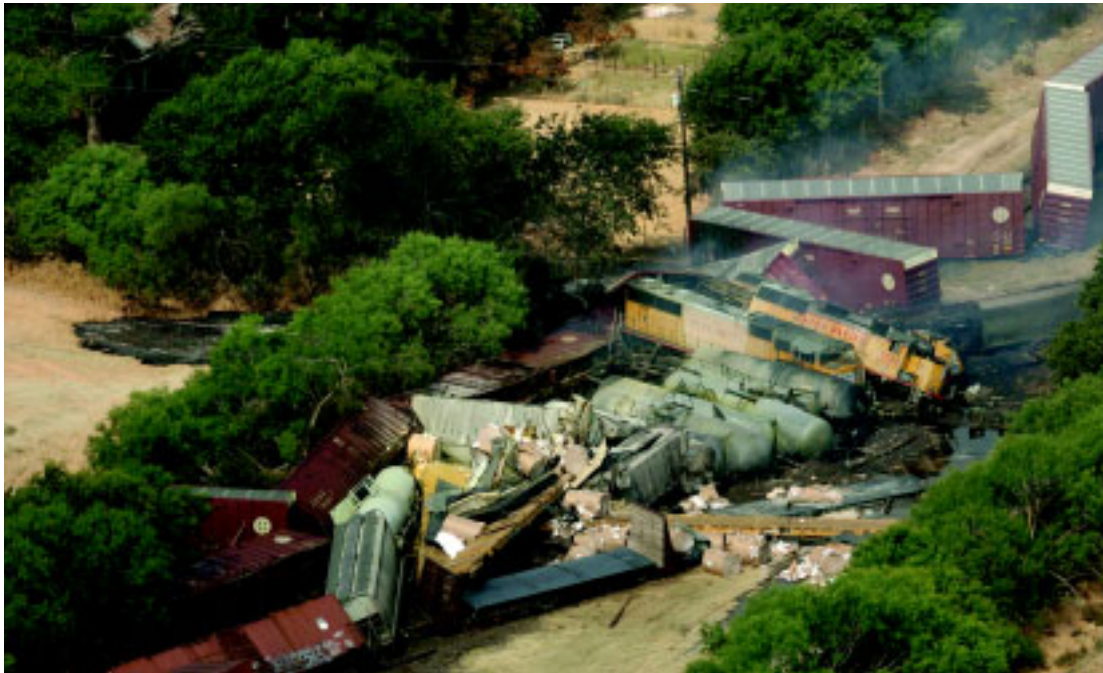
**Figure 1.** Post-derailment pileup.

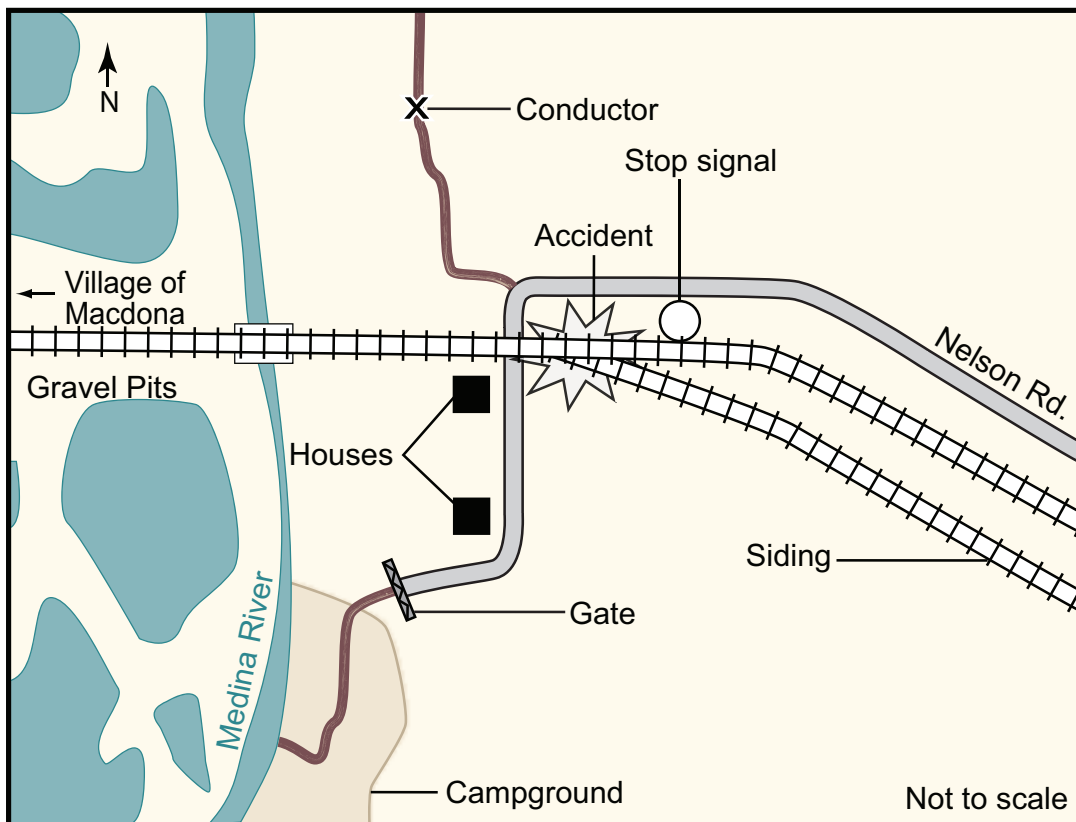
Event recorder data showed that between 5:03:17 and 5:03:19, the UP train's emergency braking automatically activated, and the train's recorded speed dropped from 44 mph to 0. The investigation later determined that the UP train had passed the *stop* signal at the west end of the Macdona siding, struck the 63rd car of the BNSF train, and derailed near the west siding switch. (See figure 3.)

**Figure 3.** Accident site showing point of collision, driveway leading off Nelson Road where conductor was found, and houses where residents were trapped by gas cloud.

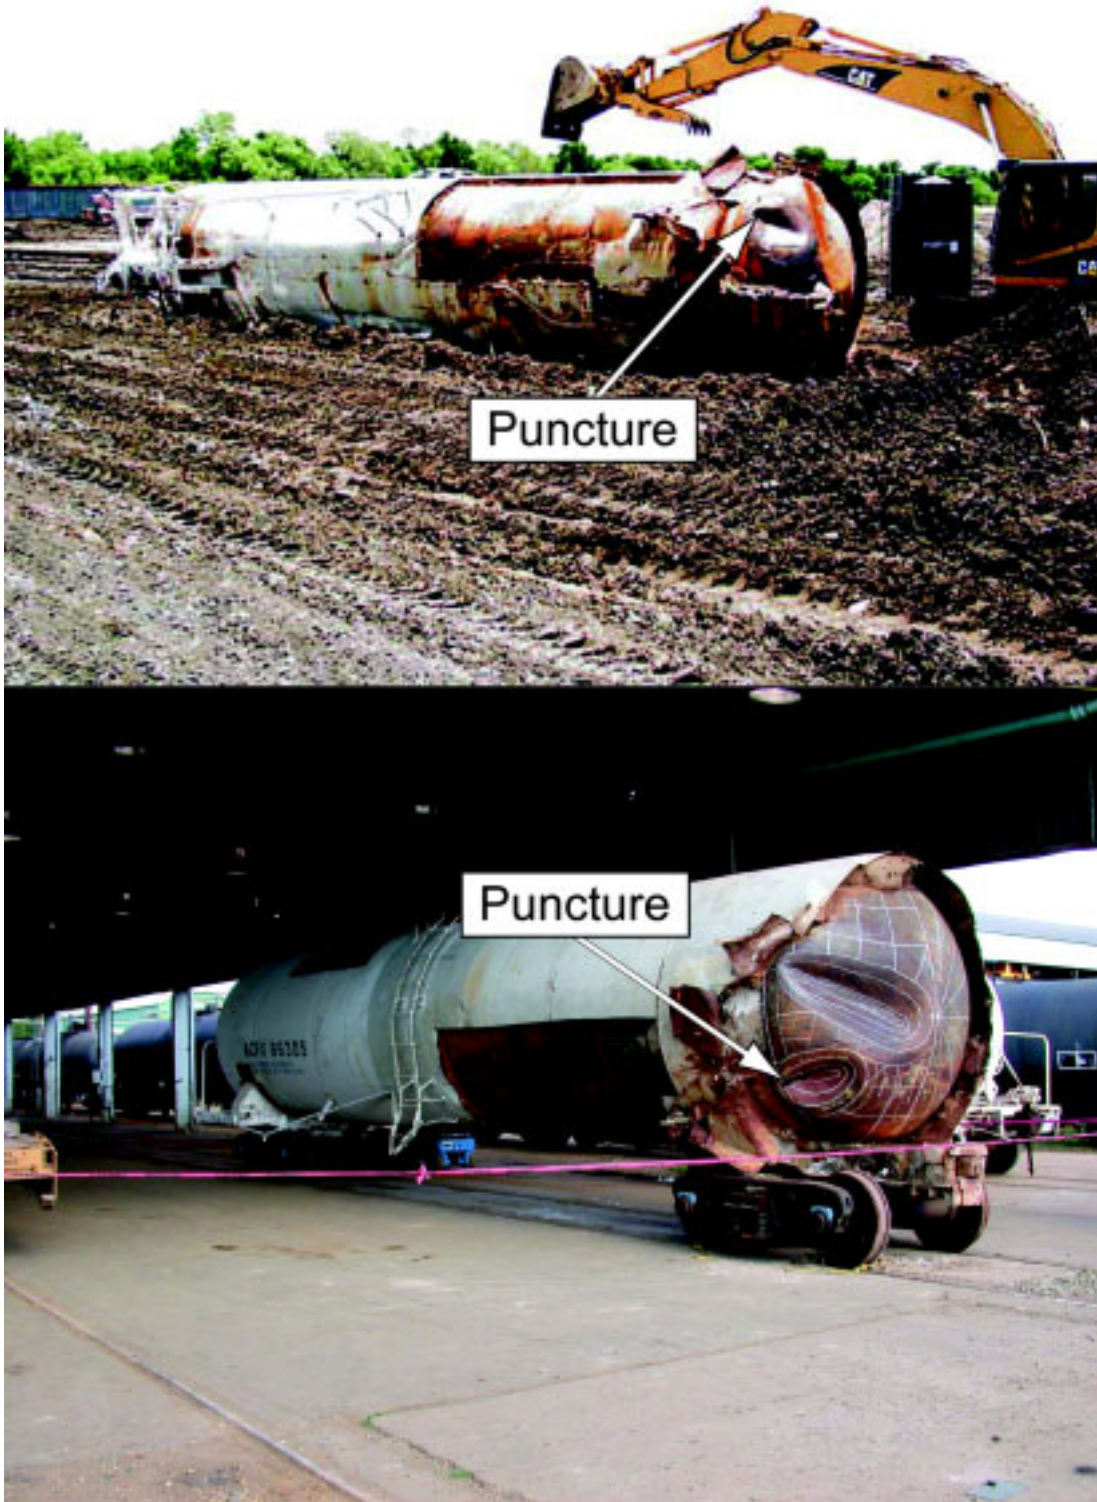
The right corner of the A-end had sustained two dents. One was a 4-inch-deep dent in the lower quadrant of the head (the curved end) of the tank. This dent contained a 2-inch by 11-inch puncture, which terminated 1 inch beyond the seam joining the tank head to the tank shell. The response team had plugged the puncture with wooden wedges during the initial response. The second dent had overall dimensions of 34 inches by 58 inches. This dent contained a rectangular impression measuring approximately 2 inches by 58 inches. There was no evidence of additional damage to the remainder of the tank head, shell, or pressure-retaining components of the car. (See figure 4.)

**Figure 4.** Punctured chlorine tank car at accident site (top) and after recovery (bottom).

The portion of the breached tank that contained the puncture and dent was cut from the car for examination. When this excised head portion was placed against the deformed corner of the flatcar with the foam residue, the fold on the top surface of the flatcar fit snugly into the punctured portion of the head. The size of the puncture and inward deformation on the head were consistent with the shape and size of the damaged corner of the flatcar.

Although the details of the fracture surface of the puncture were obliterated by exposure to chlorine and water, many portions of the fracture were on a slant plane, and the tank was severely deformed in the vicinity of the puncture. Such features are consistent with ductile failure. To gain more information about the fracture toughness and resistance to fracture of the tank head and tank shell, the Safety Board arranged to conduct Charpy tests on coupons from those areas.<sup>25</sup> The results of the Charpy tests indicated that the hot-formed tank head had properties similar to normalized steel,<sup>26</sup> with a ductile-to-brittle transition temperature of  $-40^{\circ}$  F. The tests revealed that the steel in the tank shell had a ductile-to-brittle transition temperature greater than  $85^{\circ}$  F.<sup>27</sup> At  $32^{\circ}$  F (close to the loading temperature of the chlorine in the tank car), the energy absorbed by tank shell Charpy specimens oriented transversely to the rolling direction of the steel plate (the orientation with minimum fracture toughness) averaged 13 foot-pounds.
