Derailment of Norfolk Southern Railway Company Train
68QB119 with Release of Hazardous Materials and Fire
New Brighton, Pennsylvania
October 20, 2006

NTSB/RAR-08/02

Railroad Accident Report

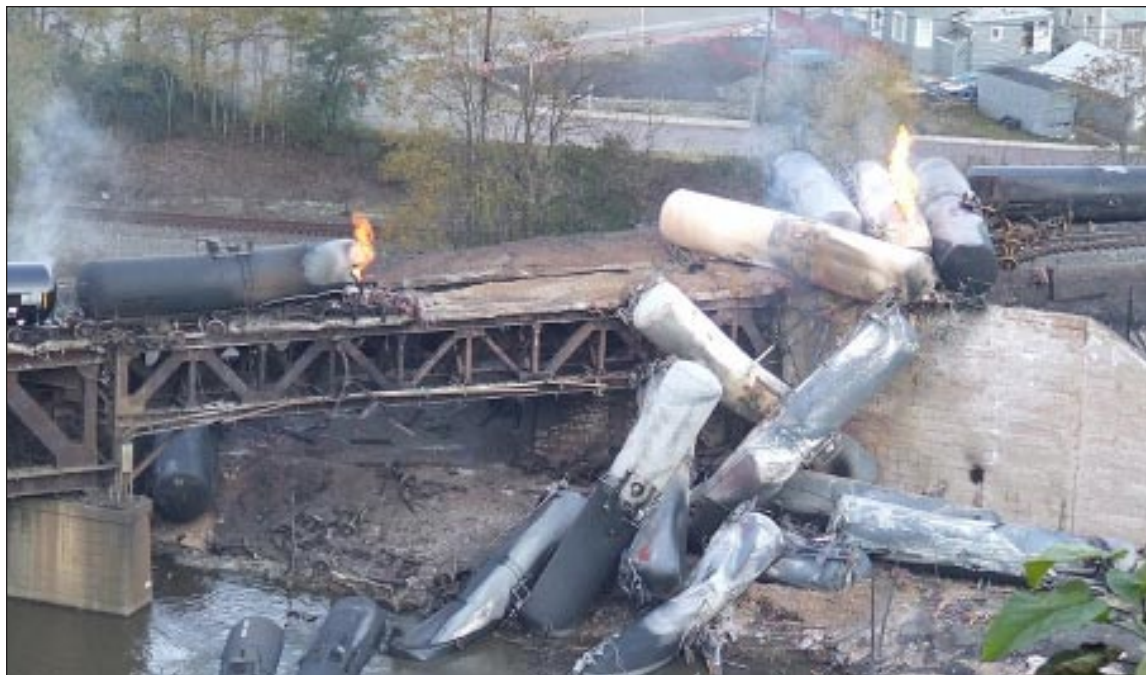
Figure 1. View of derailment. NS train 68QB119 was traveling from left to right.

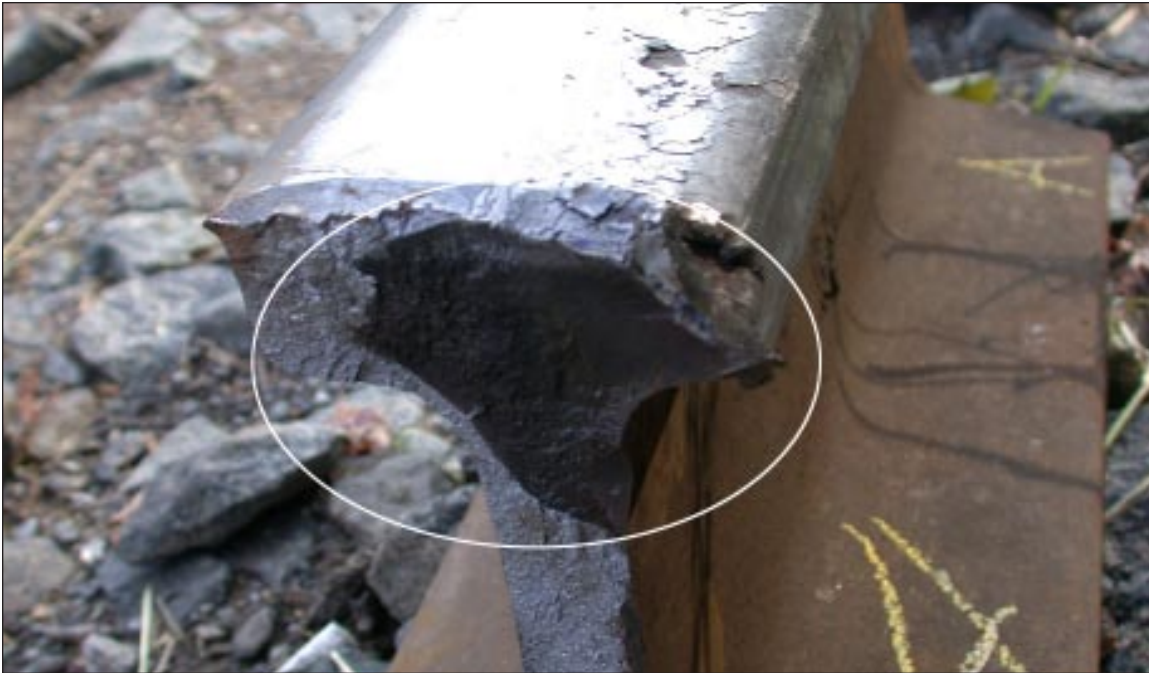
Safety Board investigators found no track anomalies or evidence of dragging equipment west of the location between a destroyed track section near milepost PC 29.26 and milepost PC 30.5 on main track 1. Based on the footprint⁸ of the derailment, investigators determined the point of derailment to be the north rail at milepost PC 29.26. At this location, investigators found pieces of broken rail under the last derailed car, some of which exhibited markings consistent with rail-end batter.⁹ A total of seven segments of broken rail were recovered east of milepost PC 29.26 and sent to the Safety Board's Materials Laboratory for further examination. (The results of these examinations are detailed in the "Tests and Research" section of this report.) Five rail defects described as "detail fracture from shelling"¹⁰ (also called a *shell crack*) were visibly evident on the fracture faces of the rail head segments. (See figure 3.)

Figure 3. Recovered rail showing detail fracture from shelling in head area.

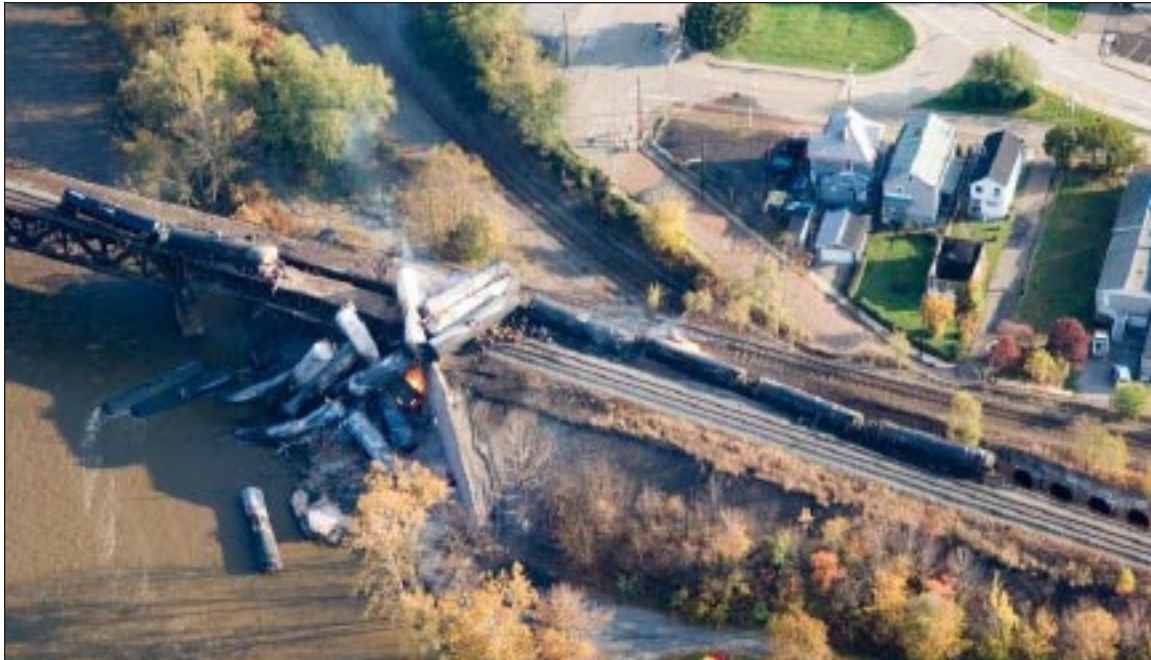
The NS Beaver River bridge is a 10-span steel and concrete-ballasted deck bridge that spans both the river and the CSX railroad tracks. The top of the rail is about 35 feet above the river. The 1,314-foot-long bridge was built for the Pennsylvania Railroad in 1926 by the Mount Vernon Bridge Company. Two parallel bridge structures support a double main track with the track on the south side of the bridge designated track 1 and the track on the north side designated track 2. The train derailed at the eastern end of the bridge where the two main tracks that cross the bridge begin curving away from each other on separate bridge spans. (See figure 4.)

Figure 4. View of derailment showing track layout and curved track.

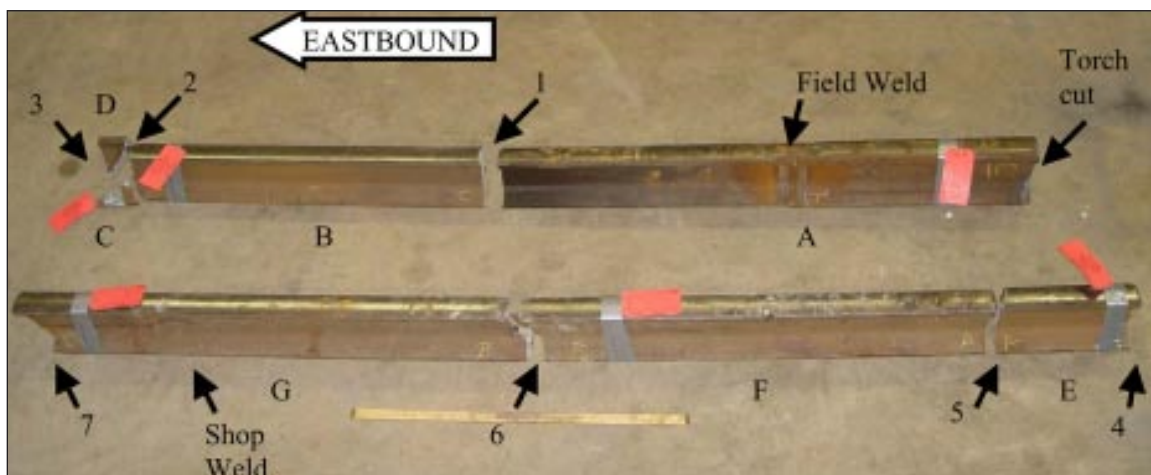
About 19 feet of broken rail (five pieces varying in length from 13.75 to 60.5 inches and two small pieces) from the accident area were recovered and transported to the Safety Board’s Materials Laboratory for examination. The rail pieces came from the north rail (left rail in direction of train movement) and included the rail from the identified point of derailment. Initial examination and measurement revealed that a rail piece about 64 inches long had not been recovered. The total length represented by the recovered rail was thus about 24 feet 4 1/2 inches. The rail pieces were laid out and matched to determine their original placement, as shown in figure 5.

Figure 5. Field side of recovered rail after reassembly. (The rail pieces are lettered west to east; fractures are numbered west to east. The missing 64-inch-long rail section is bounded by fractures 3 and 4.)

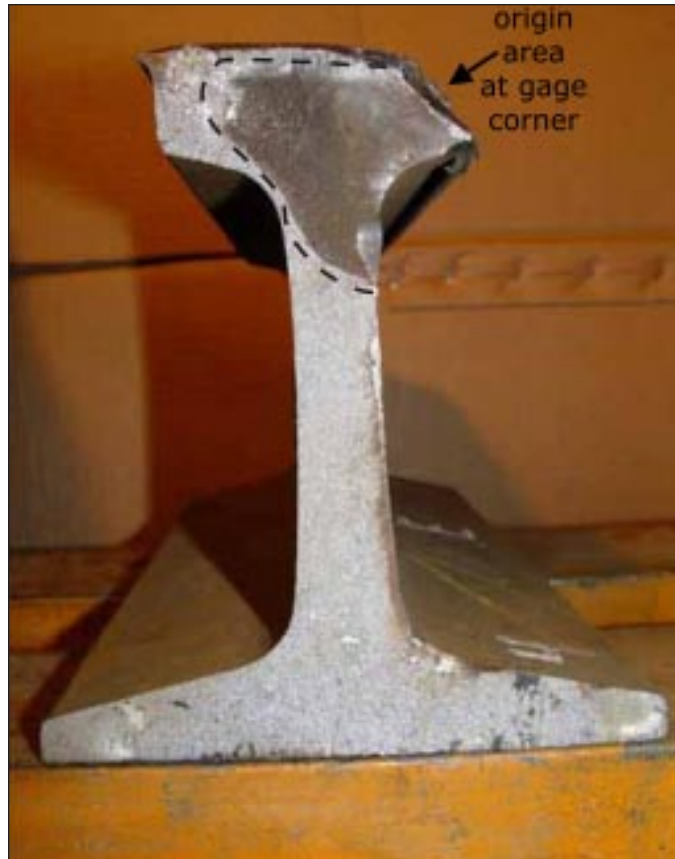
Shell flakes, spalling, and open shell cracks were present along the length of recovered rail. The rail contained seven complete fractures (through the rail head, web, and base), which are numbered 1 through 7 in figure 5. Six of the seven fracture faces contained transverse defects encompassing from 8 to 78 percent of the worn rail head area. All the defects showed features consistent with a detail fracture from shelling, with several fractures emanating from an open shell crack at the gage corner. The largest defect, covering 78 percent of the worn rail head, was found at fracture 4. The second largest defect, covering 45 percent of the worn rail head, was at fracture 5. Both fracture surfaces showed features consistent with detail fracture from shelling. (See figure 6.)

Fractures 4 and 5 were at each end of a 14-inch-long piece of rail. This piece had receiving rail-end batter at fracture 4, and the other end of this piece had no trailing batter at fracture 5. The mating piece of recovered rail had a relatively small amount of receiving batter at fracture 5.

Figure 6. View of east surface of fracture 4. (The dashed line indicates the boundary of a detail fracture covering about 78 percent of the worn rail head and extending into the web. The defect emanated from an open shell crack at the gage corner.)

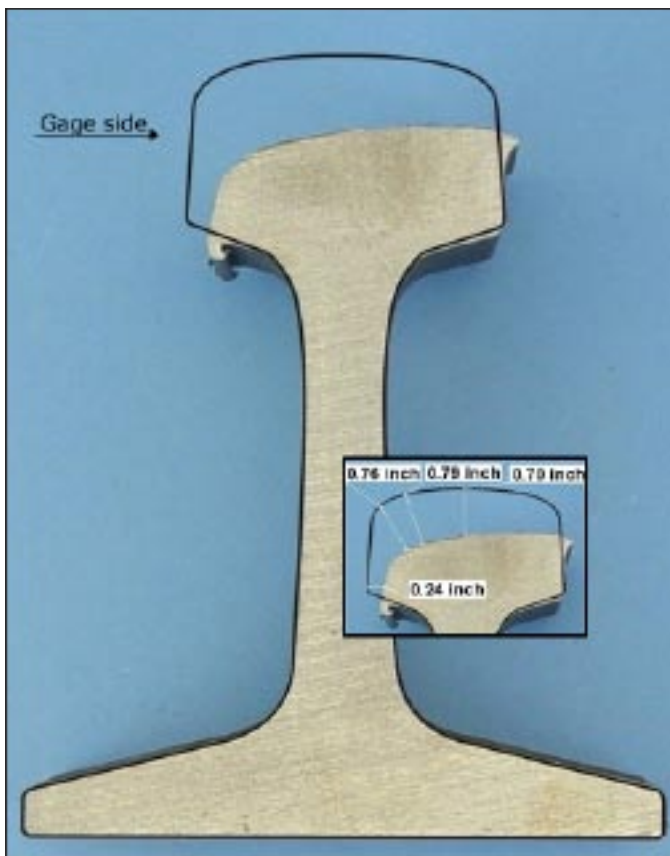
At each of the six locations where the ultrasound inspection had indicated a possible defect, Safety Board investigators cut and then fractured the rail. Four of the fractures had uniform rough gray features consistent with overstress fracture with no indications of transverse defects intersecting the lab fracture surface. A portion of the surface of one lab fracture had features consistent with a defect that had not opened to the surface. This defect covered about 5 percent of the worn rail head area. Two areas of the surface in another lab fracture had features consistent with a pair of transverse defects in proximity to one another. These combined defects

covered less than 5 percent of the remaining head area. A shell crack that was oriented almost parallel to the gage corner was observed at the inner boundary of the detail fracture areas, and the fracture features radiated outward toward the surface from the intersection with the shell crack. None of the transverse defects that were found at the lab fracture locations had been indicated during the lab's inspection using the 70° transducer from the running surface of the rail.

Figure 7. Cross section of one of the recovered rail pieces examined in the Safety Board's Materials Laboratory. (Superimposed on the rail is a profile of new 140-pound rail. The inset image shows the amount of head loss since rail was new.)
