NATIONAL TRANSPORTATION SAFETY BOARD
WASHINGTON, D.C.

SAFETY RECOMMENDATION(S)

P-83-11

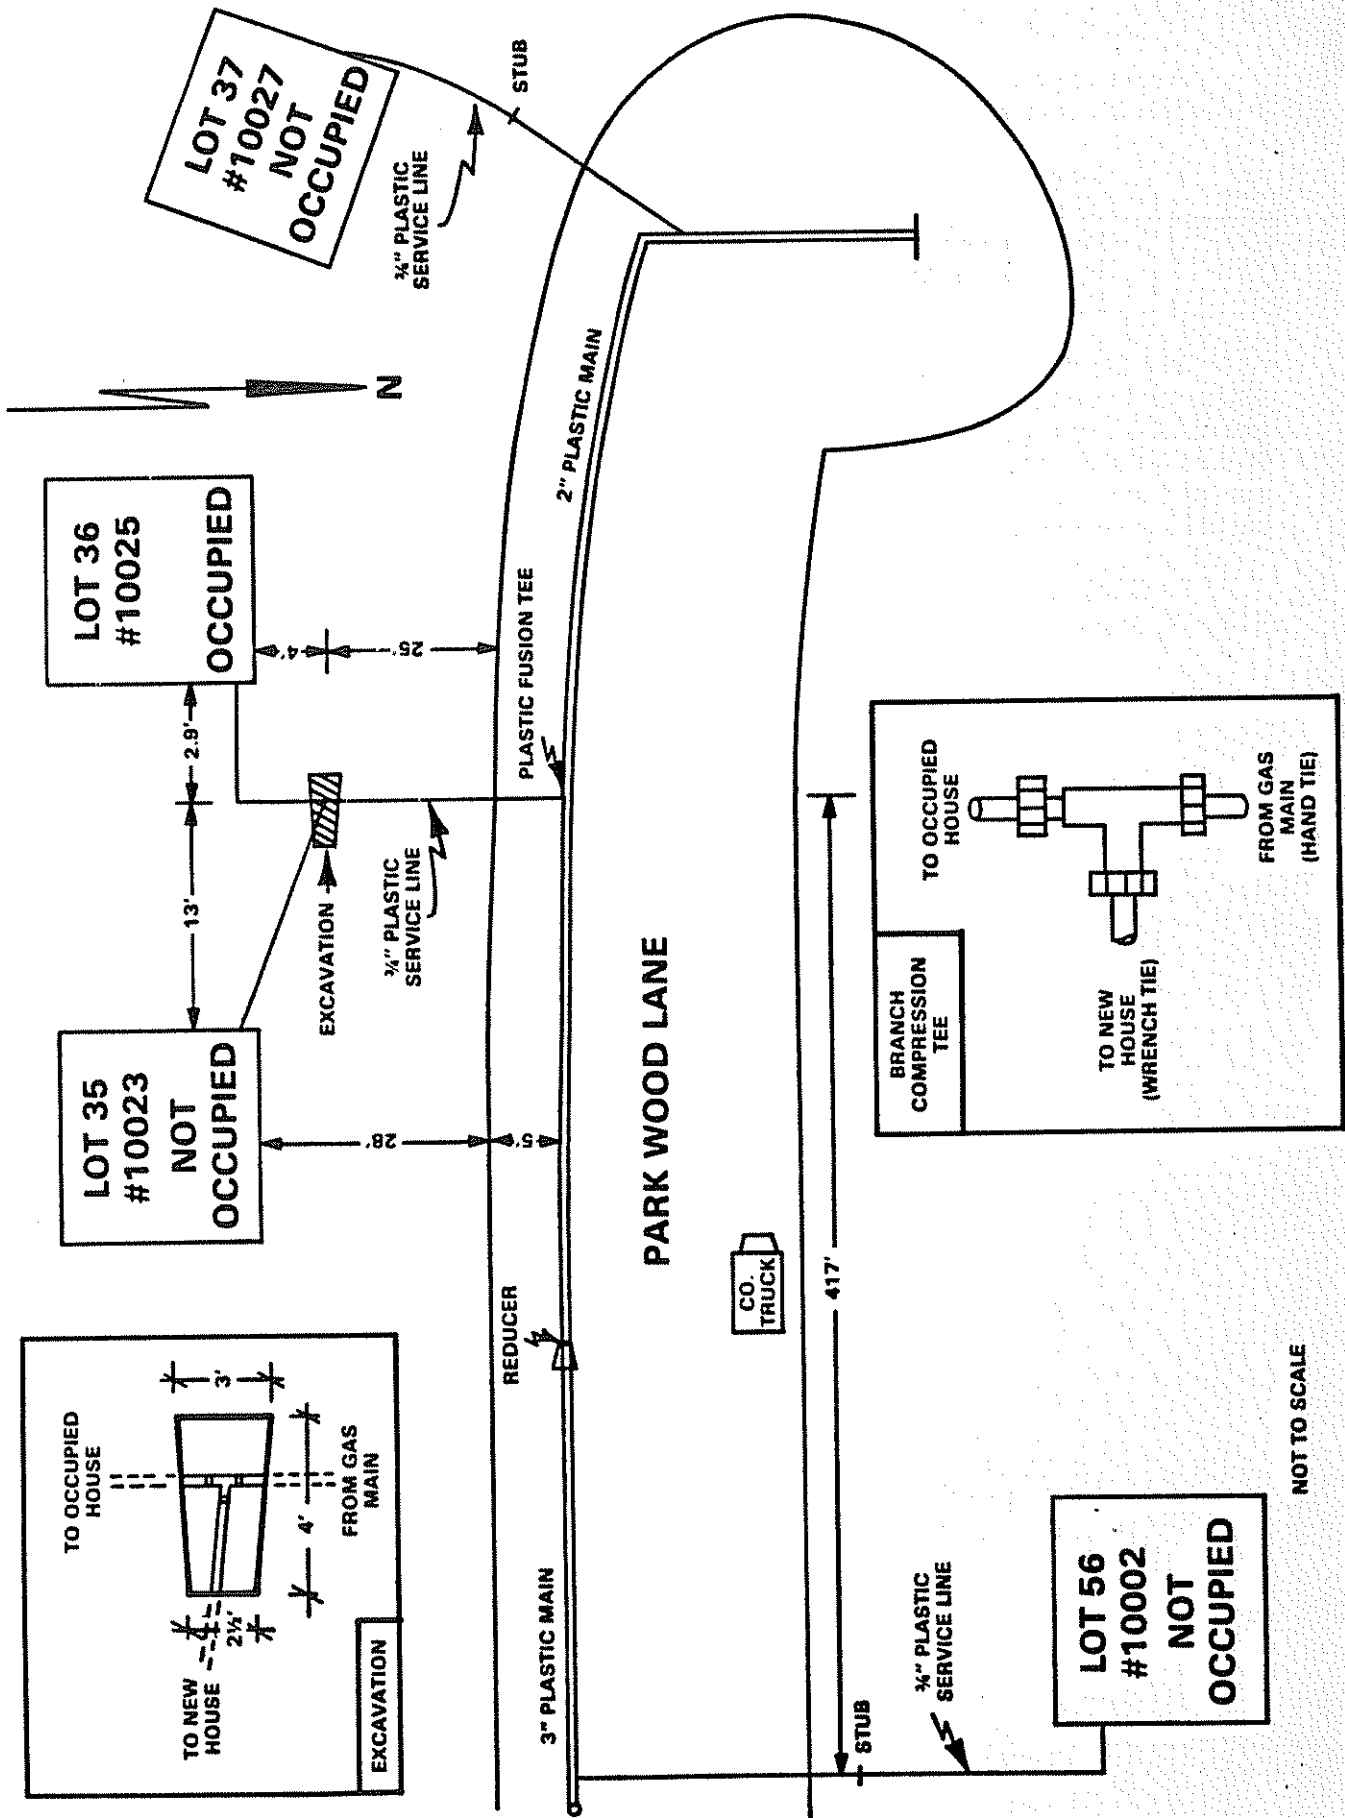
FIGURE 1: PLAN VI OF ACCIDENT SITE

About 10:30 a.m., the crew arrived at the work site and connected the service line for residence No. 10027 (see figure 1) to an existing service line stub. After making this connection, the crew was to install a branch service line to residence No. 10023 from the service line connected to the house next door, No. 10025. Using hand tools, a hole 30 inches deep was excavated to expose the plastic service line. The service line was cut, and the end of the service line segment which contained gas under pressure was sealed with a cap. The installation required that a branch tee connection be installed in the service line to No. 10025 to allow No. 10023 to be served from the same service line. A check of the service truck disclosed that the appropriate compression tee was not available at the job site; by radio, the crew leader called the foreman and advised him that a branch tee was needed. While waiting for the requested fitting, the crew began work at residence No. 10002.

After removing the crew mechanic from the excavation, the crew leader and helper mechanic noticed that the compression tee was partially installed. One downstream connection was completed; the other downstream connection had been made, but the retaining nut was only hand-tight. The upstream connection had not been made, and the cap had been removed from the portion of the service line under pressure. Company
