**INTERIM REPORT OF THE  
U.S. DEPARTMENT OF  
ENERGY'S POWER  
OUTAGE STUDY TEAM**

**FINDINGS FROM THE SUMMER OF 1999**

**January 2000**

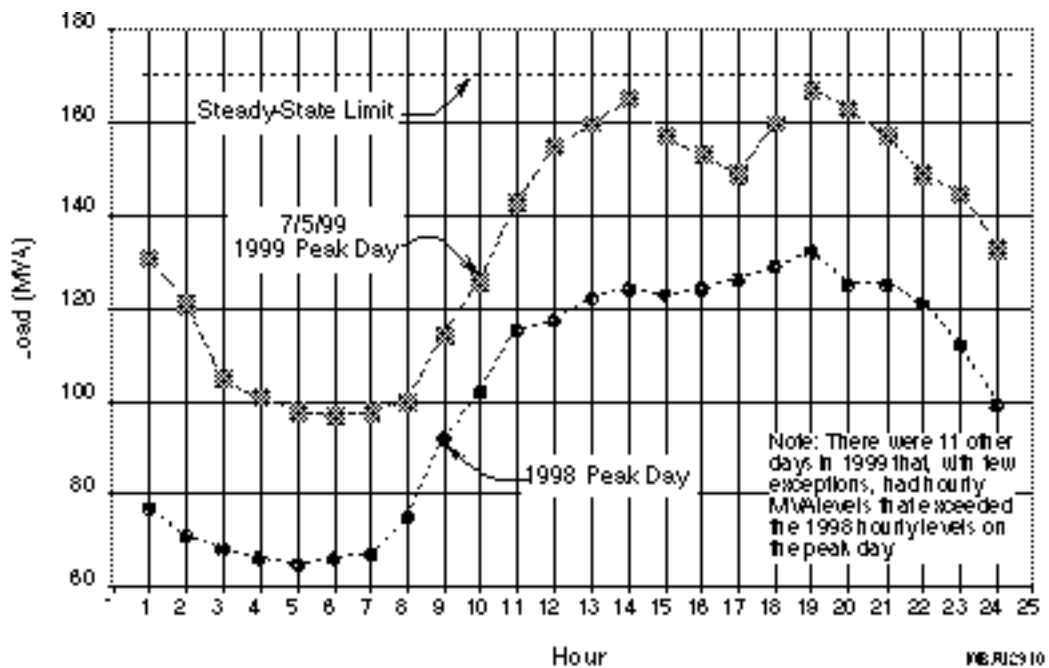
Figure 3 Long Island: Long Island Power Authority’s Hourly Loads in the South Fork Area

During the heat storm, loss of one major generating station on Long Island would have required load shedding. The South Fork of Long Island, an area that has experienced rapid load growth, was on the edge of *voltage collapse*. Voltage collapse probably would have occurred if the peak demand had not been reduced as a result of voluntary load curtailment procedures, a 5% voltage reduction, and load decreases associated with overloaded wire burndowns. The peak load in the South Fork on July 5 was 25% higher than last year's level.

Figure 3 shows plots of South Fork load versus time on the July 5, 1999 peak, and the 1998 peak. The figure also shows the maximum steady state-limit before voltage collapse.

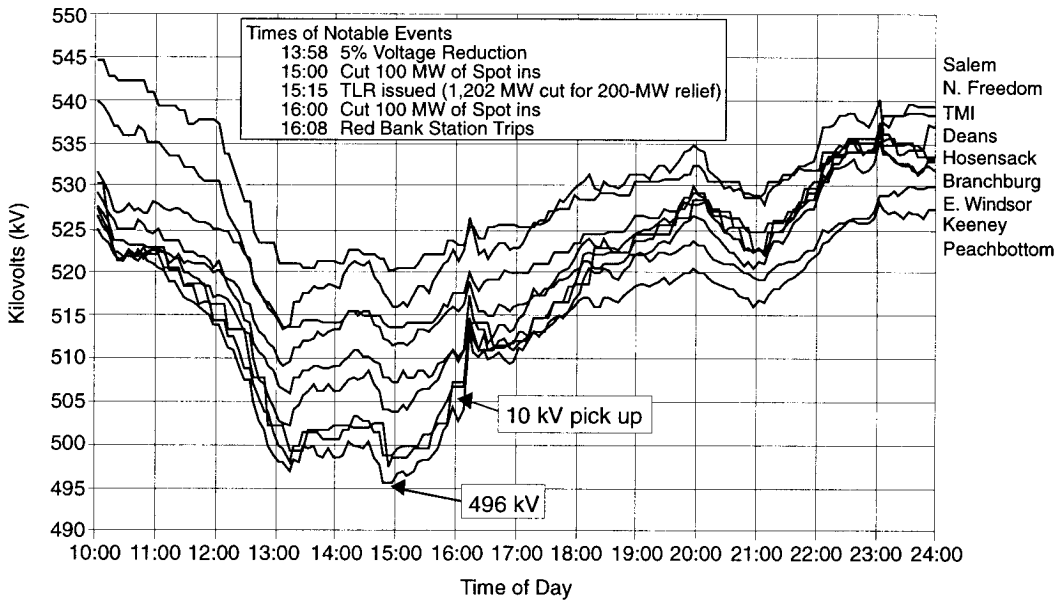
**Figure 4 Mid-Atlantic Area: PJM Interconnection 500-kV Voltage Profile on July 6, 1999**

Between 12:00 noon and 1:00 p.m. on July 6, voltages on the PJM system began to drop precipitously (Figure 4). PJM responded by taking its remaining, short-lead-time, interruptible customers off line, starting maximum emergency generation, issuing appeals for voluntary customer load curtailment, and curtailing emergency exports to NYPP.

Starting shortly after 1:00 p.m., voltages stopped dropping, and, in some areas, they began to recover. However, between about 1:00 and 4:00 p.m., voltages remained low. Moreover, they dropped slightly again just before 3:00 p.m., before they started to recover. During this period, PJM ordered a 5% voltage reduction. It also took actions to reduce the effect of parallel flows on its system by issuing a TLR on the eastern PJM-to-NYPP flowgate. The load loss that resulted from the outage at the Red Bank substation (described in the section on New Jersey) had a measurable beneficial impact on PJM system voltages, although by this time, system voltages were already recovering. By 10:21 p.m. that July 6 evening, the last emergency action taken by PJM was lifted. So on July 6, PJM had operated for 12 consecutive hours above its previous all-time load.

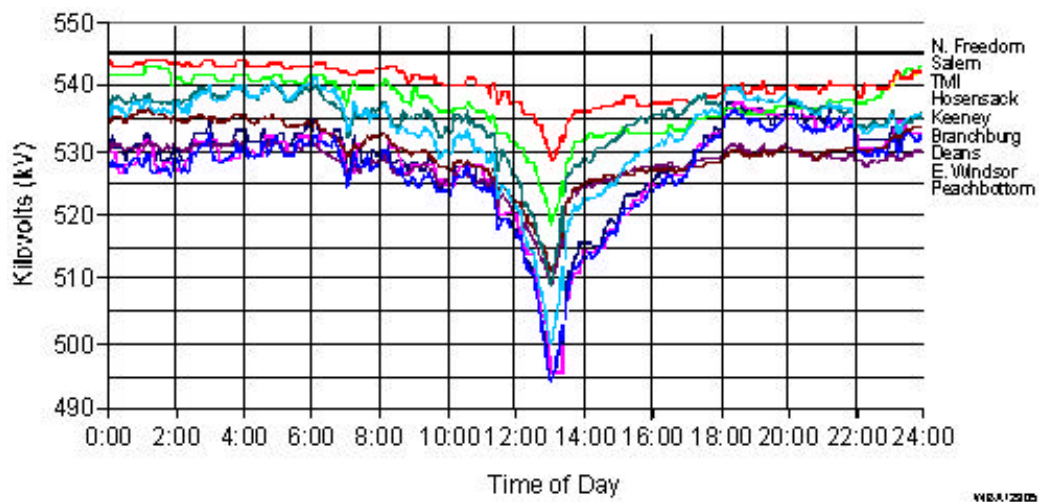
**Figure 5 Mid-Atlantic Area: PJM Interconnection 500-kV Voltage Profile on July 19, 1999**

On July 19, 1999, PJM experienced a similar drop in system voltages. Once more, the drop started at about 12:00 noon and reached a low point at about 1:00 p.m. (Figure 5). PJM implemented a series of actions that included a 5% voltage reduction, load management, increased eastern generation, and reduced imports from the west. In contrast to the slow restoration of voltages that occurred on July 6, on July 19, the system responded quickly, and normal voltages were restored within about one hour.

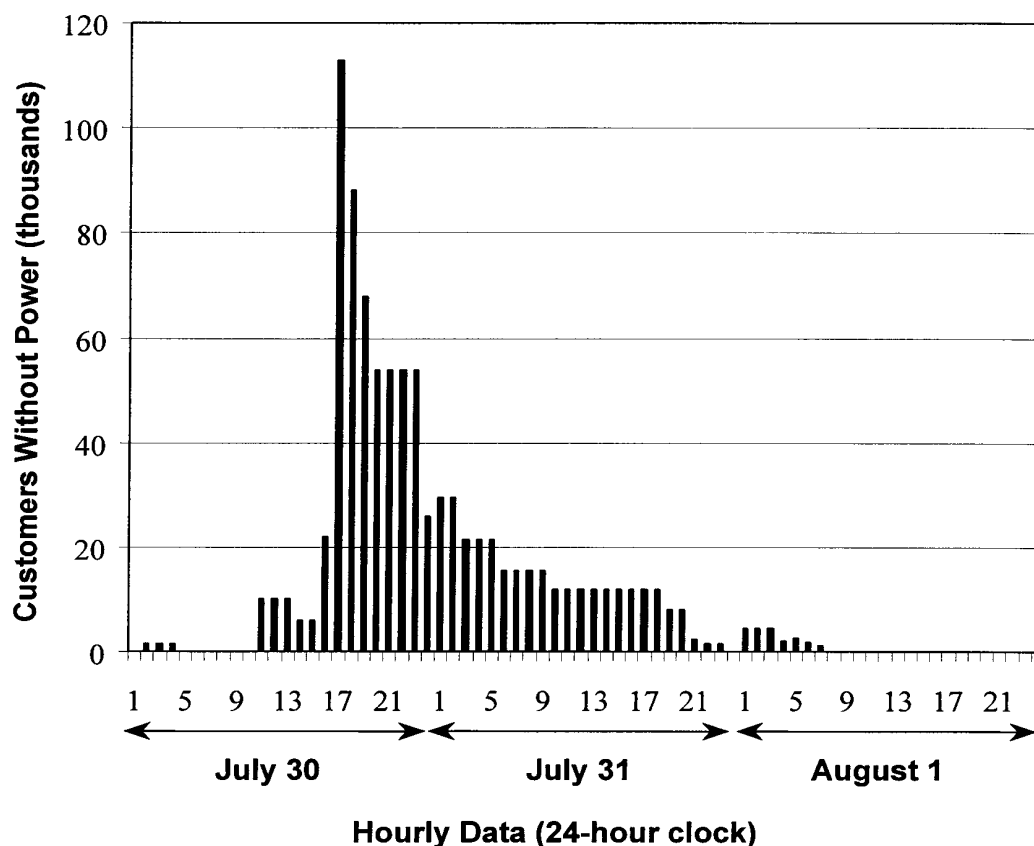
**Figure 8 Chicago: Customer Outages Associated with Commonwealth Edison's Northwest Substation**

On July 30, a modest number of customers were without power during the working hours; however, in the late afternoon (between 4:00 and 5:00 p.m.), the number of customers affected by the outage increased and remained quite high until midnight. Figure 8 traces the severity of the outage. The restoration process that proceeded through Saturday, July 31, and Sunday, August 1, is also evident in that figure.

The events that caused the loss of power to customers served by the Northwest substation related primarily to two classes of equipment: 12-kV cables and 12- to 4-kV transformers. The basic cause appears to have been 12-kV cable faults. In cases where the cable supplied a transformer, that transformer was de-energized with the cable. In other cases, de-energizing transformers, coupled with the overall high load conditions, overloaded other transformers. The units at the Northwest substation were protected by ComEd's Transformer Overload Relief Scheme, an automated process of relay actions that remove load from a transformer operating above its rated capacity. As a result of the

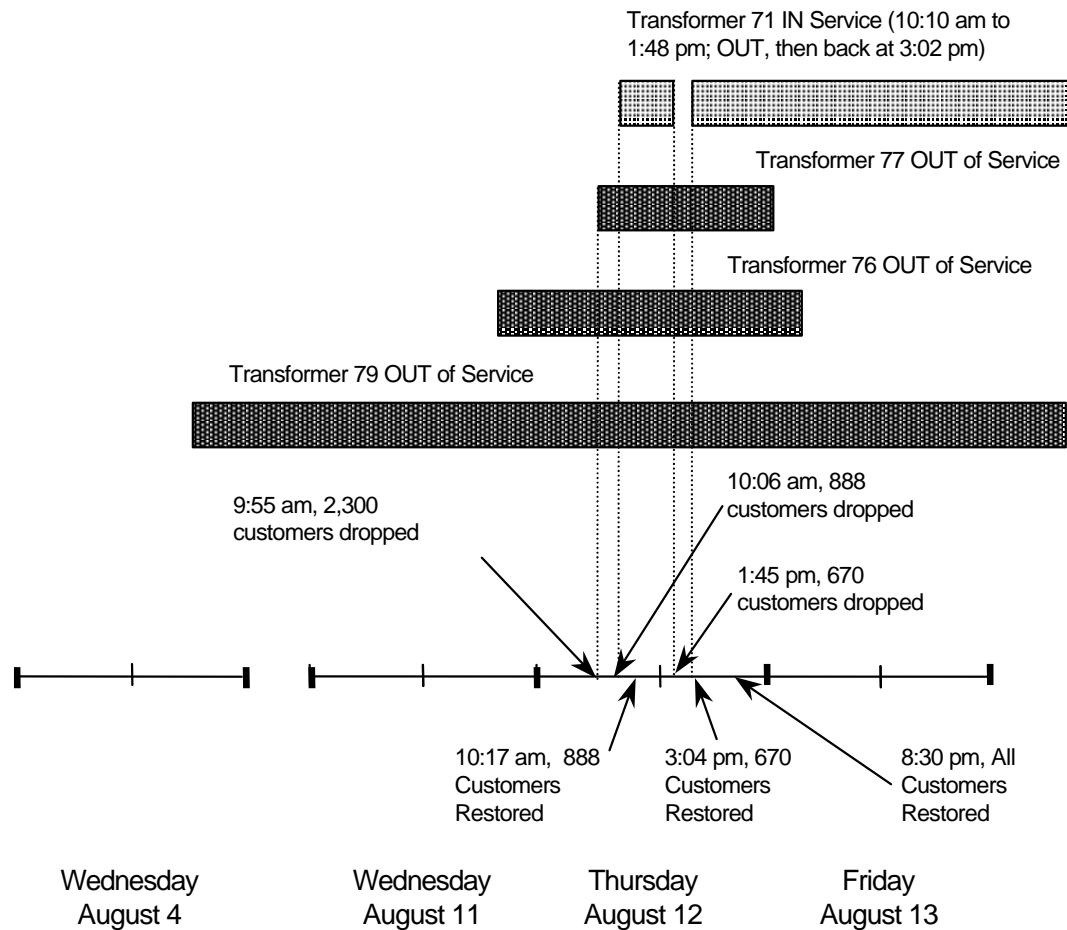
**Figure 10 Chicago: Event Timeline for Commonwealth Edison’s Jefferson Substation**

At 4:19 p.m. on Wednesday, August 4, 1999, one transformer bank was removed from service because routine testing revealed evidence of overheating and arcing. The situation remained stable for one week, and the three remaining Jefferson transformer banks proved adequate to serve their load.

At 7:44 p.m. on Wednesday, August 11, a second transformer bank was automatically de-energized because of a fault on its associated 69-kV secondary cables. Inspection showed two failure points in the 69-kV cables. The substation was reduced to having only two operational transformer banks, each with a manufacturer's continuous power rating of 200 MVA. To put these ratings in perspective, consider that Jefferson substation's load had peaked earlier on this day (August 11) at 473 MVA. At 11 p.m., plans were made to shift load to the LaSalle substation so that demand would be removed from the 69-kV portion of the regional transmission system onto the 138-kV portion of the system.

On Thursday, August 12, at 9:39 a.m., one of the two remaining Jefferson transformer banks was automatically de-energized because of a fault on its 69-kV secondary cables. As a result, a single, 200-MVA-rated transformer was available for servicing the Jefferson load, which had reached a level of approximately 360 MVA at 9:30 a.m. To avoid overload and permanent damage to the remaining transformer bank, ComEd shut down its Vernon Park substation, which removed 2,300 customers and 55 MW of load from service at 9:55 a.m. At 10:06, additional load was intentionally shed by shutting down a section of the 12-kV distribution grid, which interrupted service to an additional 888 customers.

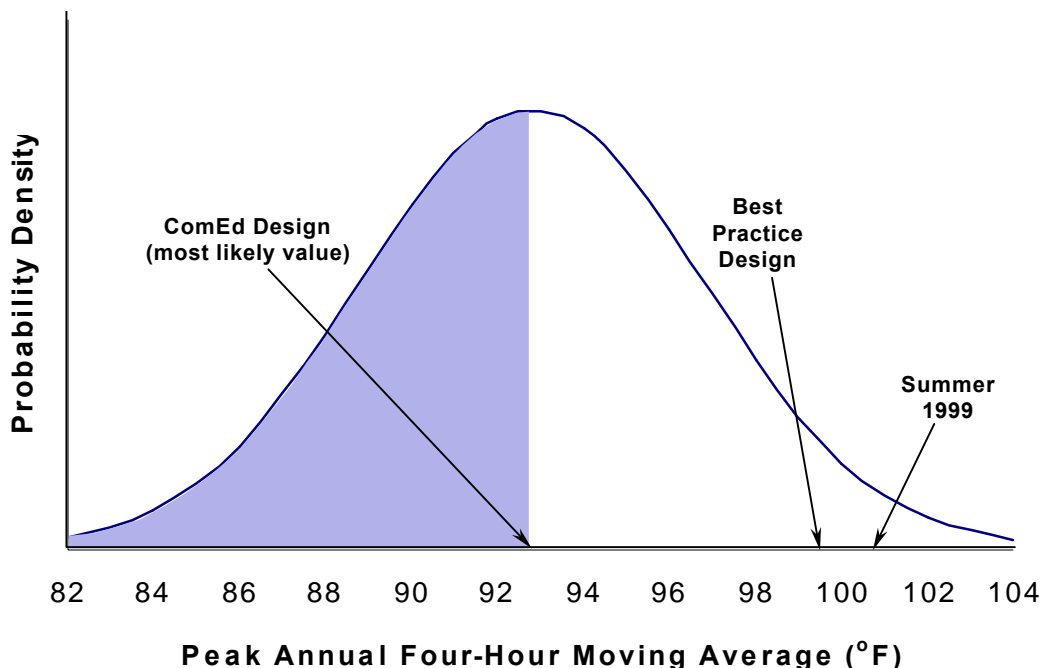
Figure 11 Chicago: Value for the Average of Extreme Weather Used by Commonwealth Edison for Forecasting

28. **Load forecasting techniques and associated distribution planning tools failed to adequately accommodate the effects of unusual summer weather conditions as experienced in 1999. (Reliability Metrics, Planning, and Tracking)** – Planning has been based on “average” weather conditions, meaning that load exceeds the design criterion approximately once in every 2 or 3 years (Figure 11). A criterion of 1 in 10 years is more commonplace in the industry. These shortcomings were compounded by further uncertainty in predictions for individual substation load levels. ComEd has now changed to a 99°F, four-hour moving-average peak temperature as a basis for planning.
29. **Emergency preparedness and management plans did not address distribution problems. (Operations Management and Emergency Response; Reliability Metrics, Planning, and Tracking)** – Although ComEd had an emergency plan for

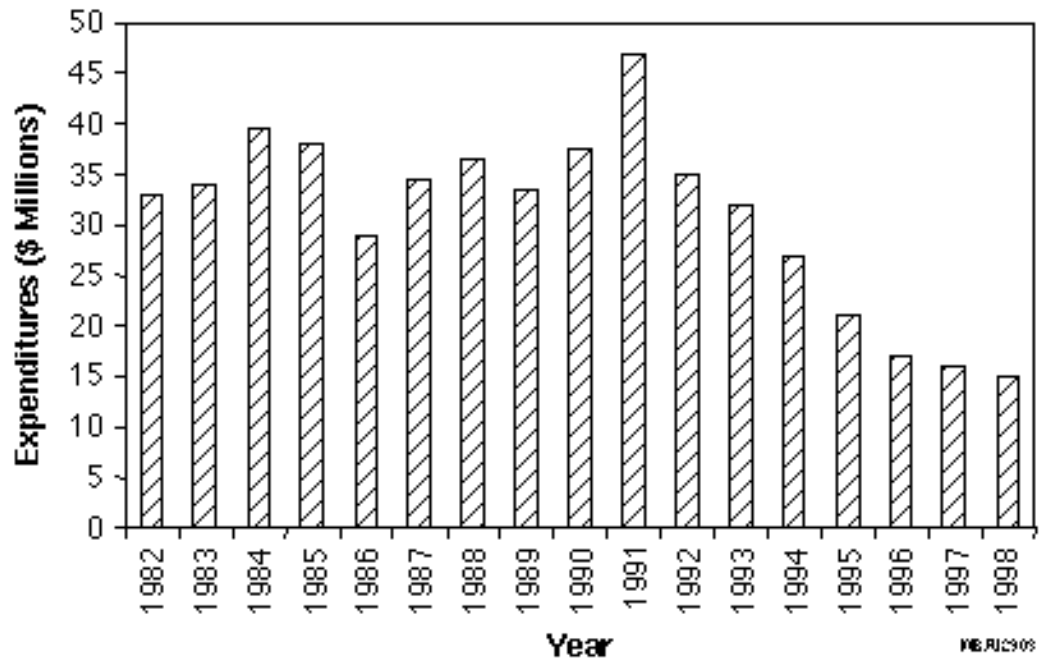
Figure 12 Chicago: Annual Substation Maintenance Expenditures for Commonwealth Edison

37. **Transmission and distribution maintenance expenditures declined over time and became inadequate. (Transition to Competitive Energy Service Markets; Regulatory Policy for Reliable Transmission and Distribution)** – T&D maintenance expenditures declined dramatically and consistently from 1991 to 1998 (e.g., see the annual substation maintenance expenditures shown in Figure 12). The decline coincided with other cost pressures faced by ComEd, including those associated with nuclear plant maintenance and industry restructuring.

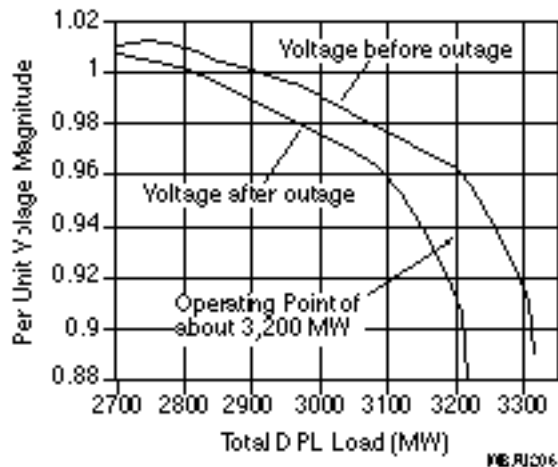
**Figure A.1 Delmarva Peninsula: Power Voltage Curves for Delmarva Power & Light Company’s Lewes Substation 69-kV Voltage before and after the Indian River 2 Generator Outage**

Figure A.1 shows the curves for 69-kV voltage at the Lewes substation when IR2 was in service and out of service. These curves were developed by solving multiple power flows for each situation and then plotting the Lewes substation 69-kV voltage. Note that when IR2 is out of service, the system operating point of 3,200 MW is very close to the point of maximum loadability, when voltages could collapse toward zero, and emergency actions would be needed to avoid catastrophic failure.
