National Transportation Safety Board

Flora Investigation

- Focused on:
 - Canadian National's Track Maintenance
 - Federal Railroad Administration's Oversight of Railroad's Track Maintenance
 - Amtrak's Emergency Preparation
- More than 4,000 man-hours

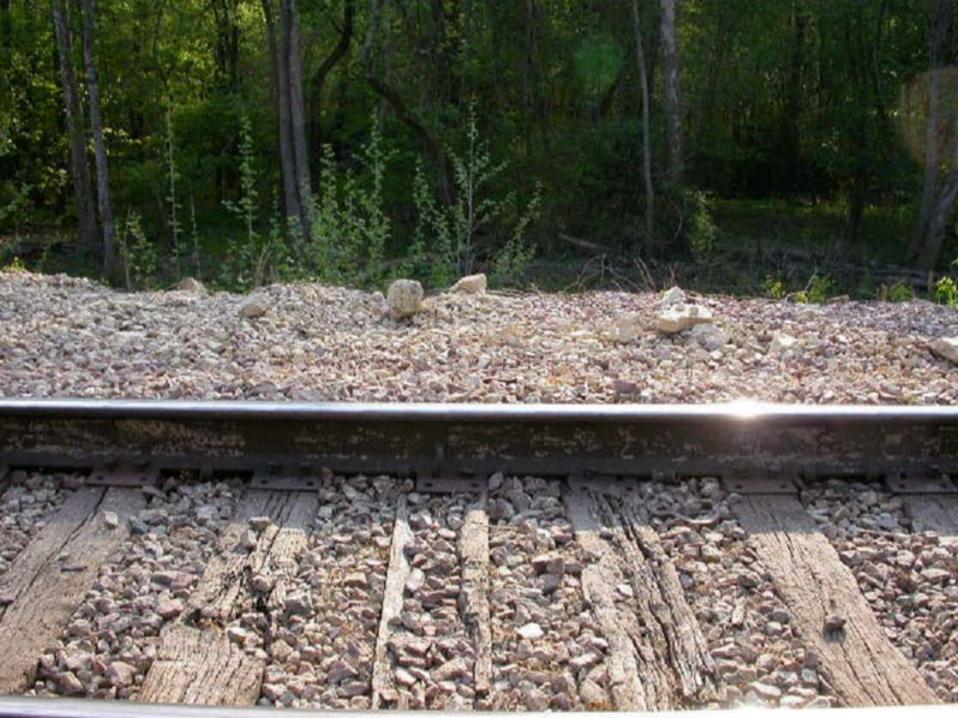
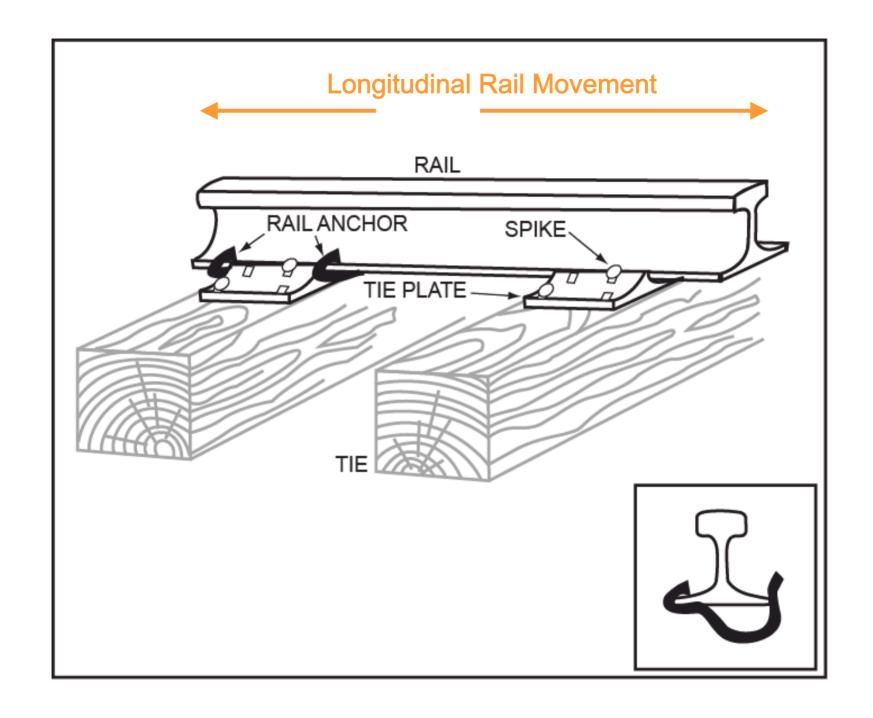
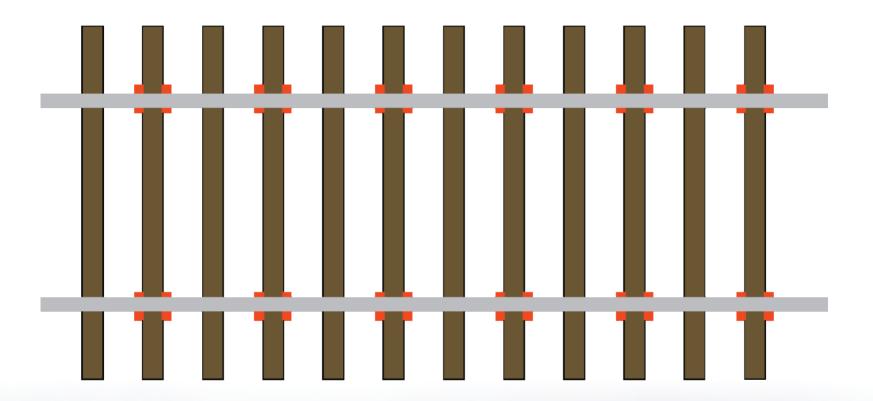
Track Conditions

- Marginal crossties north and south of the rail plug
- Missing rail anchors and loose fasteners
- Rail anchor movement

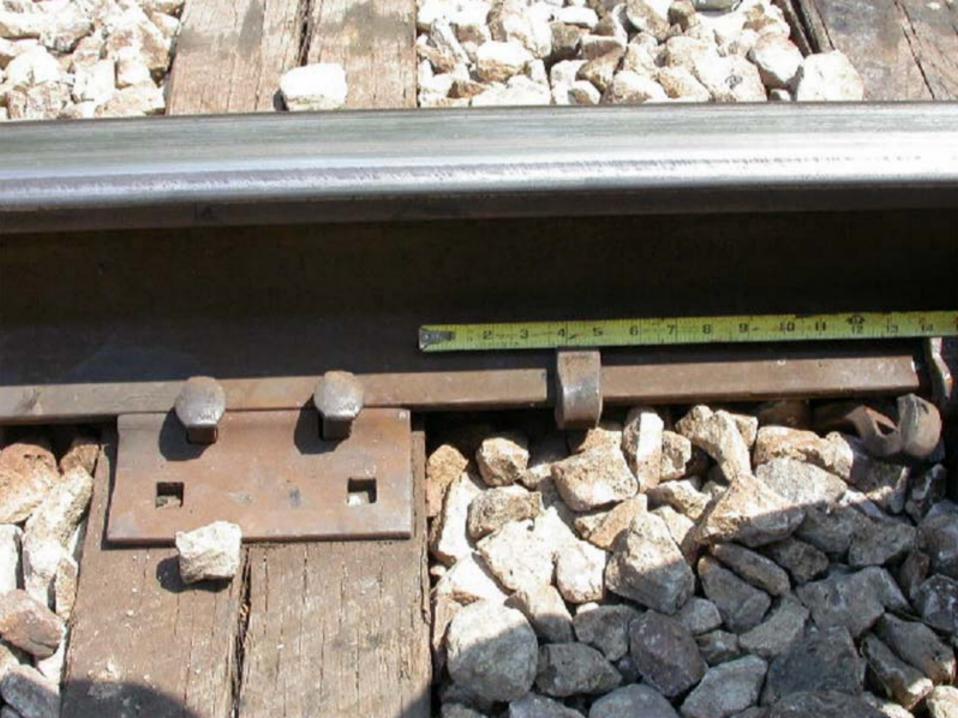
Postaccident Investigation

- 281 ties surveyed
- 50% of anchors ineffective or missing
- Lack of longitudinal rail restraint

The inadequately restrained east rail lifted out of the tie plates because of expansion caused by warm temperatures resulting in the rail shifting and the gage widening, causing the wheels of the train to drop between the rails.
