**National Transportation Safety Board**

# Factors in Tamaroa Rail Failure

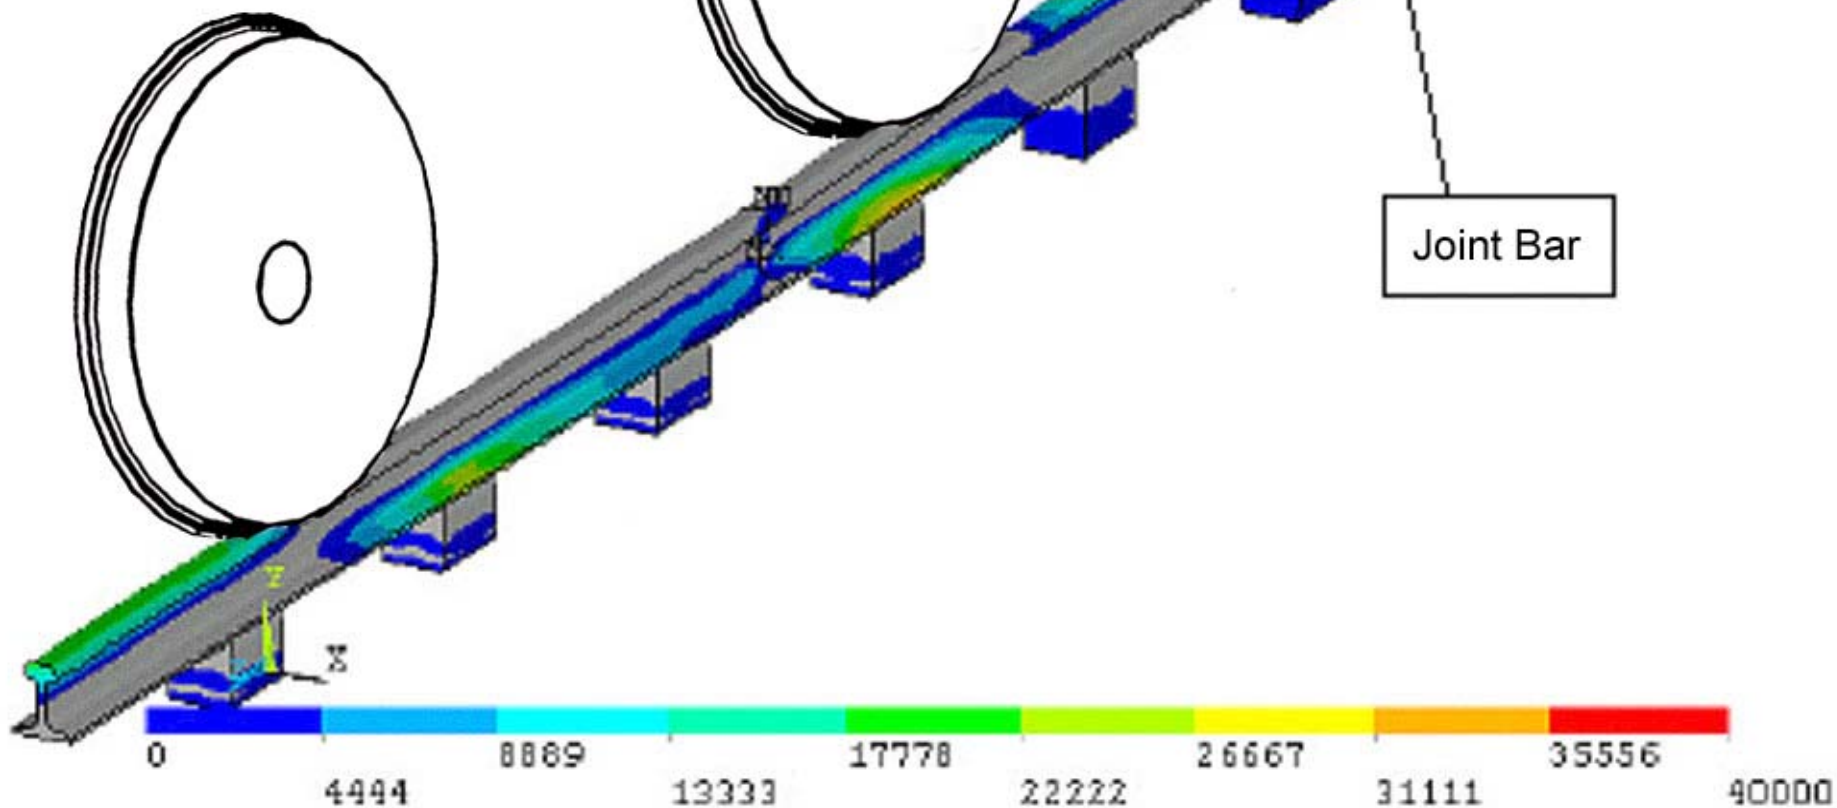
High Bending Stress  
Caused by Change in  
Rail Stiffness

- Soft ballast conditions
- Increased bending stresses

- The known soft ballast condition in the area of the insulated joint increased the amount of rail flexing in that area which, in turn, significantly increased stresses in the rail.

- The increased stresses due to the flexing of the rail in the area of the insulated joint caused the propagation of the cracks that had originated in areas of untempered martensite at the rail head, causing the rail to fail only 17 days after installation.

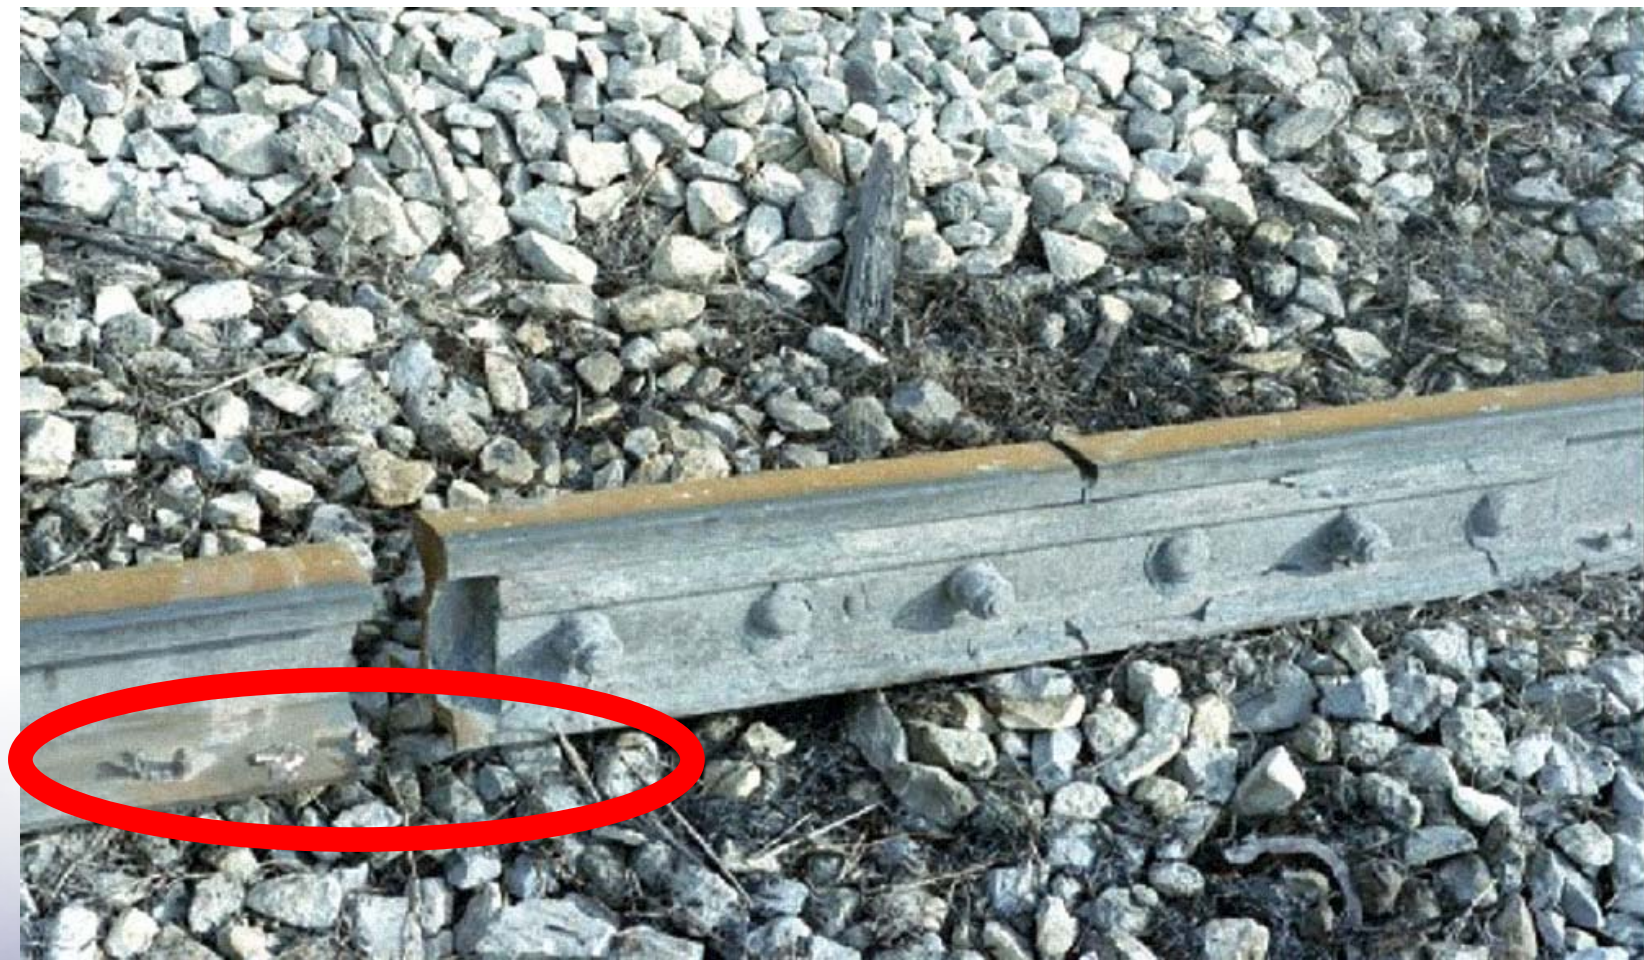
# St. John's Insulated Joint Plug

- Failed at an exothermic bond wire weld
- The welds were made on a high stress area outside the confines of insulated joint bars

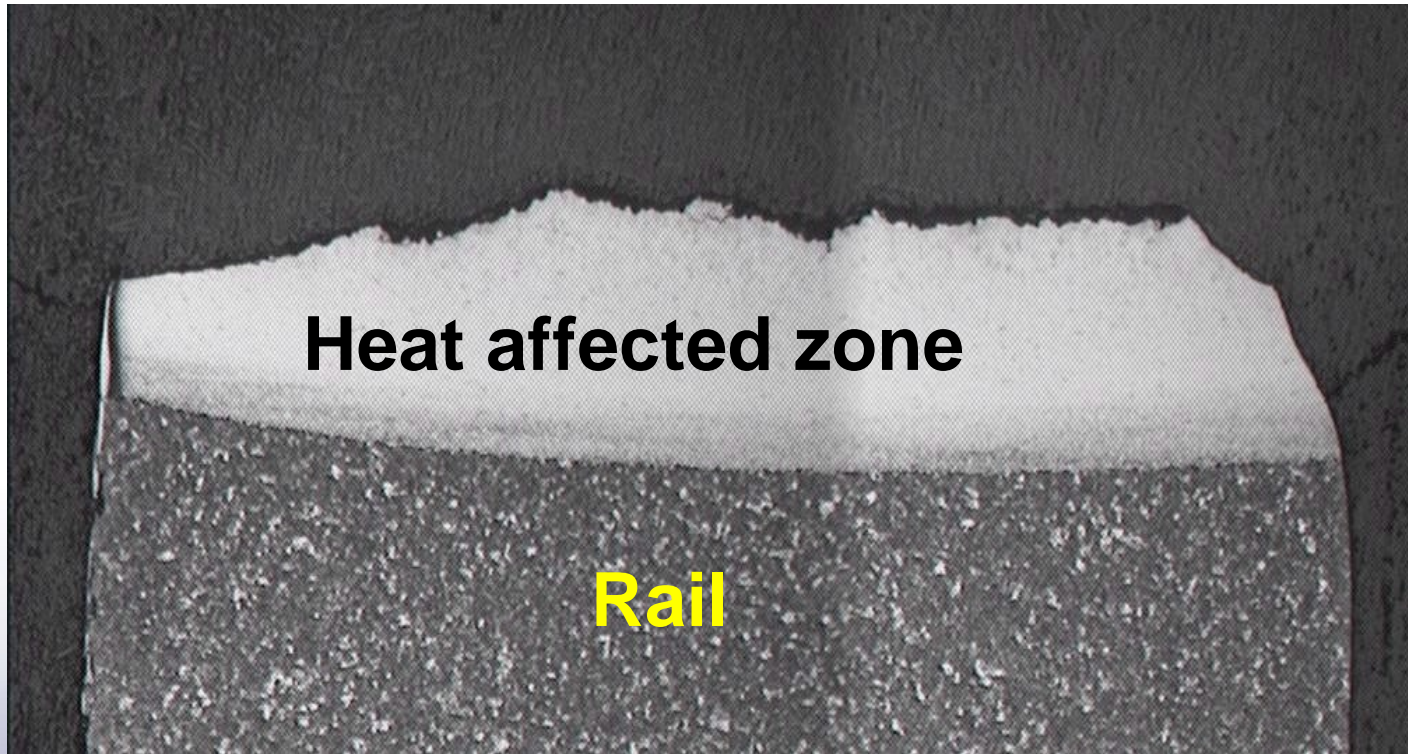
# Section Through Rail Head Fracture

- Bond wire welding produced untempered martensite.
- Fatigue cracks developed from areas of untempered martensite.
- The bond wire welds had been located at a high stressed portion of the insulated joint.
- The bond wire at the fracture initiation of the St. Johns rail had been installed on top of a previous bond wire weld.

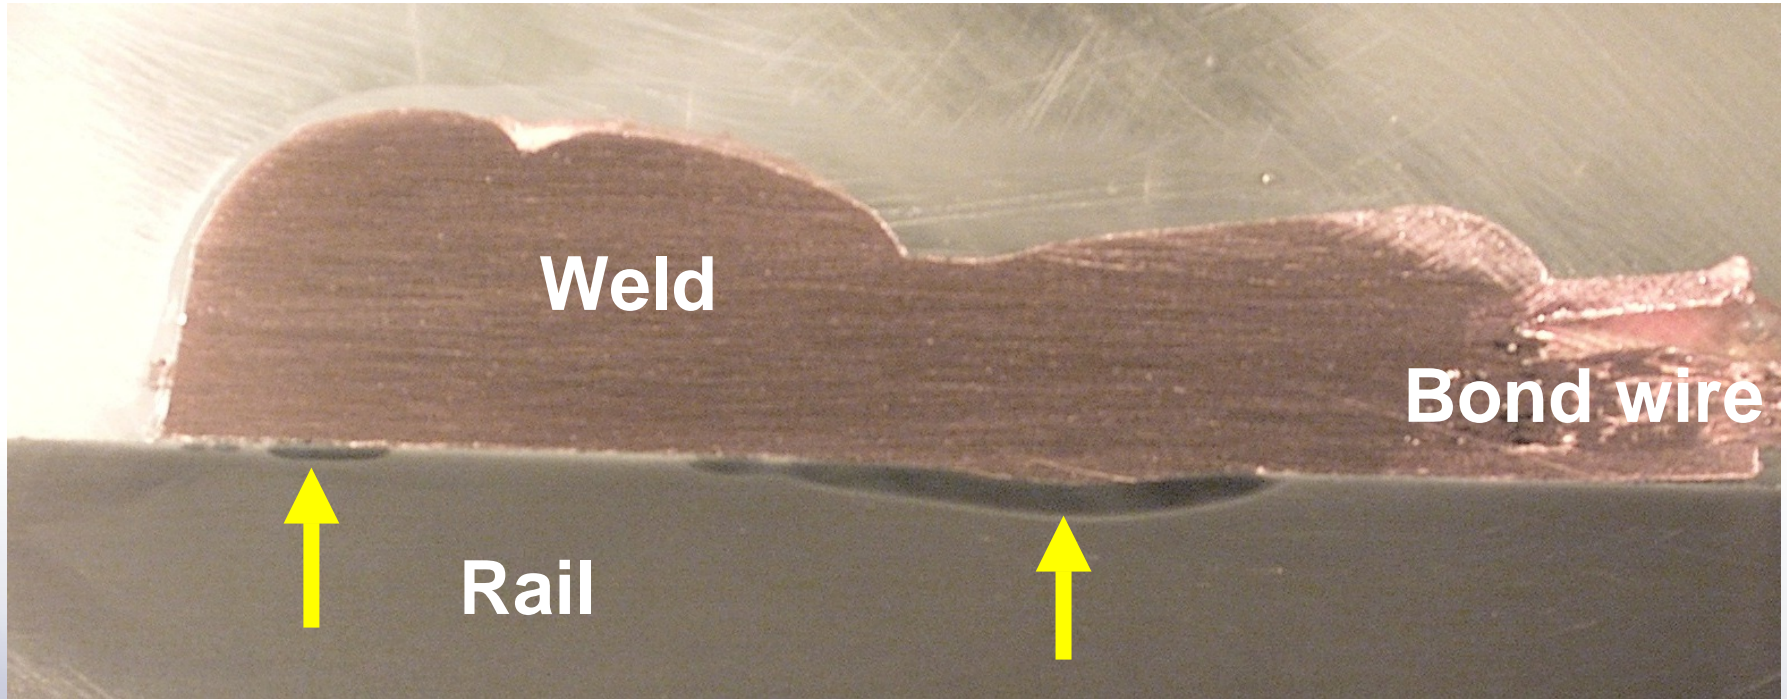
# Section of a Demonstration Weld

- States that untempered martensite would not be produced in the welding process
- All welds examined during the investigation contained untempered martensite
- Other inconsistencies were also found in Cadweld bonding instructions
