FALL ABATEMENT RESOLUTIONS AT NAVAL COMPUTER & TELECOMMUNICATION STATION (NCTS), CUTLER, ME

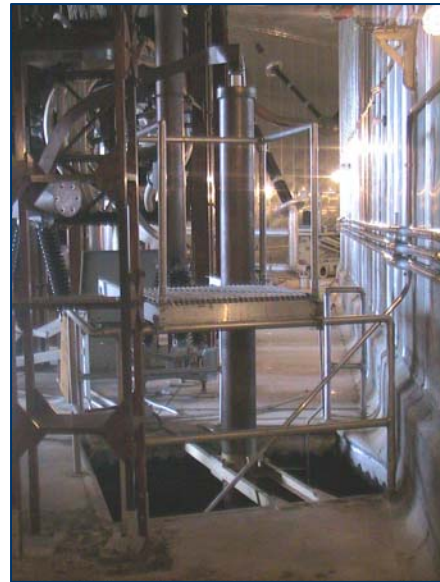
Trap door to lower section of Helix House was not surrounded by guard rails.

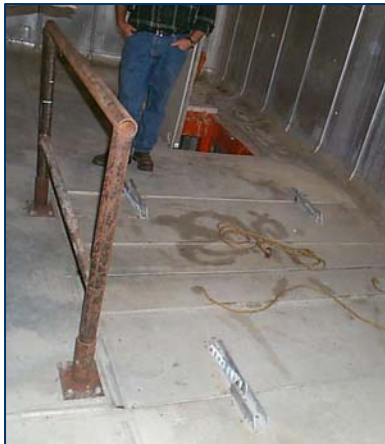
Open platform atop the “Horn Gap” had no fall protection guard rails.

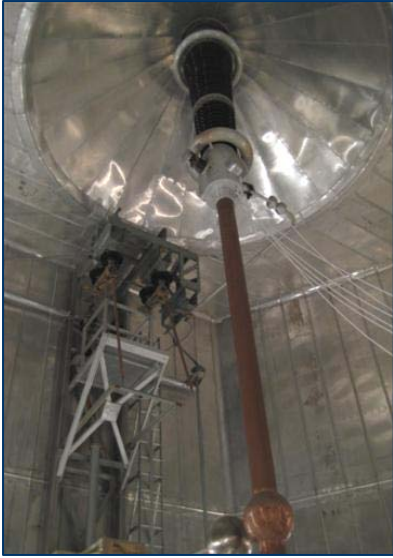
During cold weather, maintenance technicians must access the tuning capacitors within the Helix Houses as often as necessary to remove ice that has formed on the capacitor plates as icing adversely affects system operation. Maintenance technicians gained access to the de-icing switch platform via ladders that were unanchored, and the platform itself did not have fall protection guard rails.

Customized anchored ladder and platform with fall protection guard rails provide safe access to deicing switch.

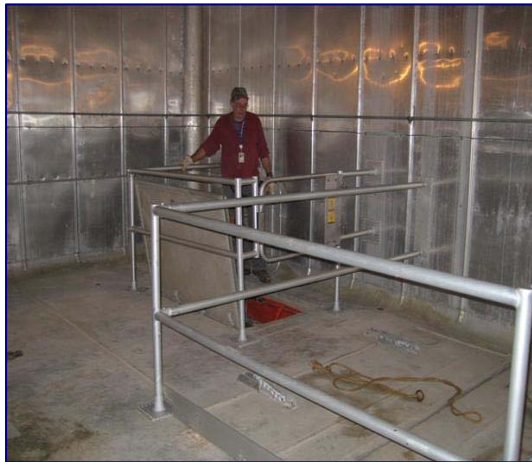
18-foot hole between the Main Variometer and the Triple Stack. Maintenance technicians worked on an open platform with no fall protection guardrails. In addition, maintenance technicians worked around trap doors separating the three divisions of the Helix House. The platforms around these trap doors had no fall protection systems.

Large trap door (closed in foreground), separating one of the three divisions within the Helix House, is surrounded by a new safety rail.
