## **ELECTRICAL SAFETY HAZARDS RESOLVED AT FLEET READINESS CENTER MID-ATLANTIC DETACHMENT, NAVAL STATION NORFOLK, VA**

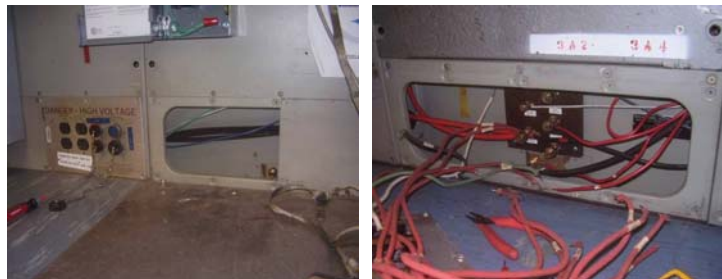
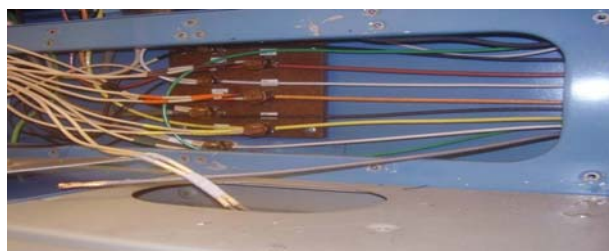
- Internal workbench wiring not properly color-coded. Typically there are at least three different electrical circuits running through the benches;

400Hz, 60Hz, and 28V DC. The color coding (see above photos) is meant to allow anyone to easily identify the individual circuits and their associated phases.

During the hazard abatement project, the correct wire size and color were installed in the PS1-A power supplies and benches, and neutral circuits were isolated from ground circuits.

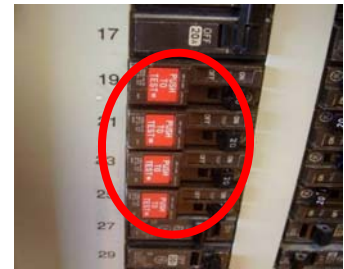
- Ground Fault Circuit Interrupter (GFCI) protection missing from all electronic workbench 60Hz circuits. (An unintentional electric path between a source of current and a grounded surface is referred to as a "ground-fault." Ground faults occur when current is leaking somewhere; in effect, electricity is escaping to the ground. If a worker's body provides a path to the ground for this leakage, the worker could be electrocuted.

On complex circuits - GFCI Outlets were installed at the bench location to provide shock/fault protection to the bench circuit.

On simple circuits - GFCI Circuit Breakers were installed to provide shock/fault protection to the entire, downstream circuit.

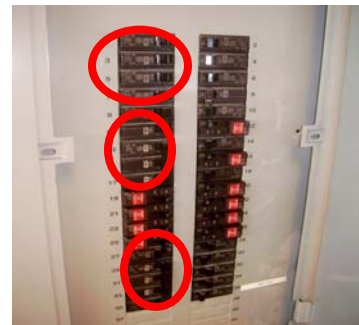
- Circuit breakers improperly sized for the circuit wiring, which could cause an overload resulting in a fire and/or short to equipment and a shock hazard to personnel.
- Safety straps, used to ground equipment being repaired, missing from all workbenches.
- Loose ground fittings.
- 400Hz frequency inverter (electronic device which inverts DC energy (type of energy found in batteries) into AC energy (type of energy produced by the power company)) not properly bonded to building steel.

All oversized 30 Amp breakers were replaced with proper 20 Amp breakers.
