Submarine Division of the Naval Safety Center Factual Lines About Submarine Hazards

Oct-Dec 08

Now that we have come to the end of the fiscal year, it is time to revisit the most common deficiencies identified during Submarine surveys. The references and recommended corrective action for each deficiency are included. If you have any questions contact the subject matter expert listed at the beginning of each section using the contact information provided.

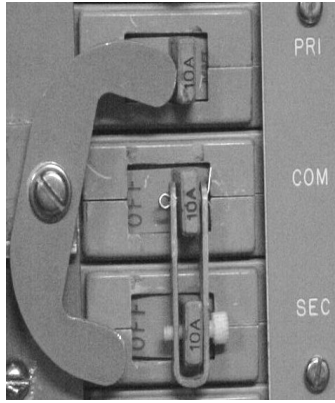
#1. Navigation lighting panel N-1 - 84.6% had shock hazards in their N-1 lighting panels. This hazard was supposed to be eliminated by A&I N-3171 and TZ-0856. The hazard comes from an exposed, energized, metal stiffener in the circuit breaker handles. Unfortunately the safety hardware, which consists of plastic thumbscrews and plastic insulating bushings that are designed to insulate the operators, is often found to be missing. Check your N-1 panel and ensure it is safely configured. If you are unsure of the correct configuration please contact me for clarification. This is a properly completed A&I that reduces the shock hazard first noted in 1996. Ref: COMSUBLANT/ COMSUBPAC A&I N-3171 FOR 688 CLASS, A&I TZ-0856 FOR 726 CLASS

INSULATOR SCREW NSN: 96 5970-01-094-3317, INSULATOR BUSHING NSN: 96 5970-01-094-1582.
