Mech

Winter 2008-09

**Warnings Are Given
for a Reason**

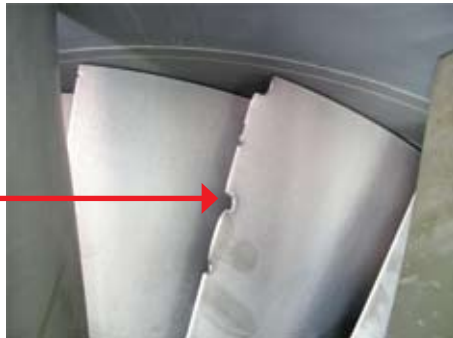
The aircrew executed their aborted-takeoff procedures, suspecting that the port engine had just been FODed. The aircrew stopped the aircraft and secured the port engine. After the aircraft was towed back to the hangar, an investigation into the source of the FOD damage was commenced. Initially, it was thought the aircraft may have sucked up a chunk of asphalt or a bolt or screw that was left on the runway.

Damaged engine blades

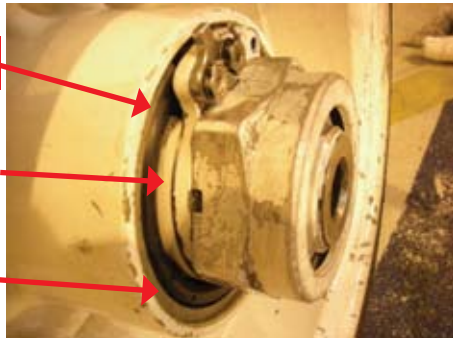
was on the inboard side of the tire, which didn't allow the bearings to seat. The bearings had worked loose and pushed out onto the dust cover. The pressure on the dust cover was so great that the metal retaining clip popped.

Dust cover

Metal retaining clip

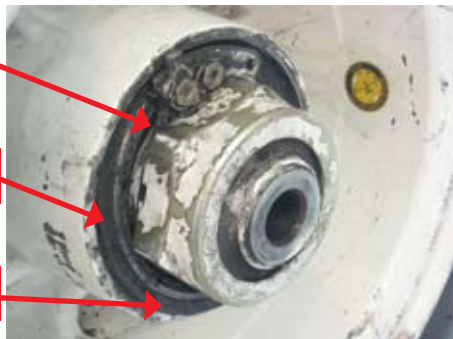
But what had happened to the metal spacer? Once the port nose tire was removed, it was discovered that the metal spacer was installed wrong. The metal spacer

Missing metal spacer

Missing retaining clip

Damaged dust cover

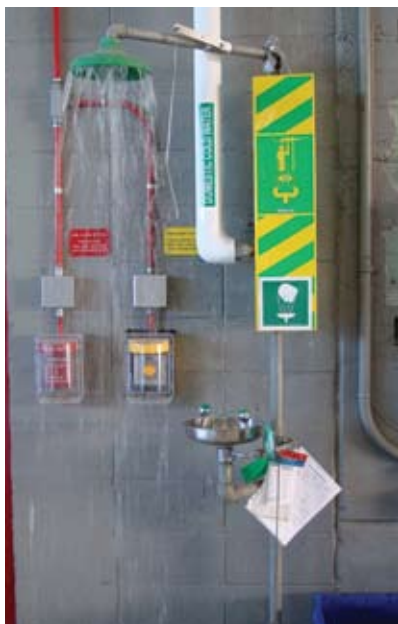
Water flows onto electrically hard-wired fire alarms

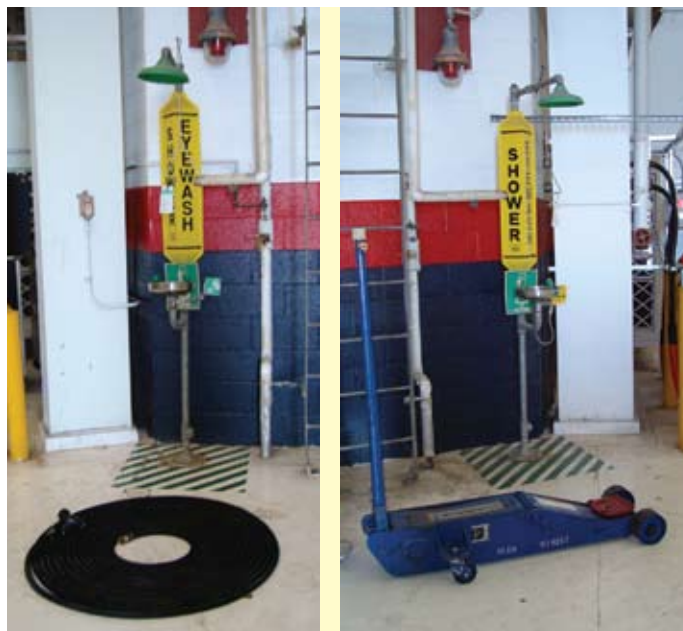
Blocked by trip hazards

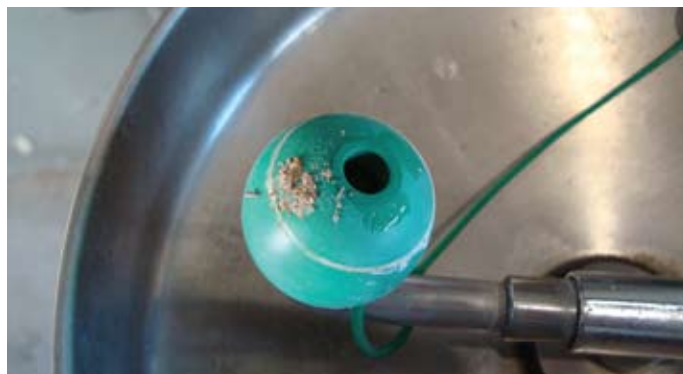
Dirty with bird excrement
