**SERVICE BULLETIN SPSB005**  
**JH101-3 (HIP RING MLW) AND JH101-4 (4 RING MLW) RING DAMAGE**  
**INSPECTION**

**SERVICE BULLETIN #** SPSB005

**SUBJECT:** HIP RING AND 4 RING MAIN LIFT WEB INSPECTIONS

**STATUS:** MANDATORY

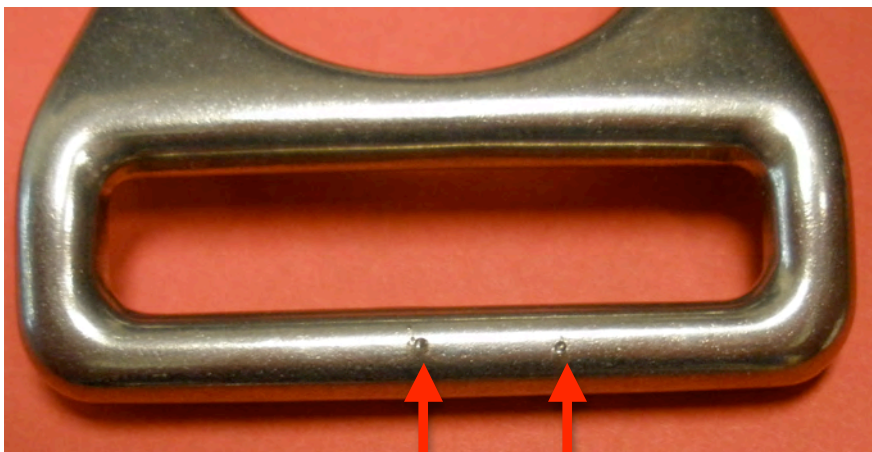
Needle strike example:

It has been brought to our attention that the hip ring on JH101-3 (Hip Ring Only) and JH101-4, (4-Ring) main lift webs, may have been struck by the needle used for installing the 5 cord harness stitching. This needle strike on the hip ring may cause damage to the Type 12 buffer, 5 cord stitching and possibly the Type 7 webbing. As a precaution, a mandatory inspection of the hip rings is required for all systems with a date of manufacture between September 2008 and December 2008.

The picture below is an example of a needle strike on an SR8 hip ring.

1. If damage is found or suspected, the harness/container will need to be sent to Sun Path Products, Inc. for repair. Please ship to the following address and include a completed Hip Ring Damage Repair Form found at the end of this document:

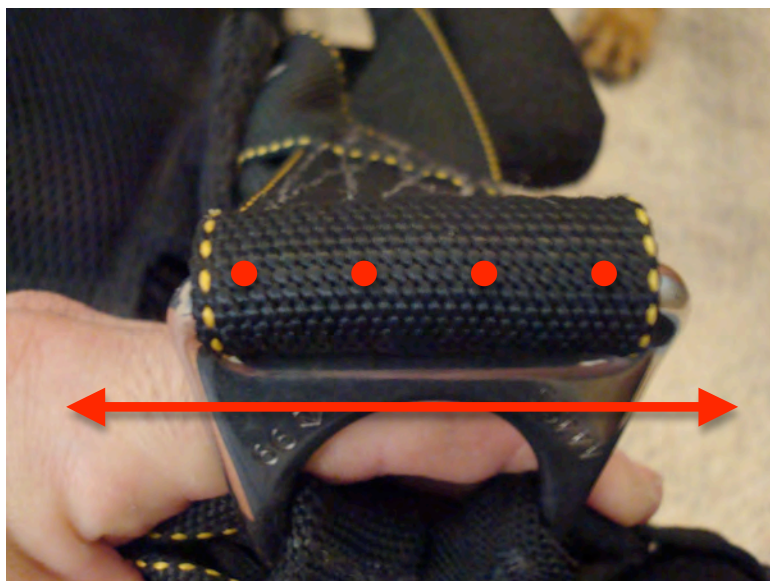
**BACK AND FORTH/ SIDE TO SIDE MOTION**

6. Move the hip ring back and forth (side to side) and rotate inside the webbing, while pressing the top of the ring through the webbing. If a needle strike is present, the rough spot on the top of the webbing bar of the ring will catch or snag on the TYPE 12 buffer on the inside of the TYPE 7 MLW. This will feel like a rough spot(s) on the top of the bar and cause a rough or snagging feel.

**FEEL HERE FOR DAMAGED RING INSIDE WEBBING. DAMAGE WILL MOST LIKELY BE ALIGNED WITH THE BOTTOM POINTS OF THE 4 POINT STITCH PATTERN.**

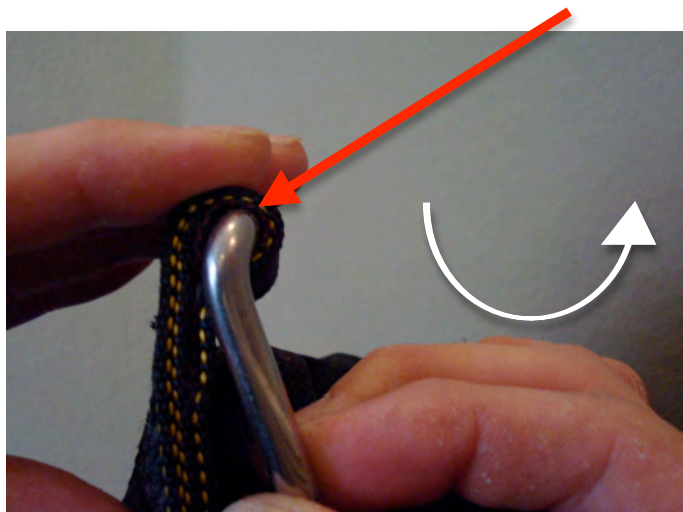
WHILE ROTATING, FEEL HERE FOR NEEDLE STRIKE.
