NIST Response to the World Trade Center Disaster

**Federal Building and Fire Safety Investigation
of
the World Trade Center Disaster**

November 19, 2008

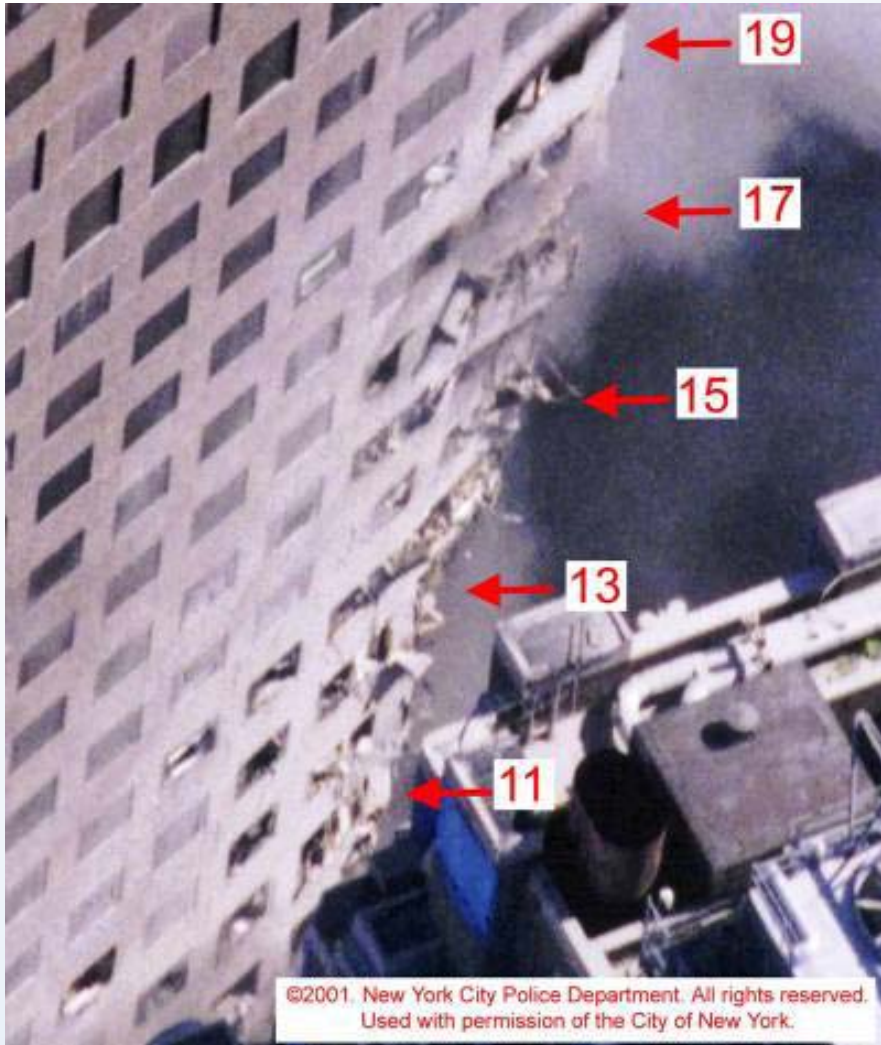
Debris Impact Damage to WTC 7

- Collapse of the WTC Towers.
 - Collapse of WTC 2 did not cause any structural damage or start any fires in WTC 7.
 - Collapse of WTC 1 damaged seven exterior columns on the lower floors of the south and west faces and initiated fires on 10 floors between Floors 7 and 30.
- Aerial photograph shot $14 \text{ s} \pm 0.5 \text{ s}$ after WTC 1 began to collapse.
- Arrows mark arcs formed by debris that seemed to be ejected outwards from the debris cloud

- Enlargement of a photograph showing part of the west face of WTC 7.
- Arrows and floor numbers have been added for the corresponding rows of windows.

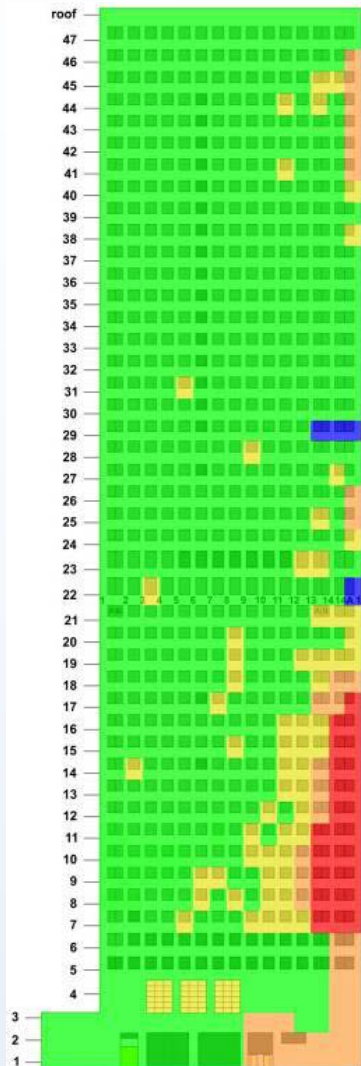
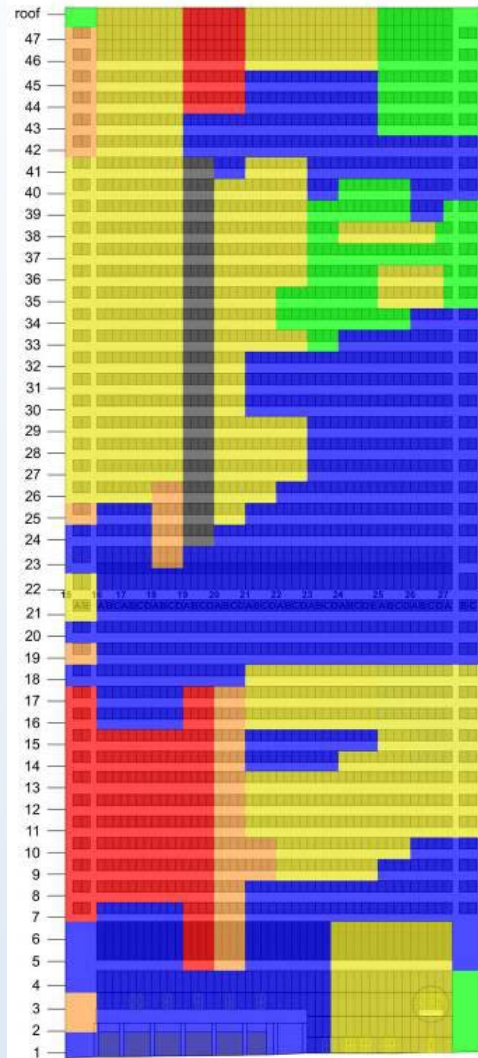
Observed Debris Impact Damage to WTC 7

green (■) - no visible damage

yellow (■) - window glass broken

orange (■) - granite and underlying truss damage

red (■) - damage to exterior structural steel

blue (■) - not visible due to smoke, dust, and intervening buildings.

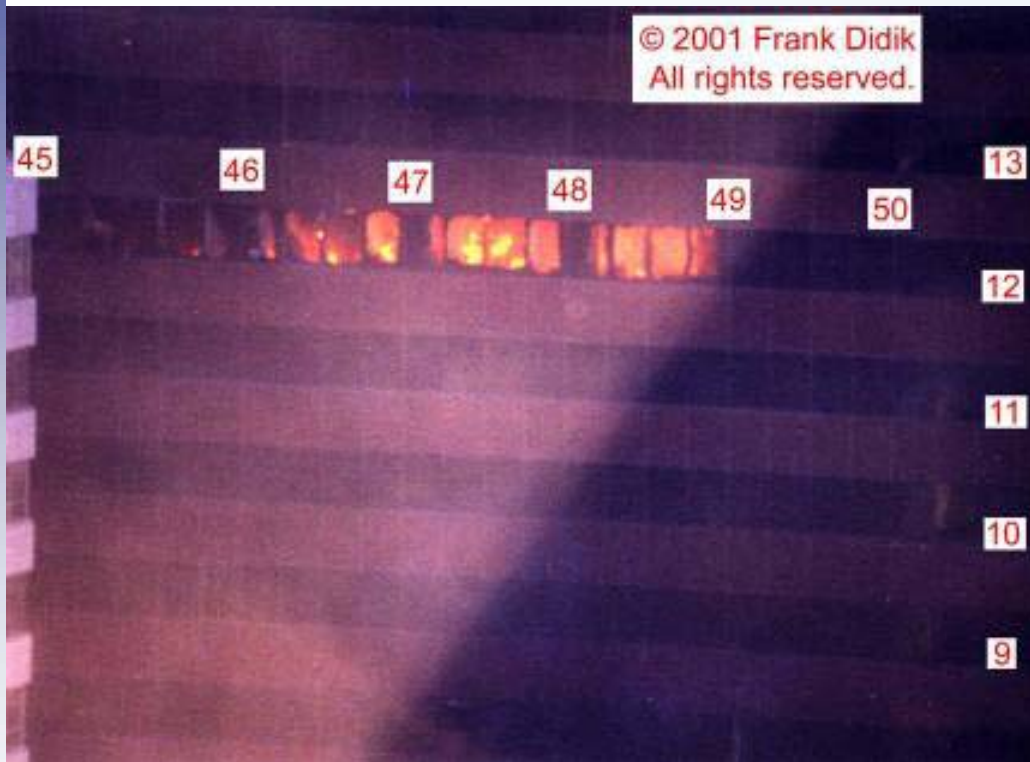
Observed Fires

- Cropped photograph of north face of WTC 7 taken between 3:11:15 p.m. and 3:16:51 p.m.

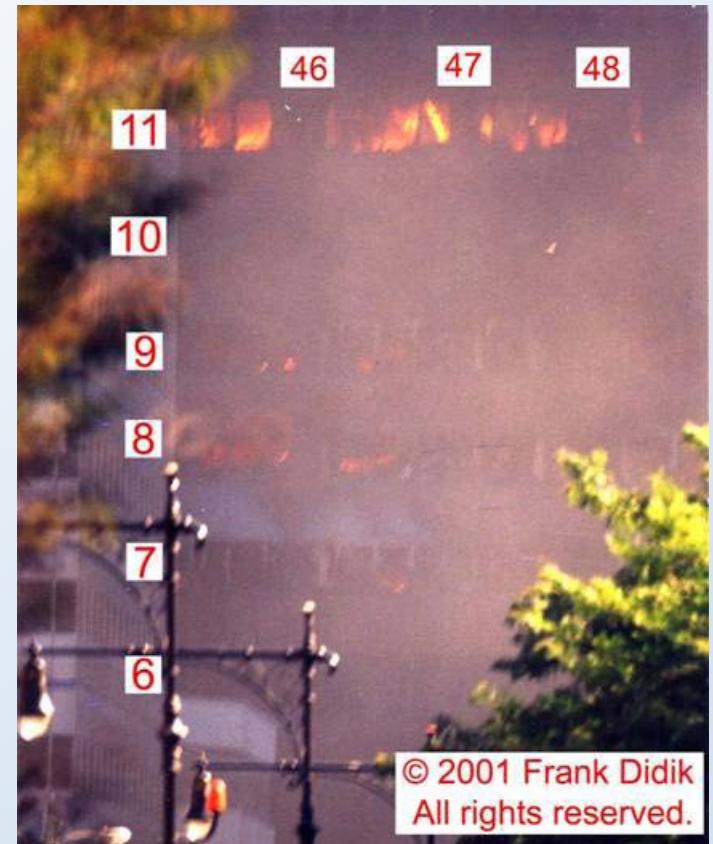
- Cropped photograph showing part of north face of WTC 7 at 4:39 p.m. \pm 120 s.

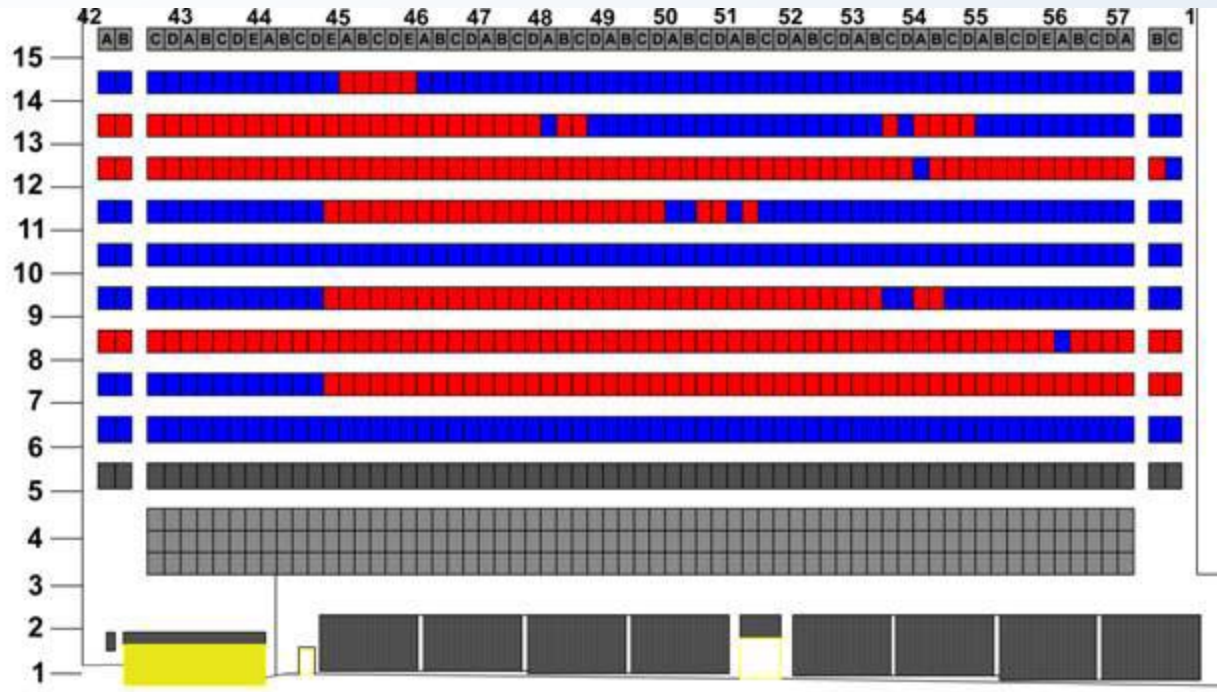
Summary of Fires on North Façade of WTC 7

- Façade map showing where windows were broken and/or fire was observed during the period when fire first appeared shortly before 3:00 p.m. until the building collapsed at 5:20:52 p.m.
- Red represents windows where the glass was broken out and/or fire was observed through the window. The remaining windows are colored blue indicating that no direct evidence was observed for fires at these locations.

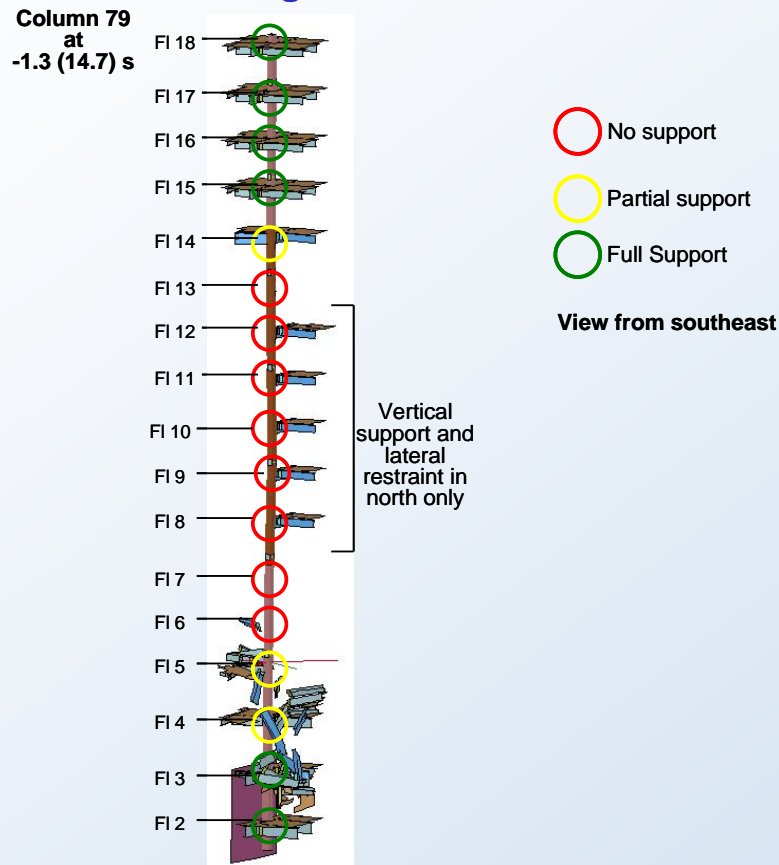
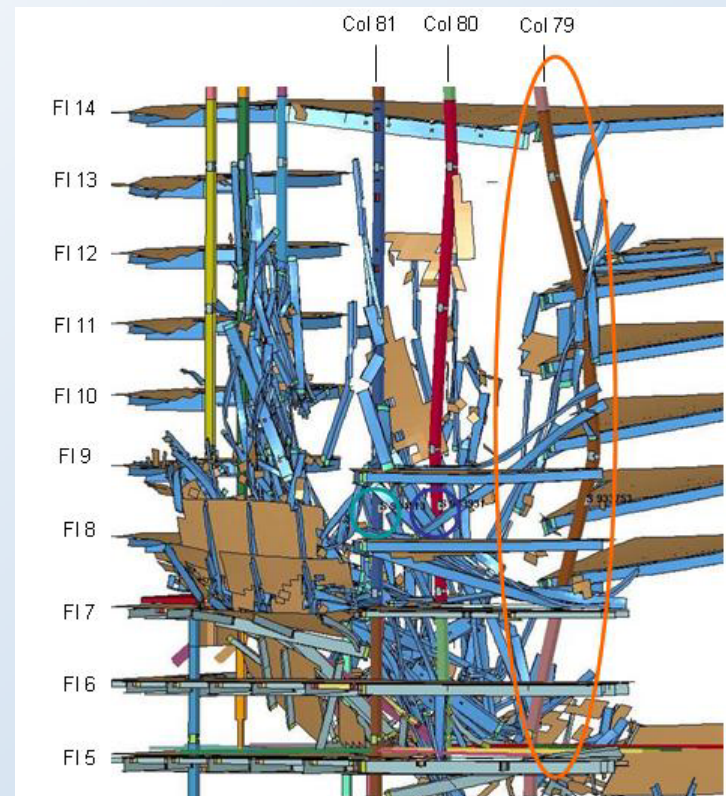
- Initial Local Failure for Collapse Initiation.
 - Fire-induced thermal expansion of the floor system surrounding Column 79 led to collapse of Floor 13 that triggered a cascade of floor failures.
 - This, in turn, led to loss of lateral support to Column 79 over nine stories, resulting in the buckling failure of Column 79.

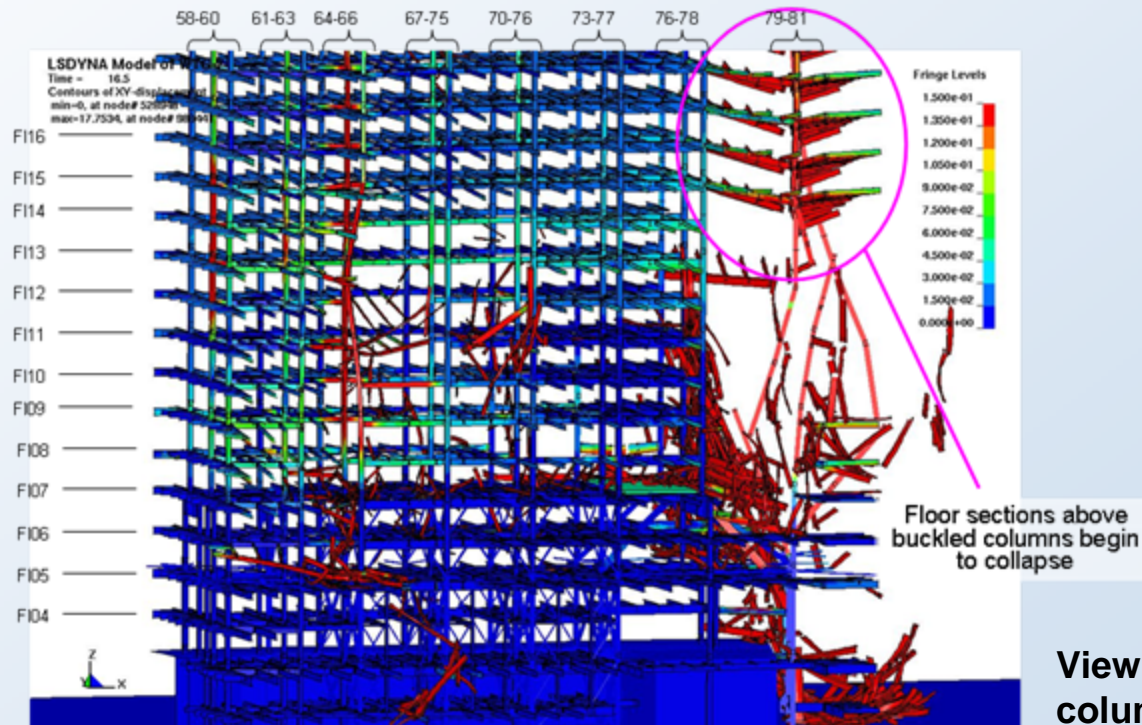
- Buckling of Column 79 (the collapse initiation event) triggered a vertical progression of floor system failures to the east penthouse and subsequent cascading failure of the adjacent interior columns on the east side of the building (i.e., Columns 80 and 81).
- Vertical progression of floor system failures spread to include the entire east region all the way to the top of the building.

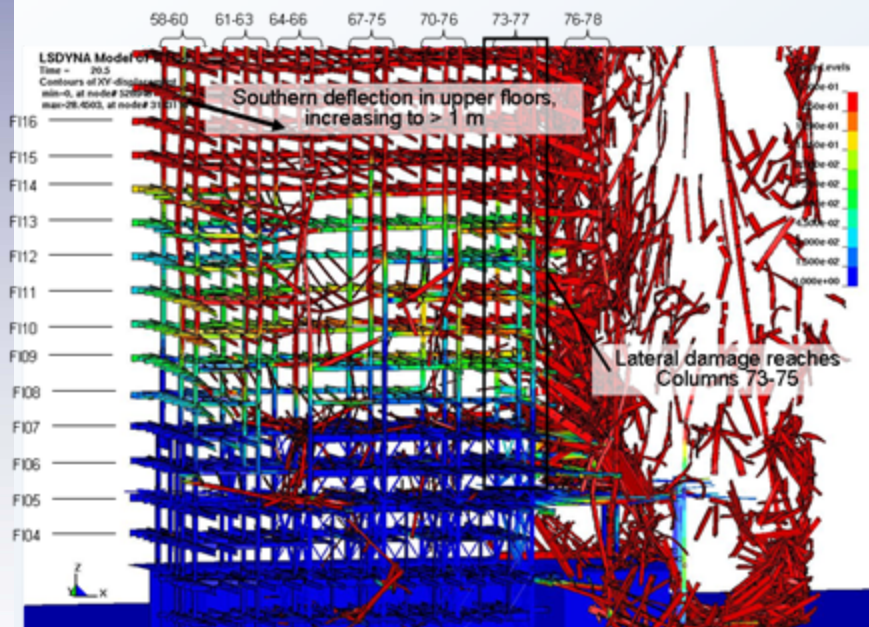
Failure progresses to the third line of interior columns from the east at 4.5 s following collapse initiation.

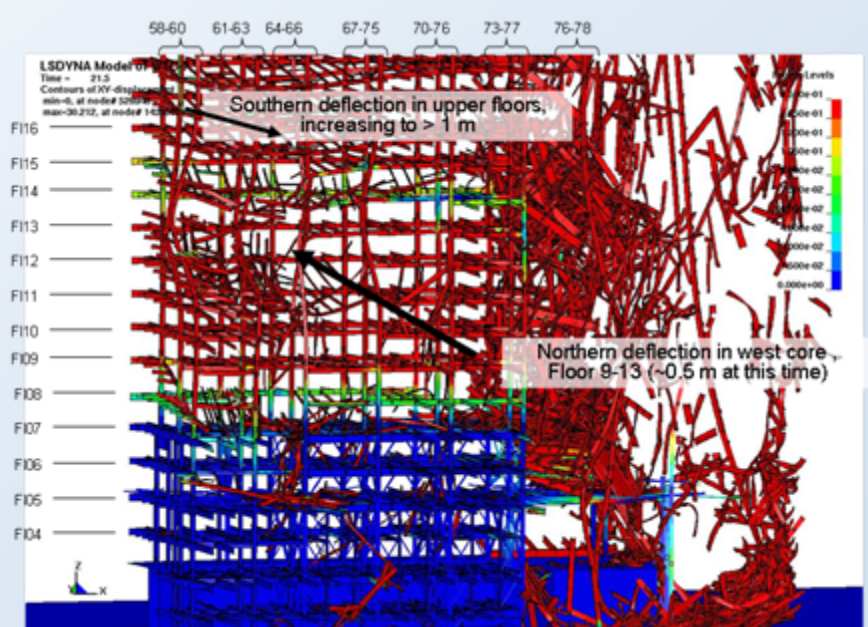
Buckling of all interior columns at 6.5 s following collapse initiation.

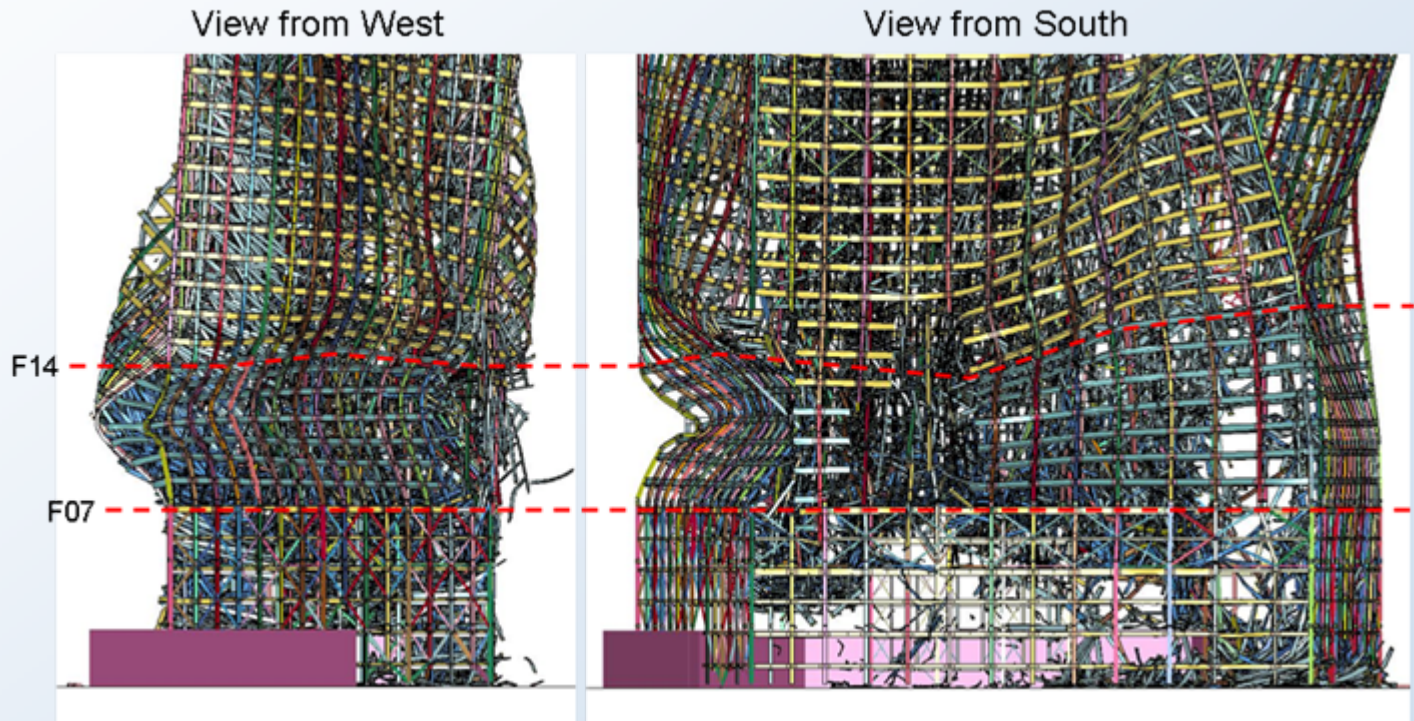
- The exterior columns buckled at the lower floors (between Floors 7 and 14) due to load redistribution to the exterior columns from the downward movement of the building core.
- The entire building above the buckled-column region then moved downward in a single unit, as observed, completing the global collapse sequence.

Buckling of lower exterior columns.
