# National Transportation Safety Board

## Safety Recommendation

**In reply refer to:** A-01-01 and -02

In this letter, the National Transportation Safety Board recommends that the Federal Aviation Administration (FAA) take action to address a safety issue concerning corrosion and fatigue cracking of main landing gear (MLG) spring struts on Cessna 170, 180, 185, 190, and 195 series airplanes. The recommendations were prompted by the Safety Board's investigation of a September 14, 1999, accident involving a Cessna 185, N85LC, near Delta Junction, Alaska. This letter summarizes the Board's rationale for issuing these recommendations.

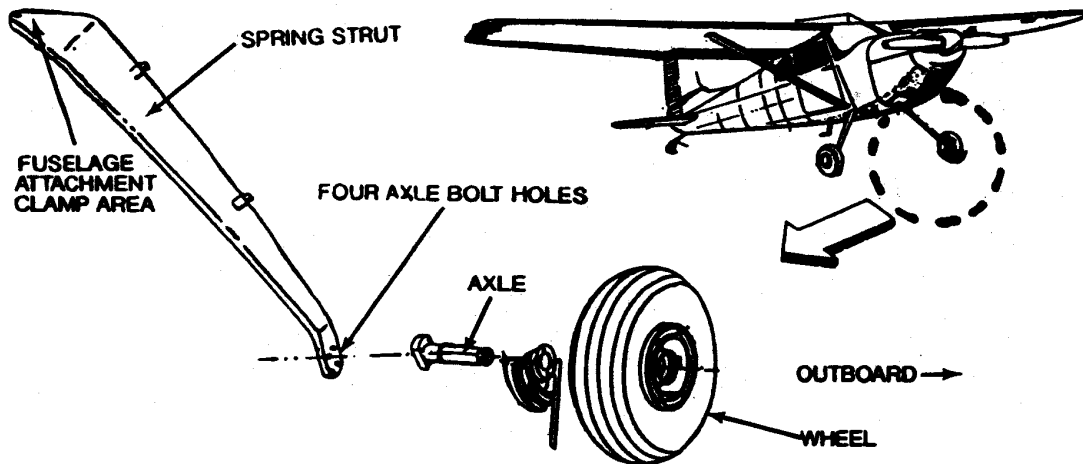
**Figure 1. Cessna 180 Main Landing Gear Spring Strut and Axle Assembly**

Cessna 170, 180, 185, 190, and 195 series airplanes are tail wheel-equipped with MLG that have a tapered, spring-steel cantilever strut supporting each main wheel (see figure 1). The spring-steel cantilever strut is made from chromium-vanadium steel, which is heat treated and shot peened for added fatigue resistance, and is attached to the fuselage bracket and clamp by bolts at the upper end. The lower end of the spring strut has four holes through which the axle is bolted.

The Safety Board's postaccident examination of the Cessna 185 revealed the left MLG spring strut had fractured above the left wheel axle through the upper two axle bolt holes. Further examination of the fractured spring strut at the Board's Materials Laboratory revealed corrosion pitting had caused fatigue cracks to emanate from two regions on the interior surface of the forward upper axle bolt hole.

Despite the inspections required by 14 CFR Part 43 and recommended in the Cessna Aircraft service manual, MLG spring strut failures continue to occur. Visual inspections have not prevented all spring strut failures and do not adequately detect the relatively small fatigue cracks before failure occurs. The lack of a requirement for detailed inspections of the MLG spring strut fuselage attachment clamp area and axle assembly area allows airplanes with corrosion and cracks in the spring strut to experience fatigue failures. An initial inspection, involving the removal of the MLG spring strut and the use of NDI techniques to examine the spring strut, should aid in the detection of fatigue cracks that cannot be identified through visual inspections, thereby reducing the possibility of an incident or accident. The Safety Board notes that initial inspections, although beneficial, might not be enough to monitor whether corrosion and cracks are developing in the spring struts. Repetitive inspections performed at appropriate intervals<sup>4</sup> should further reduce the possibility of fatigue failure incidents or accidents.

Issue an airworthiness directive to require an initial inspection of Cessna 170, 180, 185, 190, and 195 series airplane main landing gear spring struts, involving the removal of the spring struts from the fuselage attachment clamp and axle assembly and the use of nondestructive inspection techniques to

examine the upper and lower ends of the spring struts for corrosion and cracks, at the next 100-hour or annual inspection, whichever occurs first. (A-01-01)

Issue an airworthiness directive to require repetitive inspections of Cessna 170, 180, 185, 190, and 195 series airplane main landing gear spring struts, involving the removal of the spring struts from the fuselage attachment clamp and axle assembly and the use of nondestructive inspection techniques to examine the upper and lower ends of the spring struts for corrosion and cracks, at appropriate intervals. (A-01-02)
