National Transportation Safety Board

Safety Recommendation

In reply refer to: A-01-03 through -05

On September 17, 1999, a McDonnell Douglas¹ MD-88, N947DL, operating as Delta Air Lines flight 2030, experienced a fire in the forward cargo compartment shortly after takeoff from Northern Kentucky International Airport (CVG), Covington, Kentucky. The flight attendants reported to the flight crew that there was a sulfurous smell and then, shortly after that, fumes and smoke entered the forward cabin. The flight crew declared an emergency and performed a precautionary landing at CVG. During the descent, a flight attendant discharged at least one Halon fire extinguisher into a floor grill, through which a “glow” was reportedly seen. After the discharge of the Halon, the glow was no longer visible. None of the occupants were injured, and the airplane sustained minor fire damage.

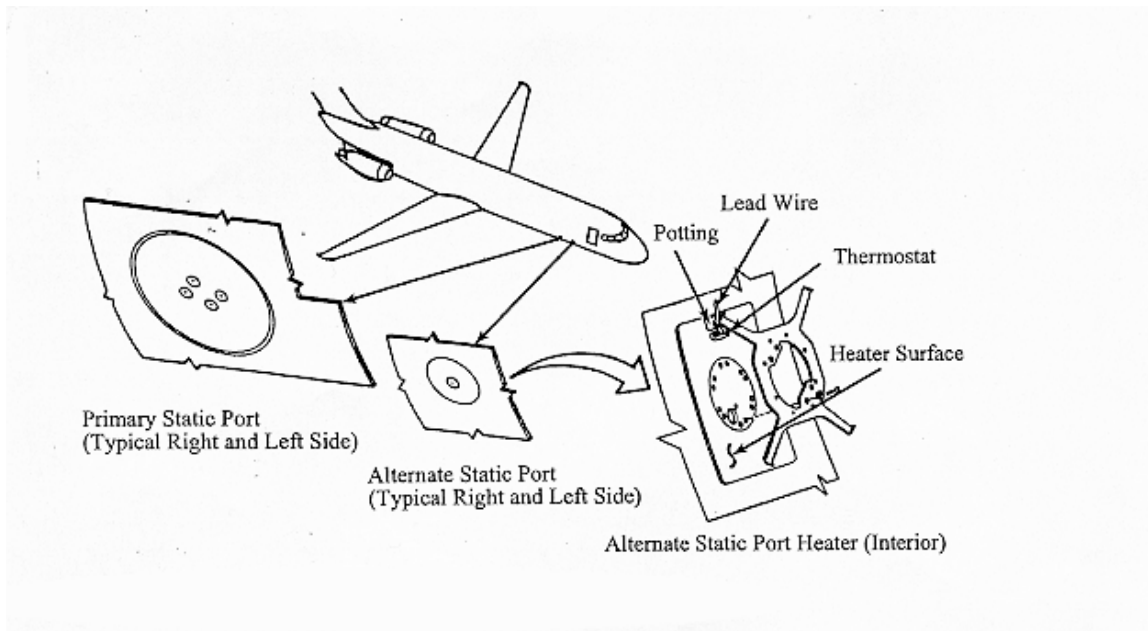
Figure 1. Static port heater installation.

McDonnell Douglas MD-88 airplanes are equipped with two static port heaters (one primary and one alternate) on the left interior sidewall and two on the right interior sidewall (see figure 1). The heaters are flush-mounted against the static air pressure sensing ports to ensure that the ports do not become blocked by ice.² The heaters are manufactured by Electrofilm Manufacturing Company, Valencia, California, and are powered by 115-volt alternating current through a 10-ampere circuit. The heaters are controlled by a switch in the cockpit and are normally on from before takeoff until after landing. The heaters have two resistive elements. One of the elements is always powered, whereas the other element receives power, as necessary, depending on the temperature of the heater. A thermostat on the heater controls whether power is applied to the second heater element; the thermostat applies power when the temperature is less than 80° Fahrenheit (F) and removes power when the temperature is 180° F. The maximum power used by the alternate static port heater is 225 watts.

The National Transportation Safety Board's investigation of the Covington, Kentucky, incident revealed that a spark from the right alternate static port heater ignited the fire and that the fire propagated by consuming the metalized Mylar covering on the sidewall insulation blankets surrounding the heater. There was substantial damage to the insulation blankets and soot and heat distress to components in the area, such as some floor structure and a potable water tank. Postincident examination of the right alternate static port heater revealed localized soot on the thermostat case, on the lead wire that carries the 115 volts to the thermostat, and on the red potting compound in the area where the lead wire is bent sharply around the thermostat case. The conductor of the lead wire was exposed at the point where the wire was bent around the thermostat case. Investigators concluded that the spark that ignited the metalized Mylar covering resulted from electrical arcing between the exposed conductor of the lead wire and the grounded thermostat case.

electrical connector; two had charred and exposed heater elements on the heater surface; and seven had cracked and flaked rubber on the heater surface, which can lead to electrical arcing if a liquid is introduced.⁵ The report concluded that the sharp bends in the heater elements can concentrate the heat and cause disbonding, which can expose the heater elements.

Issue an airworthiness directive requiring operators of MD-80, MD-90, and DC-9 series airplanes to inspect the primary and alternate static port heaters on these airplanes for evidence of electrical arcing or thermal damage and, if such damage is found, replace the heaters. (A-01-03)

Initiate a design review of the primary and alternate static port heaters on MD-80, MD-90, and DC-9 series airplanes and, if feasible, require design changes to reduce the potential for arcing. (A-01-04)

Issue an airworthiness directive requiring the replacement of metalized Mylar-covered insulation blankets near primary and alternate static port heaters on all MD-80 and MD-90 airplanes with approved metalized Tedlar-covered insulation blankets at the earliest maintenance opportunity, in accordance with Alert Service Bulletins MD80-30A092 and MD90-30A023. (A-01-05)
