# National Transportation Safety Board

## Safety Recommendation

**In reply refer to:** A-01-41 through -48

On January 31, 2000, about 1621 Pacific standard time, Alaska Airlines, Inc., flight 261, a McDonnell Douglas MD-83 (MD-83), N963AS, crashed into the Pacific Ocean approximately 3 miles north of Anacapa Island, California. All 83 passengers and 5 crewmembers were killed, and the airplane was destroyed. Flight 261 was operating as a scheduled international passenger flight under the provisions of 14 *Code of Federal Regulations* Part 121 from Puerto Vallarta, Mexico, to Seattle, Washington, with an intermediate stop planned in San Francisco, California. Although the National Transportation Safety Board's investigation into the accident is ongoing,<sup>1</sup> evidence gathered to date raises concerns that warrant the Federal Aviation Administration's (FAA) attention regarding industry maintenance practices associated with the MD-80's horizontal stabilizer trim system and potential adverse effects caused by the use of inappropriate grease types or incompatible mixtures of grease types.

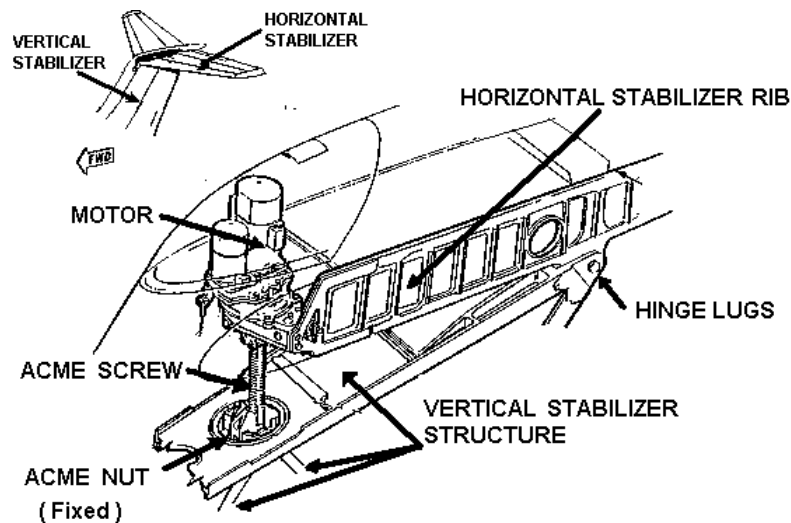
The horizontal stabilizer for the MD-83 (and also for all Douglas<sup>2</sup> DC-9 [DC-9], McDonnell Douglas MD-80/90 [MD-80/90], and Boeing 717<sup>3</sup> [717] series airplanes) is a critical flight control system located at the top of the vertical stabilizer. (See figure 1.) The horizontal stabilizer is hinged near its trailing edge so that the leading edge can traverse up and down to provide trim for the airplane in the pitch axis. The actuating mechanism for the horizontal stabilizer consists of an acme screw (attached to the horizontal stabilizer) that is rotated through a stationary acme nut attached to the vertical stabilizer. Up and down movement of the horizontal stabilizer is commanded automatically by the autopilot when it is engaged or manually by the flight crew by depressing a switch on the control wheel or by moving handles on the center

pedestal. These actions activate an electric motor that rotates a titanium torque tube that is held fixed inside the acme screw by a retaining nut assembly at the lower end of the acme screw. (See figure 2.) The motor is deenergized whenever the trim commanded by the pilot or autopilot is achieved or when the horizontal stabilizer reaches its design (maximum travel) limits and activates a travel limit shutoff switch. A lower stop is installed on the acme screw just above the torque tube retaining nut assembly to stop acme screw rotation if the travel limit shutoff switch is misrigged or malfunctions. The MD-83 horizontal stabilizer's design limits its movement to about 12.2° leading edge down (airplane nose-up trim) and 2.1° leading edge up (airplane nose-down trim).

**Figure 1.** Horizontal stabilizer actuation system.

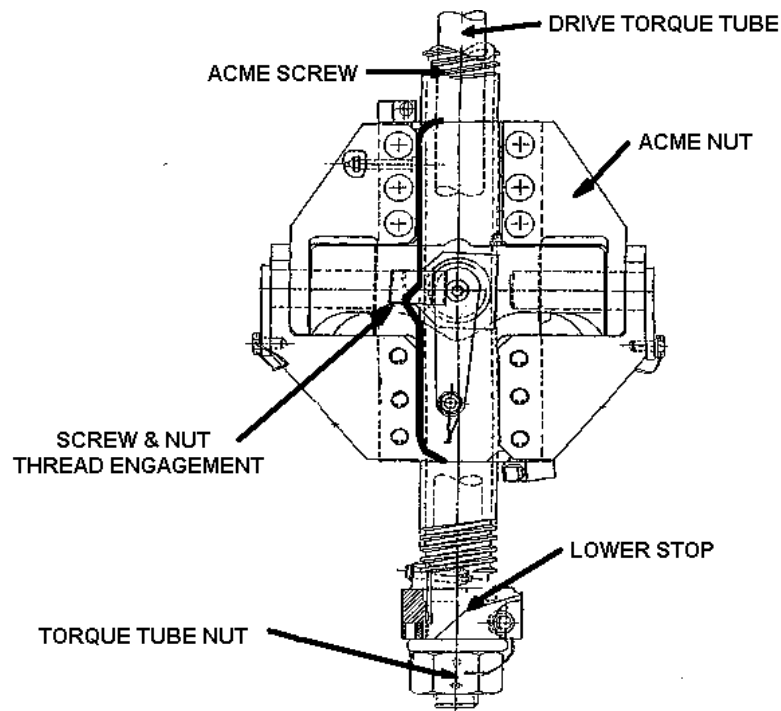
Performance data based on the accident airplane's flight data recorder indicate that the leading edge of the horizontal stabilizer rotated upward well beyond its design limit. Examination of the acme screw and nut from the accident airplane revealed that approximately 90 percent of the acme nut threads had worn away before the remainder of the acme nut threads stripped out. Those remnants were found wrapped around the acme screw.<sup>4</sup> The stripping of these threads would have allowed the acme screw to slip upward<sup>5</sup> through the acme nut until the lower stop impacted the bottom of the acme nut.

**Figure 2.** Acme screw and nut assembly.

Examination of the lower stop revealed evidence of numerous strike marks, which is consistent with the lower stop repeatedly impacting the bottom of the acme nut. Additionally, the torque tube was fractured at its lower end, just above the torque tube nut.<sup>6</sup> Examination of the torque tube revealed evidence of low-cycle fatigue<sup>7</sup> cracking on a portion of this fracture, which is consistent with a failure caused by dynamic loads being imparted to the torque tube via repeated impacts of the lower stop on the acme nut. The fracture of the torque tube resulted in the separation of the lower stop and torque tube nut, which allowed the acme screw to slide up through the acme nut as the horizontal stabilizer was pulled beyond its upward design limit by aerodynamic loads. Aerodynamic studies indicate that the upward movement of the horizontal stabilizer's leading edge would have created an excessive aerodynamic tail load, resulting in the airplane pitching downward uncontrollably.

Require the Boeing Commercial Airplane Group to revise the lubrication procedure for the horizontal stabilizer trim system of Douglas DC-9, McDonnell Douglas MD-80/90, and Boeing 717 series airplanes to minimize the probability of inadequate lubrication. (A-01-41)

Require the Boeing Commercial Airplane Group to revise the end play check procedure for the horizontal stabilizer trim system of Douglas DC-9, McDonnell Douglas MD-80/90, and Boeing 717 series airplanes to minimize the probability of measurement error and conduct a study to empirically validate the revised
