**Collision of a Greyhound Lines, Inc.
Motorcoach and Delcar Trucking
Truck Tractor-Semitrailer
Loraine, Texas
June 9, 2002**

Highway Accident Report
NTSB/HAR-03/01

**NTSB/HAR-03/01
PB2002-916201
Notation 7532
Adopted February 26, 2003**

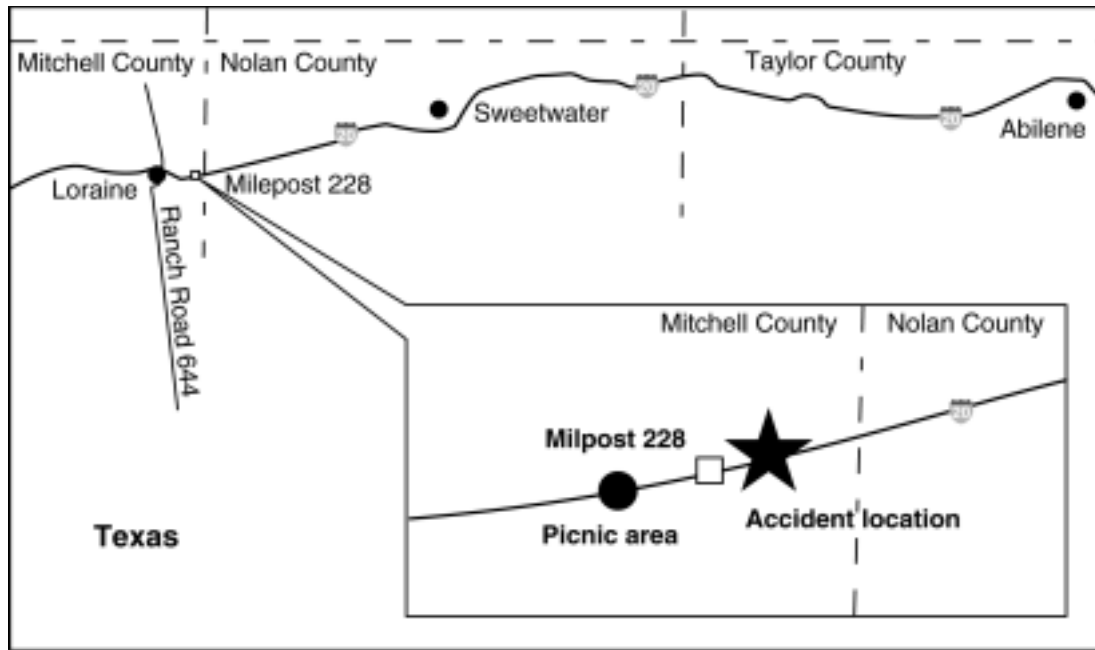
Figure 2. Accident location.

eastbound lanes (see figure 2). The motorcoach collided with the rear of the semitrailer near milepost 228 of I-20, pushing the tractor-semitrailer approximately 276 feet.

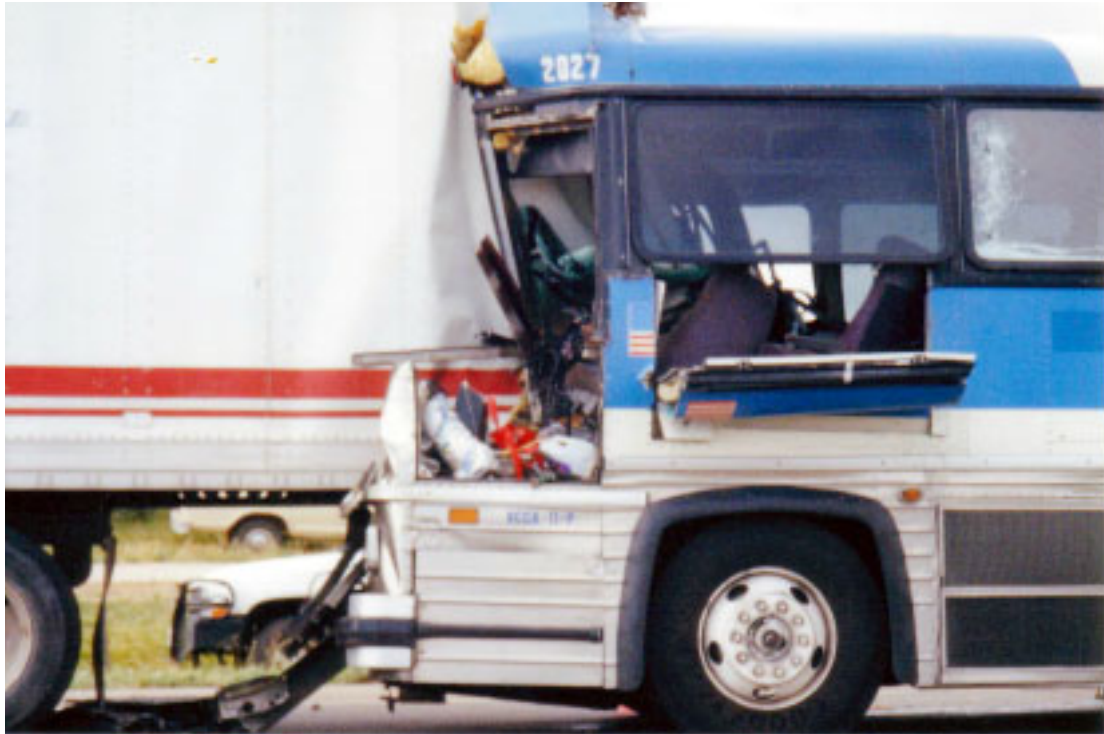
Figure 3. Postaccident left side of motorcoach and semitrailer.

After the collision, the vehicles traveled together for about 276 feet. The front of the motorcoach underrode the rear of the semitrailer and the motorcoach sustained damage extending about 100 to 125 inches rearward (see figure 3), while the tractor-semi-trailer sustained crush damage to the semitrailer (see figure 4). The tractor was not damaged.

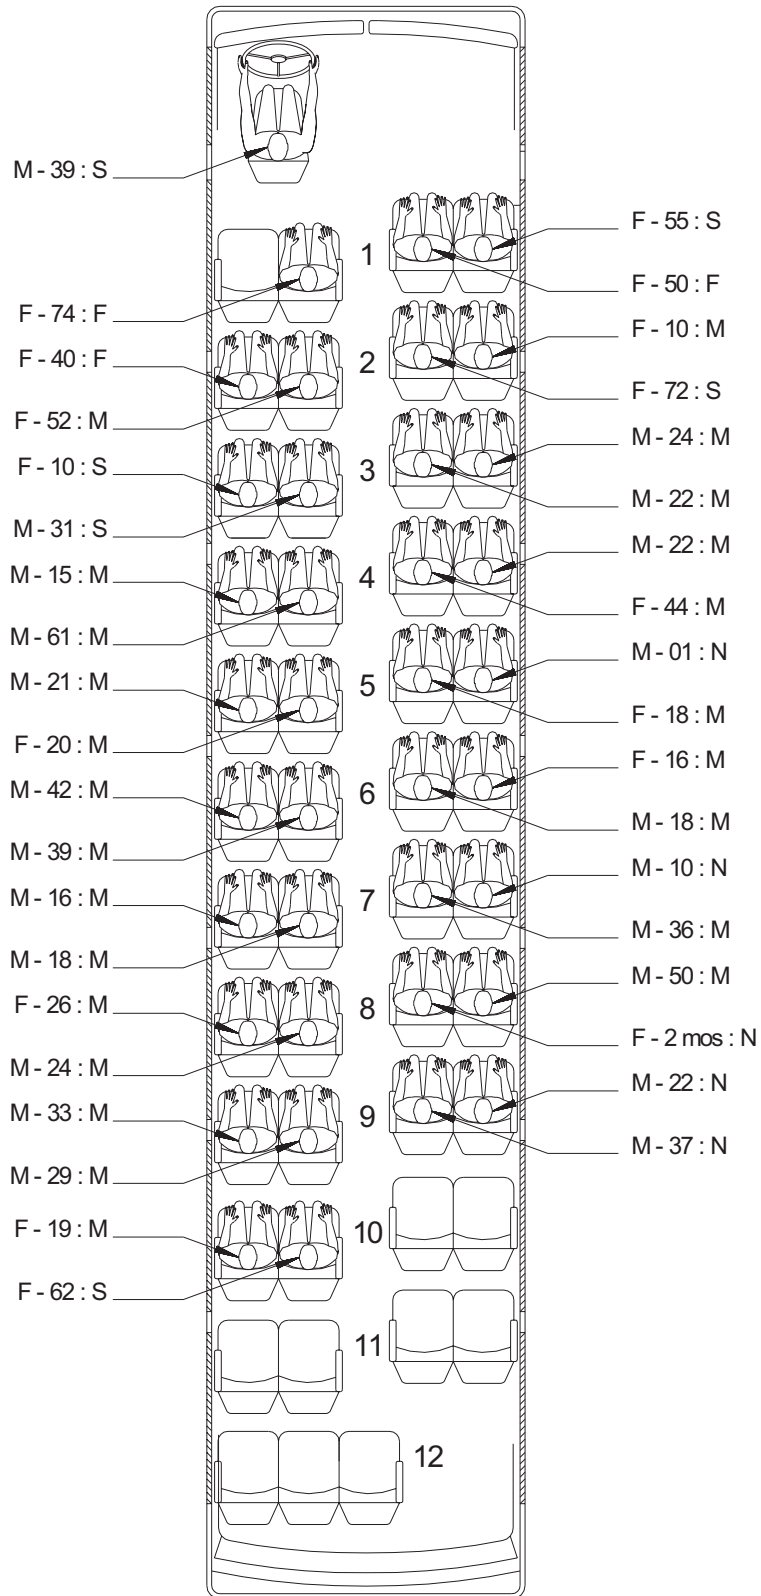
Figure 5. Motorcoach seating chart. (Probable seating locations based on passenger interviews.) *Definition of passenger labels: Gender – Age : Injury Severity.*

Three motorcoach passengers sustained fatal injuries. The fatally injured passengers in row 1 (see figure 5) sustained severe impact injuries to the head, upper torso, and arms, as well as internal injuries. The passenger in row 2 by the left window sustained a fracture of the left temporal head area and fractures of the left scapula, arm, pelvis, and leg.

Five motorcoach passengers and the busdriver sustained serious injuries. The passenger in row 1, right window seat, sustained a diffused fracture of the left hip and lacerations and contusions (bruises) to the left leg, ankle, femur, forearm, and wrist. The passenger seated in row 2, right aisle seat, sustained a fractured right femur, a contusion to the right upper chest, and multiple contusions and abrasions to the head and upper torso. The passenger in row 3, left aisle seat, incurred multiple facial and head contusions and abrasions, a fractured left shoulder, and lacerations of the left leg. The passenger in row 3, left window seat, sustained several lacerations to the face, closed head injuries, neck injuries, a fractured vertebra, and a dislocated left hip. The passenger in row 10, left aisle seat, sustained a fractured left mid tibia, fractured left hand, left forearm fracture, and contusions of the left arm. The busdriver sustained traumatic injuries to both legs, the abdomen, and internal organs; his right leg was amputated during extrication from the wreckage.

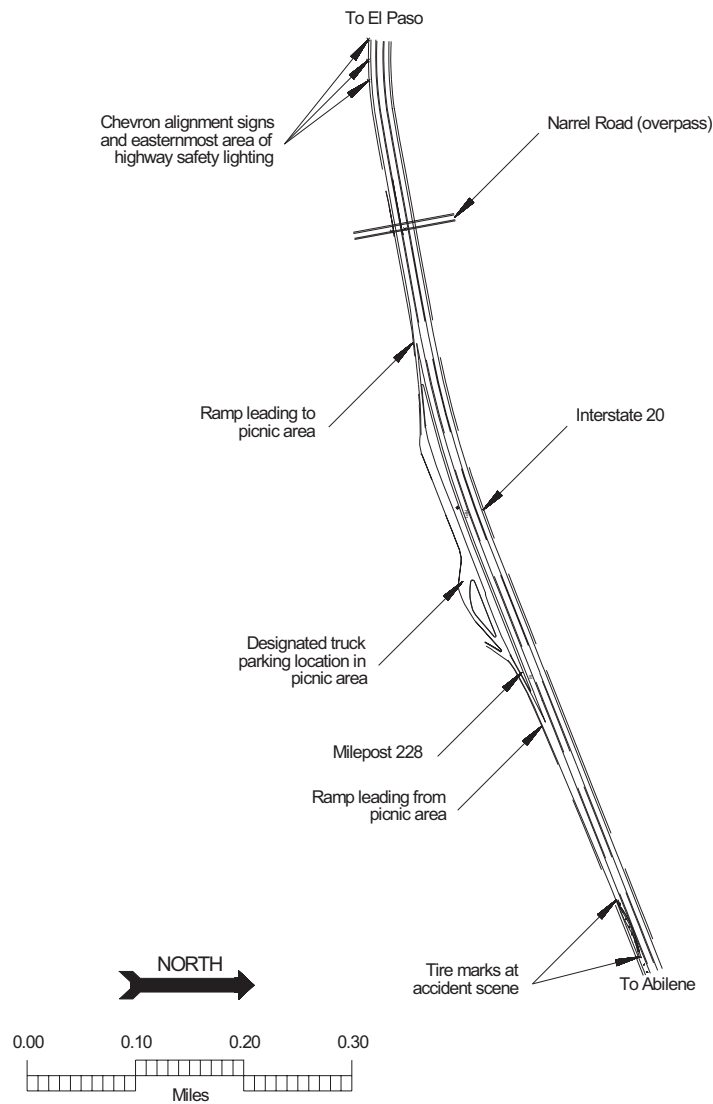
Figure 6. Interstate 20 diagram.

The accident occurred on eastbound I-20 approximately 1,200 feet east of milepost 228 in Mitchell County. I-20 is classified as a principal arterial and is a divided, two-way, four-lane, paved asphalt, controlled access highway. The posted speed limit was 70 mph during the day and 65 mph at night. A picnic area was along the south side of the interstate; the gore area¹⁰ for the entrance ramp from the picnic area was about 935 feet west of the accident site (see figure 6).

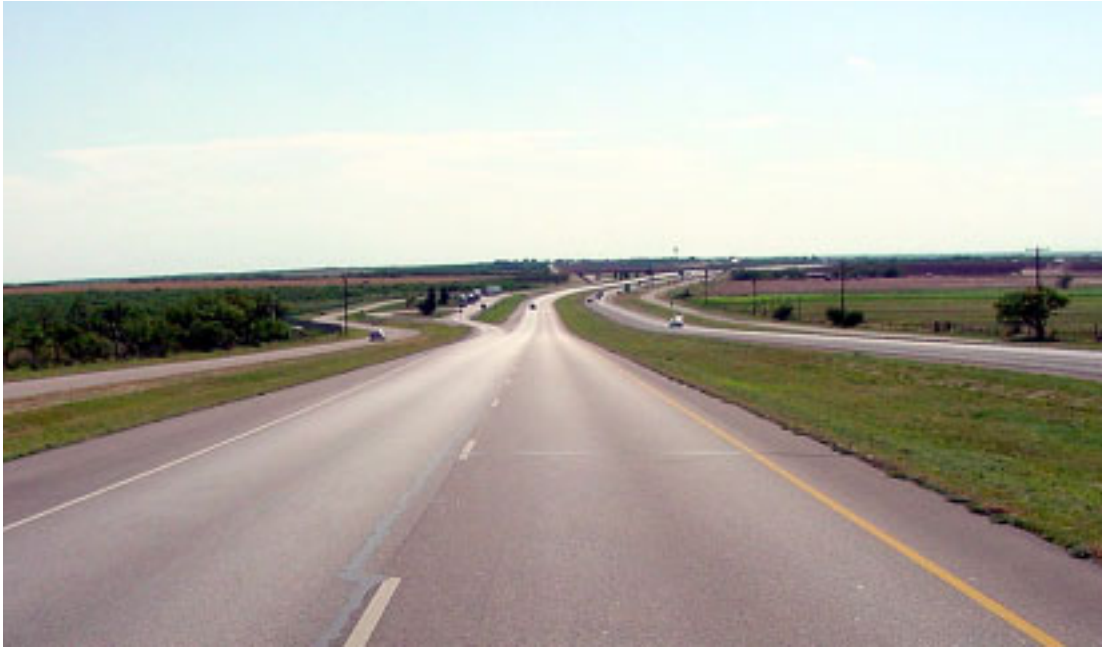
Figure 7. Picnic area acceleration ramp (looking west from accident site).

According to current American Association of State Highway and Transportation Officials (AASHTO) guidelines, an acceleration ramp should be long enough for a driver to make the transition from the speed on the entering roadway to the operational speed of the highway. The design of the ramp should be such that motorists can attain a speed

approximately equal to the average running speed of the highway, less 6.21 mph, by the time the left edge of the ramp joins the traveled portion of the highway.

The picnic area was constructed in October 1965 in accordance with the design guidelines in use at the time. The length of the acceleration ramp from the picnic area to the interstate is 975 feet, but under current AASHTO design guidelines, an acceleration ramp of at least 1,410 feet would be required. AASHTO also recommends that the speed of merging vehicles under these conditions be at least 50 mph. When investigators measured the speeds of commercial vehicles entering the interstate from the picnic area, they found that the vehicles reached an average speed of about 34 mph over a distance of 1,351 feet.

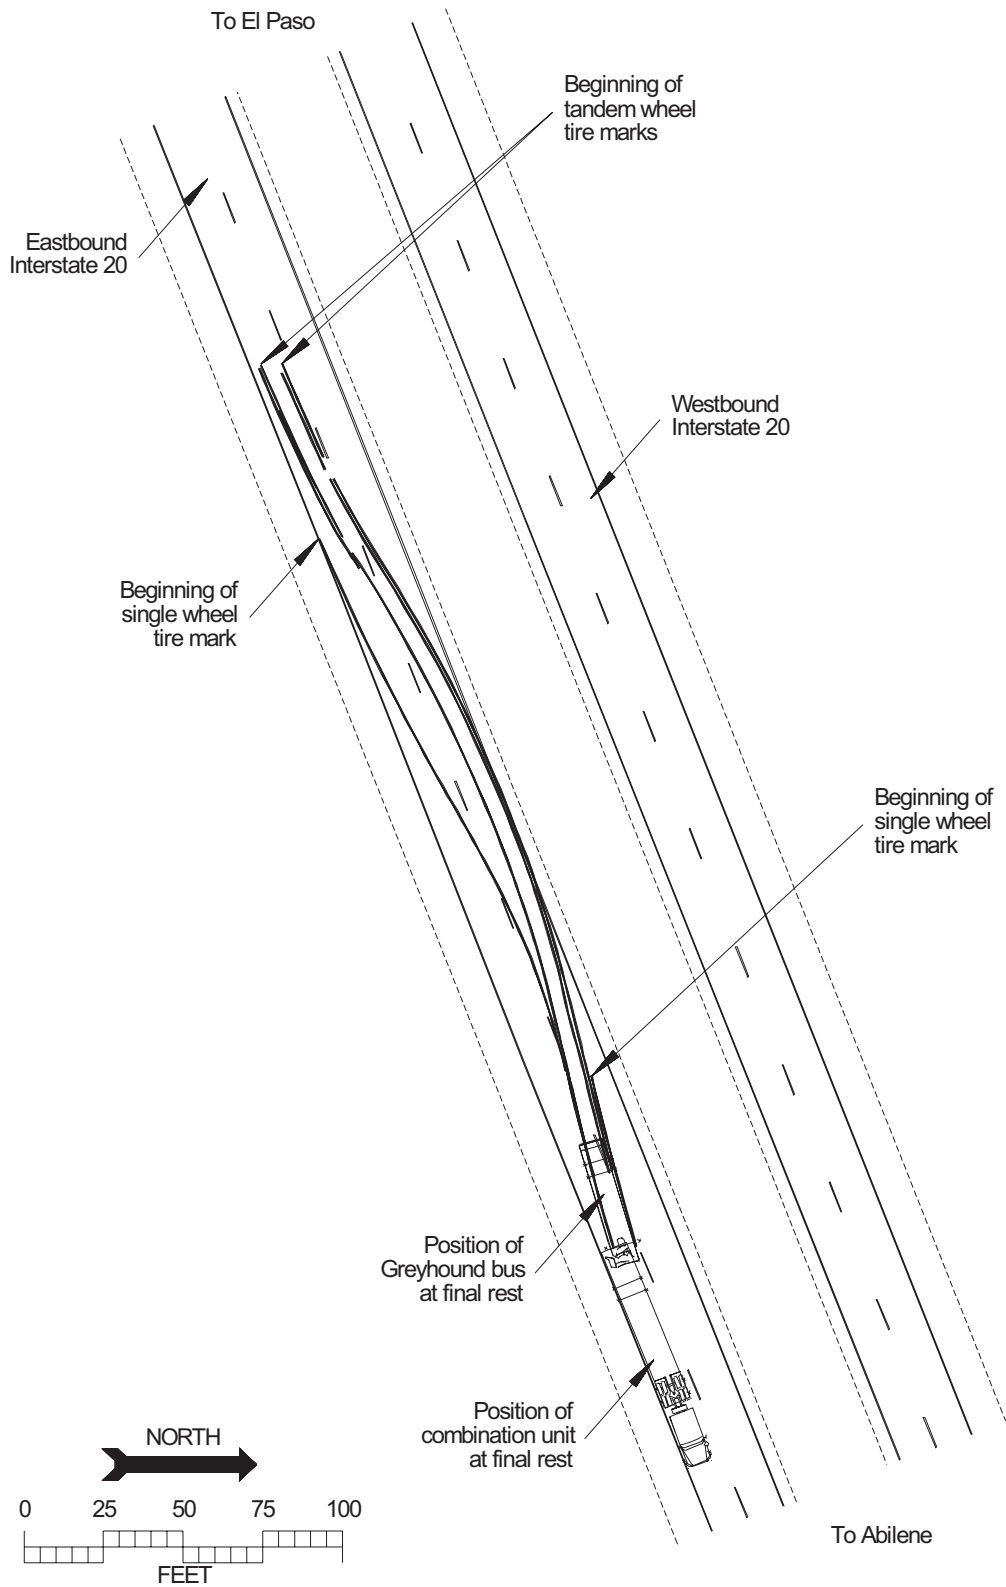
Figure 8. Postaccident diagram.

The motorcoach’s tandem wheel tire marks began in the right traffic lane about 1,202 feet east of milepost 228, continued in the right lane for about 48 feet, then transitioned into the left traffic lane in a right-hand arc for about 187 feet before crossing back into the right traffic lane and continuing an additional 64 feet to where the Texas DPS marked the final resting point of the motorcoach’s drive (rear) axle (see figure 8). A single tire mark was observed in the right traffic lane and followed the same general path as the tandem tire marks with an overall length of 242 feet. The single tire mark terminated in the right traffic lane, where the Texas DPS marked the final rest of the right side steer (front) axle of the motorcoach. Another single tire mark was observed in the left traffic lane running in a southeast direction with an overall length of 56 feet and terminating in the right traffic lane, where the Texas DPS marked the final rest of the motorcoach’s left-side steering axle.

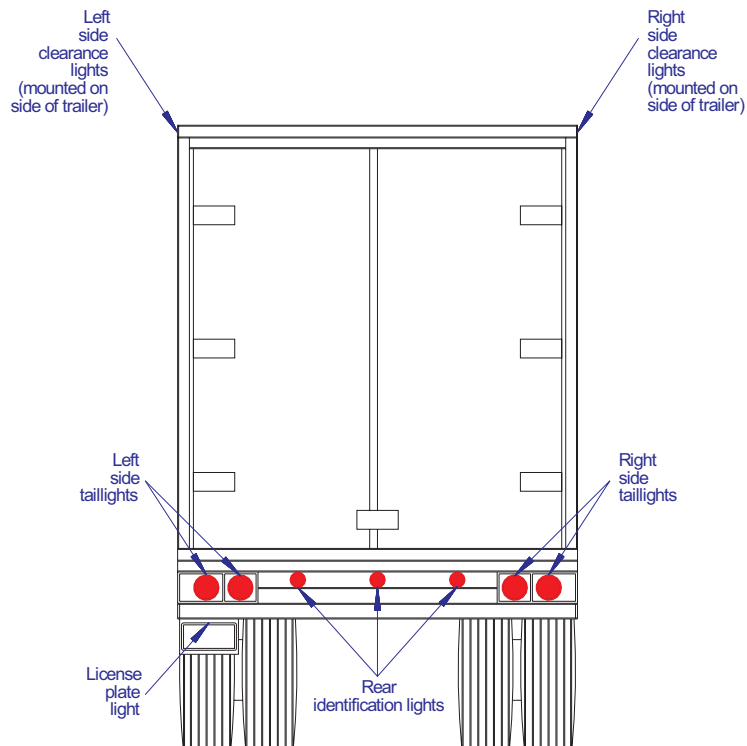
Figure 9. Rear semitrailer lighting.

Four taillights, an identification lamp, and a license plate lamp on the semitrailer (see figure 9) were examined to determine the condition of the lamp filaments. Each of the four rear semitrailer taillight lamps had two filaments, a smaller one connected to the taillights and a larger one connected to the stop lights. The filaments for all four of the semitrailer's taillight lamps were intact and connected to their respective posts. The smaller filaments for the two center taillight lamps displayed age sagging. The support and electrical posts on the identification lamp were bent and distorted, but the single filament was intact with some deformation in the area of the support hangers. No indications of filament oxidation were found on the identification lamp, even though the glass envelope was broken. None of the filaments exhibited stretching.

Examination of the license plate lamp revealed significant filament stretching between one electrical post and its nearest support post, sufficient to produce a visible loop. The filament showed faceting consistent with long-term use, and the portion opposite the stretched length showed age sagging.

The filaments of the four taillight lamps showed no indications of hot stretching, which would be a sign of impact while they were illuminated. The filament of the identification lamp did show some stretching, but because it was near the posts, it may have been due to deformation of the posts during the collision sequence and thus not indicative of illumination at impact. Additionally, no tungsten oxide was present as would be expected if the glass envelope had been fractured while the bulb was illuminated. Also, since the fuse for the identification lamp circuit was burned out, the lamp could not have been illuminated. The filament of the license plate light did display hot stretching indicative of being hot (illuminated) during an impact. Investigators could not determine whether the impact that caused the hot stretching occurred during this accident or whether it occurred prior to this accident during a high-energy bump. Because DelCar had not maintained service records, investigators could not determine whether the semitrailer had been in a previous accident. However, if the license plate light was illuminated, the taillights should have been illuminated also because they are on the same circuit. However, based on the defective wiring on that circuit, suggesting an electrical short, no evidence of hot stretching of the taillight filament, and statements by several witnesses, the taillights were quite likely not illuminated prior to the crash and, therefore, the license plate light was probably not illuminated, either. The Safety Board concludes that the rear lighting on the semitrailer was inoperable at the time of the accident.
