Appendix 1

Soil Data Report for 17th Street Canal

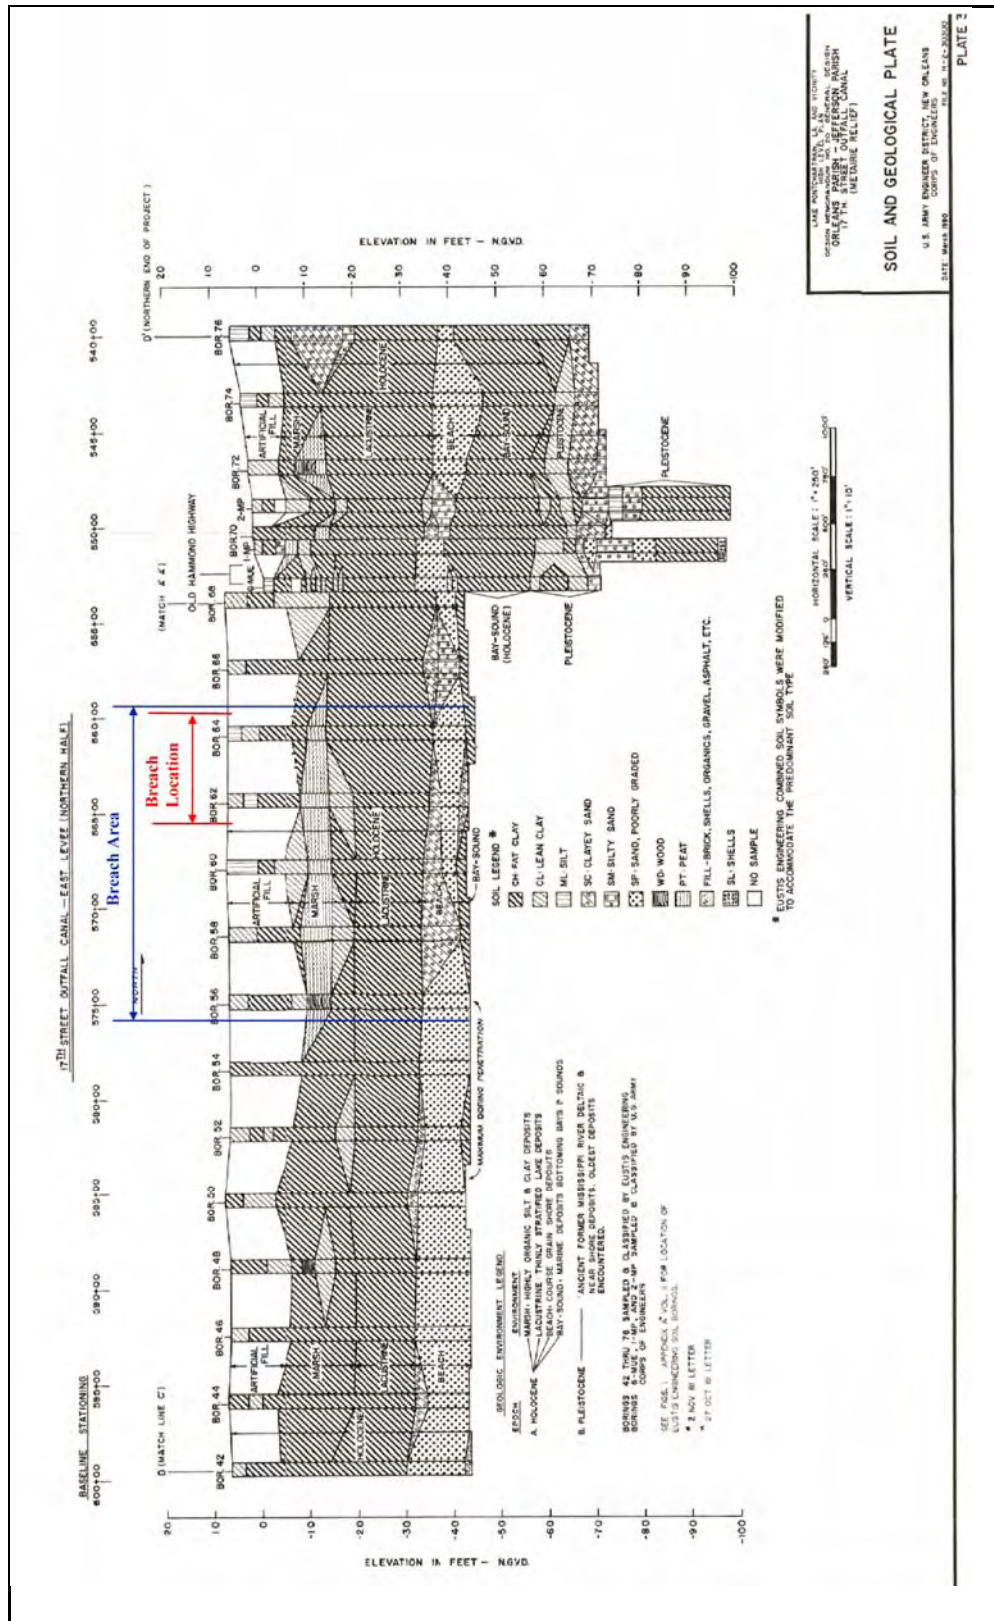
Figure 1-7. Geological Profile showing Breach Area (East Levee)

Figures 1-7 and 1-8 show longitudinal profiles of the east and west bank levees of the northern half of the 17th Street Outfall canal, respectively. These figures, obtained from GDM No. 20, show boring locations and the soil types obtained during the explorations for the project upgrade. It is noted that odd numbered borings are located on the west bank, and even numbered borings are located on the east bank. Noted on the figures is the location of the breach site which is situated on the east bank of the canal between Stations 560+50 and 564+50.

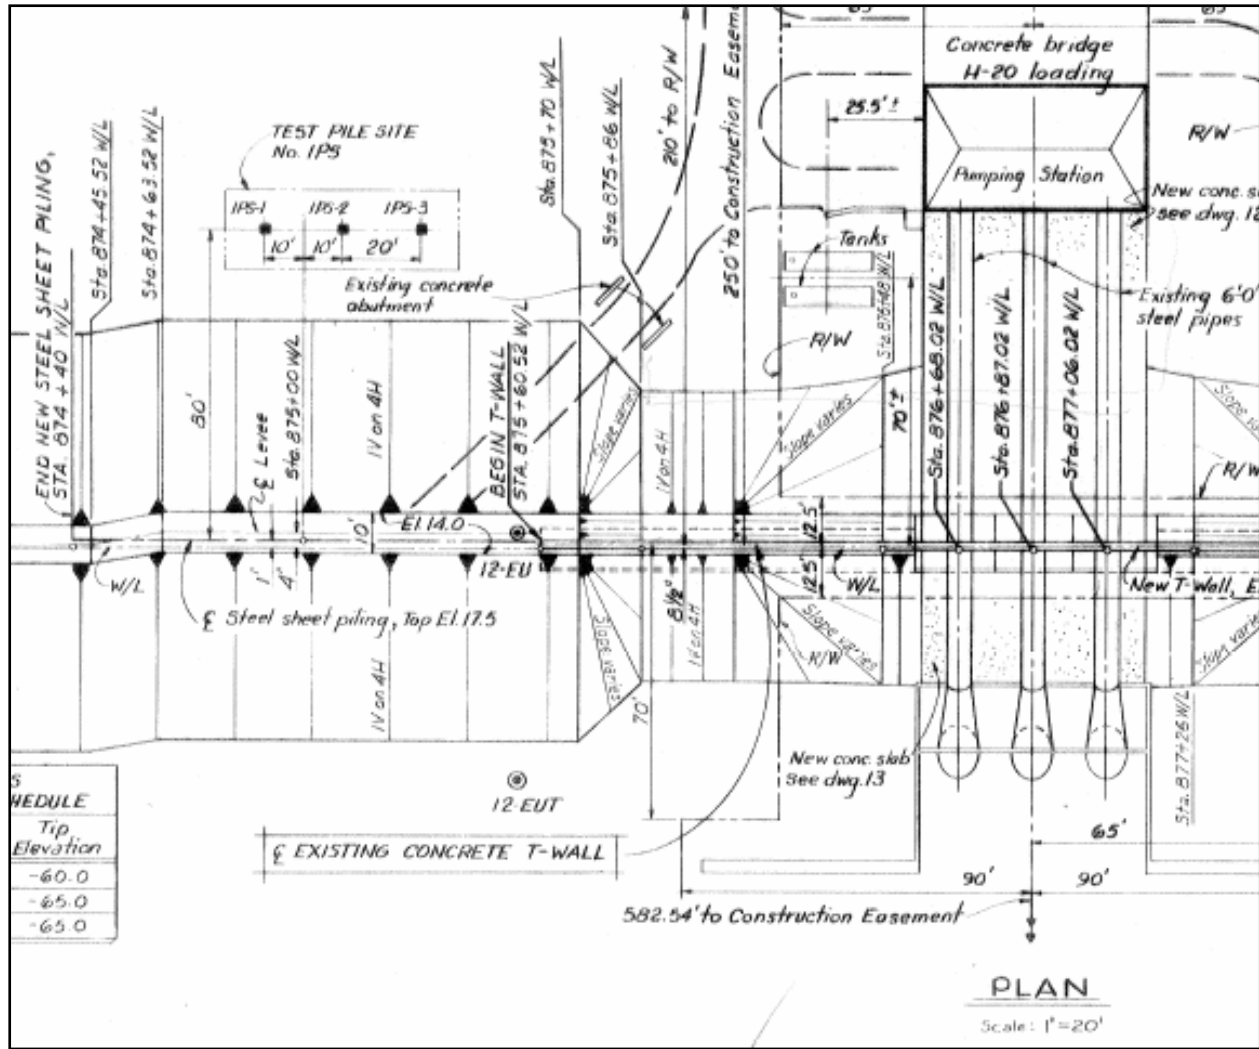
Figure 12-26. NOE2_F Failed Sheet Pile Section Between Sta 874+40 and T-Wall at Sta 875+60 (Plan view)
