Appendix 11

Analysis of Performance of the Inner Harbor Navigation Canal

Executive Summary

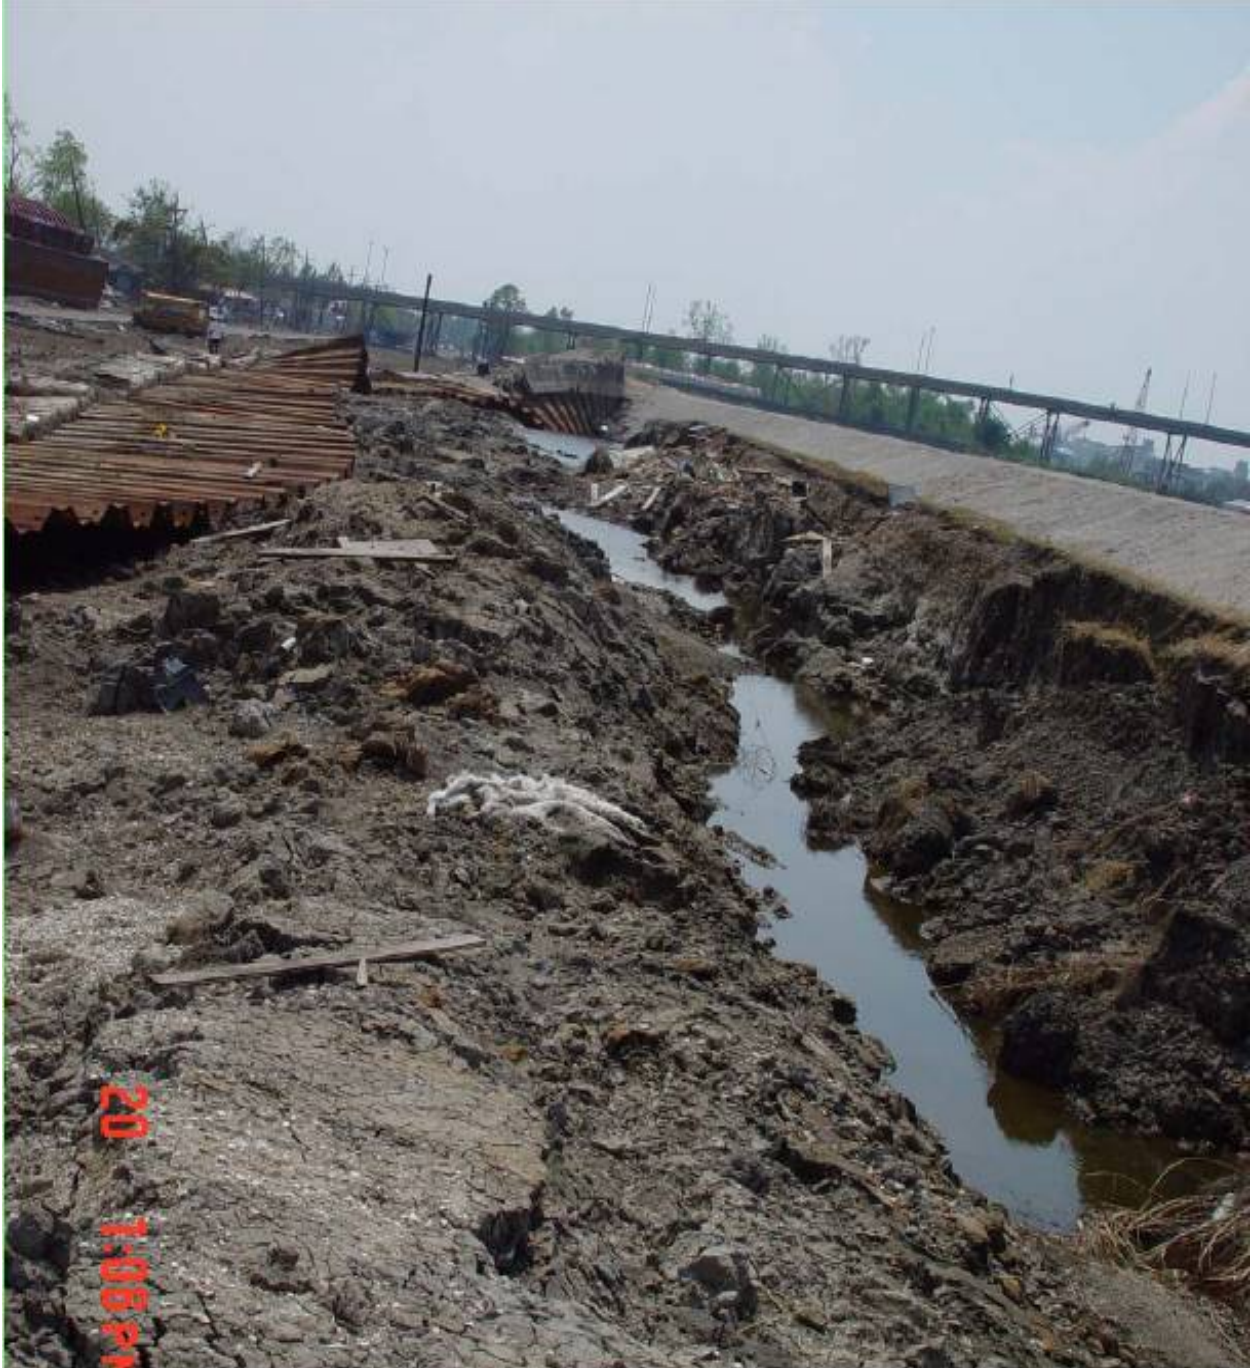
Figure 11-5. Scour and Erosion Leading to the Failure of the I-Wall on the IHNC Adjacent the South Breach (9th Ward)

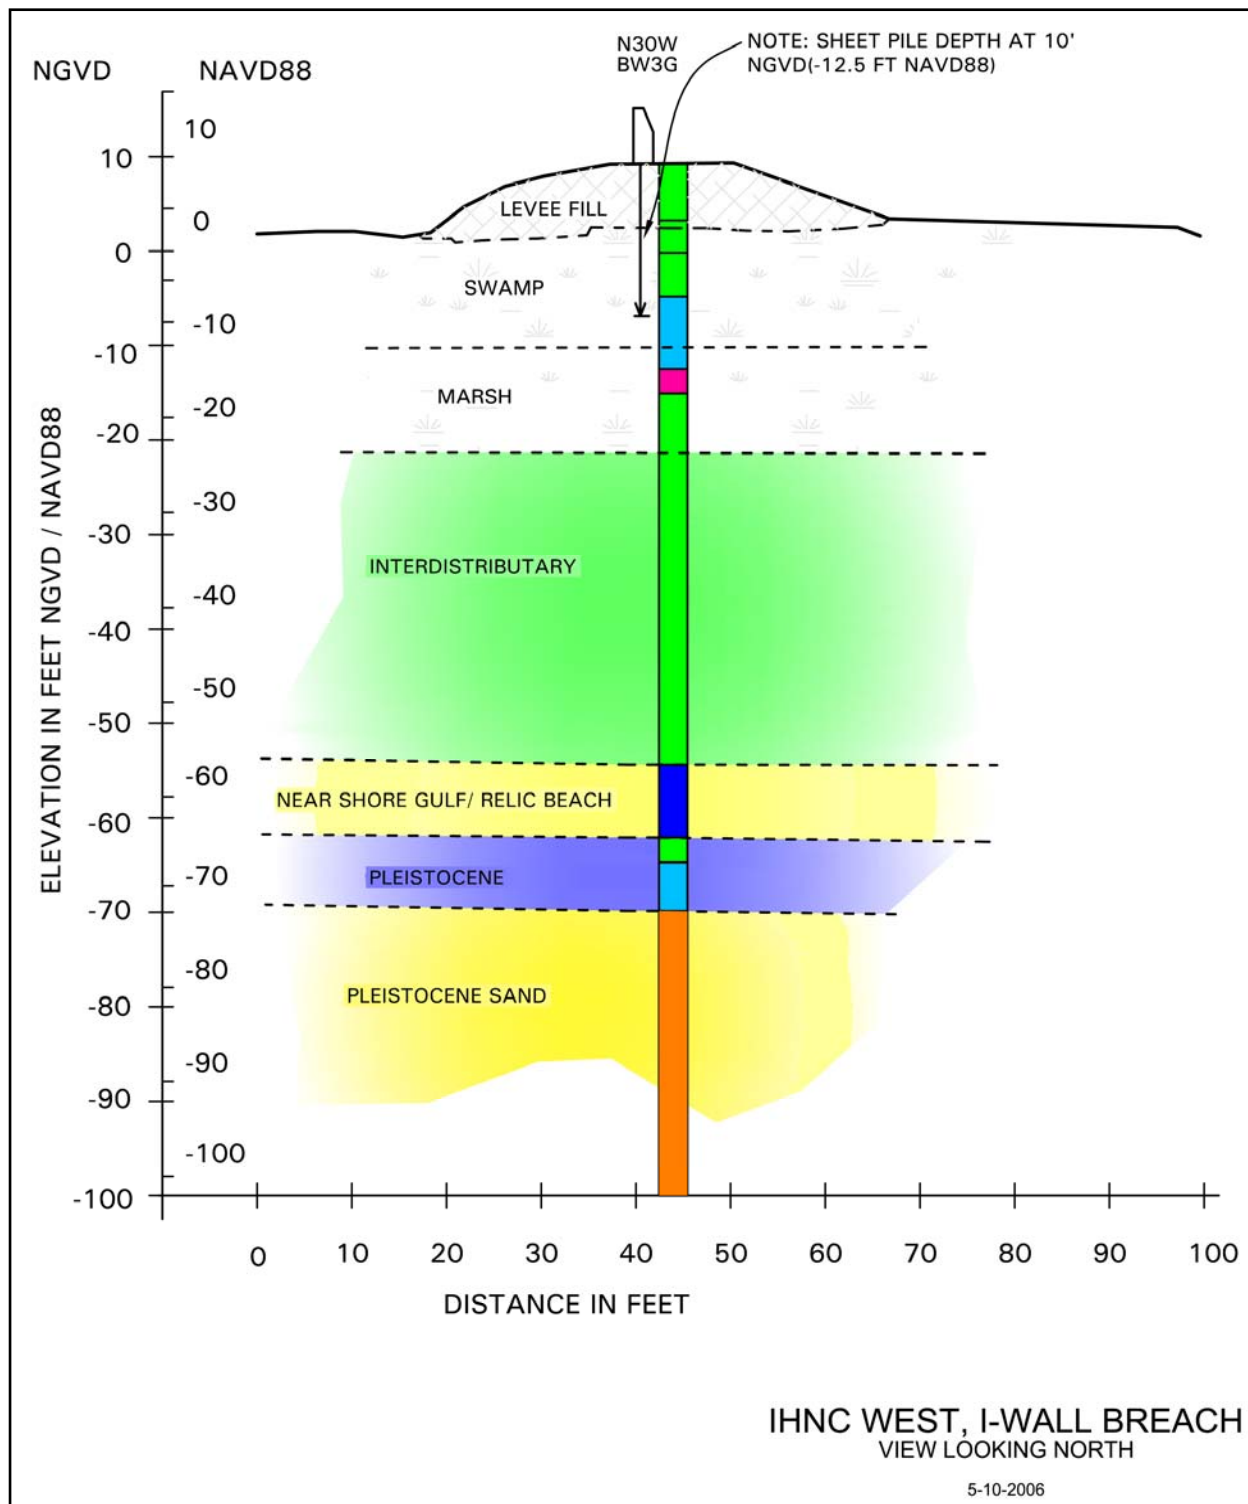
The levees at both locations were founded on about 8 ft to 10 ft of fill. The fill at the north breach was clay. At the south breach the fill consisted partly of silty sand and partly of clay, as shown in Figure 11-36. At both locations the fill was underlain by a layer of marsh material, about 11 to 12 ft thick, and a layer of normally-consolidated interdistributary clay 30 to 35 ft thick.

Figure 11-35. IHNC – West Bank – Cross Section of North Breach

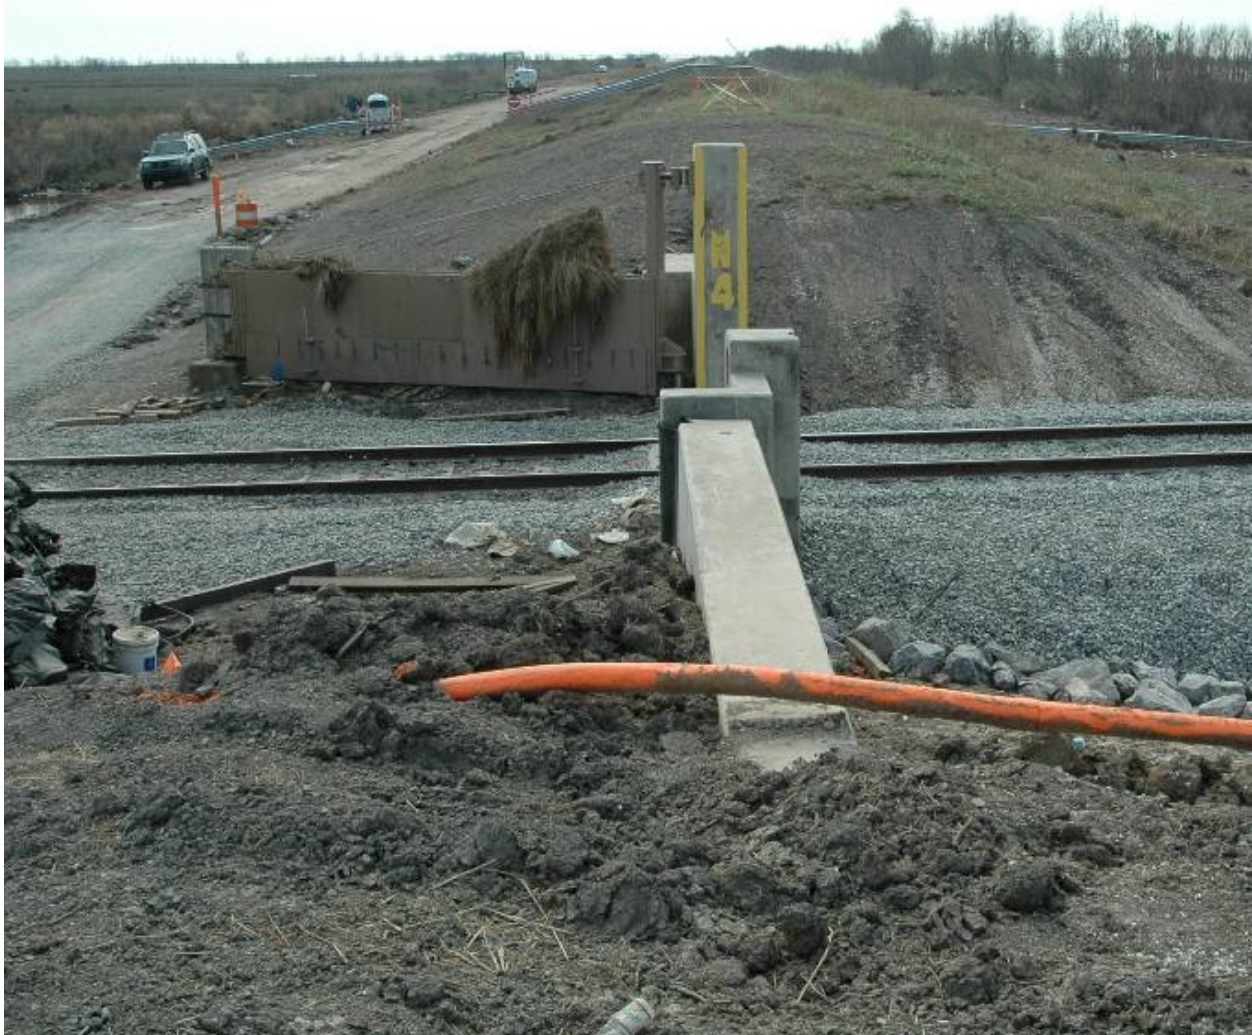
Figure 12-20. NOE5_C. Filled-In Scour Holes

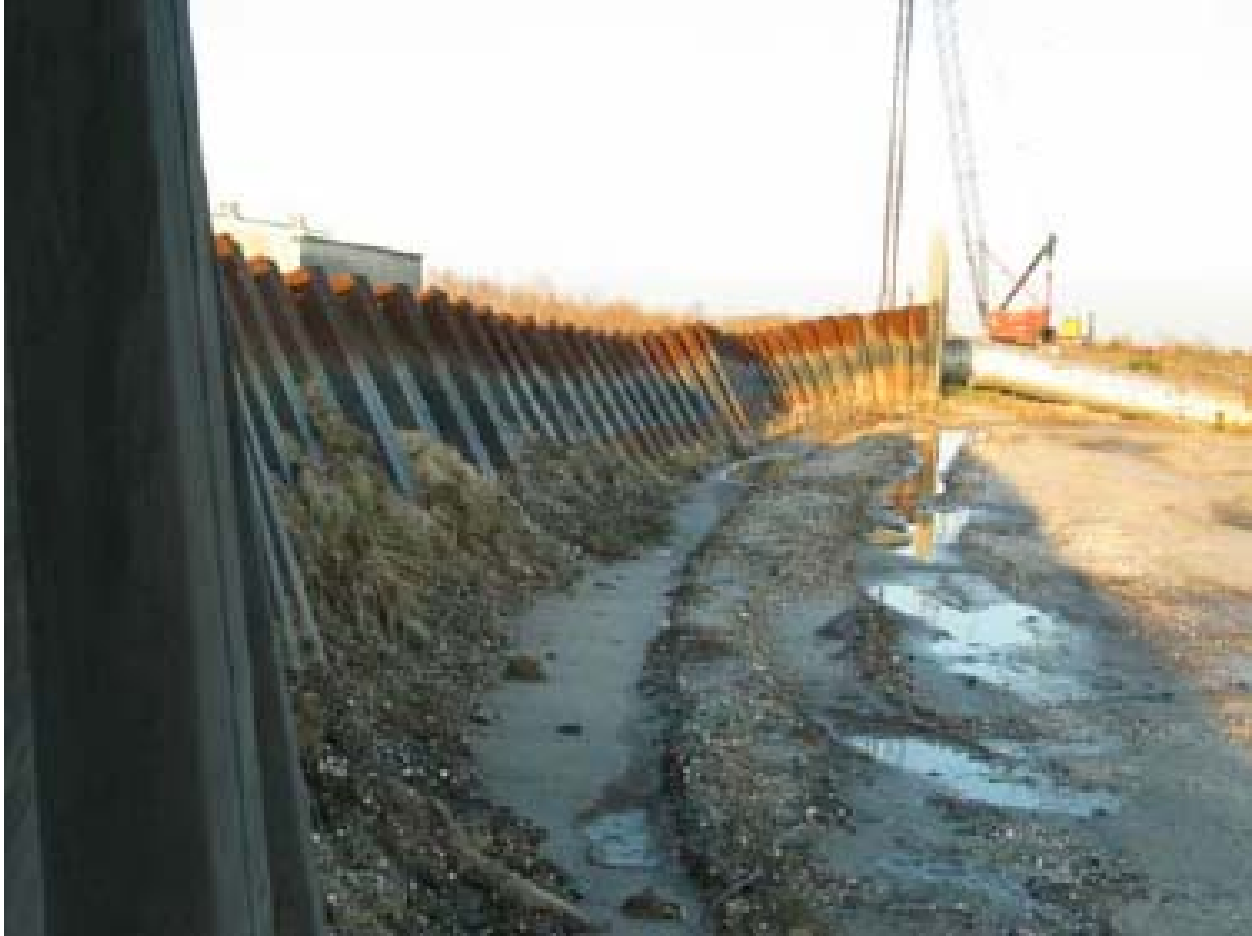
Figure 12-23. NOE2_C Closeup of Sheet Pile Damaged by Scour/Rotation/Sliding Failure

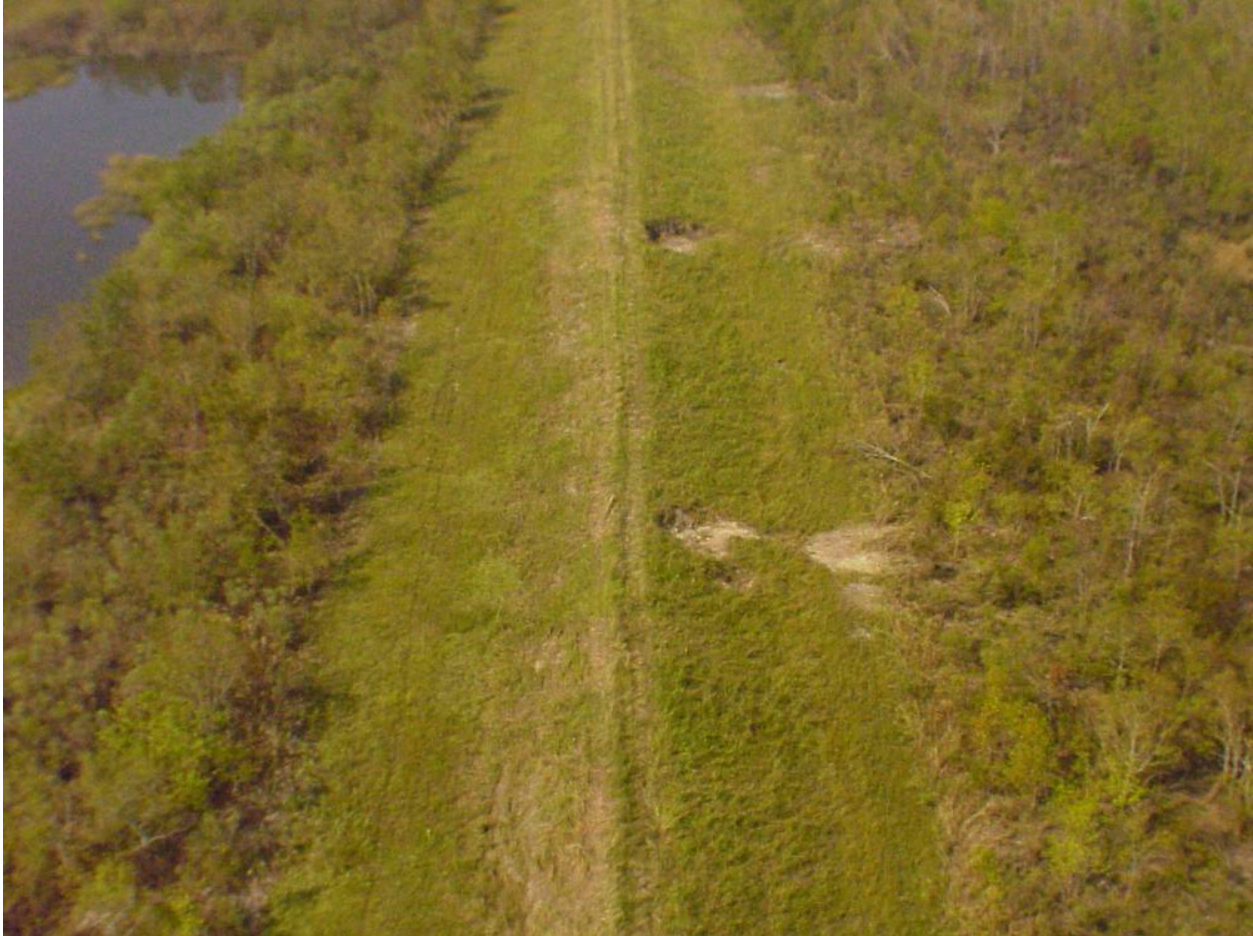
Figure 12-40. NOE1_G Localized Scour Typical of Several Locations

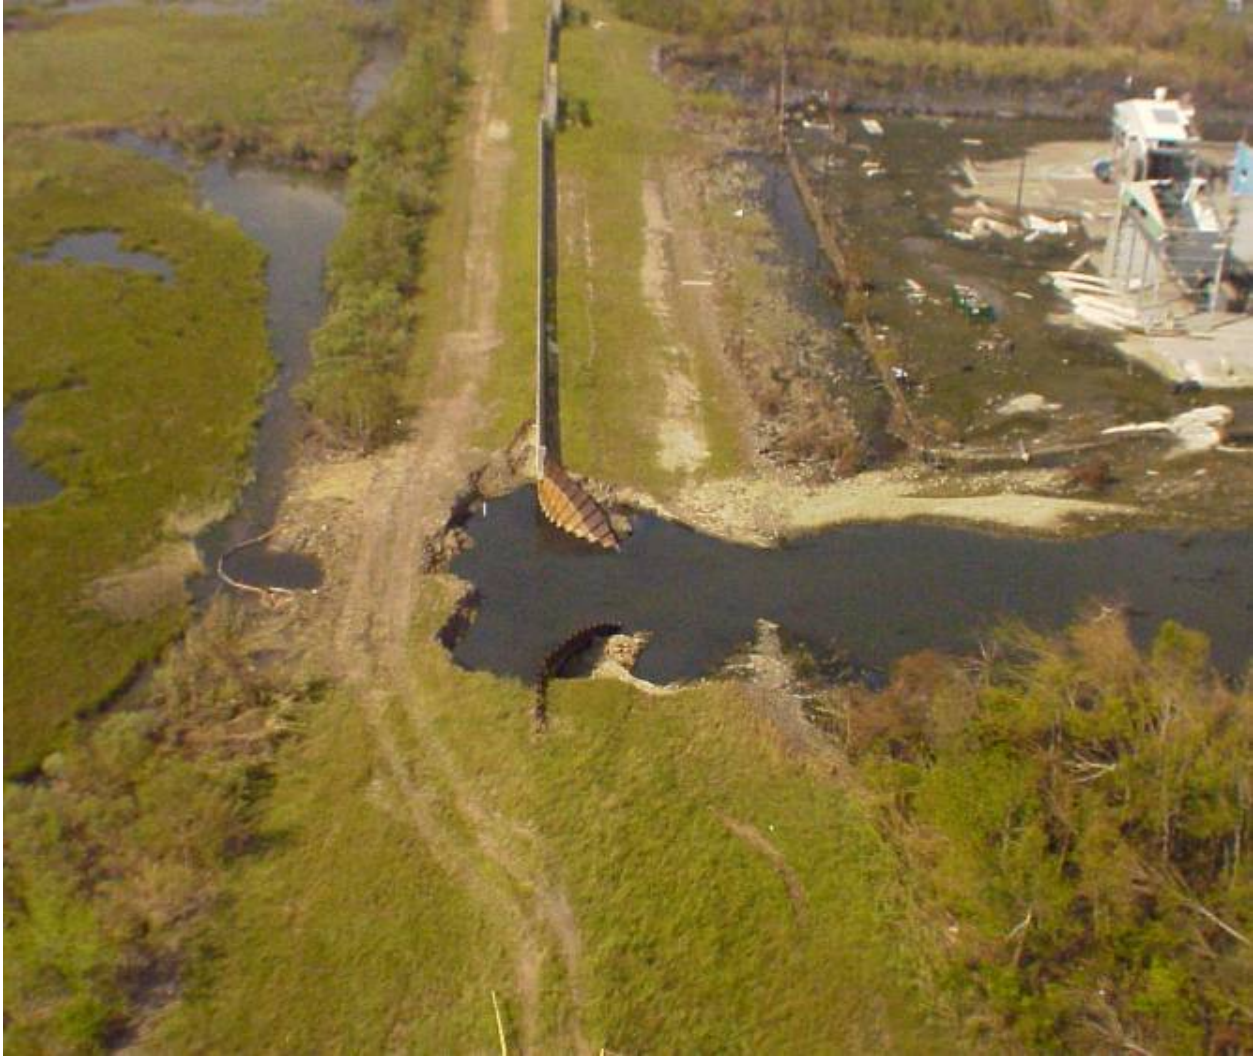
Figure 12-44. NOE3_D Sheetpile Wall Failure (near Sta 772+00 B/L New Orleans East Back Levee)
(Coordinates 30 deg 01 min 04.30 sec N, 89 deg 53 min 49.36 sec W)

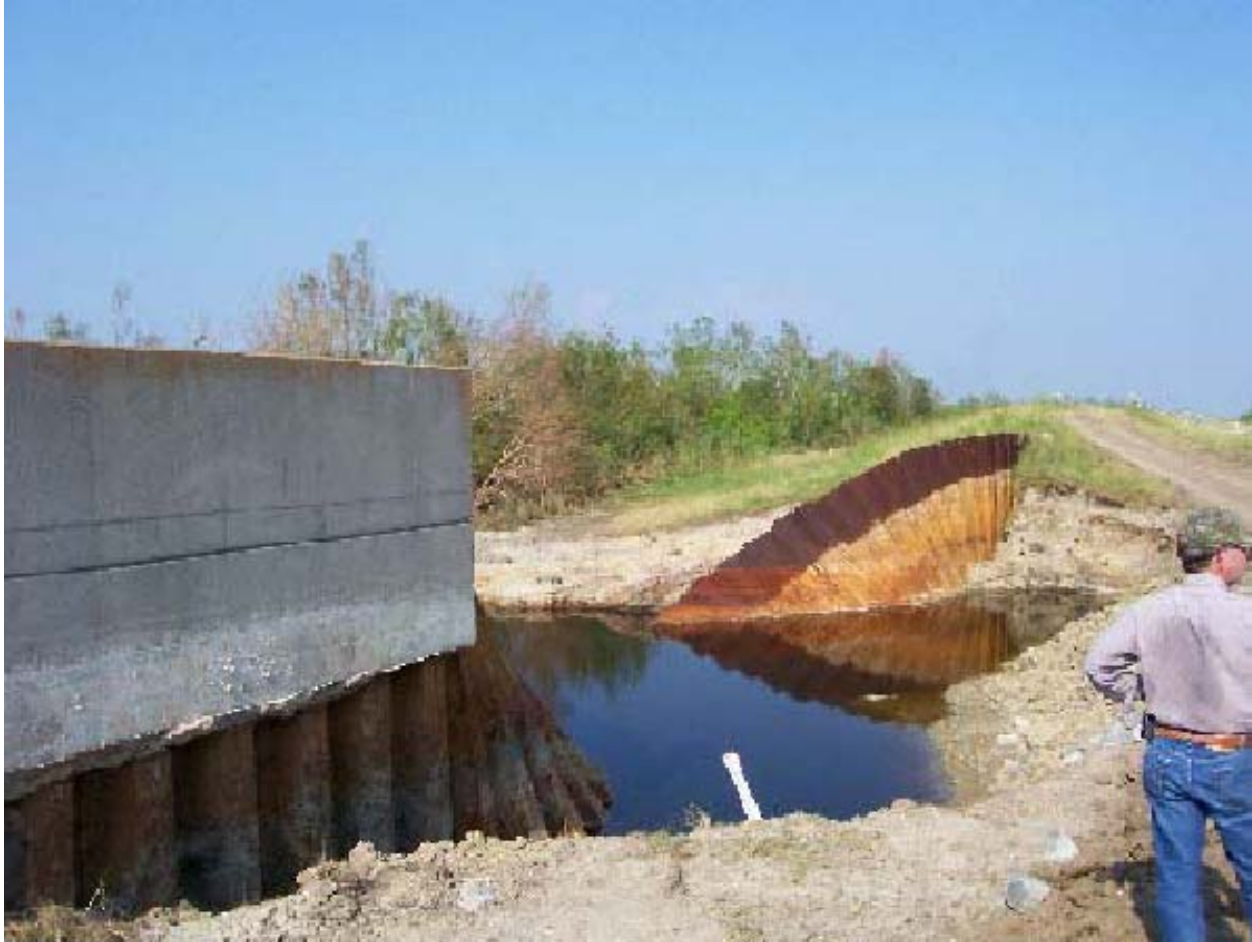
Figure 12-47. NOE3_G. West of Failure Looking East. Drawings from NOE3 Contract Solicitation Show Scour Depth And Outline

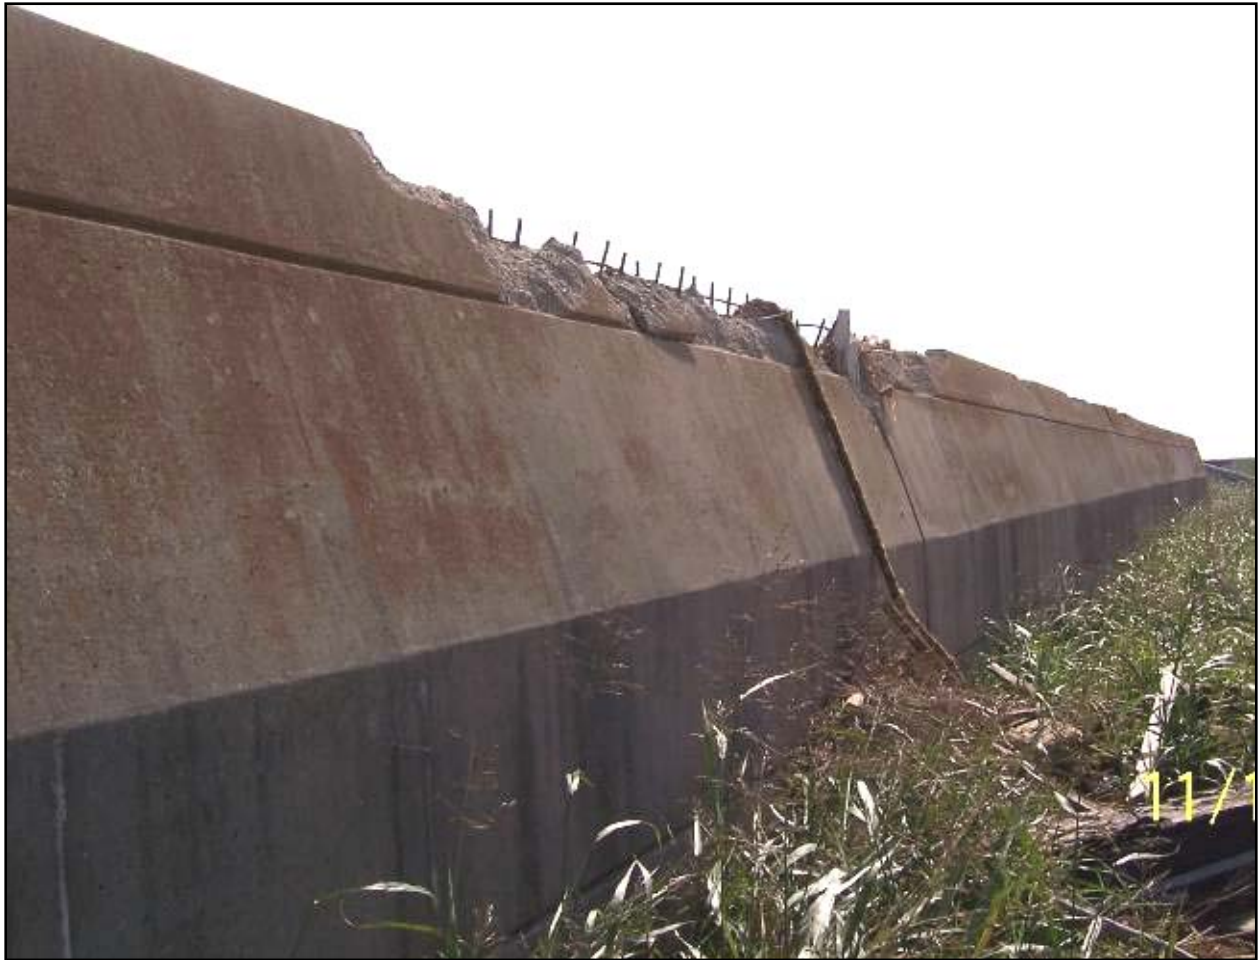
Figure 12-53. NOE9_C. I-Wall Damage Likely Due to Impact

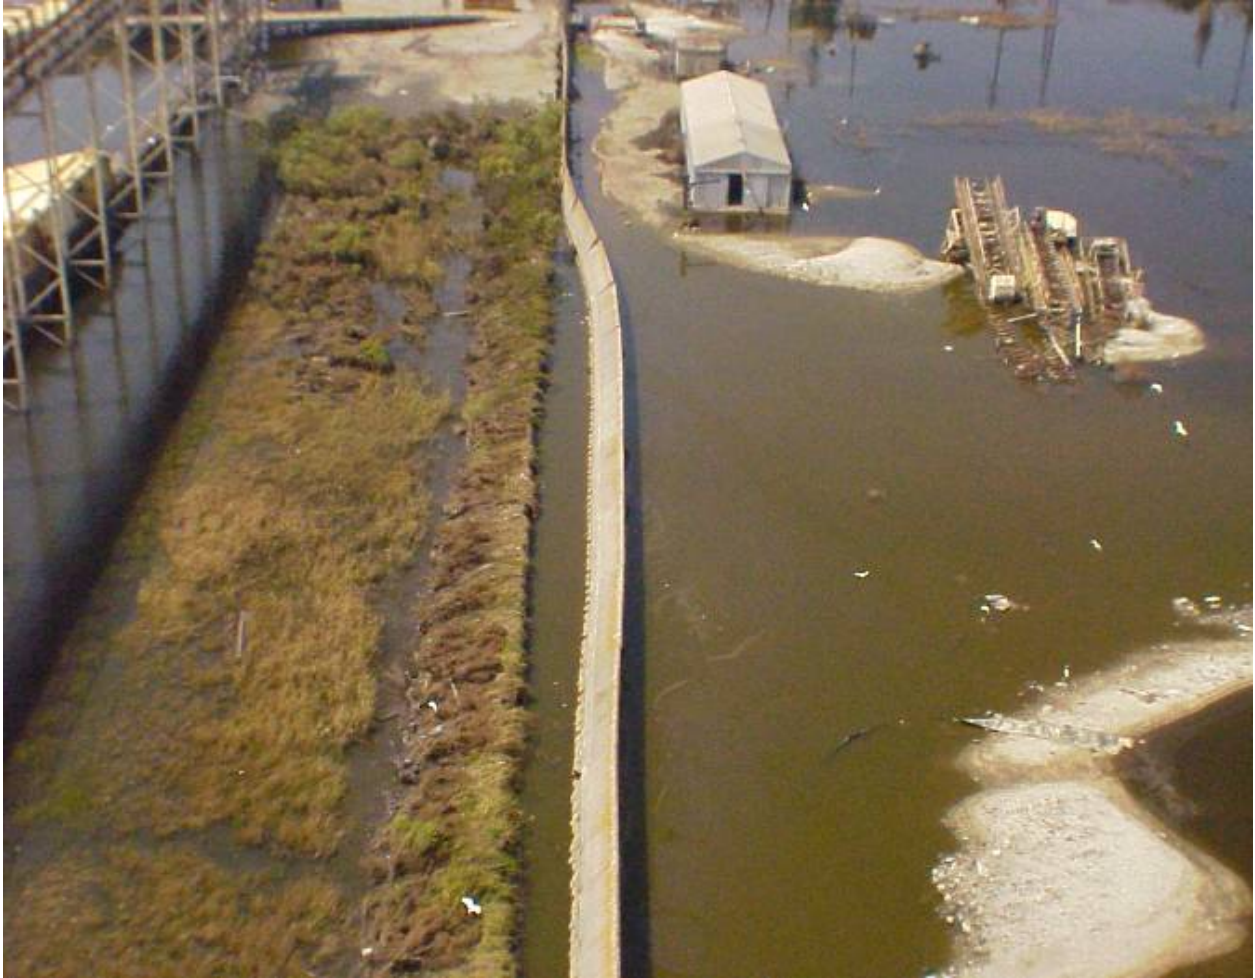
Figure 12-55. NOE4_B. Bulk Loading Terminal Facility I-Wall Failed by Rotation with Attendant Scour and Erosion (2000' near Elaine St. at GIWW), near Sta 271+55 B/L (Citrus Back Levee), Immediately Adjacent to the Tool Shed Metal Building

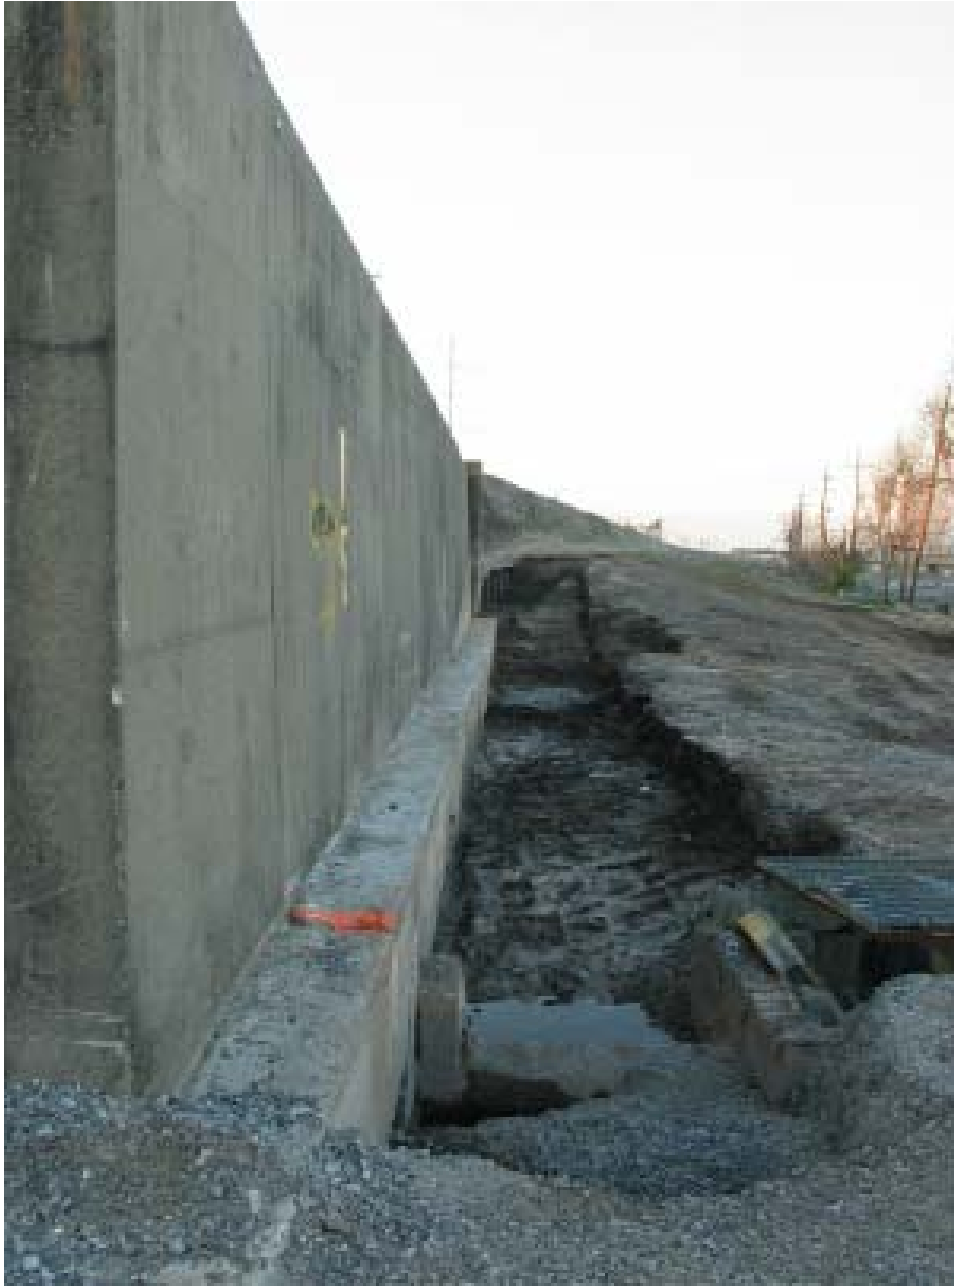
Soil scour within the structure backfill zone is also evident at other locations such as the T-wall on the north side of Gate 13E on the east side of the IHNC near Lakefront Airport at approximate W/L Sta 61+38 (DM2 Supplement 8 IHNC Remaining Levees). The top of T-wall elevation is 13.25 ft (MSL) and the existing top of ground elevation was 0.1 ft (MSL), from drawing file H-2- 24111, plate IV-20. Scour depth was 30in and width was approximately 8 ft caused by a 13-ft overtopping water impact (Figure 13-10). Figures 13-3 and 13-4 show the estimated impact velocity was about 30 ft/sec and impact force was over 700 lb/ft.

Figure 13-10. T-Wall Base Scour on Backside, East IHNC Near Lakefront Airport

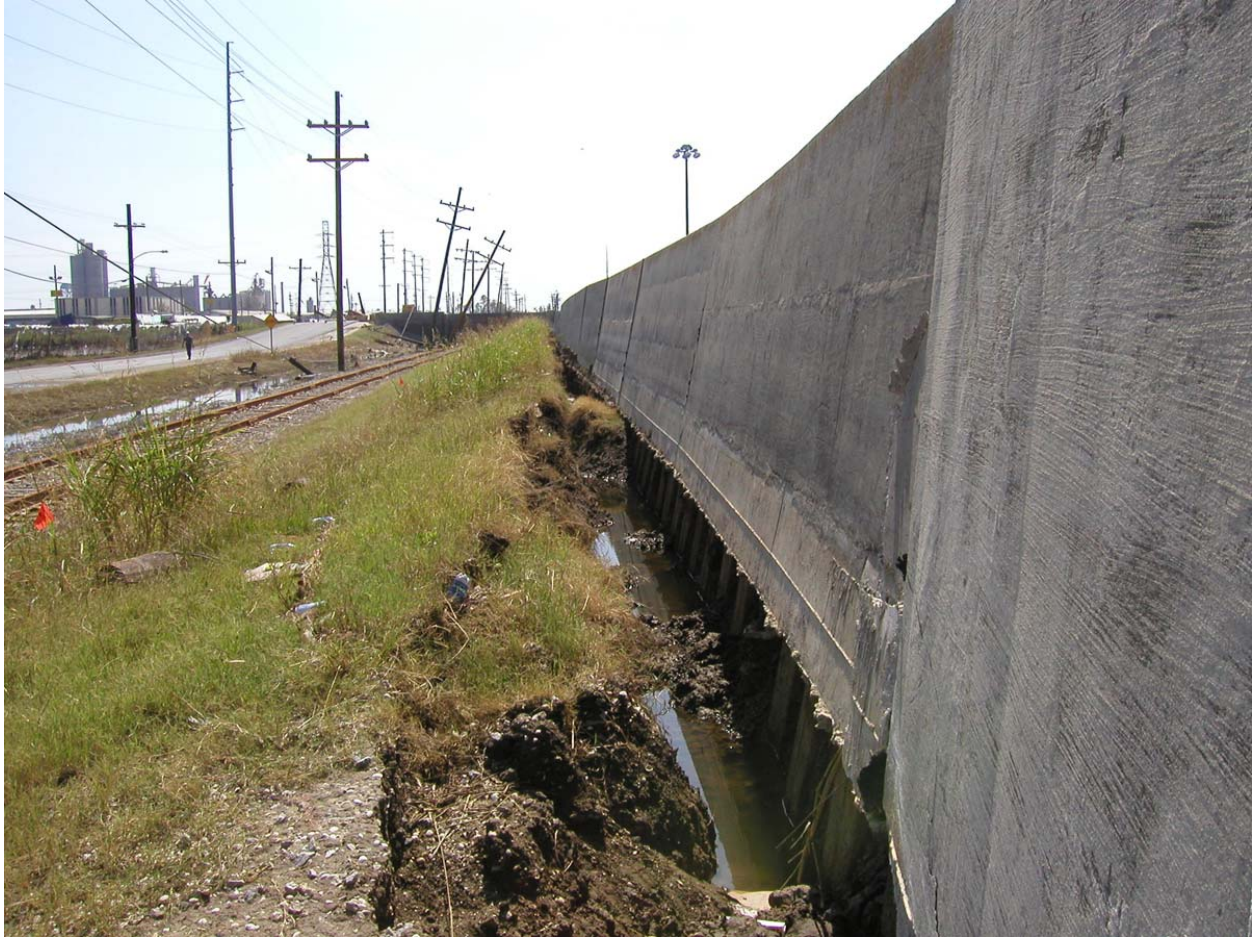
Figure 13-18. IHNC West Side, View South from Benefit St. Gate Toward France Rd Ramp. Approximate W/L Sta 5+56 (B/L Sta 205+44). Top of I-wall elevation 15 ft, levee crown 9 ft, bottom of concrete 7 ft, bottom of pre-existing Z-27 sheet pile (installed by the Orleans Levee Board) at -10ft (MSL). From drawing file H-2-24111, plate IV-15. Nearest soil boring (Figure 13-19) is 30W at B/L Sta 203+00. The I-wall rotated and floodside levee deformation occurred, probably as a result of sheetpile rotation opening up a floodside tension crack. This picture represents scour pattern "C" which is a pre-breaching failure mode

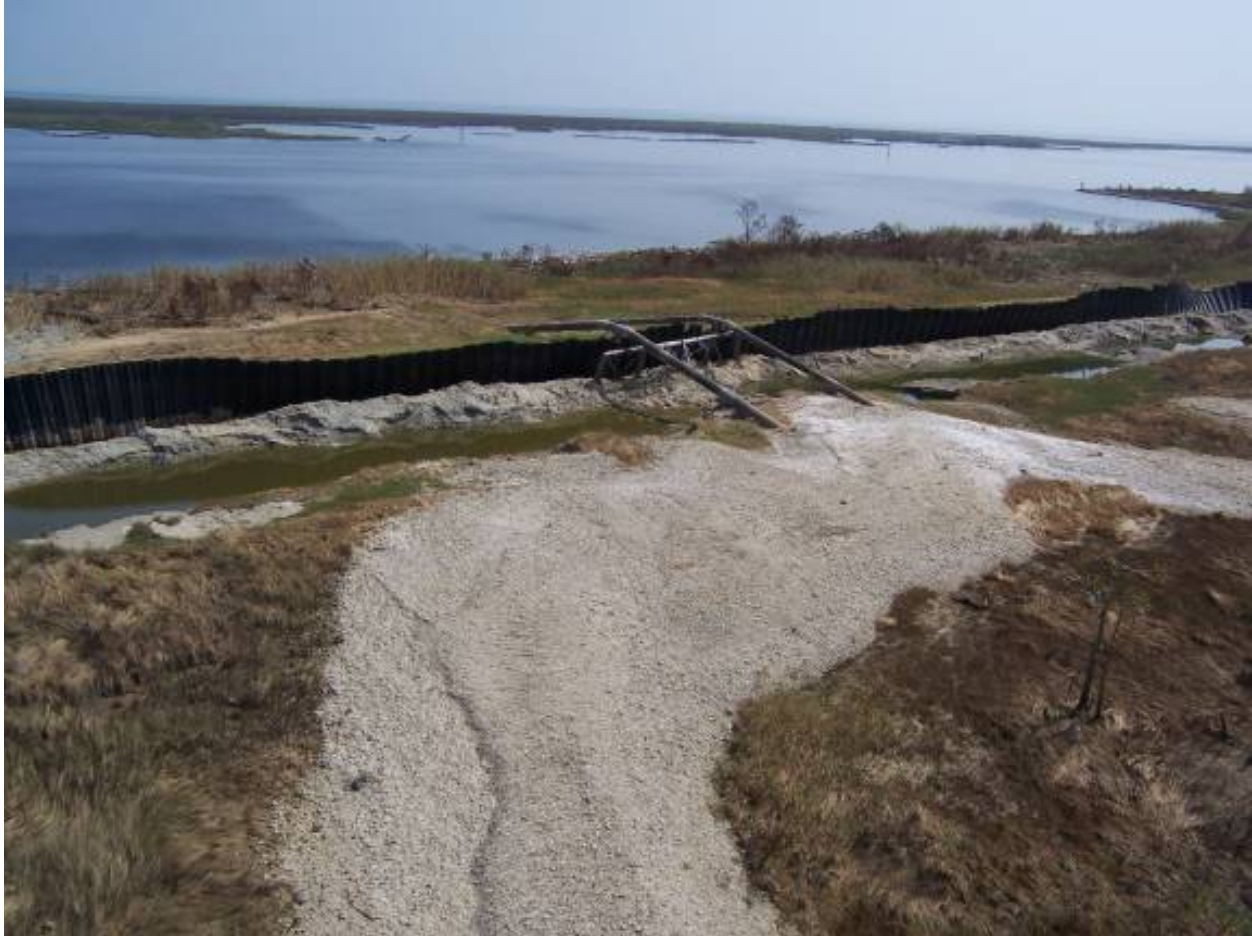
Figure 13-23 shows a section with 4300 ft of exposed sheetpile damage along MRGO between Bayous Bienvenue and Dupre, St. Bernard Parish. The damaged sheetpile section is near utility crossings, with scour on the protected side and levee crown. B/L Sta 590+70 is centerline of the two pipelines.

Figure 13-23. Pattern "A" Scour on the Backside of Exposed Sheetpile Wall Along the MRGO South Bank in St. Bernard Parish

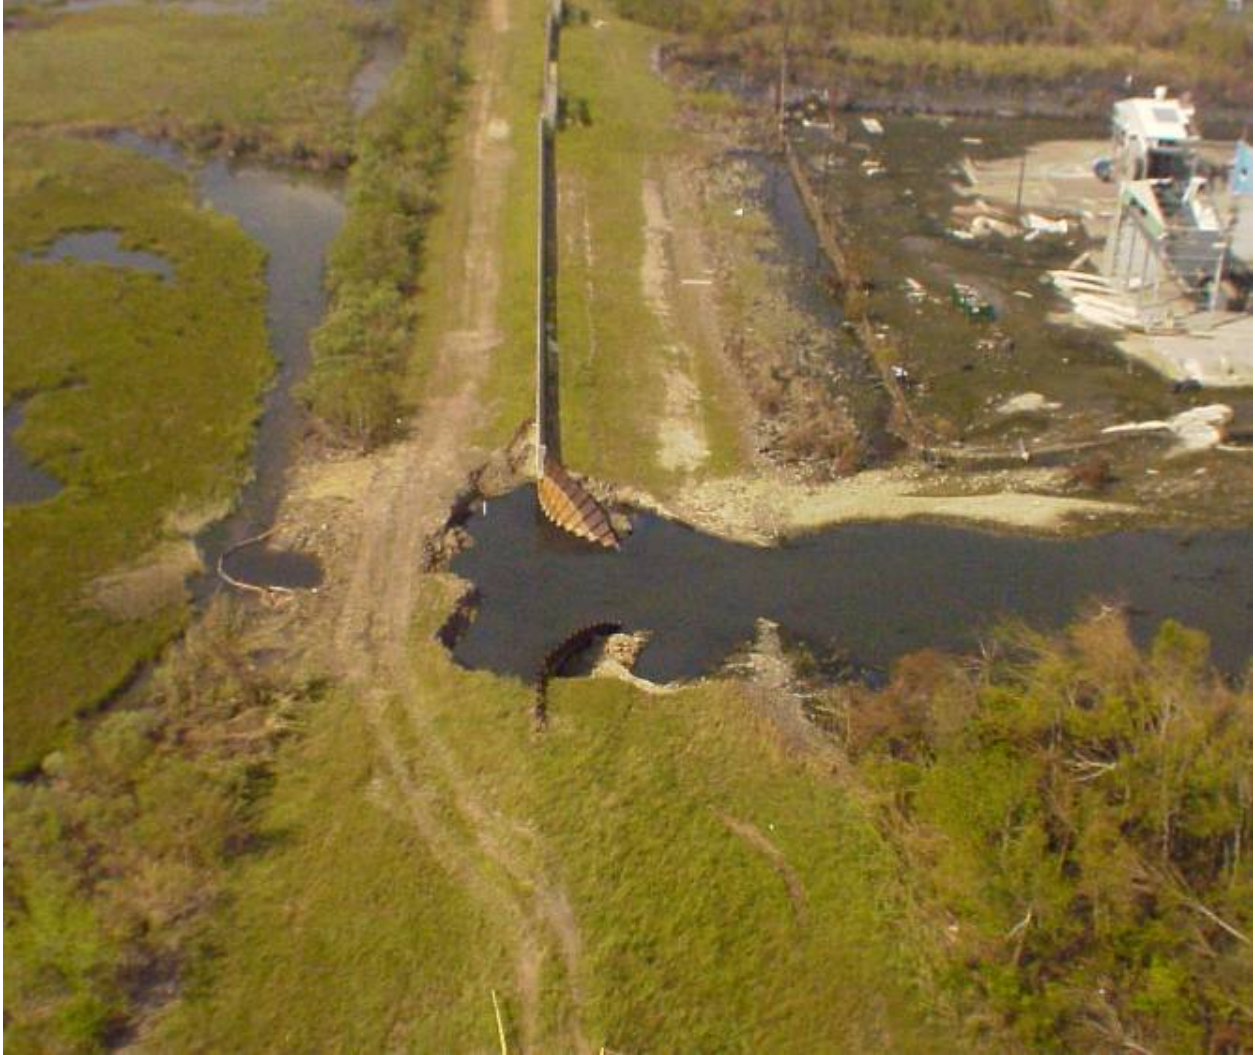
Figure 13-32 shows the Air Products plant breach near Sta 772+00 B/L (New Orleans East Back Levee). Scour depths were 10 to 12 ft on both floodside and protected side of the sheetpile wall. Nearest borings (Figure 13-29) on either side of the failure, 5-E and 6-E (from plate 5, DM2 Supp 4, March 1971) shows CH material with sand / silt lenses in the pre-existing (1965) levee at crown elevation ~12 ft, prior to construction of the sheetpile wall. The storm surge in the GIWW was approximate elevation 15 to 17 ft, and Figures 13-3 and 13-4 show the estimated impact velocity ranged up to about 23 ft/sec and impact force ranged up to about 700 lb/ft. Note that the breach occurred in the sheetpile reach, not along the adjacent transitions to earthen levee on the east side and connection to the T-wall on the west side.

Figure 13-32. Air Products Sheetpile Breach

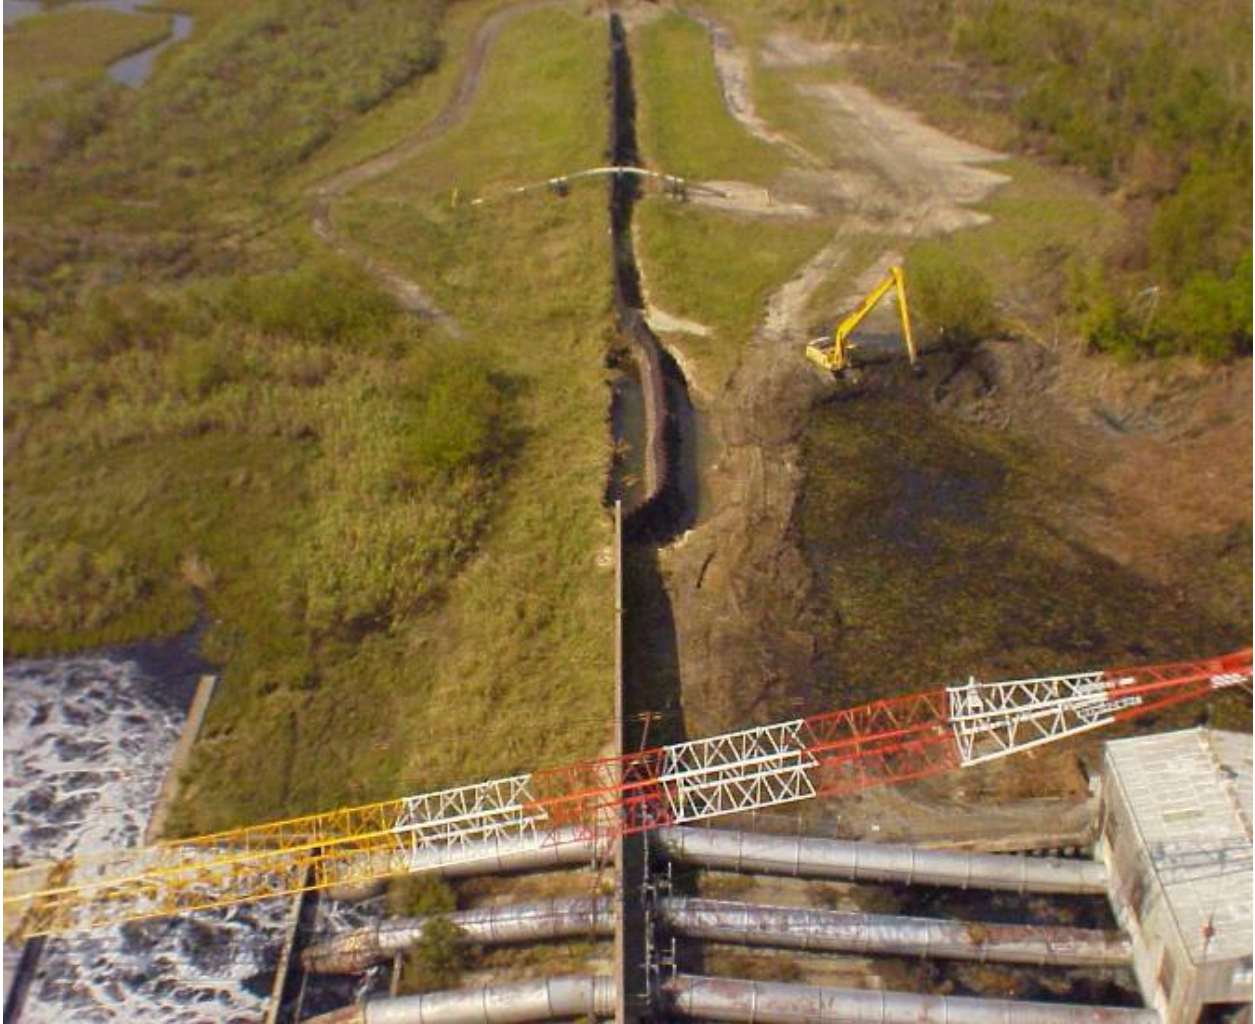
Figure 13-36. New Orleans East Basin, Pump Station 15 on the North Bank GIWW. Failed sheetpile between B/L Sta 874+40 and Sta 875+60 (N.O. East Back Levee). Pre-Katrina elevations ranged from 17.5 to 19.5 ft in this reach

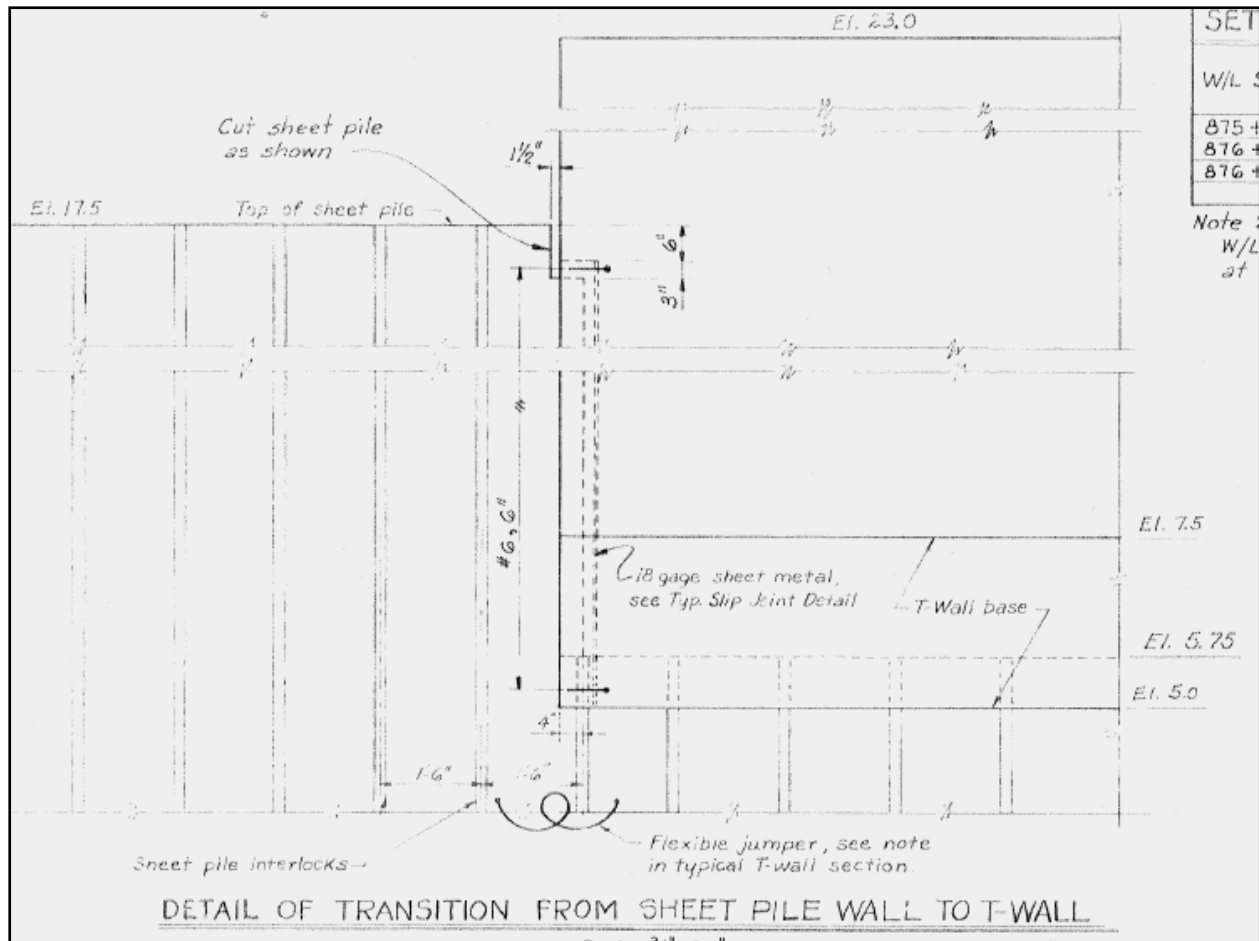
Figure 13-38. Pump Station 15 Top Elevation Difference of 5.5' Between Sheet Pile and T-Wall (plate 14 of 16 from Contract DACW29-77-C-0037, Mod P00001). If pre-Katrina sheetpile elevation was 17.5 ft and storm surge in the MRGO/GIWW was up to 18 ft, then there was minimal overtopping, and the sheetpile breach may have had contributing factors other than overtopping scour

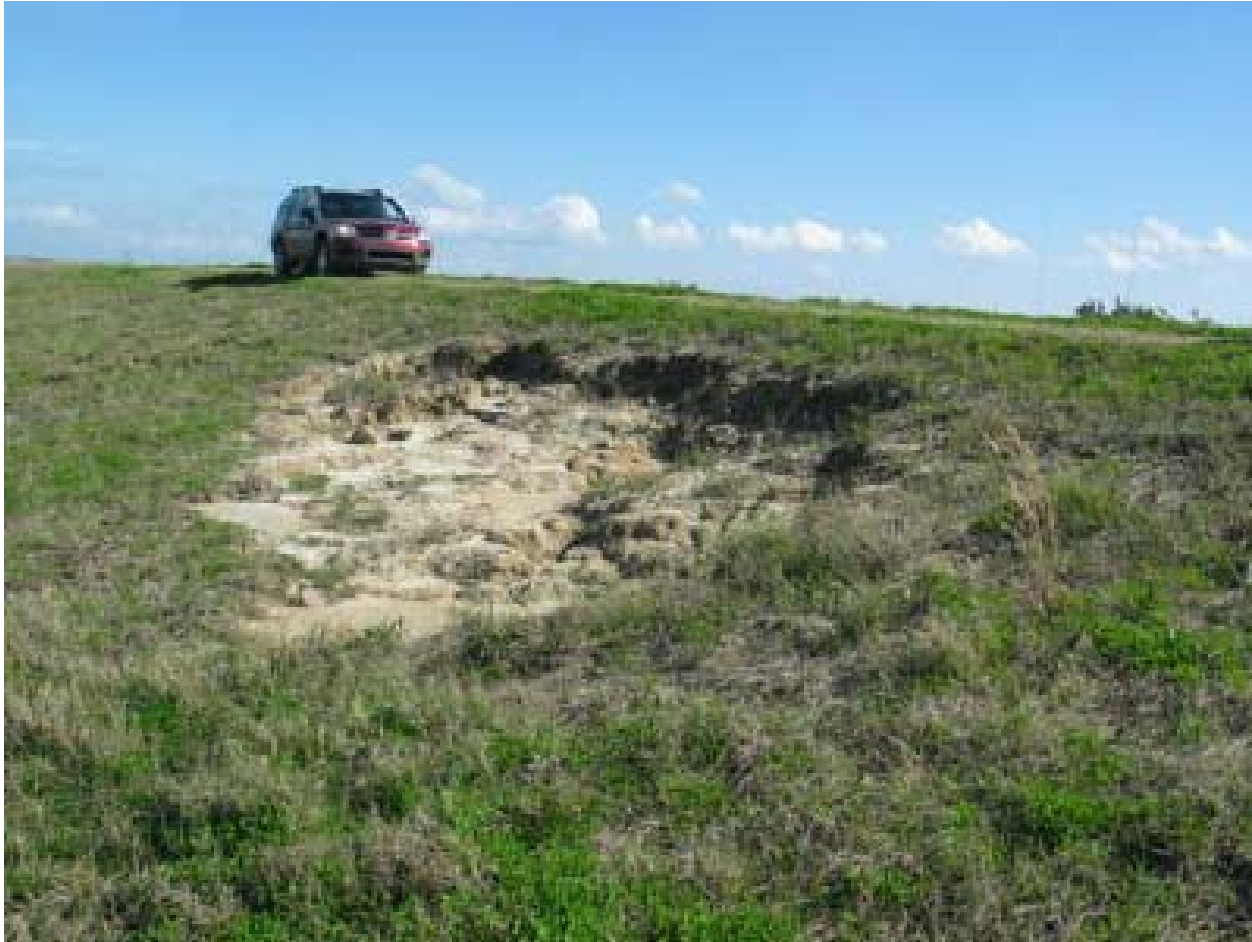
Figure 13-44 shows a closeup of landside slope scour between the Highway 47 (Paris Rd) overpass and the Elaine Pump Station from the north bank of the GIWW protected side looking east (Citrus Back Levee, New Orleans East). Erosion damage measured 24' (length) x 13' (width) x 8" (depth). Note the headcut that developed up the slope toward the crest.

Figure 13-44. Closeup of Landside Slope Erosion at N 30deg 0 min 2.29sec W 89deg 58min 27.29sec
