Appendix 11

Analysis of Performance of the Inner Harbor Navigation Canal

Executive Summary

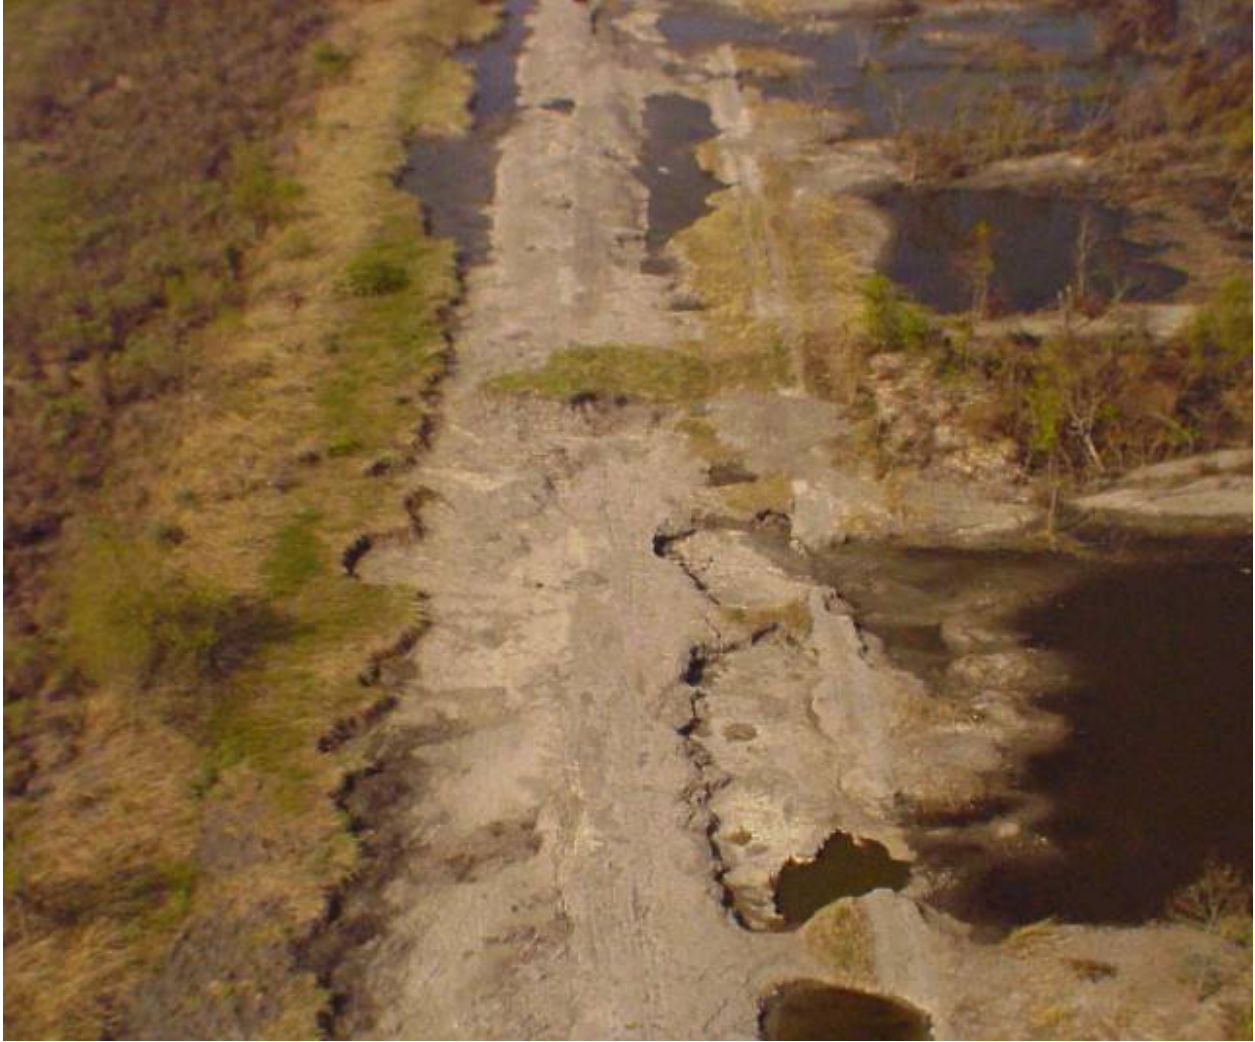
Figure 13-60. East of Pump Station 15 (N.O. East Back Levee), North Bank of GIWW. 12,750 feet of levee east of Pump Station #15 was completely degraded (Station 876+87 B/L to 1101+90 B/L). West of the pump station, 9,800 feet of levee was completely degraded (approx Sta 778+00 to 876+00). The levees in these reaches were constructed from GIWW hydraulic fill in stages over three years

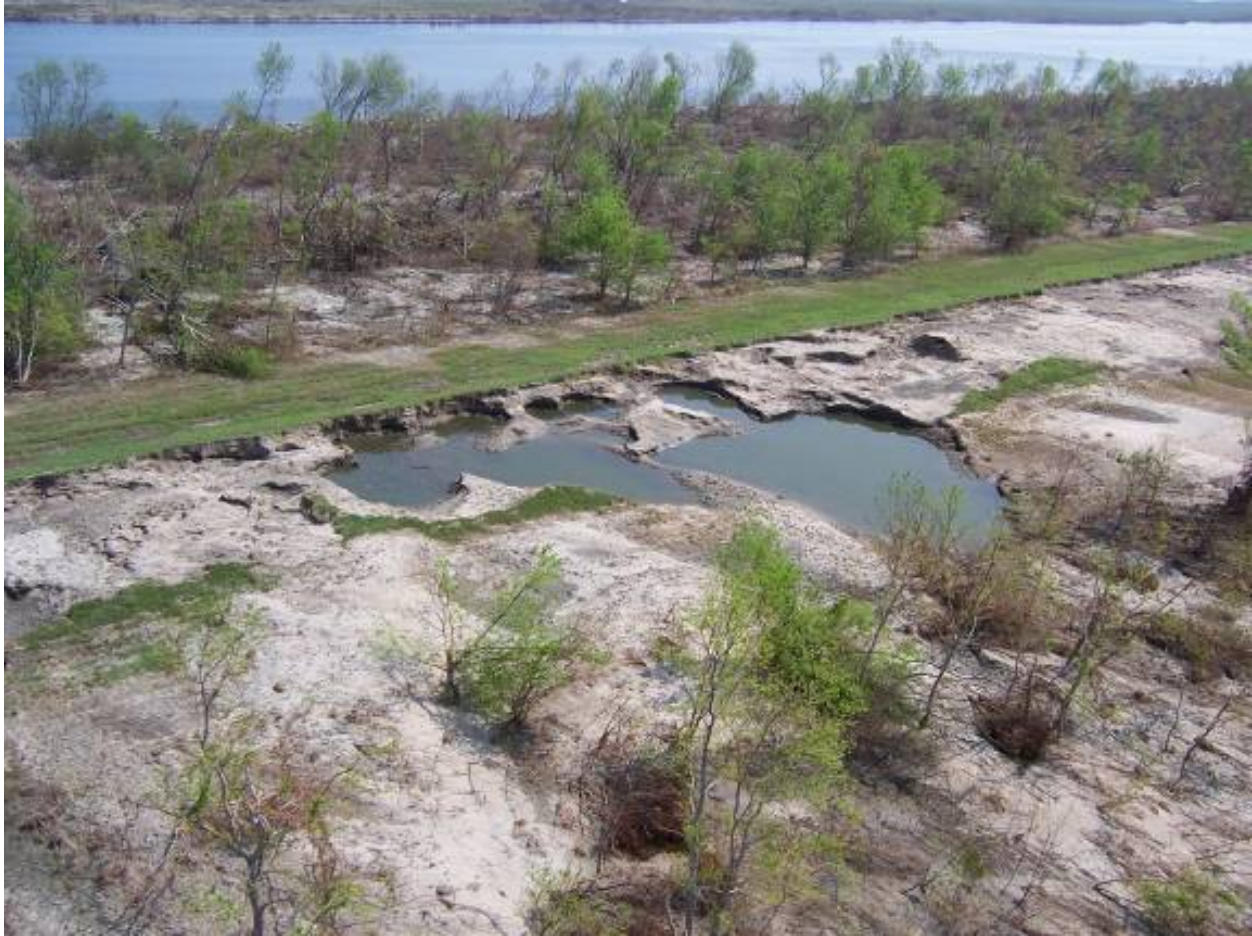
Figure 13-66. 8,000 ft. section of the levee immediately southeast of Bayou Dupre (St. Bernard Parish) that was severely damaged and not only lost approximately 12 feet of levee height but also part of the original levee foundation

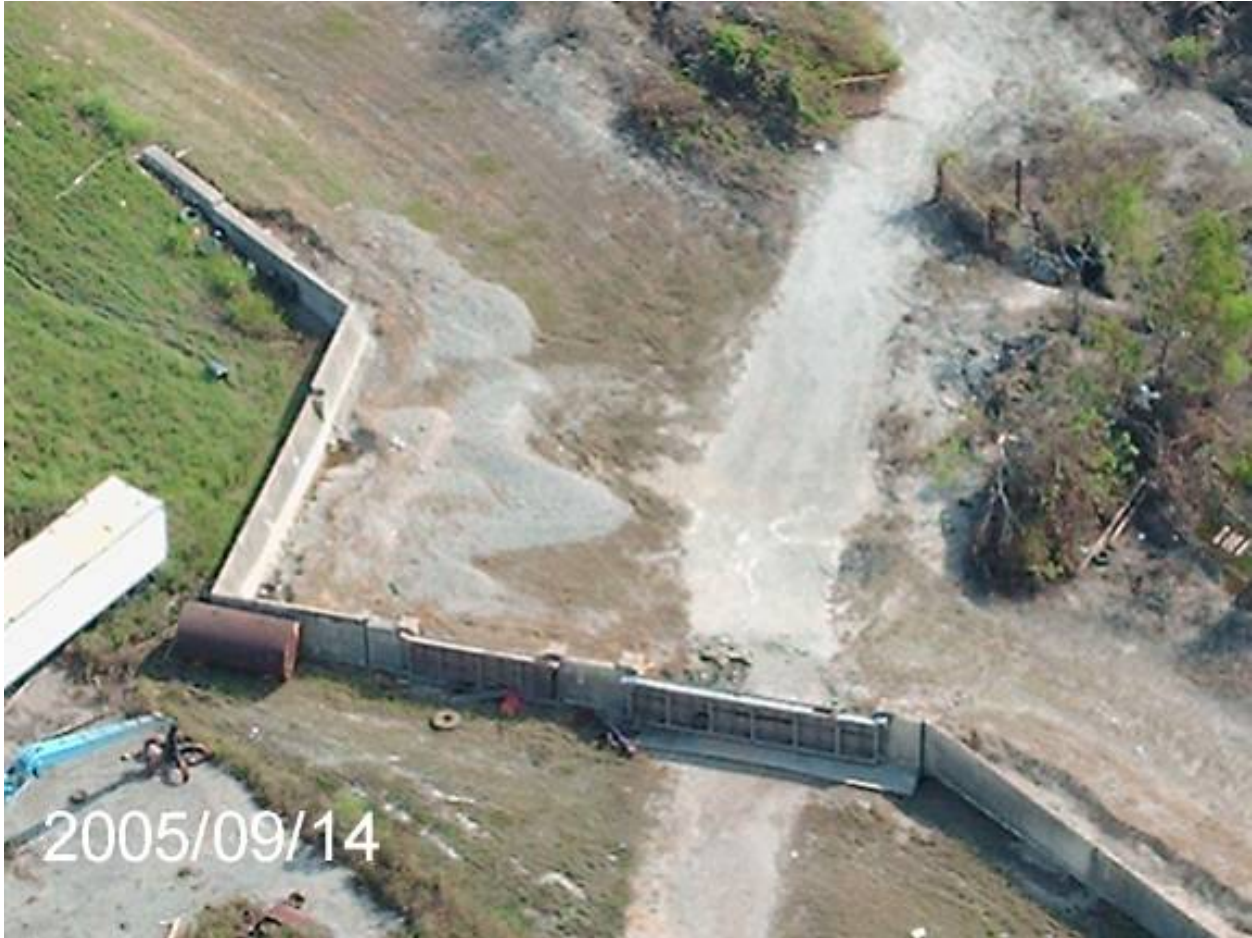
Figure 13-70 shows non-breaching scour caused by overtopping behind the concrete floodwall at closure gates S2 and S3 on the east side of the IHNC. Although the earthen levee abuts the concrete wall, the majority of scour occurred behind the concrete wall. Figure 13-71 depicts the scour pattern that developed along the levee slope behind the wall instead of the levee slope on the abutting earthen levee.

Figure 13-70. Southern Scrap Facility Gates S2 and S3

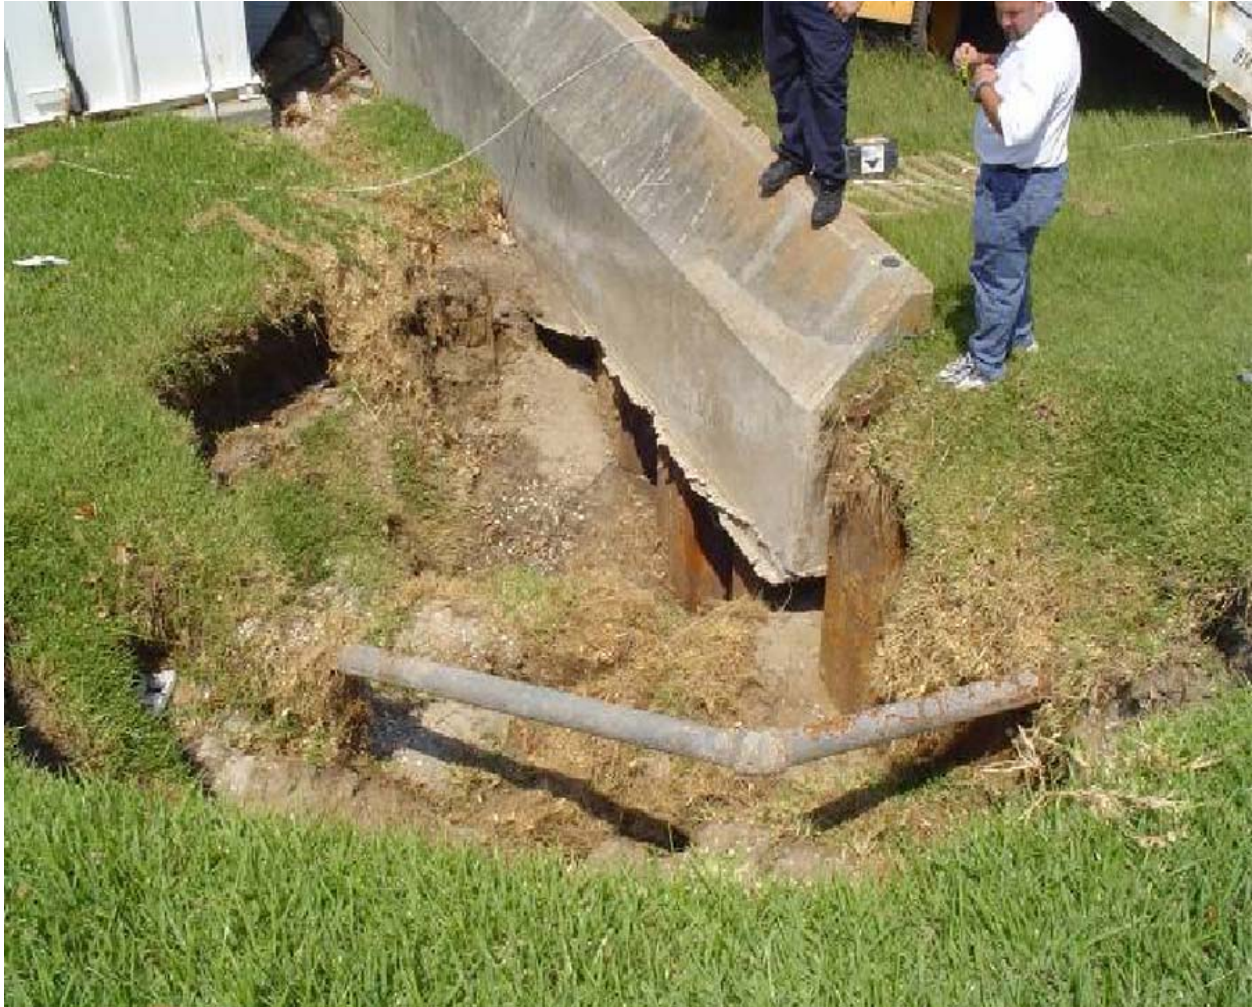
Figure 13-79 shows the I-wall/levee transition on the east side of the IHNC at the IHNC Lock. In this case, the levee crest was about a foot lower than the I-wall top, and overtopping caused erosion and/or a scour hole on the backside. Visual observation indicates a non-cohesive surface soil type.

Figure 13-79. IHNC Lock I-wall transition to levee

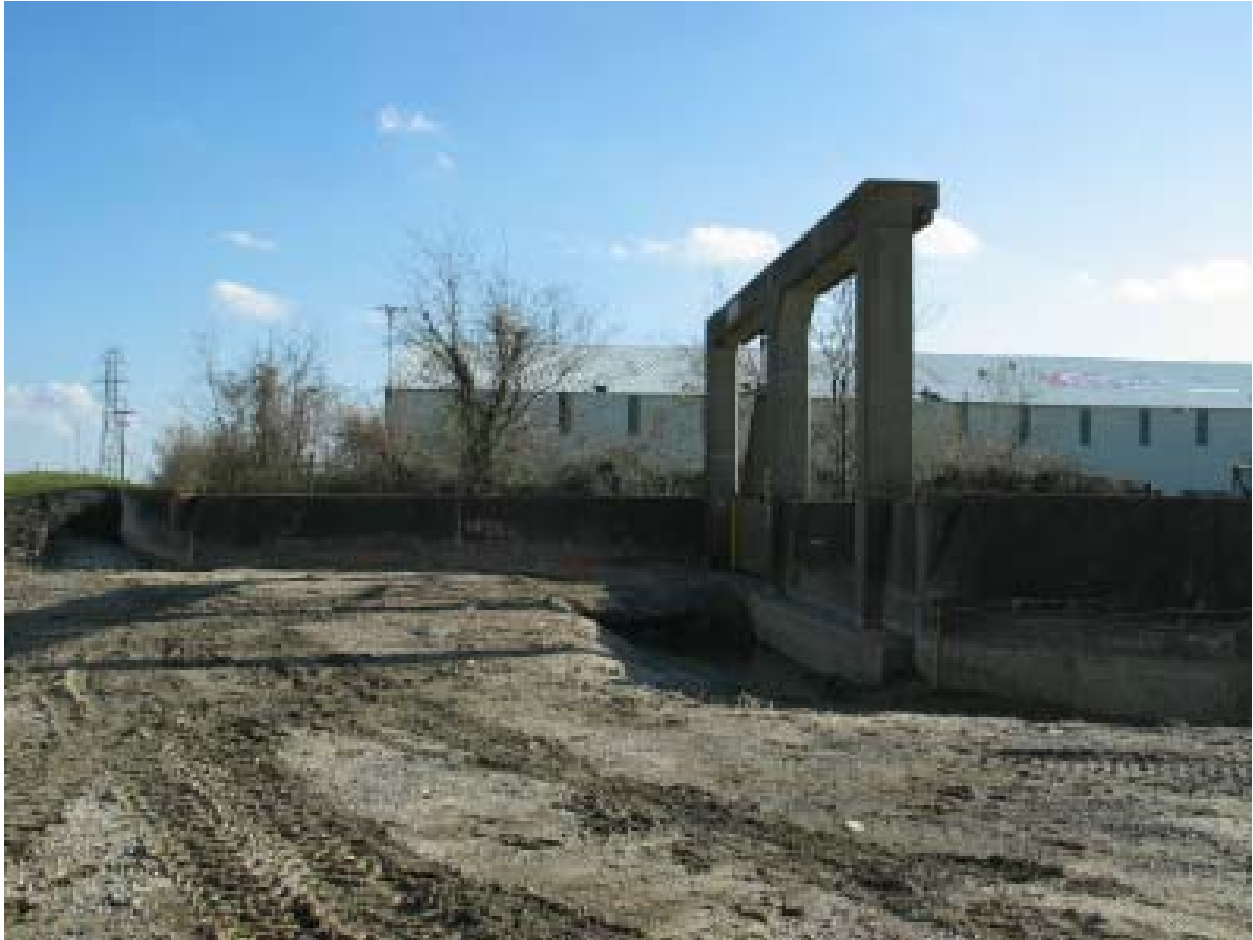
Figure 14-41. Scour at Gate 7E; Scour Measures 7' (w) x 30" (deep). Top of wall is at elev. 13.1 +/-

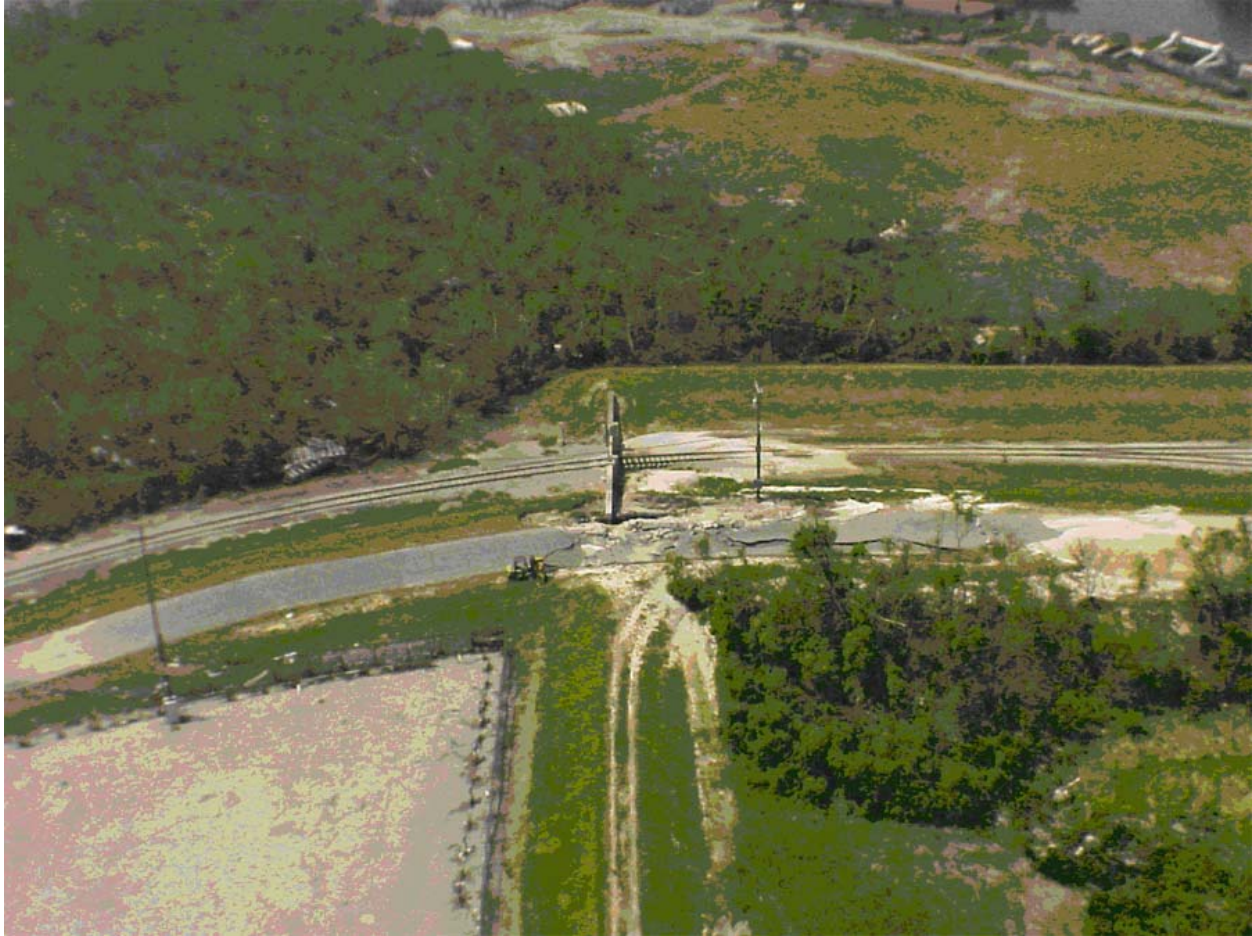
Figure 14-43. Scour at Railroad Gate Closure Structure E4 at Southernmost IHNC03 Project. 29 deg 59 min 48.76 sec N, 90 deg 01 min 11.6 sec W (Sta 176+75.9)

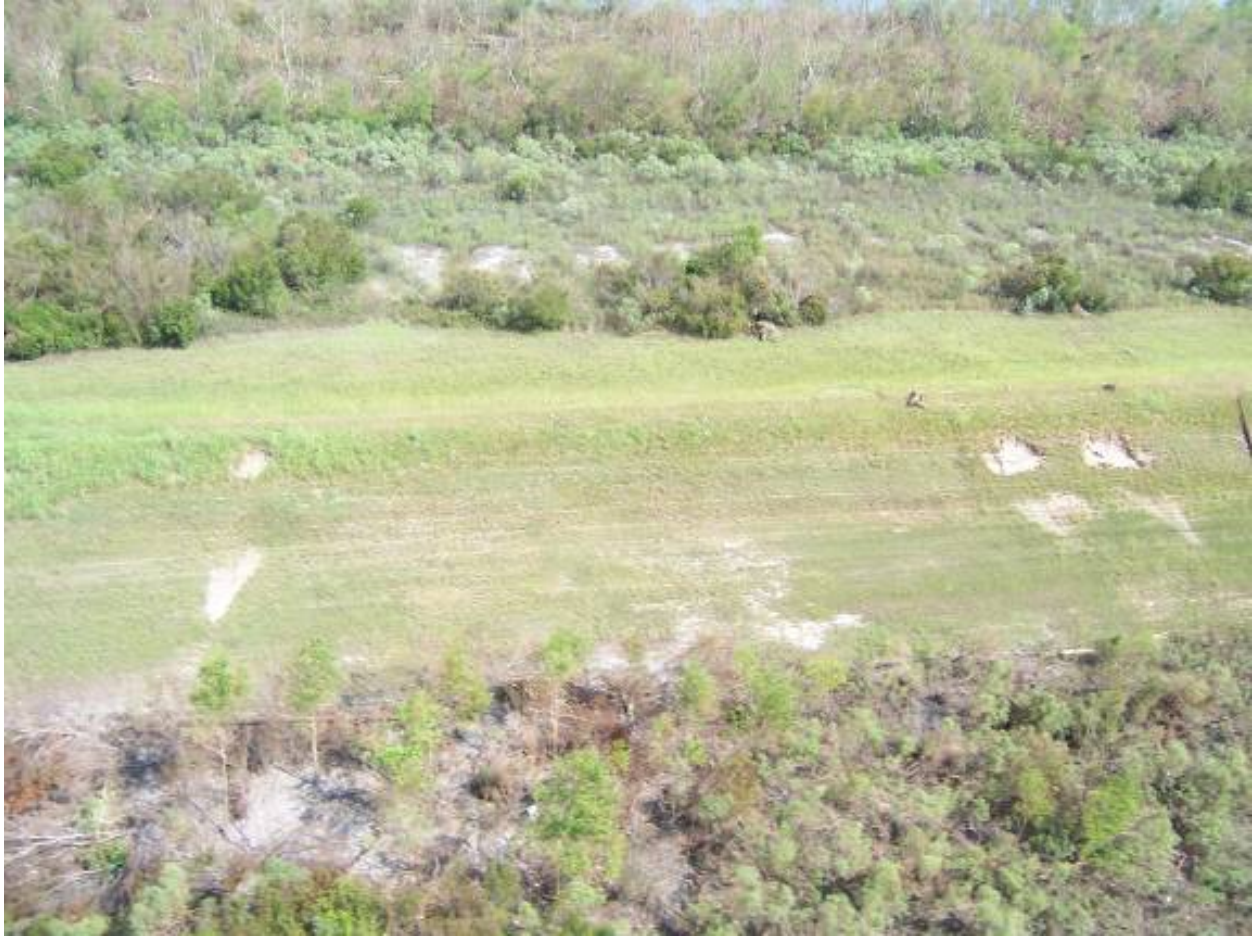
Figure 14-91. Localized Scour on the Levee South of the GIWW, Between IHNC and Paris Rd.

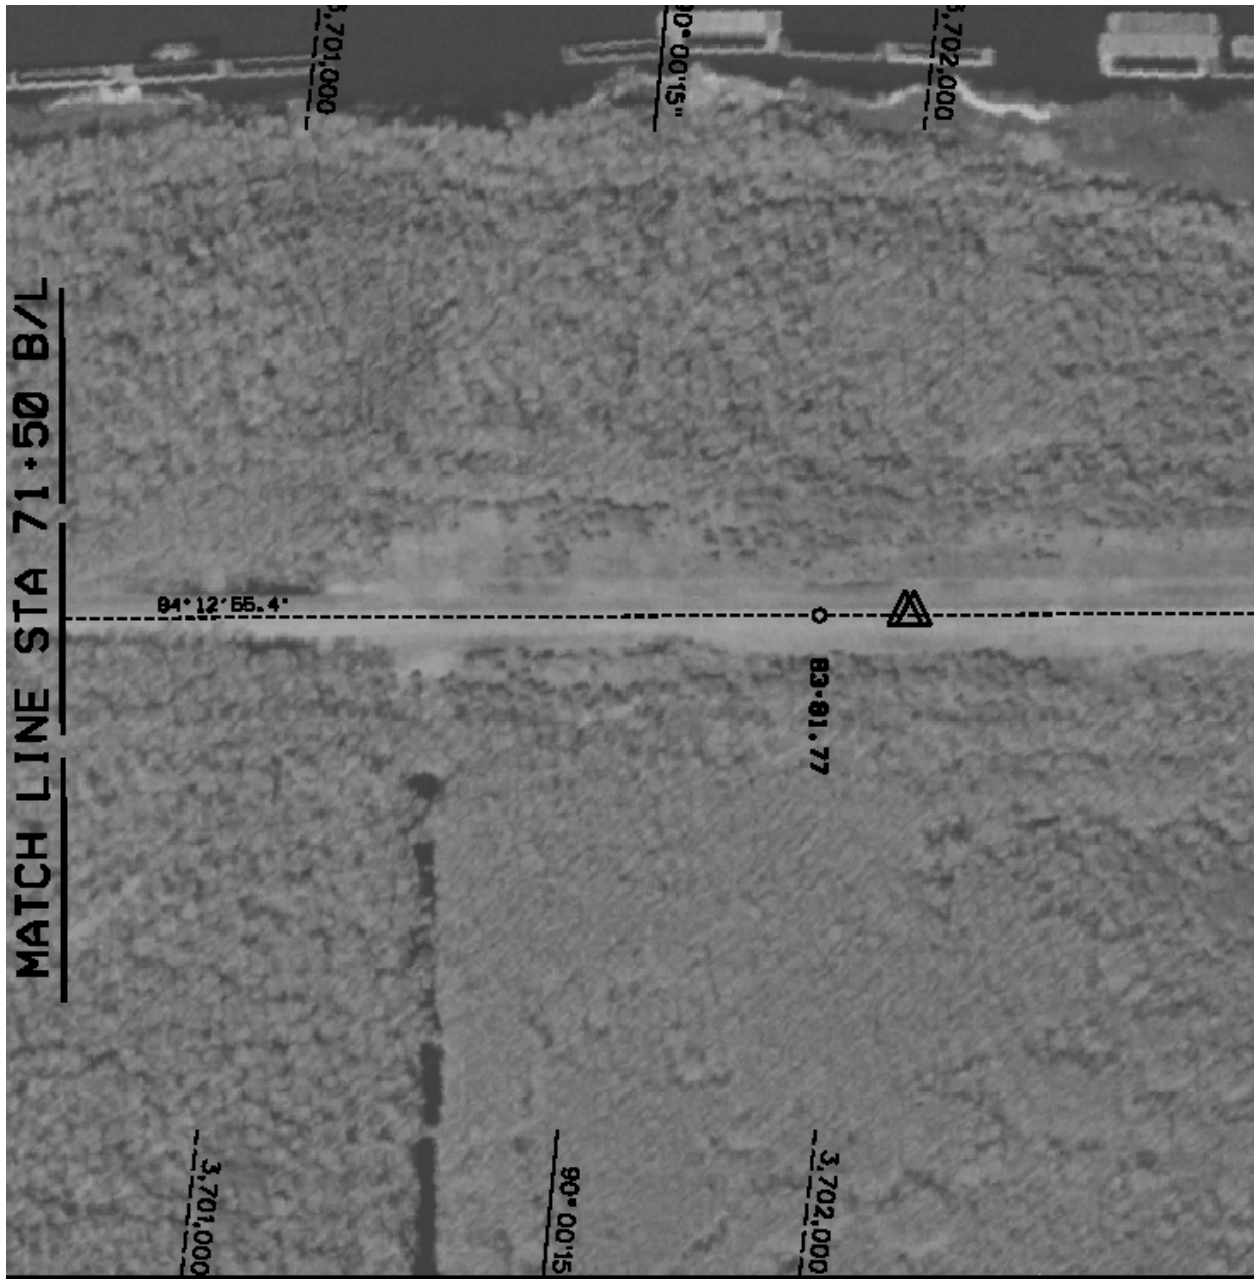
Figure 14-92. Major Scour Damage (Marked With Triangle) Identified East of B/L Sta 81+50 (From TFG Contract Solicitation W912PB-06-R-0022, Drawing 3 of 12)

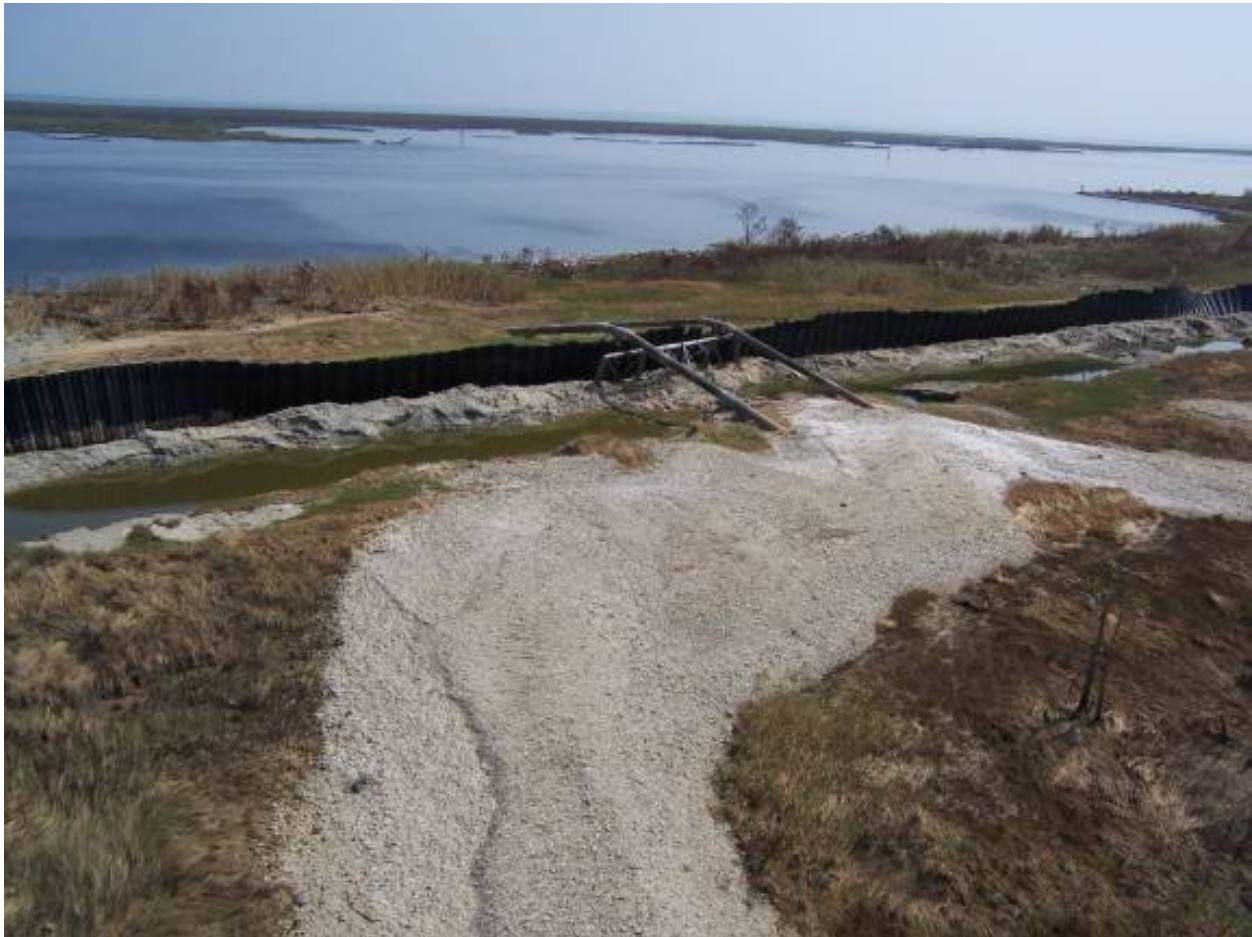
Figure 14-121. Damaged Sheetpile Section (Utility Crossing), With Scour on the Protected Side. B/L Sta 590+70 is centerline of the two pipelines

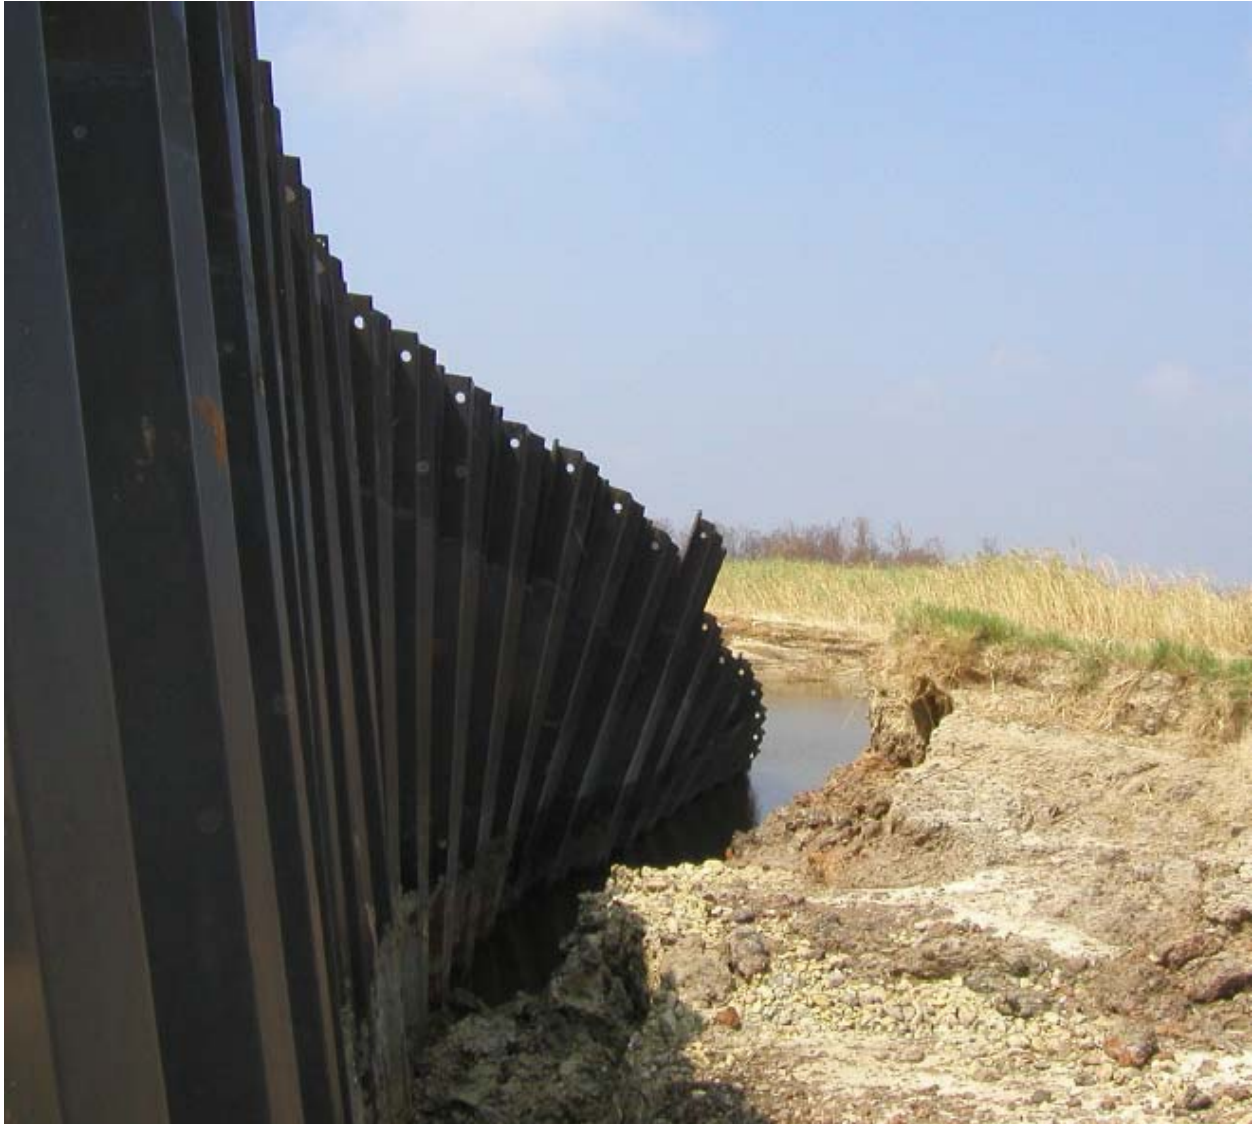
Figure 14-122. Closeup of Damaged Sheetpile and Scour. Note stratified layers in adjacent soil profile of existing hydraulic fill from the MRGO

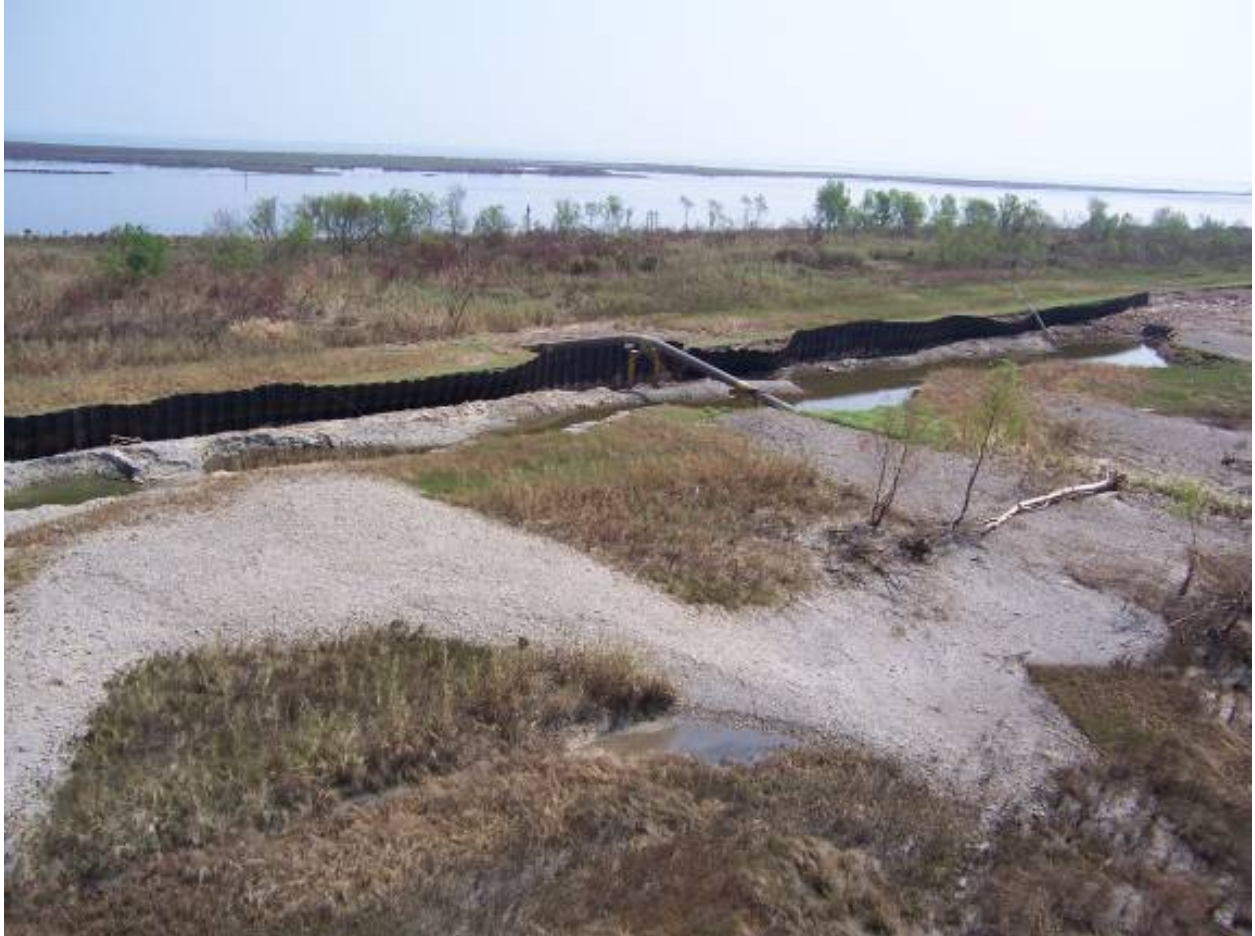
Figure 14-124. Additional Damaged Sheetpile at Utility Crossing, B/L Sta 600+00

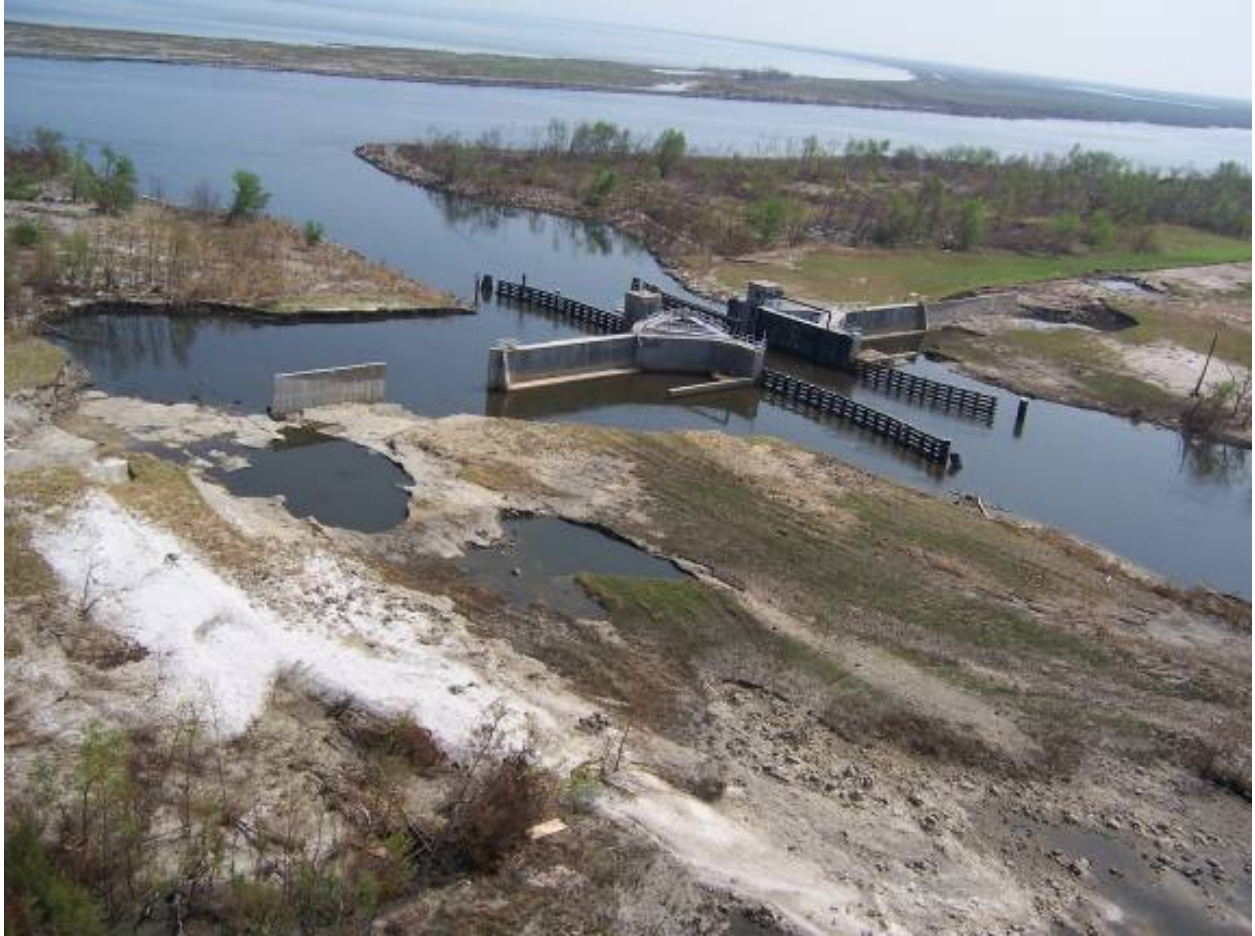
Figure 14-139. Bayou Dupre Control Structure, Post-Katrina. View toward MRGO. Note the missing levees on both sides of the structure

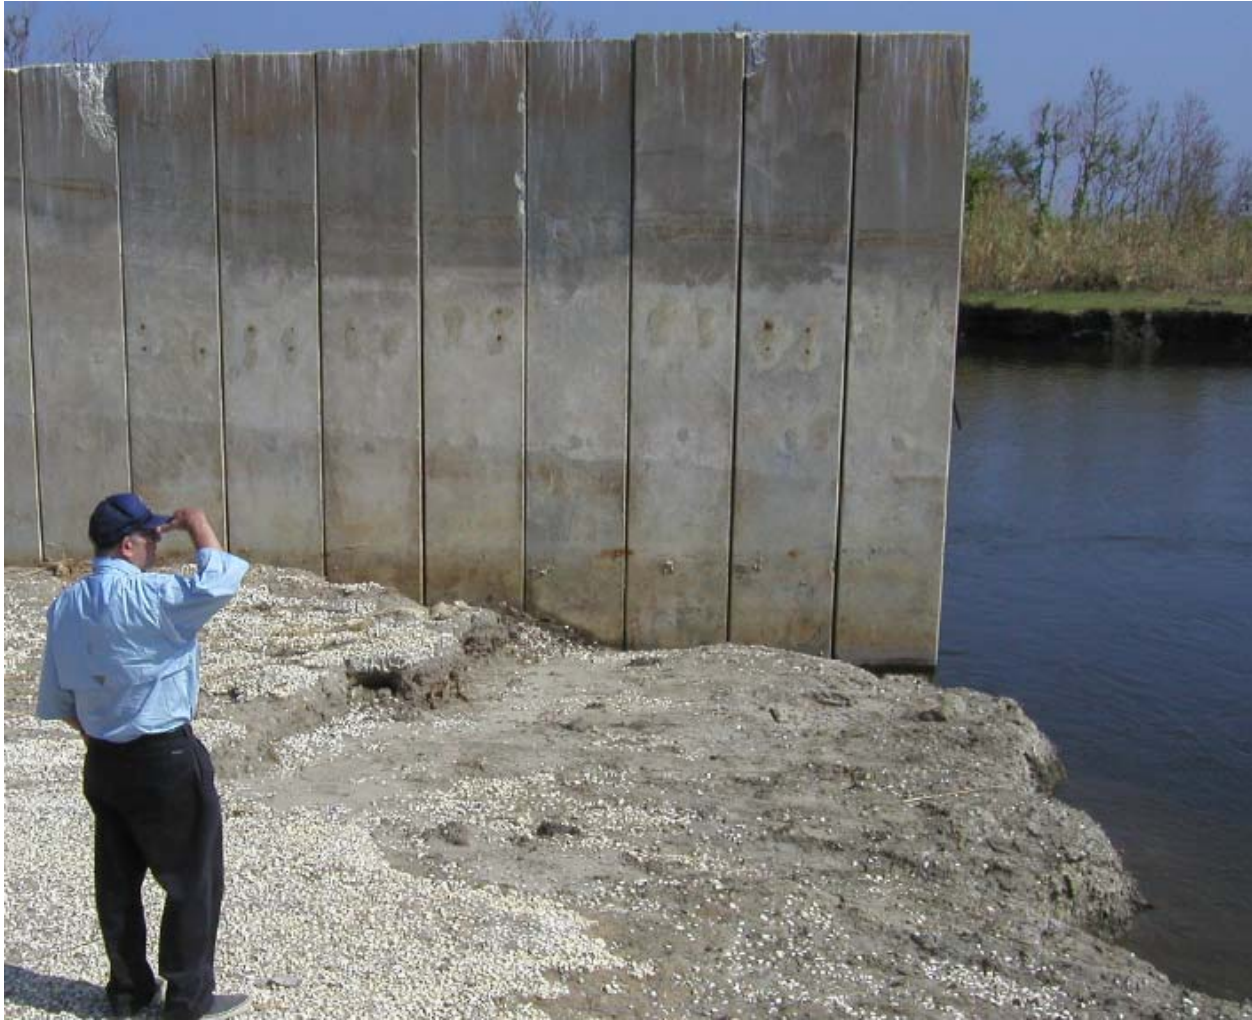
Figure 14-140. Missing Levee and Part of Wall on West Side of Control Structure

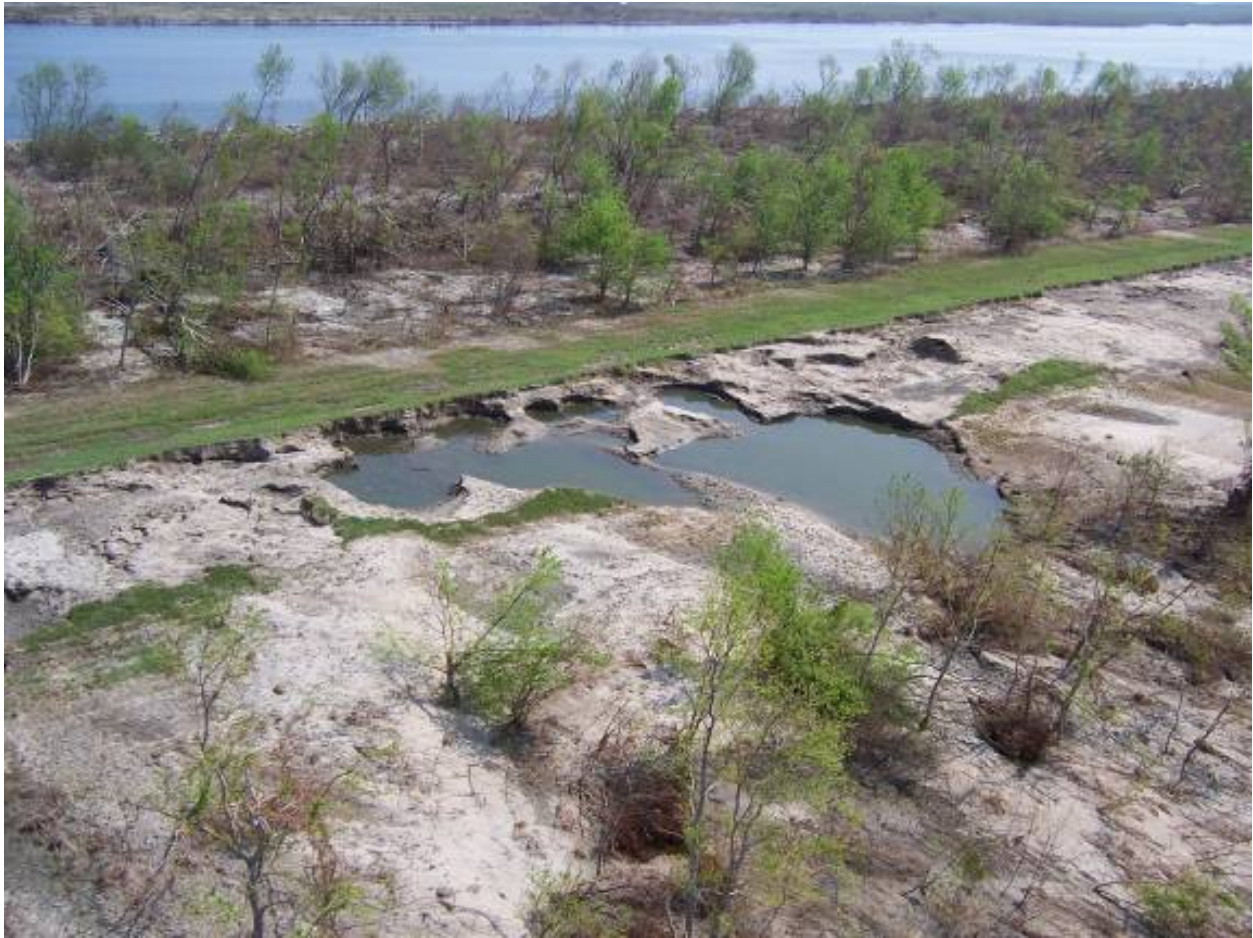
Figure 14-144. Major Scour on Levee Protected Side (Landside)

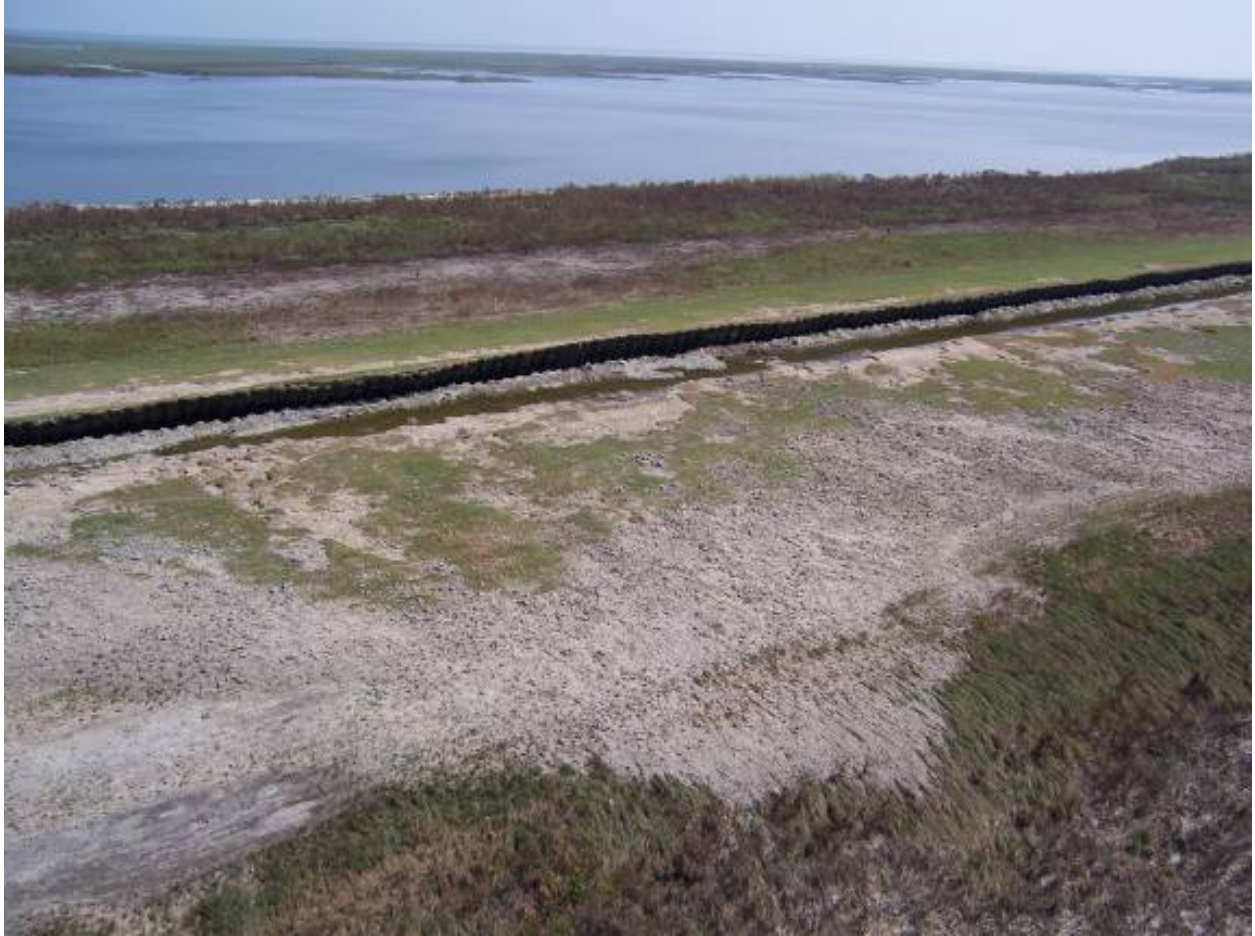
Figure 14-150. Scour on Protected Side of Sheetpile Wall
