VI. The Performance

Floodwall and Levee Performance Analysis

Interim Results - Assessment of 17th Street Canal Breach

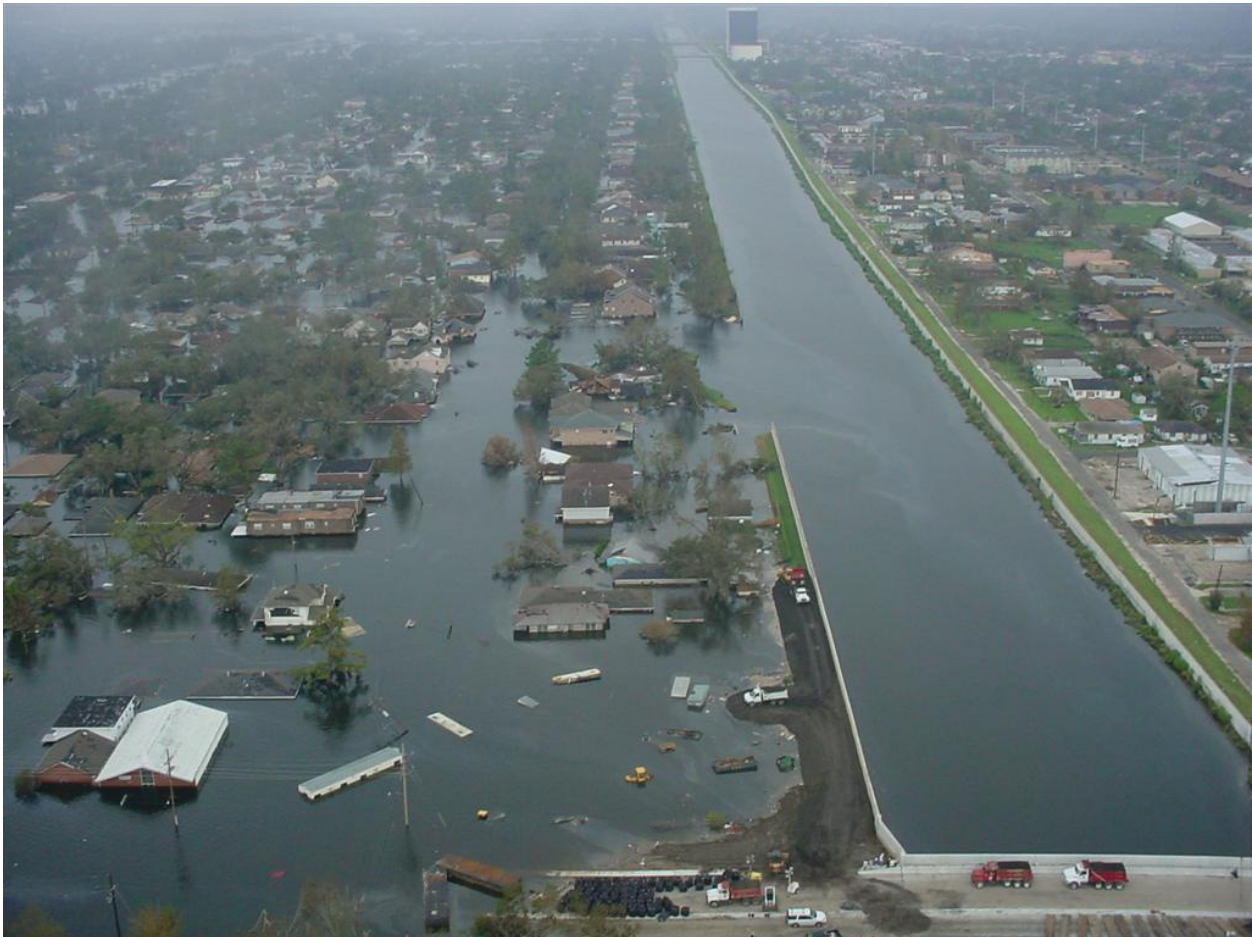
Observations made at the breach at the 17th Street Canal show that the most likely cause of breach is due to a soil foundation failure. Figure VI-1 is an aerial photo showing an approximately 450-foot breach in the floodwall along the east side of the 17th Street Outfall Canal south of the old Hammond Road bridge. Figure VI-2 shows that a section of levee has moved more than 40 feet inward to the land side. It appears the remaining levee section making up the breach was washed away by the water flowing through the breach. In the photograph in Figure VI-3, the top of the I-wall section of the floodwall in the breach can be seen adjacent to the levee section that moved into the land side.

Figure VI-1. Aerial photograph of the 17th Street Canal breach looking south from Old Hammond Road bridge

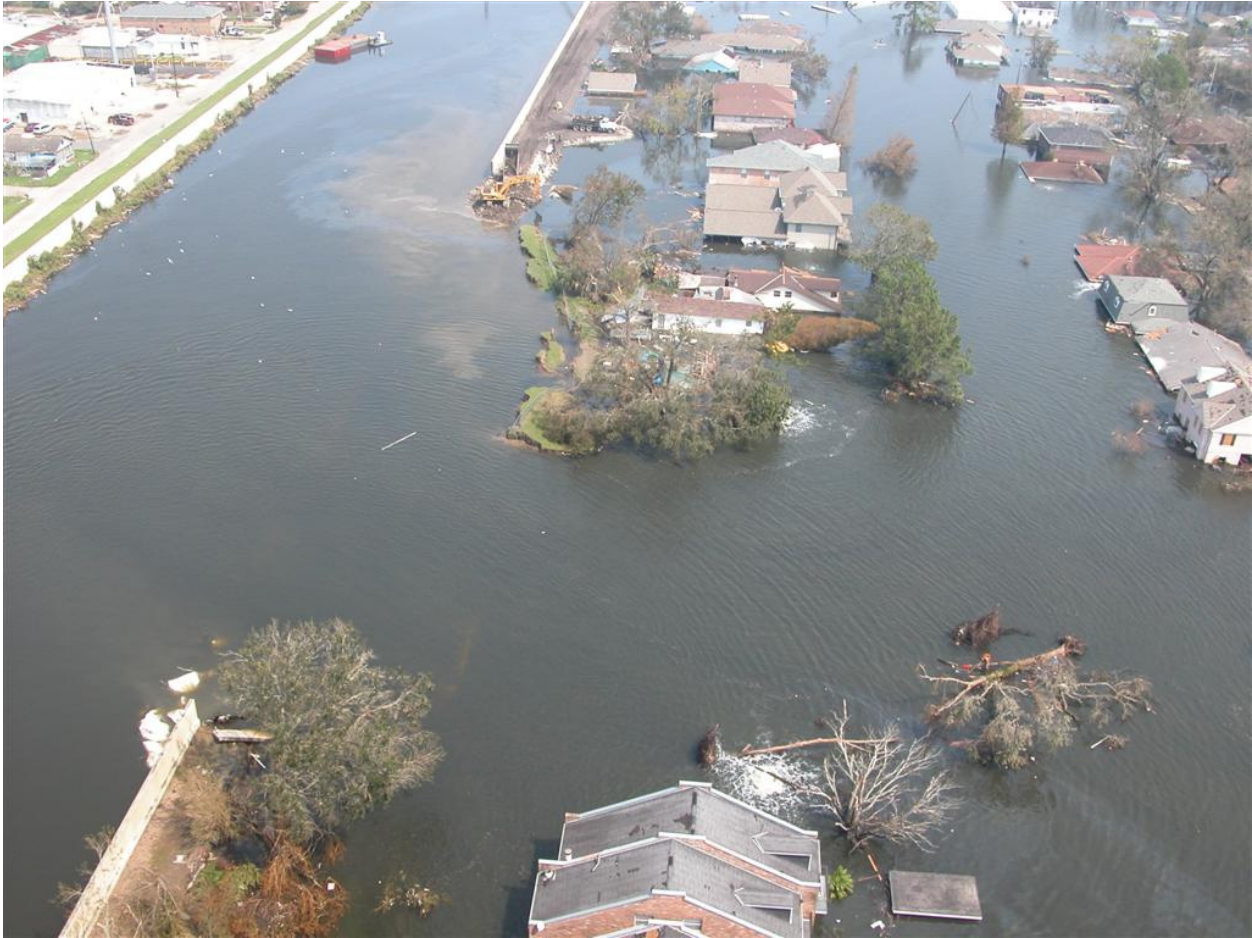
Figure VI-2. Aerial photograph of the 17th Street Canal breach looking north towards Old Hammond Road bridge

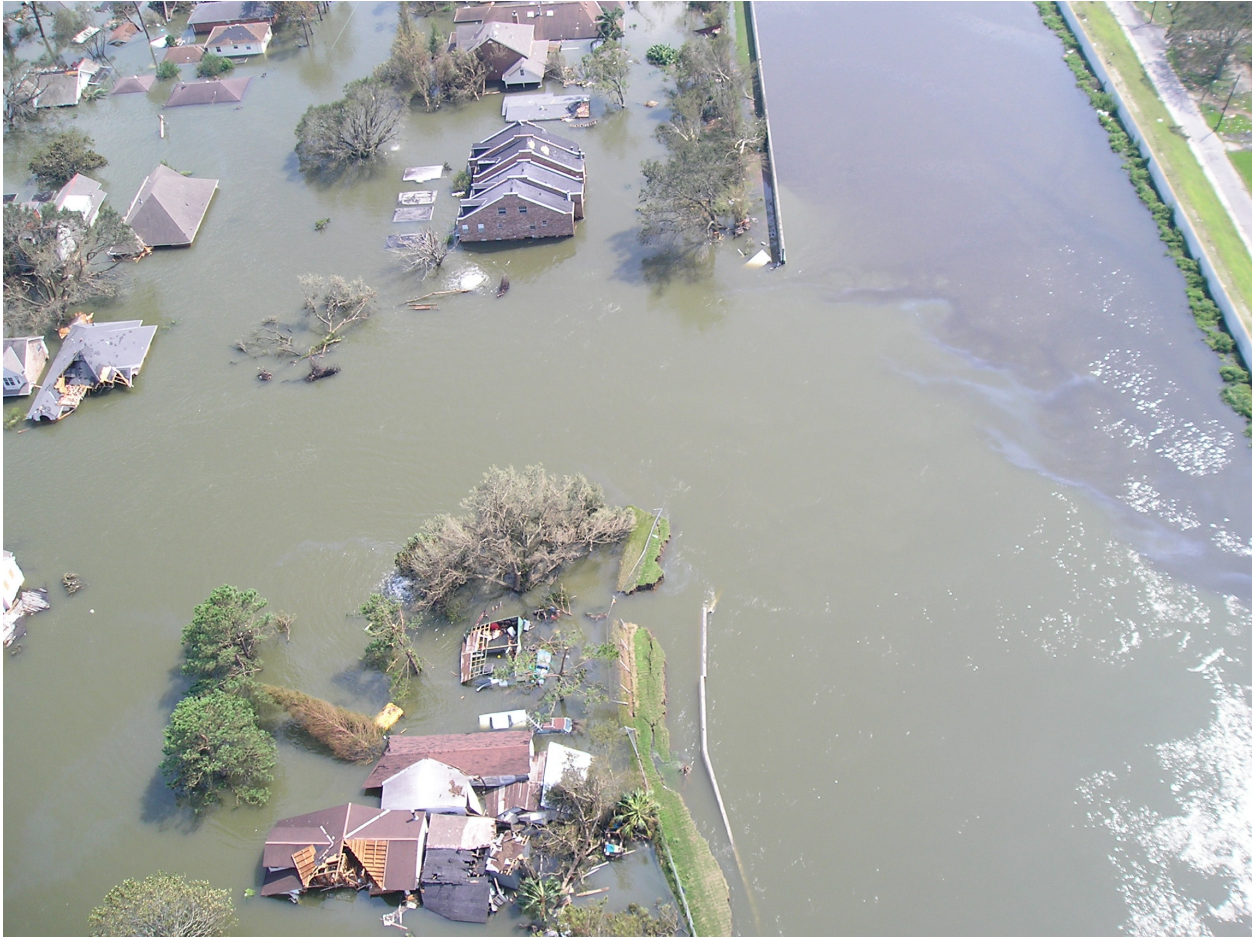
Figure VI-3. Aerial photograph of the 17th Street Canal breach showing I-wall and embankment translation

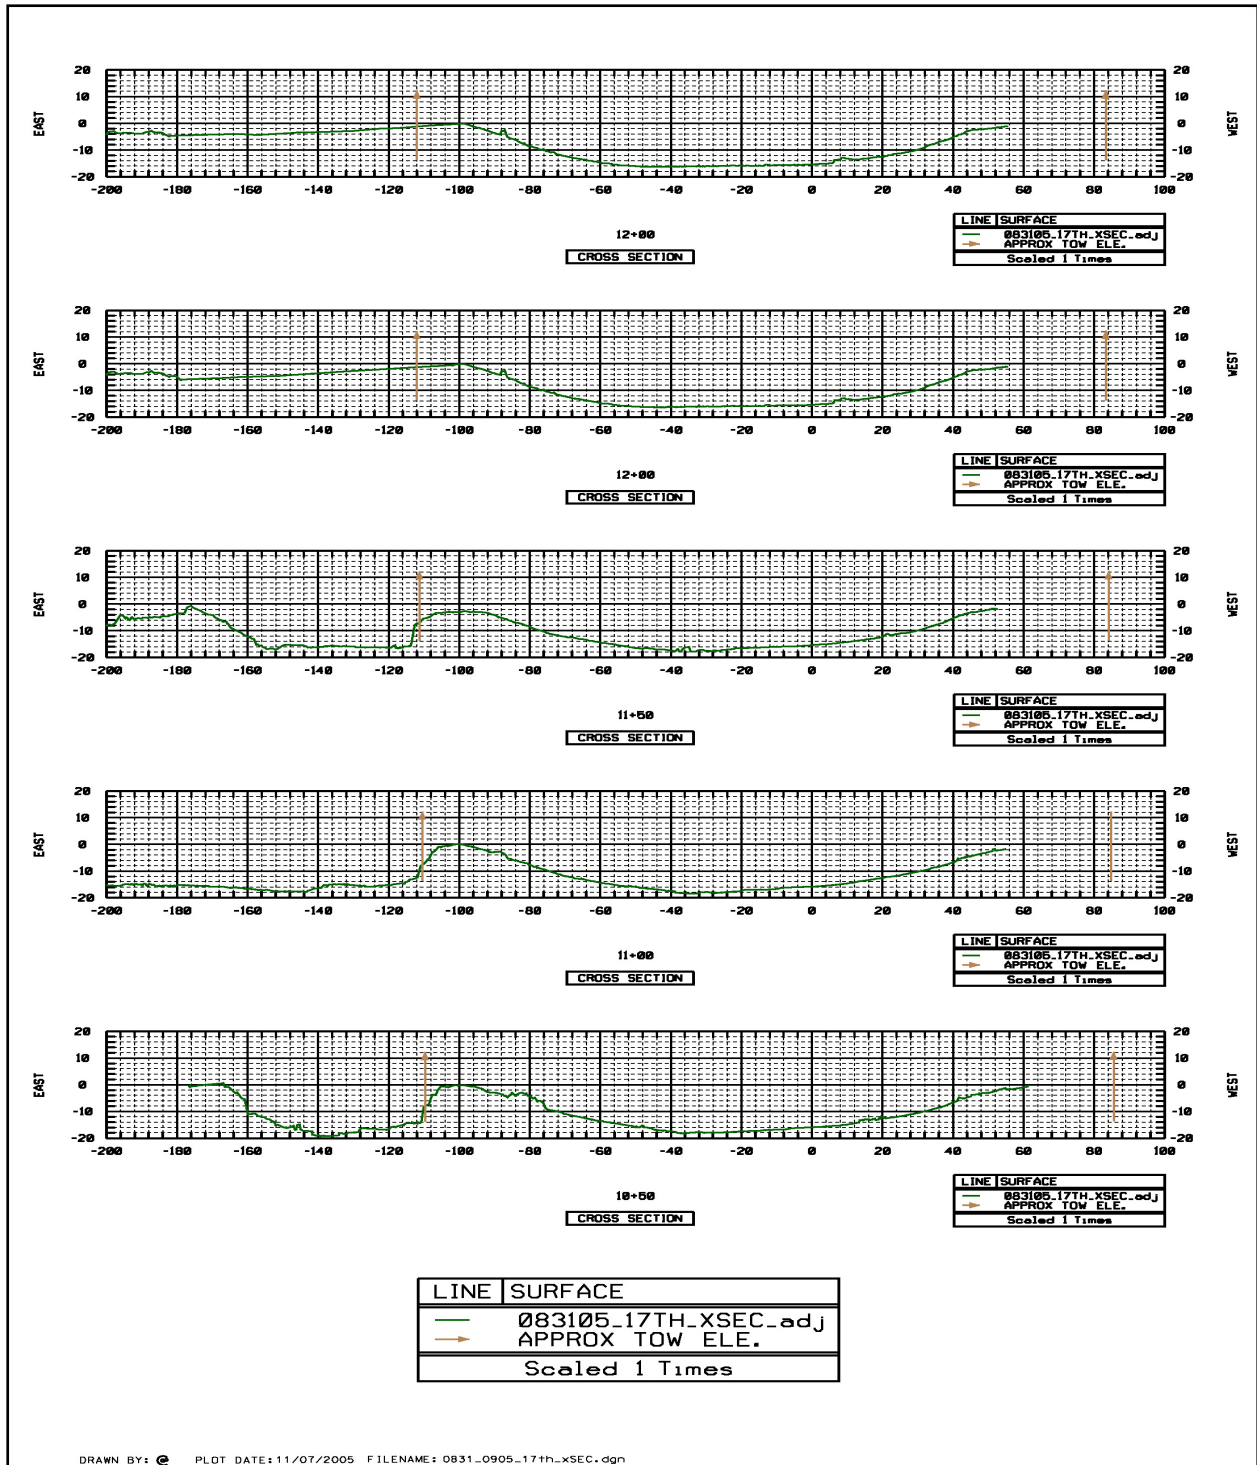
Before the construction of the emergency closure of the breach, a transverse multi-beam sonar survey of the surface of the canal bottom and breach was conducted, Figure VI-4. The survey revealed that the crest of the levee on the canal side was still present after the breach, Figure VI-5. Figure VI-6 shows a close-up of the profile at Station 11+50. It shows that the breach started at or near the floodwall and moved laterally under the land side portion of the levee at or near the elevation of the tip of the sheet pile.

Figure VI-5a. Surface profiles at the breach

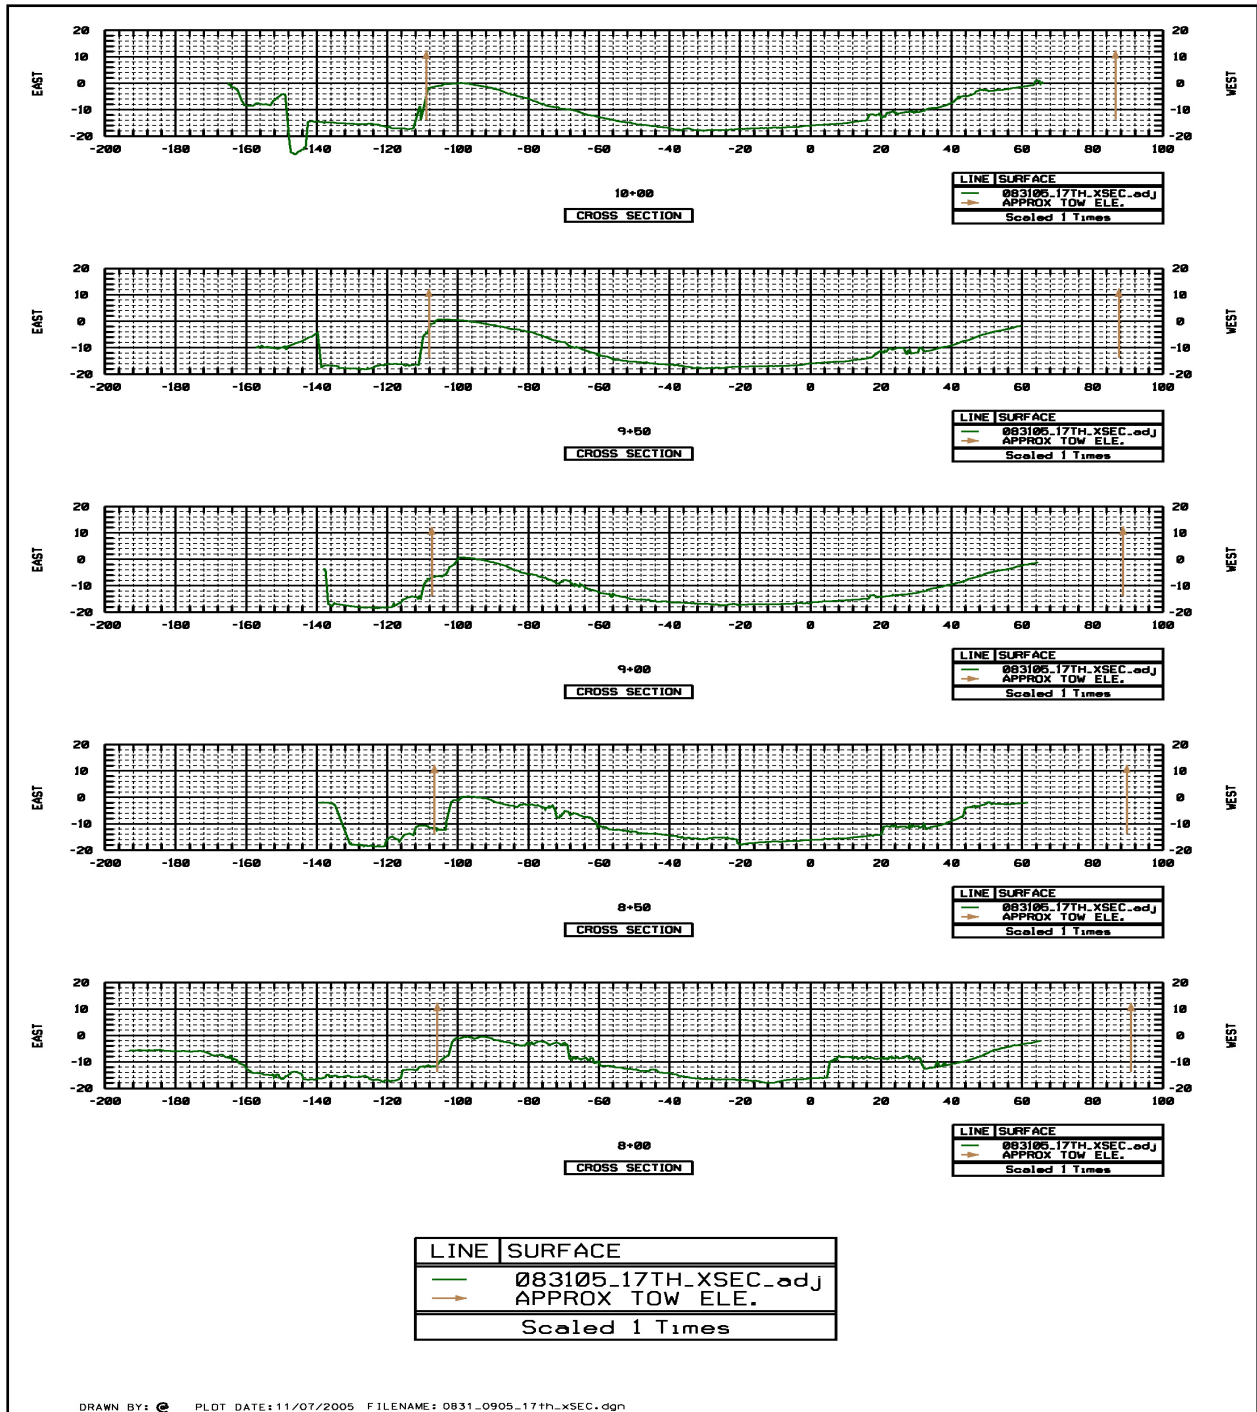
Figure VI-5b. Surface profiles at the breach

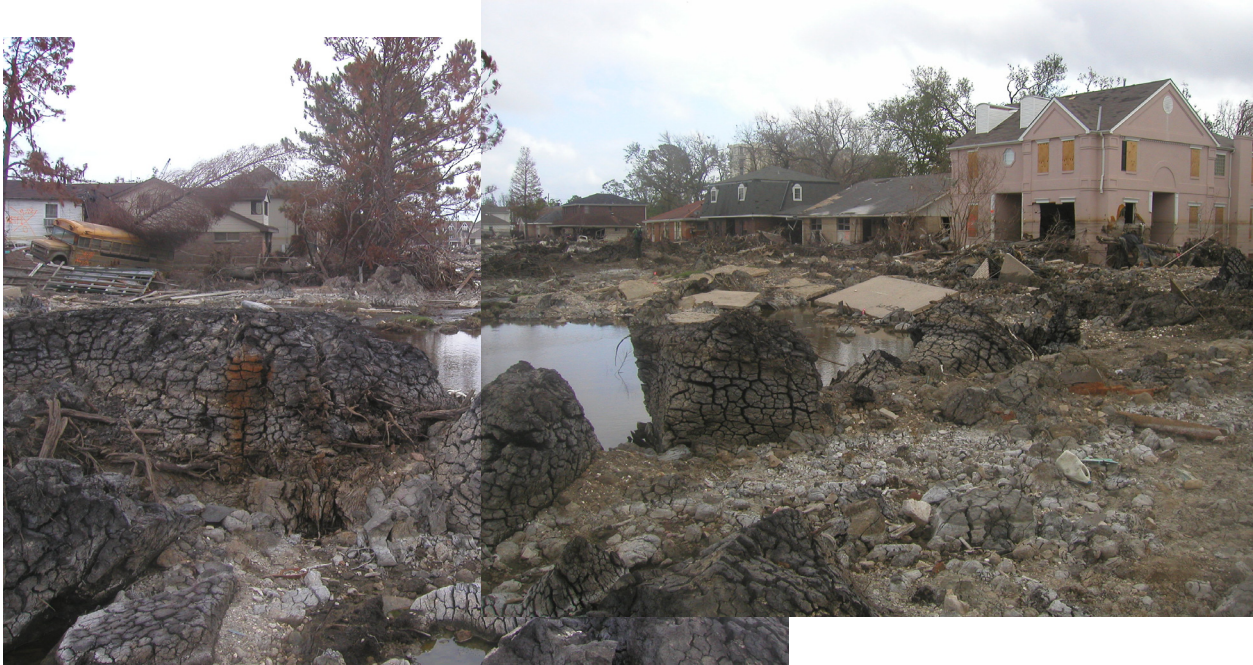
After the emergency closure was complete and the water levels were drawn down, large blocks of peat were found strewn in neighborhoods surrounding the breach, Figure VI-7. A close examination of the peat blocks reveals that an approximately one-foot-thick clay layer is attached to the bottom of the peat, Figure VI-8. In order to inspect the failure plane or zone, a backhoe was brought in to expose a vertical surface through the slide block that translated to the land side. The excavation uncovered a thin layer of clay, approximately one foot thick, protruding up through the peat at an angle between 20 to 30 degrees from horizontal, Figure VI-9. Samples of the peat above and below the clay layer were taken for carbon dating to assure that the peat was from the same deposit. This clay layer protruding through peat would only occur if the slide block with the clay attached to the bottom of the peat layer rode up over the intact peat during the deformation of the levee causing the breach. This implies that the failure plane of the slide block occurred through a clay layer below the peat. In order to understand how the failure mechanism may have occurred, the geology and soil stratification for the area were investigated.

Figure VI-7. Peat blocks from the levee embankment

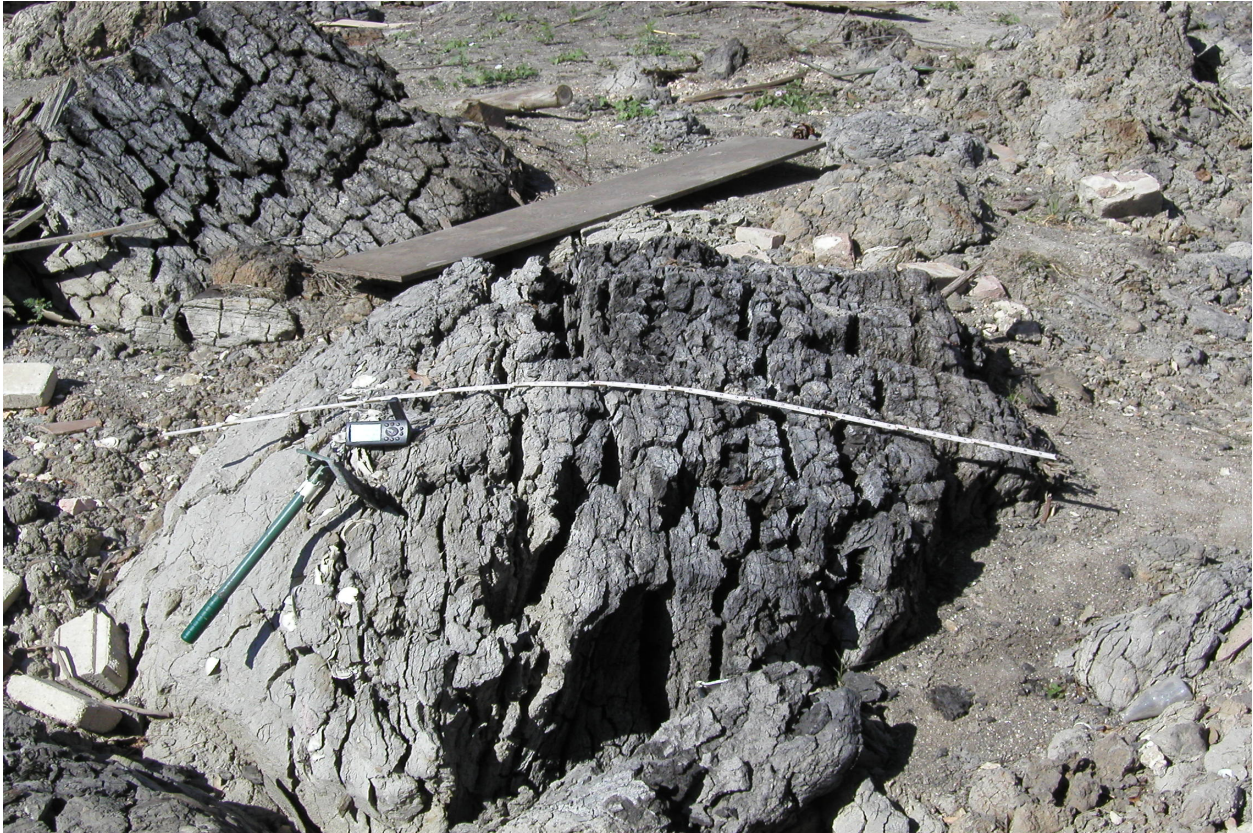
Figure VI-8. Clay attached to peat blocks

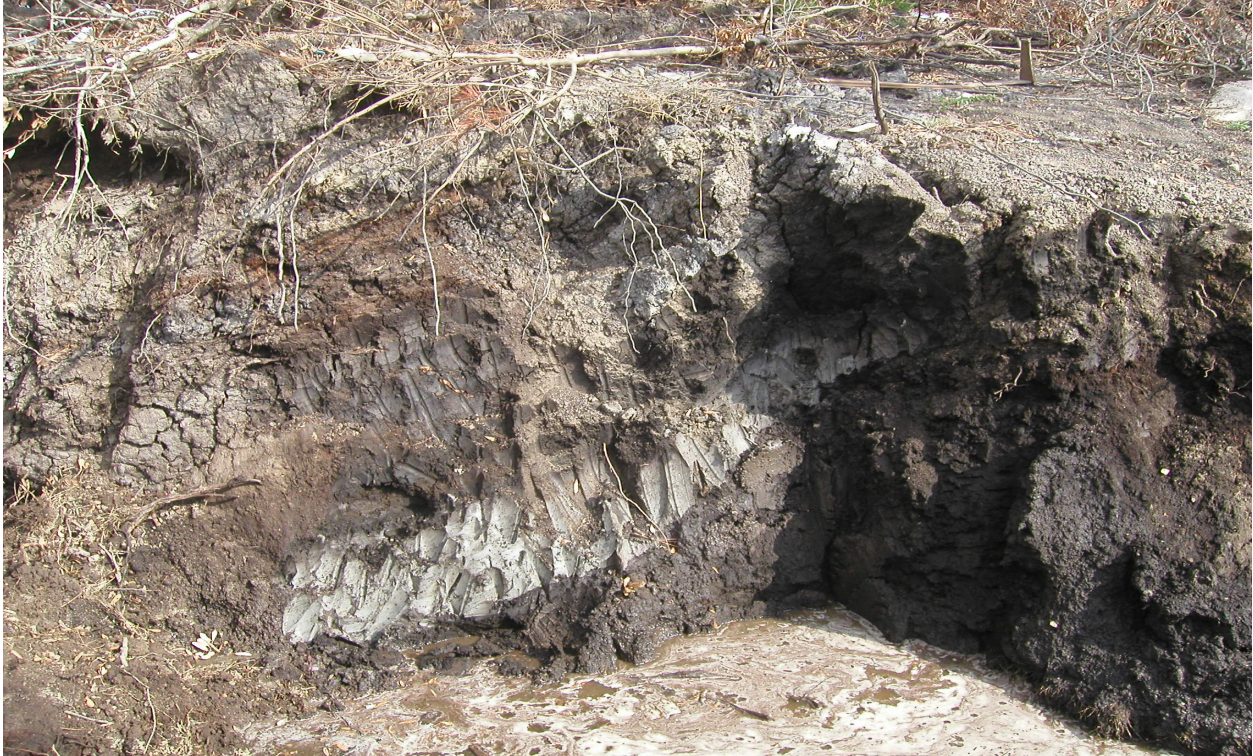
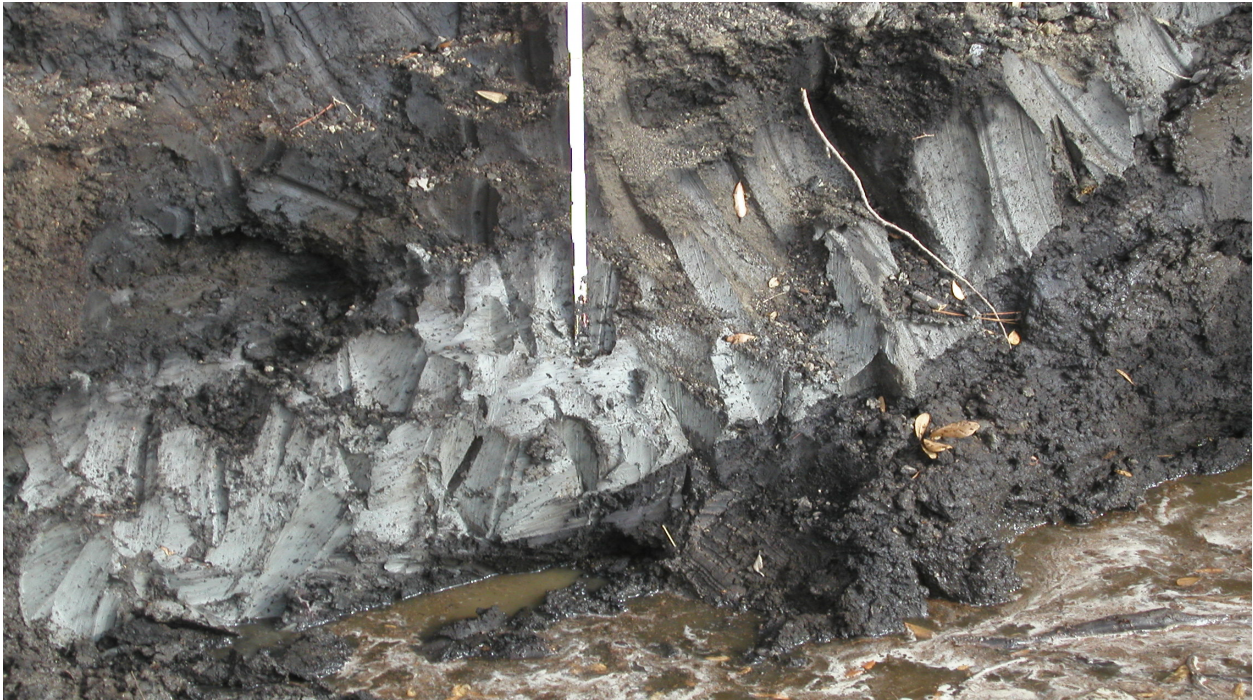
Figure VI-9. Exposed failure plane

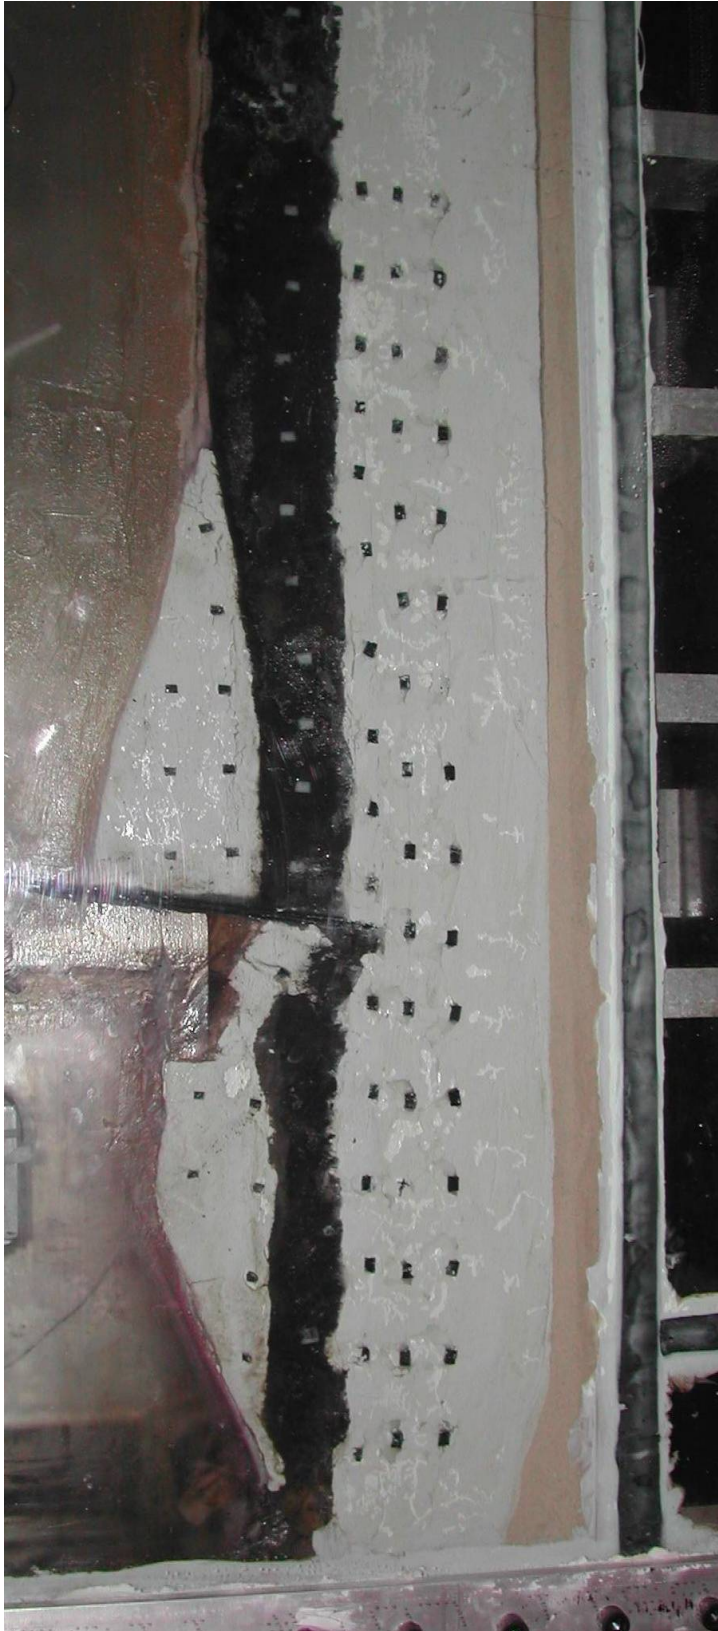
In this case, as the water rose in the canal the wall again started to lean over, which resulted in a sliding failure in the clay layer immediately below the peat. Data from both the trial models are being assessed in detail prior to the initiation of the main model test phase, planned to commence at ERDC in March.

Figure VI-21. Sliding movement of the levee landward (to the right) observed at the completion of the 17th Street trial model test

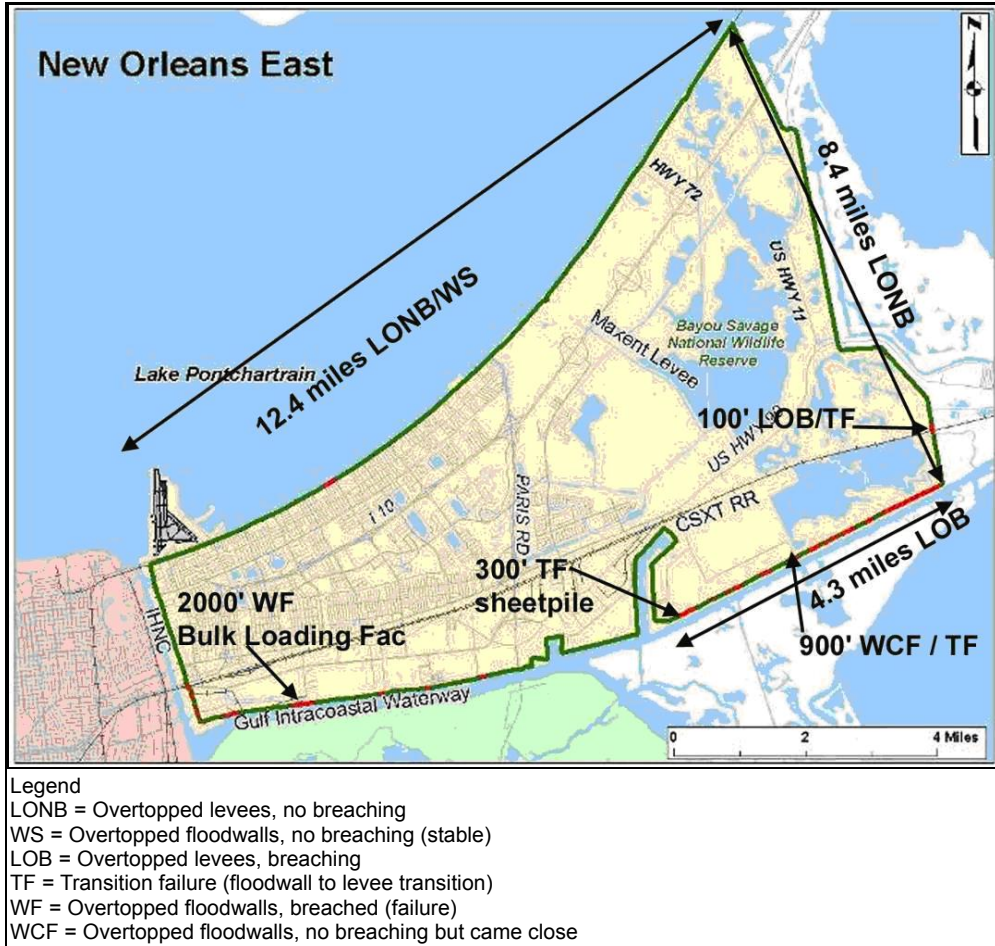
- 12,750 ft of levee breach in the NOE Back Levee between Michoud Canal along the GIWW up to the CSX railroad crossing along the NOE Levee.
- Floodwall breaches at Pump Station 15 (800 feet) near the Maxent Levee and at the Air Products Hydrogen Plant near the Michoud Canal (300 feet).
- Floodgate, floodwall, and adjacent levee damage at the CSX railroad.
- 2000 feet of floodwall damage in the Citrus Back Levee along the GIWW between the IHNC and Paris Road.
- Levee and floodwall scour along the lakefront and NOE levees.
- Damage to all eight pump stations.
- Note: Overtopping was generally associated with varying degrees of scour (surface erosion), generally on the levee landside.

Figure VI-23. Generalization of levee and floodwall failures in the NOE basin
