ST. BERNARD HURRICANE LEVEE DAMAGE SURVEY REPORT

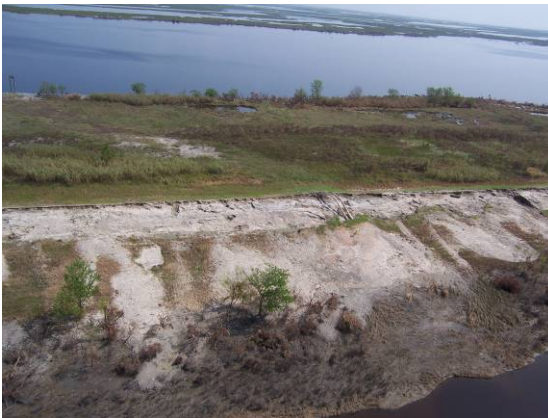
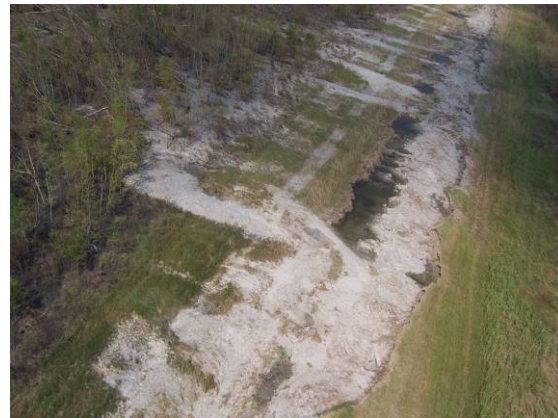
1. Hurricane Levee Between Bayou Bienvenue and Bayou Dupre. There is 19,000 ft. of levee between Bayou Bienvenue and Bayou Dupre that is severely damaged and has lost approximately 12' of levee section and is currently at EL 5.0.

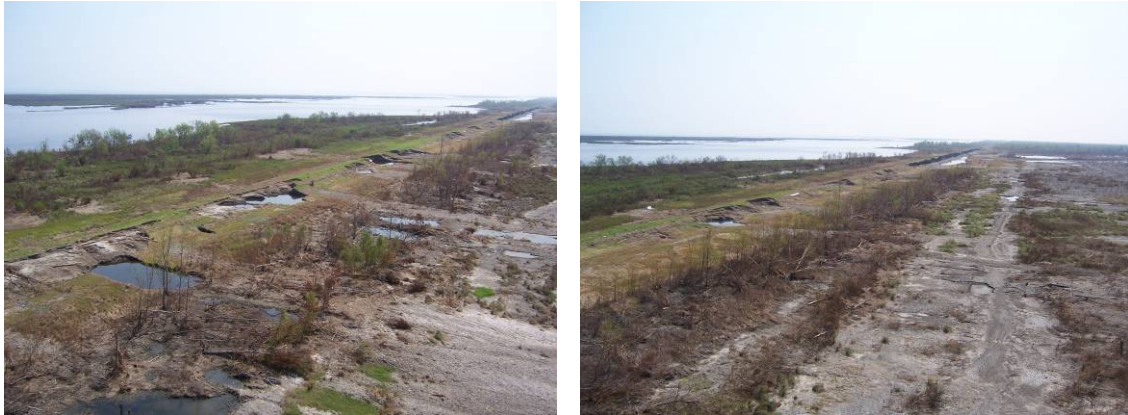
There is 2,300 ft. of levee in this reach that has some damage (assume that 50% of the levee section gone).

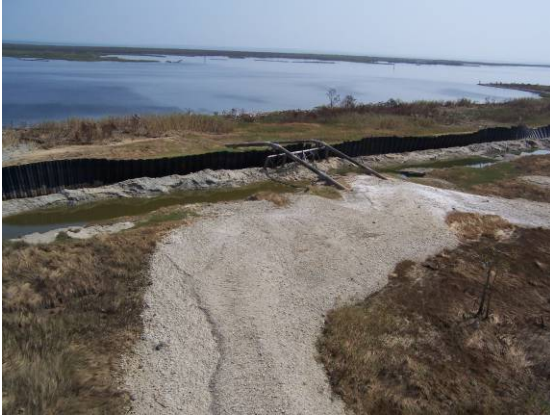
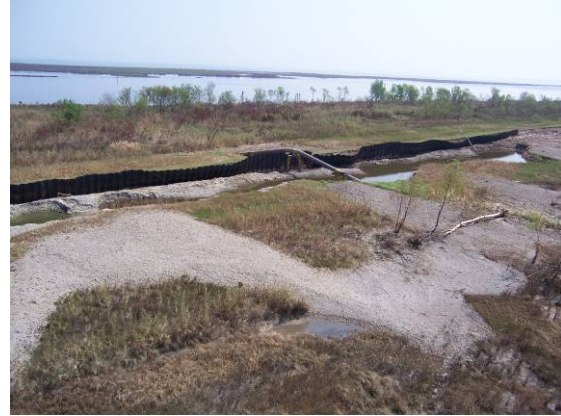
There is a total of 4,300 ft. of sheet pile floodwall in this reach that was badly damaged and will require replacement. There are three segments of sheetpile which make up this quantity. These will be replaced with 30' sheets – see section below.

Segment A:	Length – 1130 ft.	Condition – badly damaged; replacement required
Segment B:	Length – 720 ft.	Condition – badly damaged; replacement required
Segment C:	Length – 2450 ft.	Condition – badly damaged; replacement required

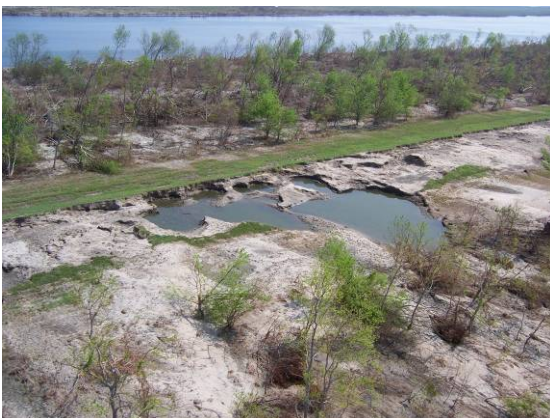
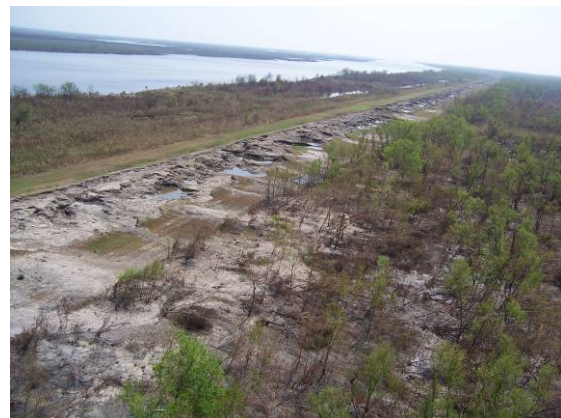
2. Hurricane Levee Between Bayou Dupre and STA. 1054+00. There is an 8,000 ft. section of the levee immediately southeast of Bayou Dupre that is severely damaged and has lost approximately 12 feet of levee section and is at approximately El. 5.0.

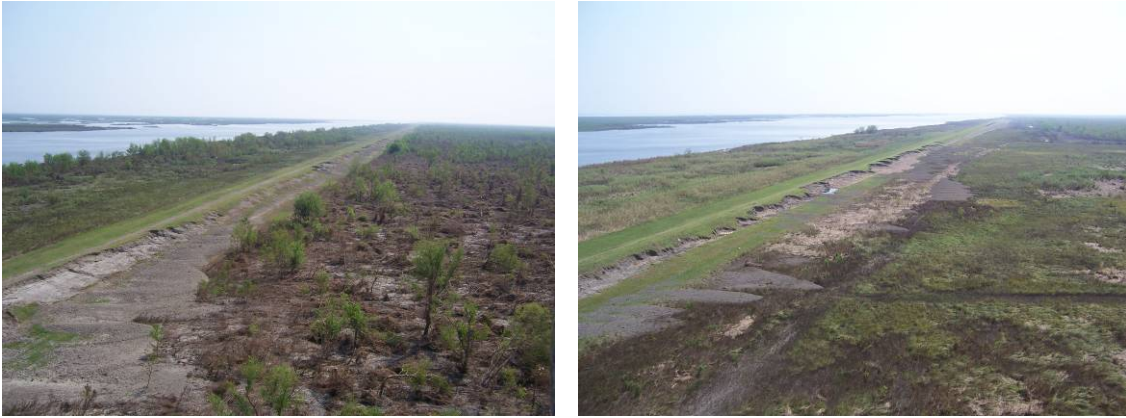
There is 2,500 ft. of levee from Bayou Dupre to STA 1007+91 that lost approximately 8' of elevation (assume that 50% of the levee section is gone)

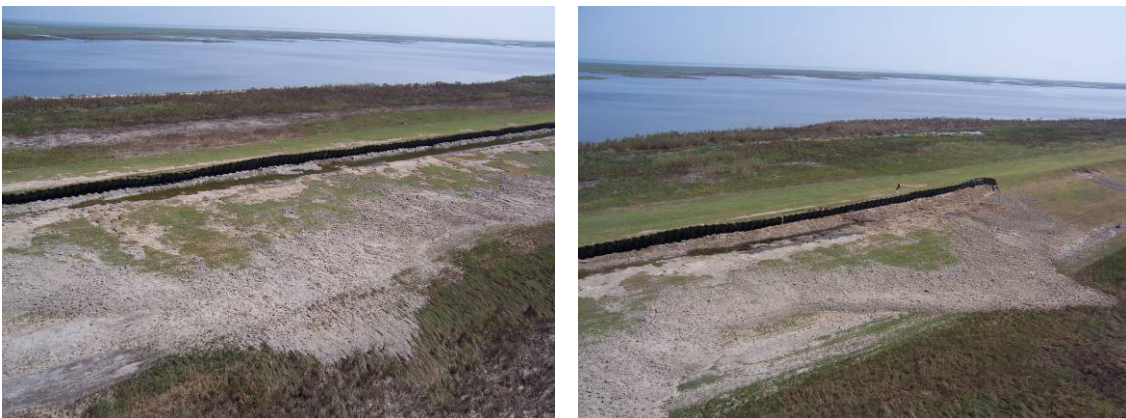
There is 700 ft. of this reach that is sheet pile floodwall that has been damaged and will require replacement.

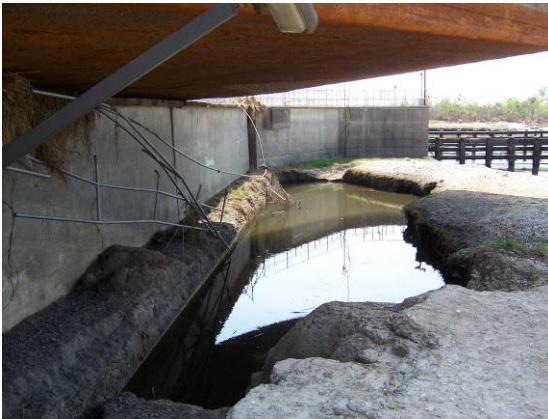
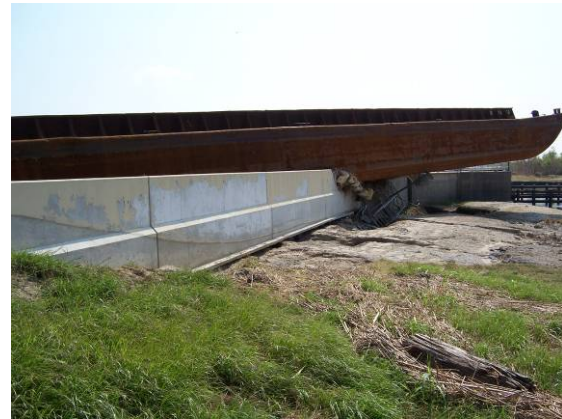
3. Bayou Bienvenue Control Structure. This control structure was damaged during the storm event. The adjacent floodwall was hit by a loose barge and the fill around the adjacent floodwalls was eroded away due to overtopping. In addition there was damage to the mechanical and electrical systems that operate the sector gates.

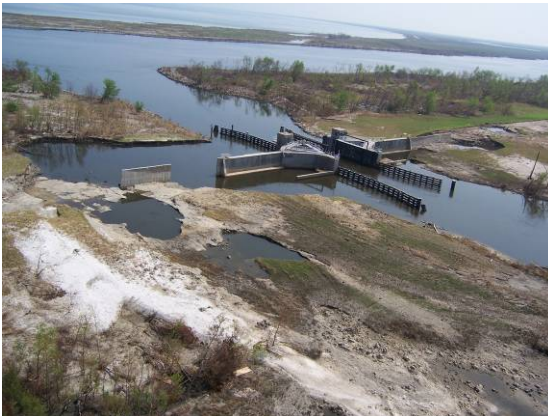
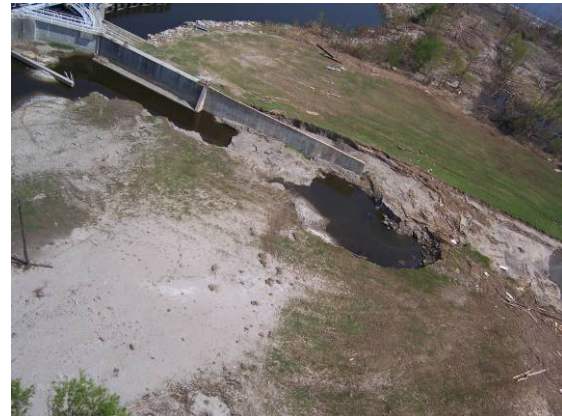
4. Bayou Dupre Control Structure. This control structure was damaged during the storm event. Adjacent sections of floodwall failed and the fill around other sections of floodwalls was eroded away due to overtopping. In addition there was damage to the mechanical and electrical systems that operate the sector gates.

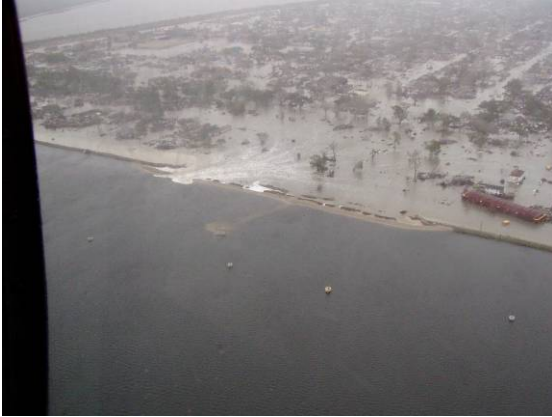
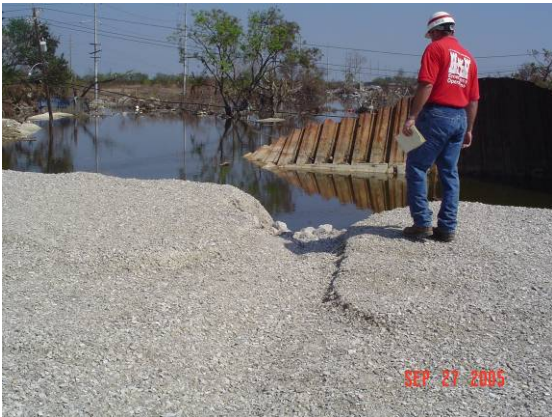
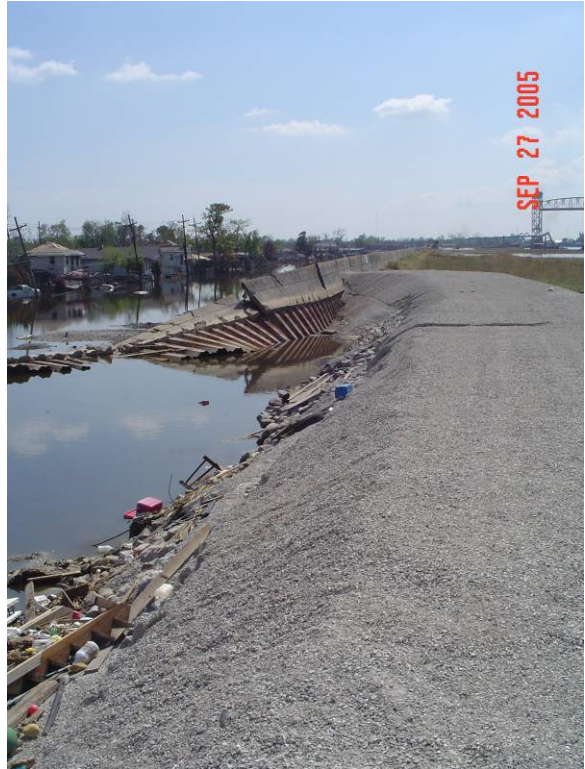
5.

IHNC Floodwall. There are two segments of floodwall just north of the IHNC Lock on the east side of the canal that were overtopped and breached by the storm event. These two segments are 350 ft. and 850 ft. in length. The overtopping caused severe damage to these segments and they will need to be replaced.

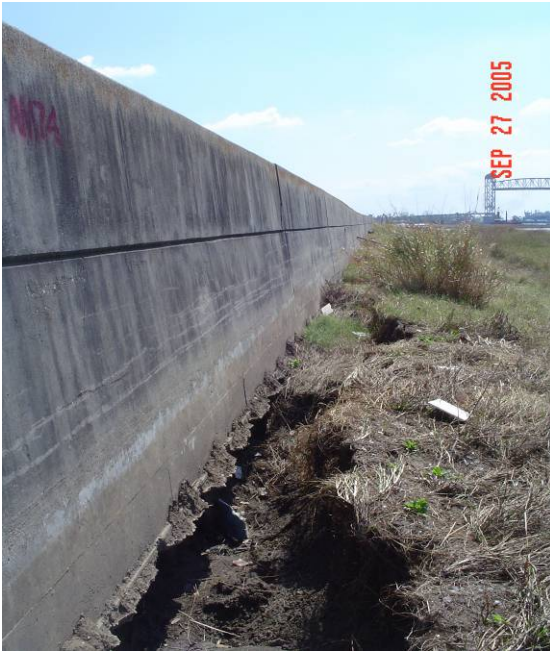
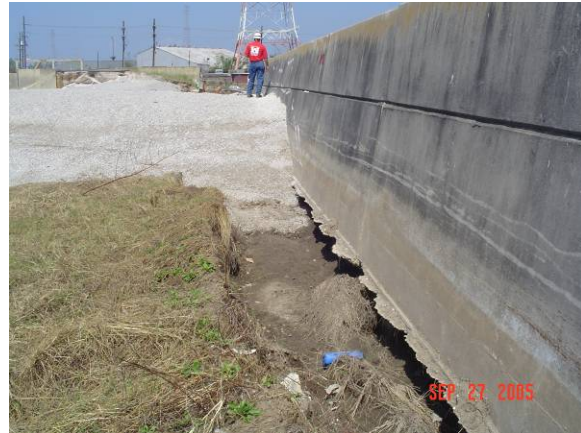
There are two segments of floodwall that were overtopped and the loss of foundation and backfill material on the protected side of the wall has caused some movement of the wall. These two segments are 200 ft. and 2000 ft. in length.

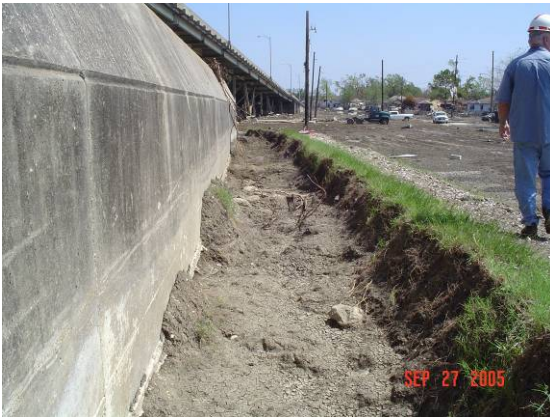
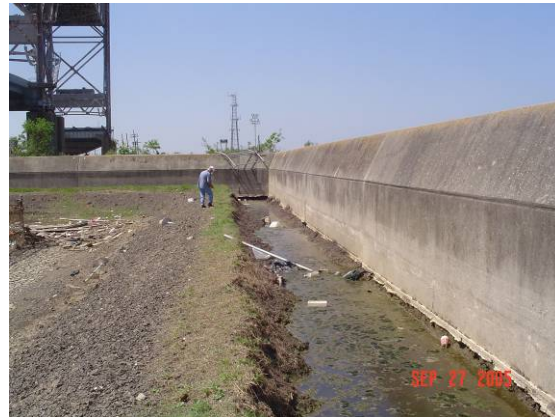
There are two segments of floodwall that were overtopped with loss of foundation and backfill material on the protected side of the wall. There has not been any movement of these two segments. These segments are 620 ft. and 2000 ft. in length.

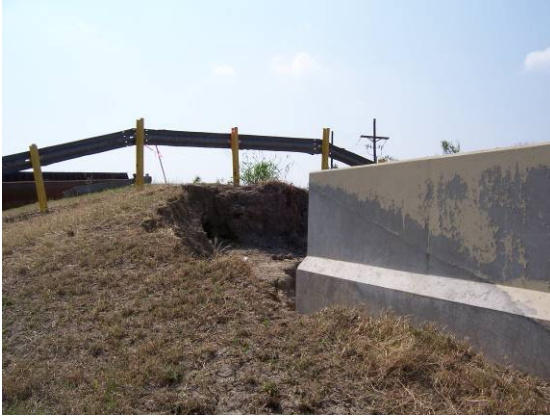
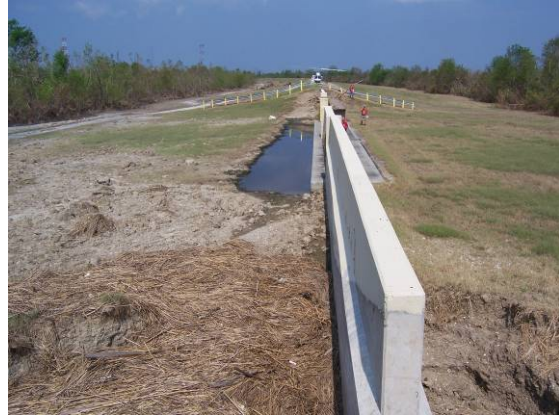
6.

Closure Structure and I-Wall West of Bienvenue. This closure structure and adjacent I-wall segments were damaged during the storm event. There was scour of the structural backfill resulting from overtopping of the closure gate and I-wall.

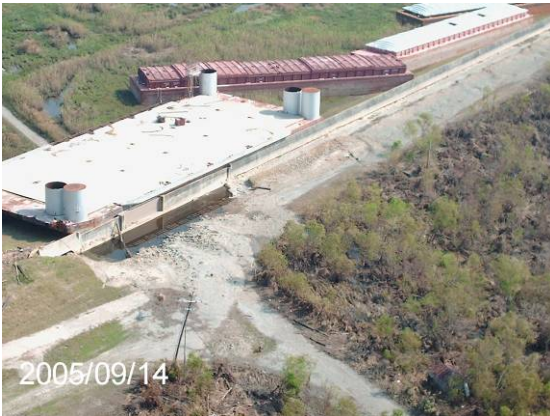
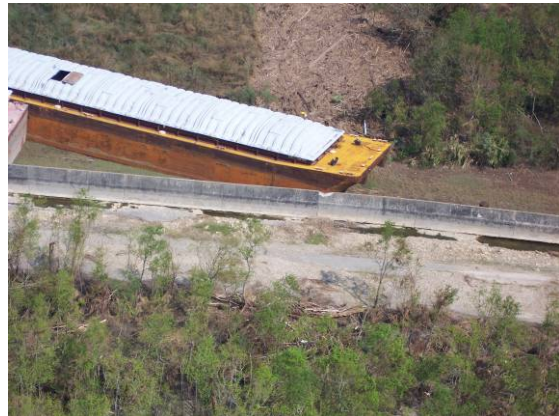
7. Paris Road Closure Structure. This closure structure was damaged during the storm event. There was scour of the structural backfill resulting from overtopping of the closure panels and additional damages due to impact from a loose barge.

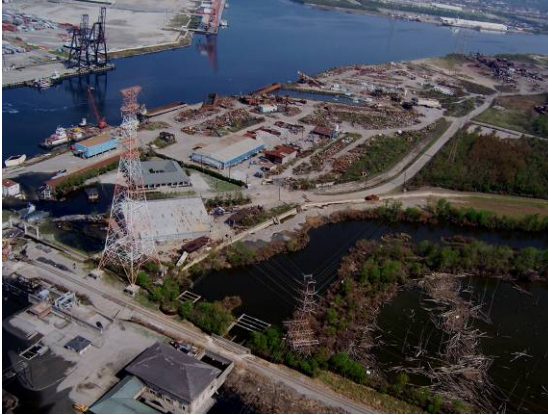
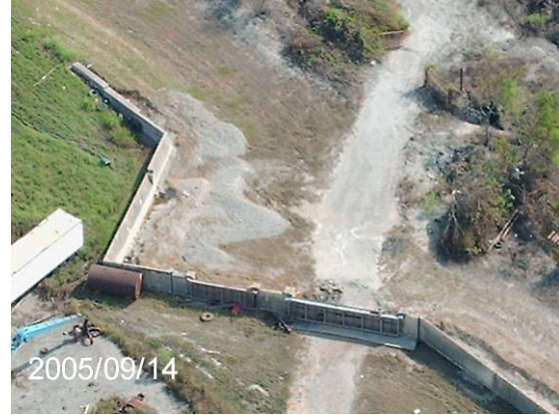
8.

Closure Structures Near Southern Scrap. There are two road closure structures that were damaged during the storm event. These closure structures are located at STA. 42+00 and STA. 68+00. There was scour of the structural backfill resulting from overtopping of the floodwall and the closure gates.

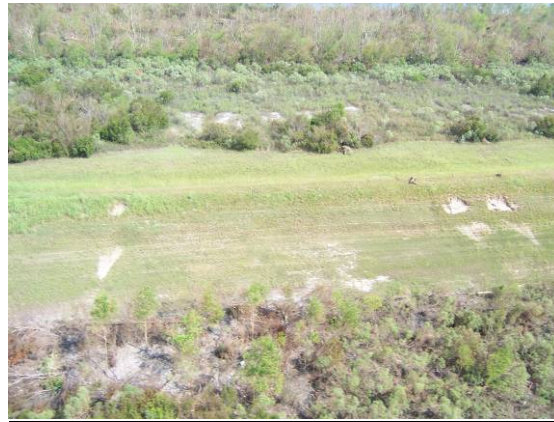
9. Levee Damage Along Intracoastal Waterway. There are small areas of scour on the backside of the levee between STA. 65+008 and STA. 277+20. This scour was the result of localized overtopping of the levees in this reach.

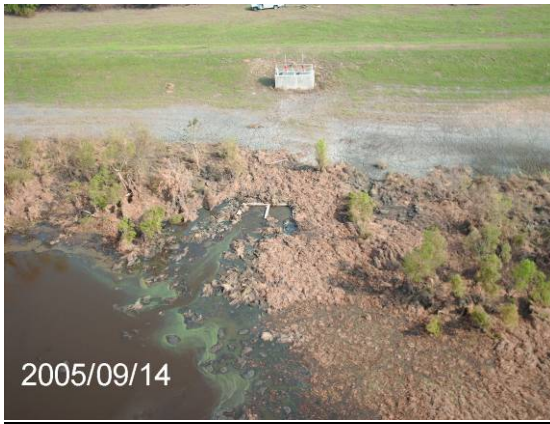
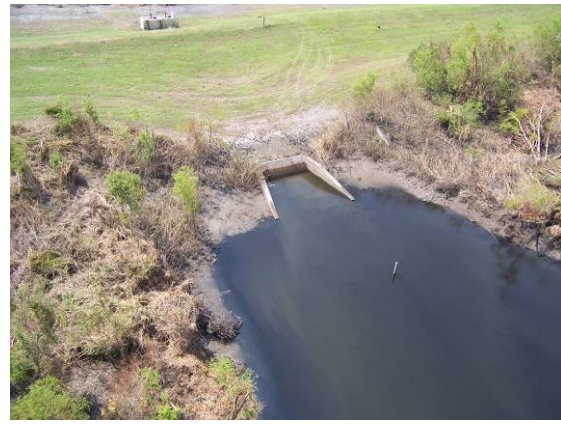
10. Creedmore Gravity Drainage Structure. The levee district has been unable to fully close the two 72-inch sluice gates on drainage structure. One sluice gate is approximately 50% closed and the other is approximately 90% closed. The cause of the sluice gates being stuck is apparently debris under the gate slides. Since there are trash racks on the inlet structure to these drains the debris must have come in through the outlet structure. While attempting to close the sluice gates against this debris the gate hoists were both damaged.
