TC550.5.N48

**US Army Corps
of Engineers®**
NEW ORLEANS DISTRICT

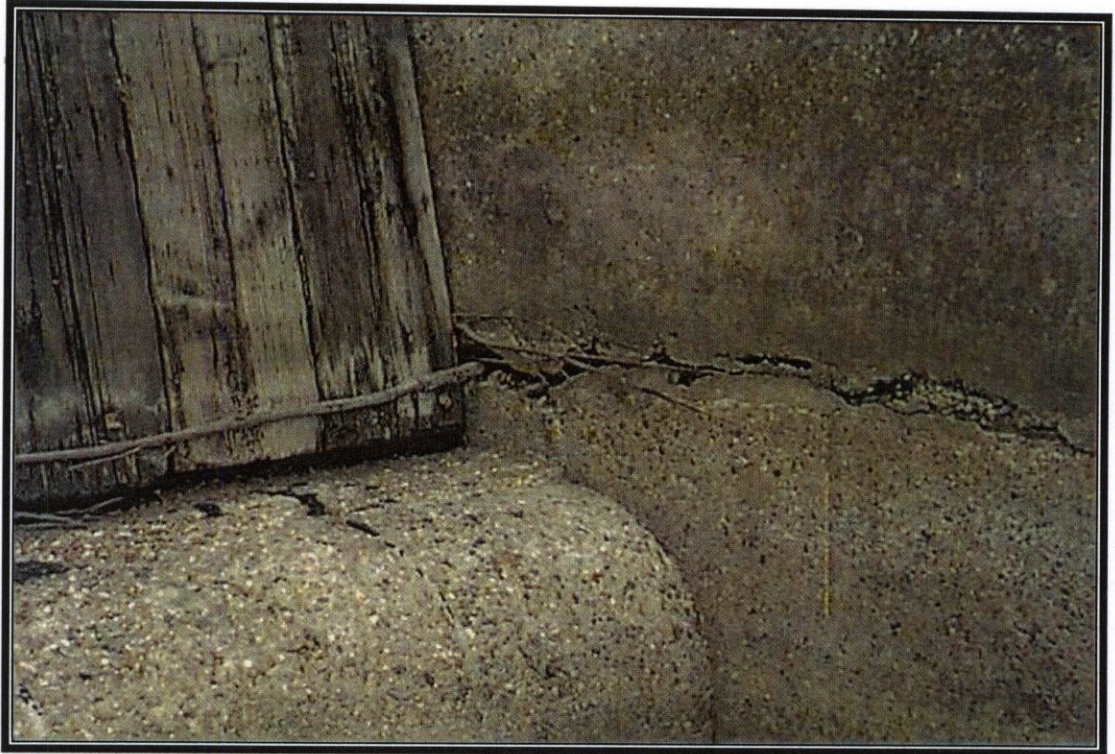
↑ PHOTO NO. 1 - A SIGNIFICANT SPALL WITH DEBRIS WAS NOTED ON THE WEST SIDE OF PIER 290-291 JUST ABOVE THE WEIR.

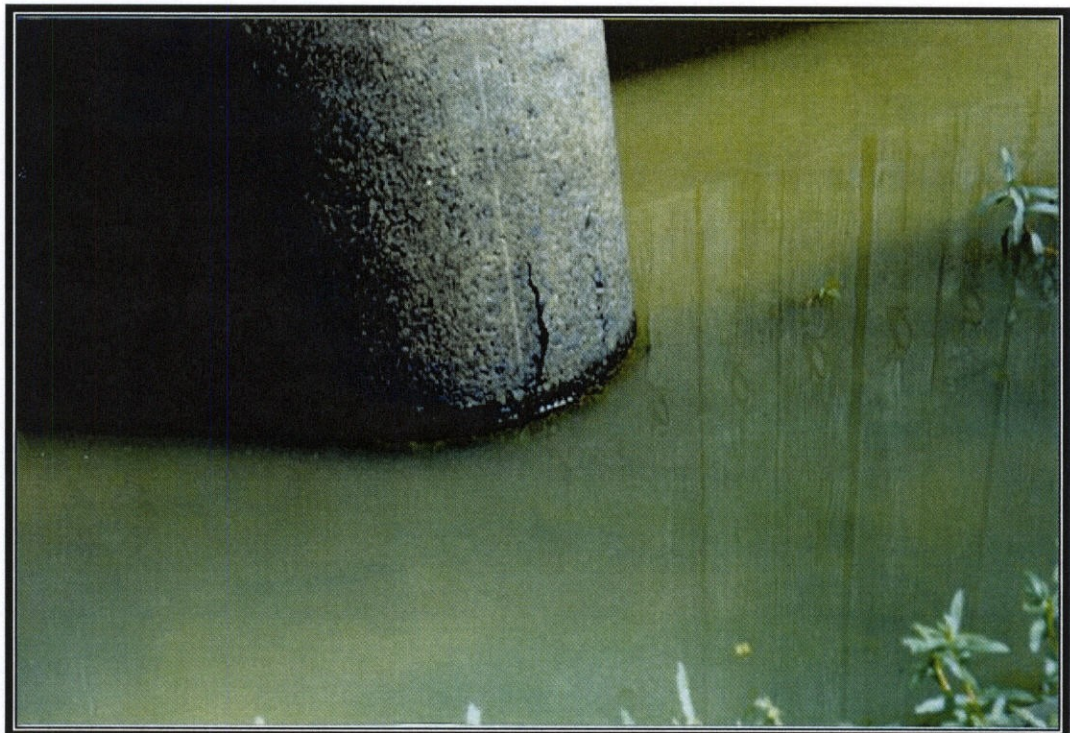
↓ PHOTO NO. 2 - A SPALL IS LOCATED ON THE RIVERSIDE FACE OF PIER 190-191 NEAR THE WATERLINE.

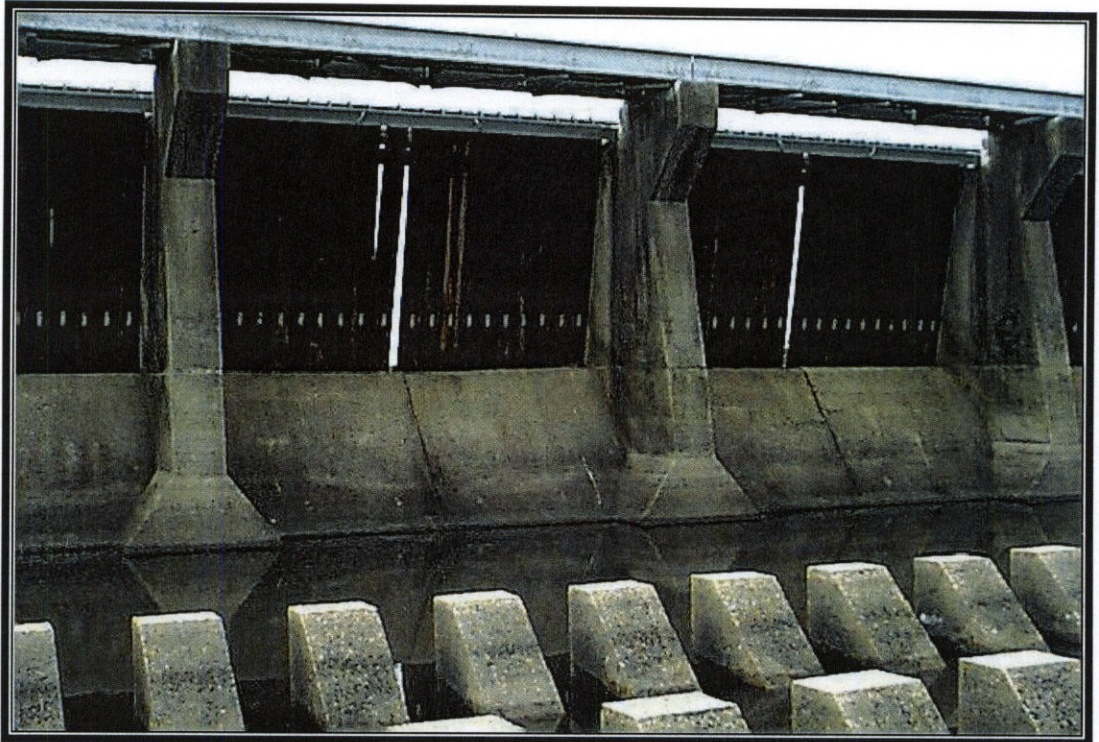
↑ PHOTO NO. 3 – DEPRESSION IN THE CENTER OF THE BAY AT THE WEIR CREST.

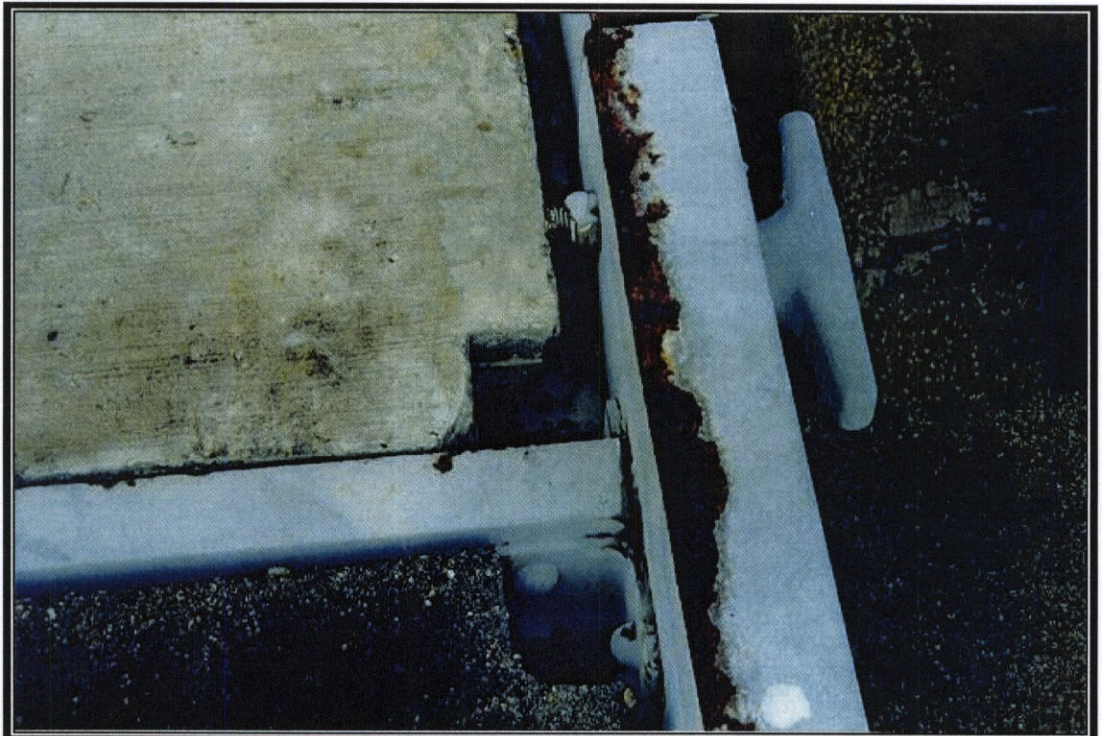
↓ PHOTO NO. 4 – SMALLER REPLACEMENT PANEL RESTING ON EDGE OF SUPPORT (R149e).

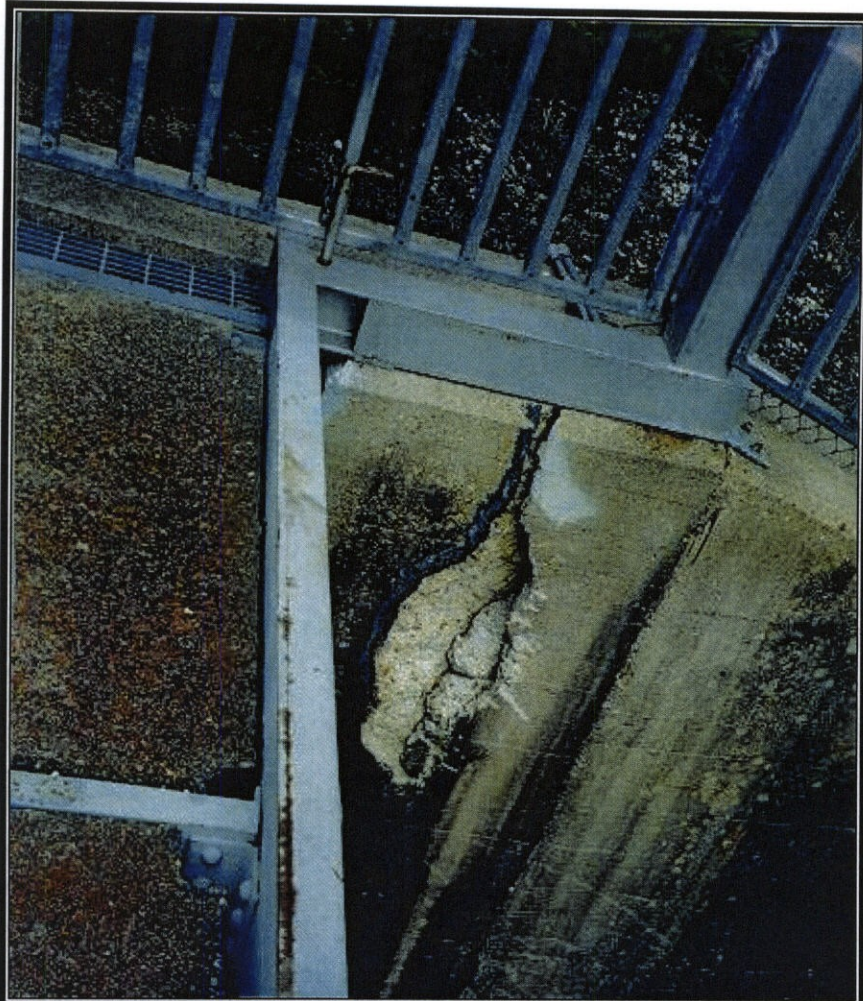
← PHOTO NO. 5
- SHEARED
FEMALE KEY
ON THE
DOWNSTREAM
SIDE OF THE
ABUTMENT.

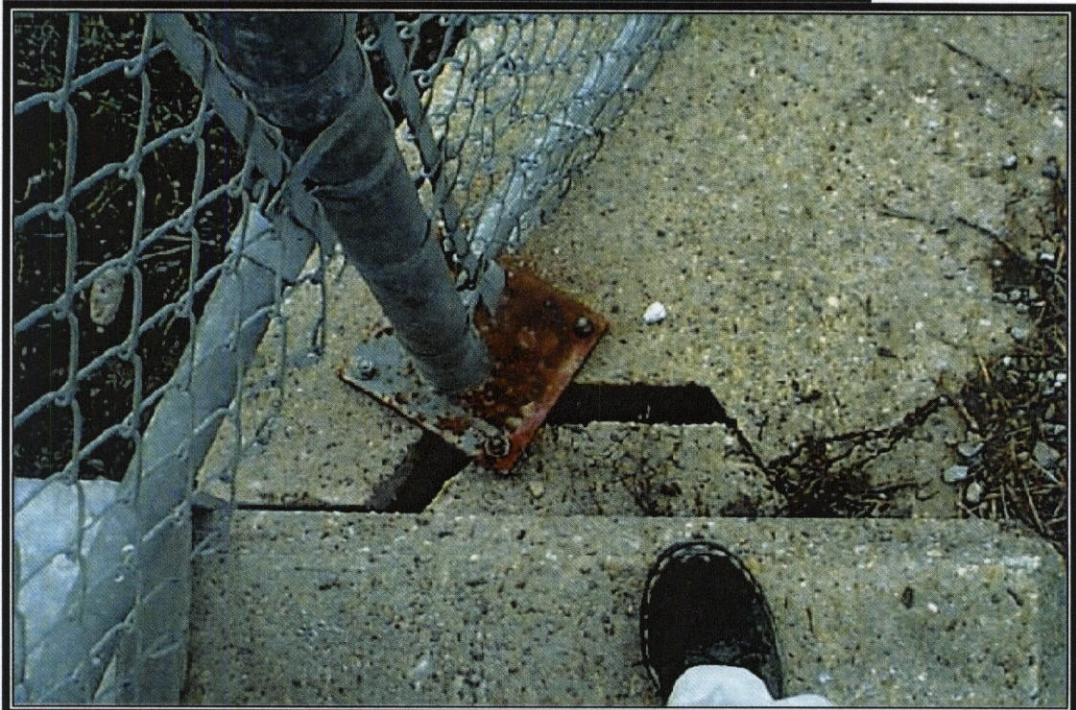
↓ PHOTO NO. 6
- SHEARED
FEMALE KEY
ON THE
UPSTREAM
SIDE OF THE
RIVERSIDE
WINGWALL.

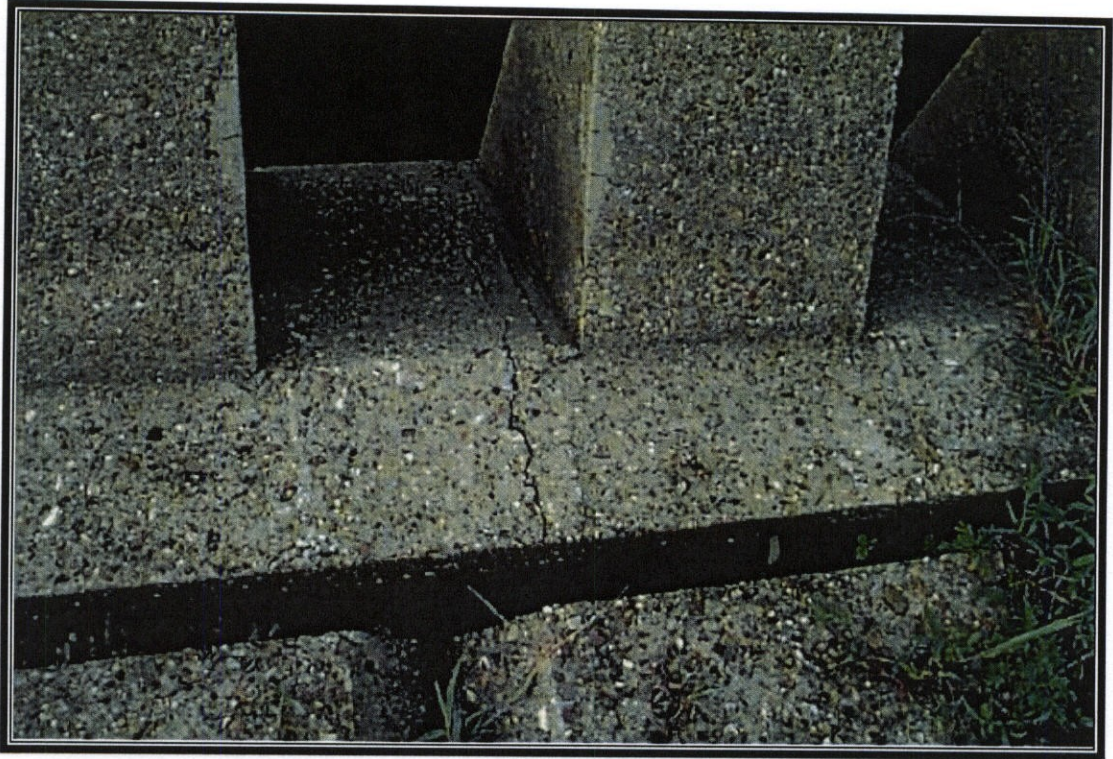
↑ PHOTO NO. 7 – ONE OF SEVERAL CRACKS AT DOWNSTREAM
END OF STILLING BASIN.

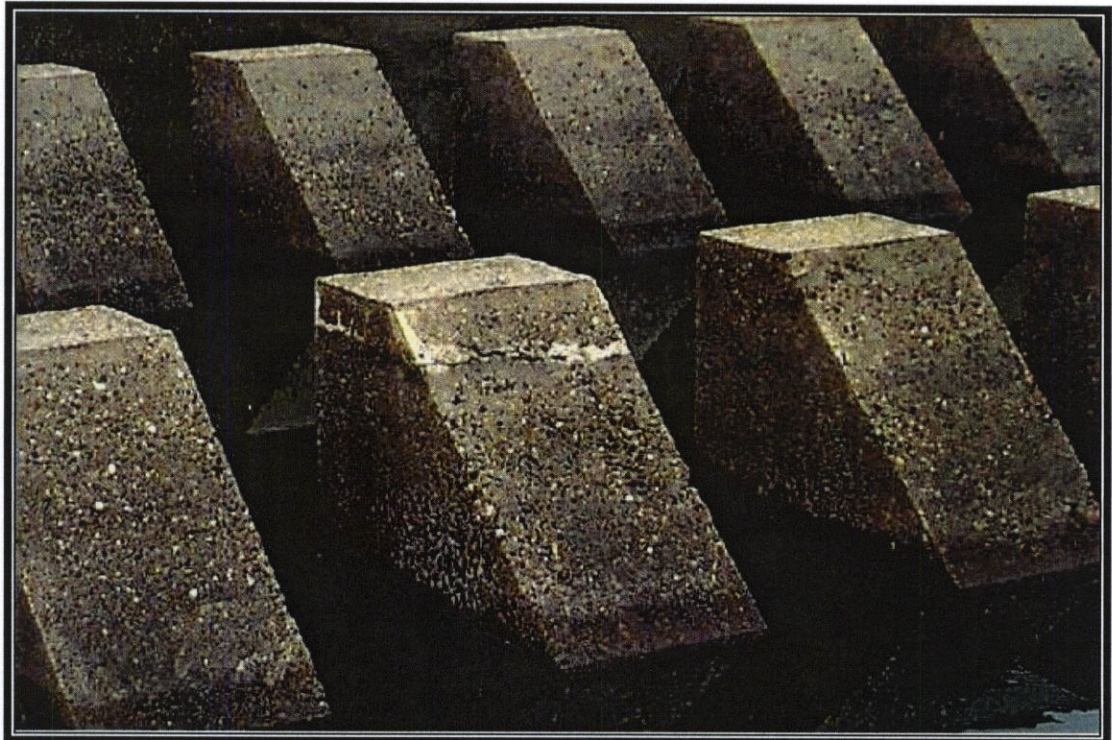
↓ PHOTO NO. 8 – HORIZONTAL CRACK THROUGH BAFFLE BLOCK
APPROXIMATELY SIX INCHES FROM THE TOP.

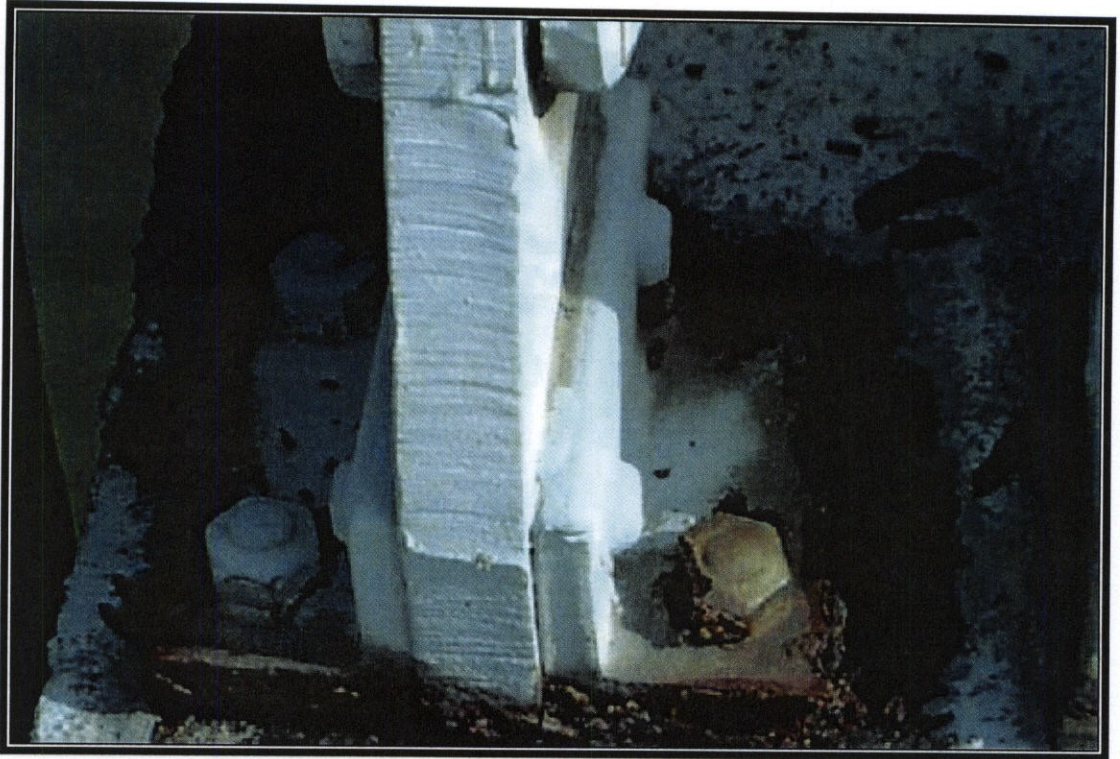
↑ PHOTO NO. 9 – RUSTING COMPONENTS ON THE ESCAPE BAR ANCHORAGE CONNECTIONS.

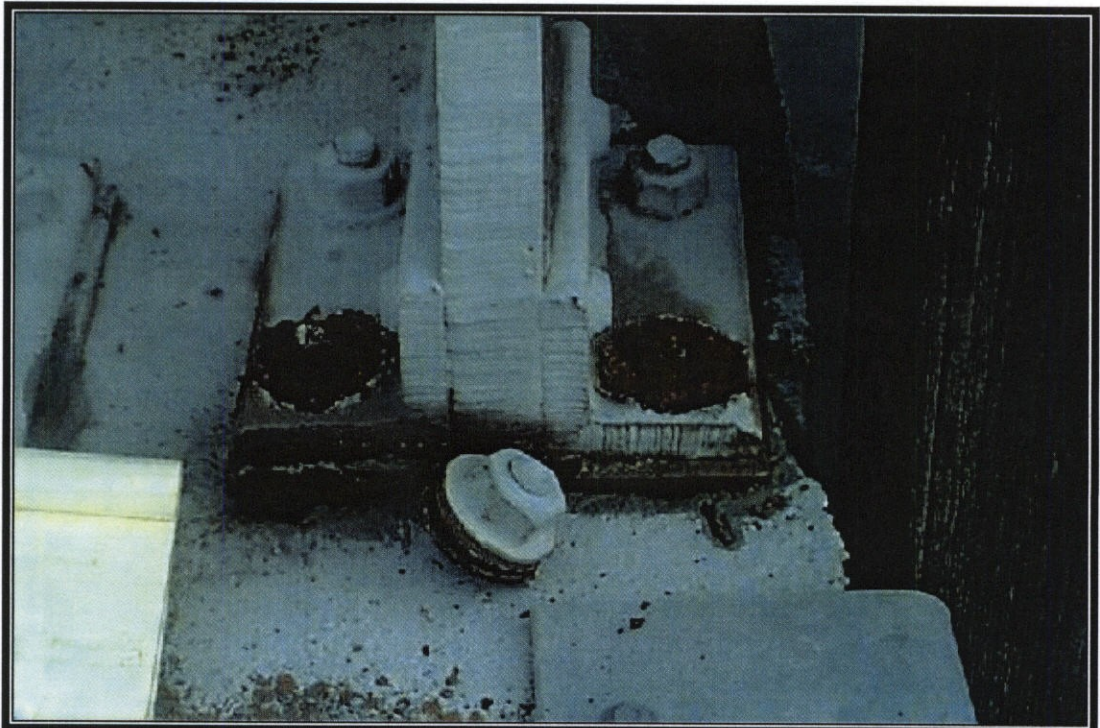
↓ PHOTO NO. 10 – DETERIORATED RIVERSIDE ANCHOR BOLTS ON THE ESCAPE BAR SUPPORT PADS.

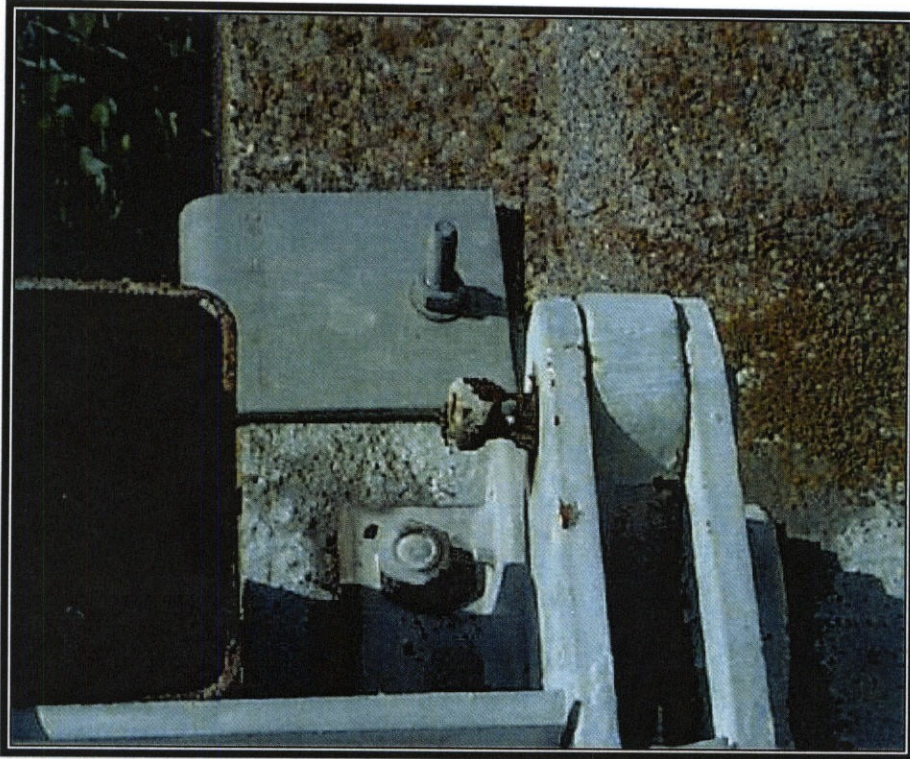
↑ PHOTO NO. 11 – CORRODED PIN IN THE WEST ESCAPE BAR SUPPORT PAD OF BAY 165.

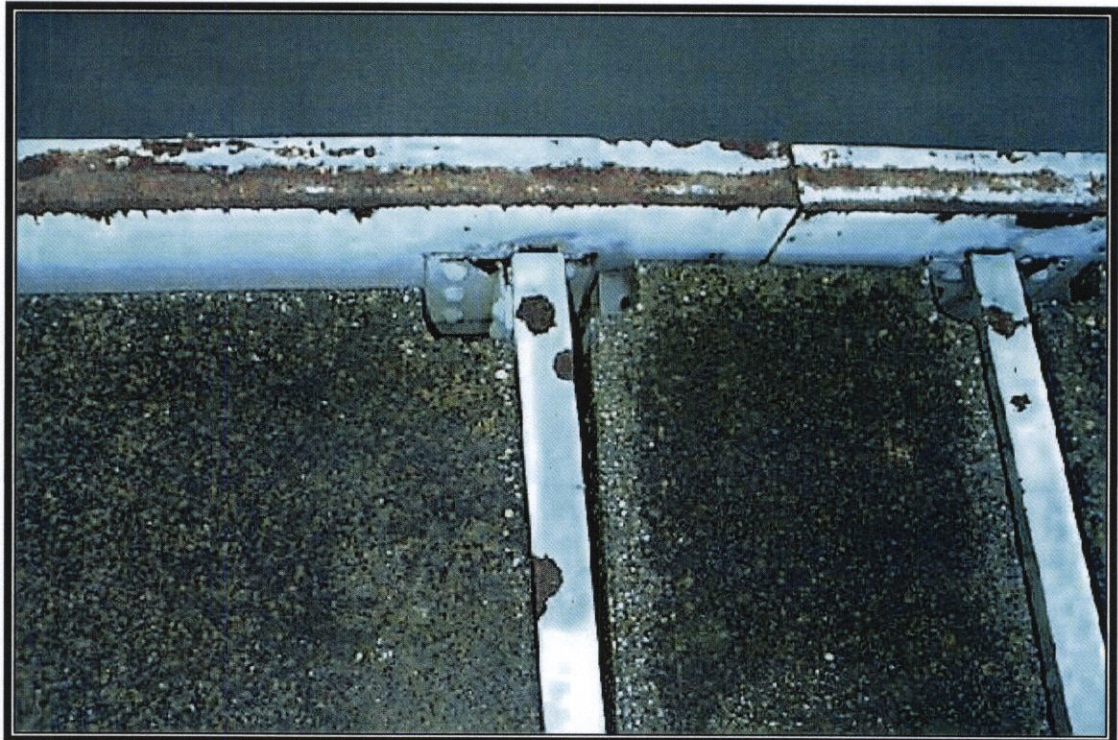
↓ PHOTO NO. 12 – TYPICAL RUST SPOTS ON CRANE/SERVICE BRIDGE.

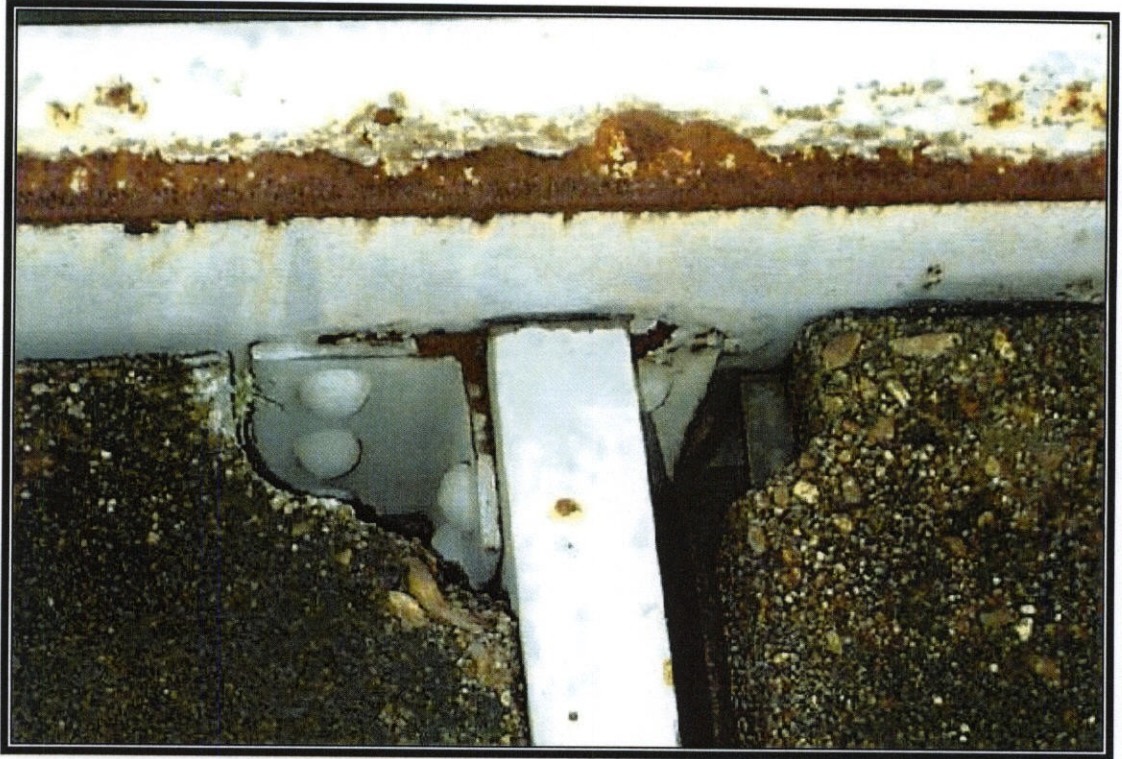
↑ PHOTO NO. 13 – CLOSE-UP OF RUST ON CRANE/SERVICE BRIDGE COMPONENTS.

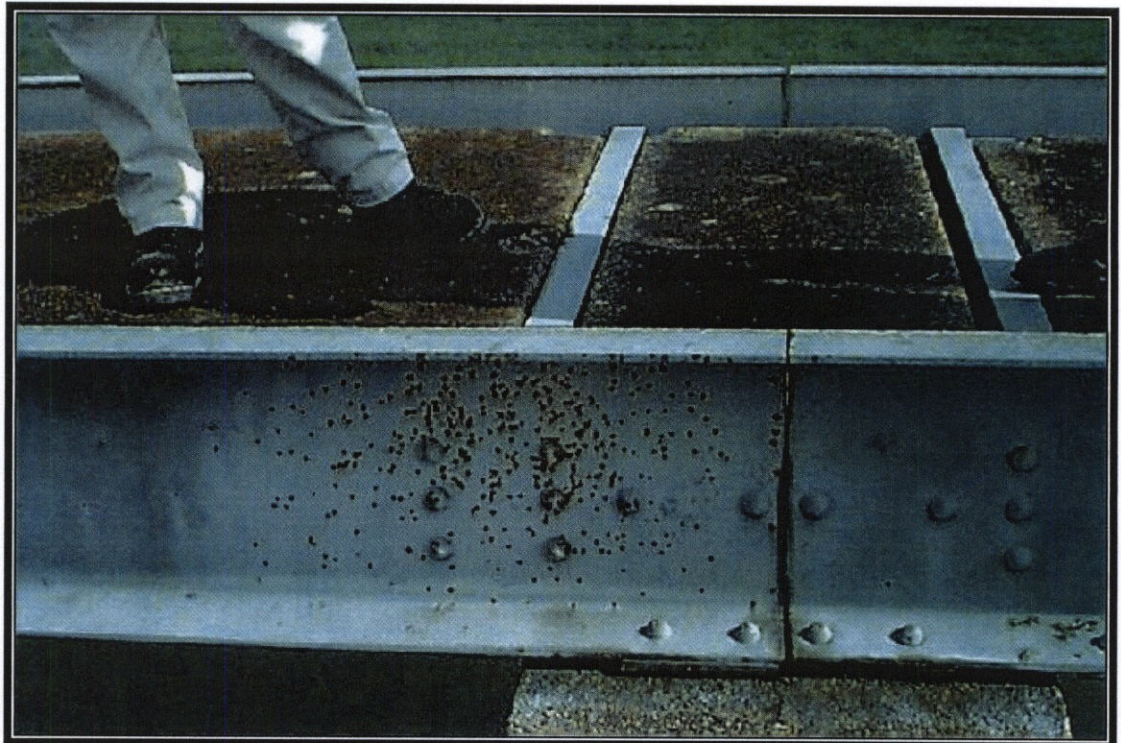
SECTION VI – CONCLUSIONS AND PROPOSED REMEDIAL ACTIONS

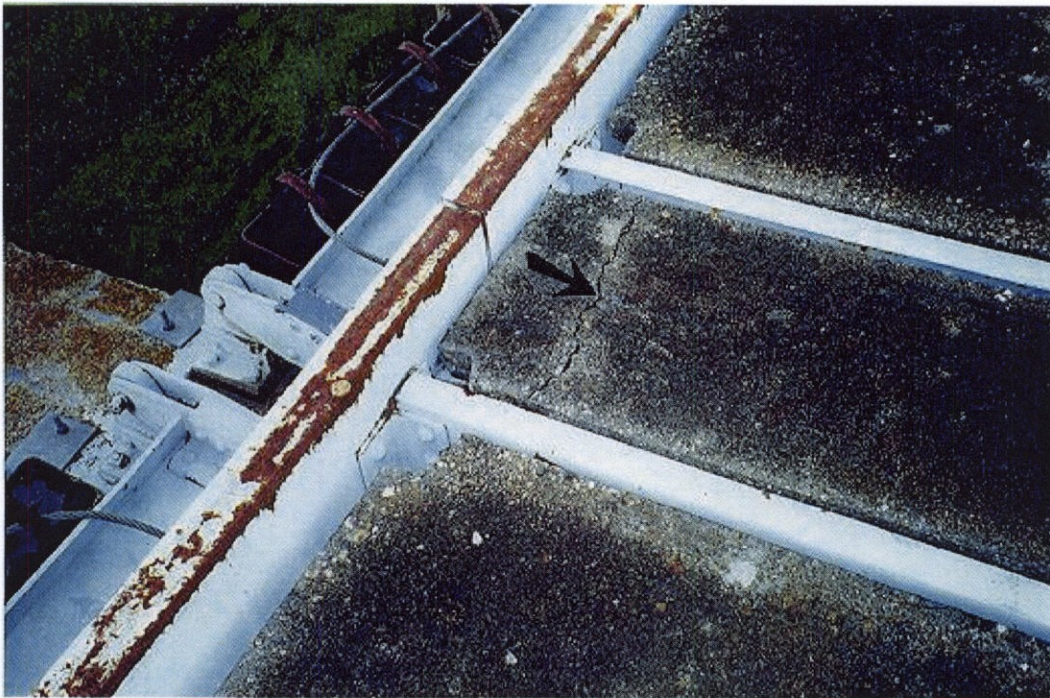
PHOTO 4 - Panel L171e (note medium size crack from one end to the other of panel).

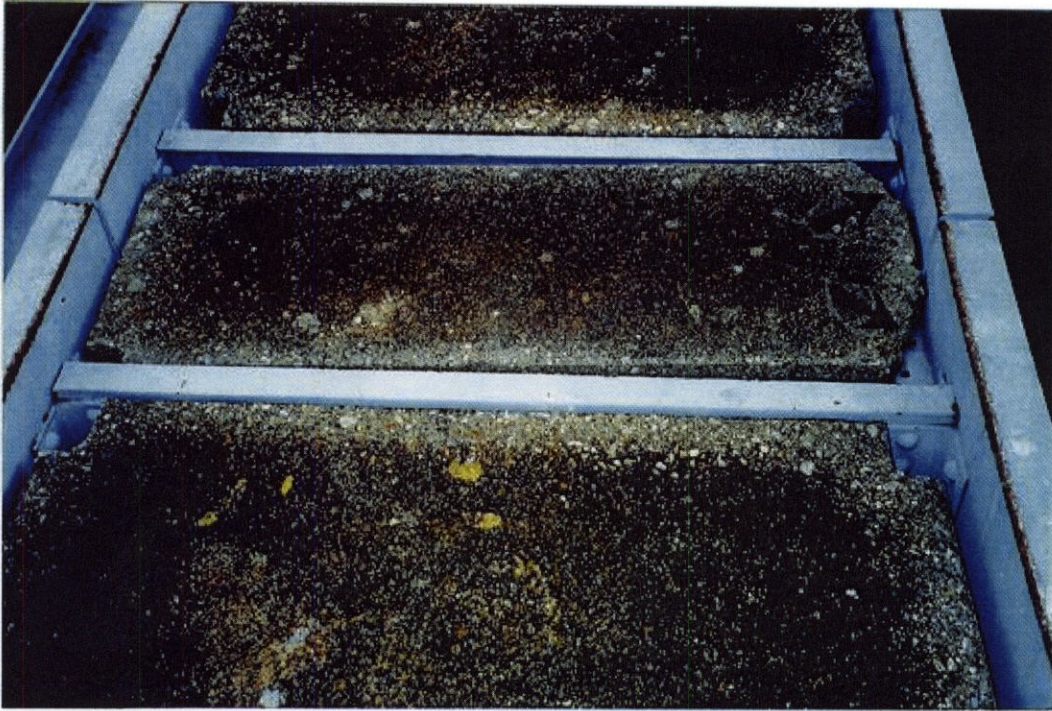
PHOTO 5 - Panel L159e (note shoe size spall on each corner with only about half of its bearing surface remaining).

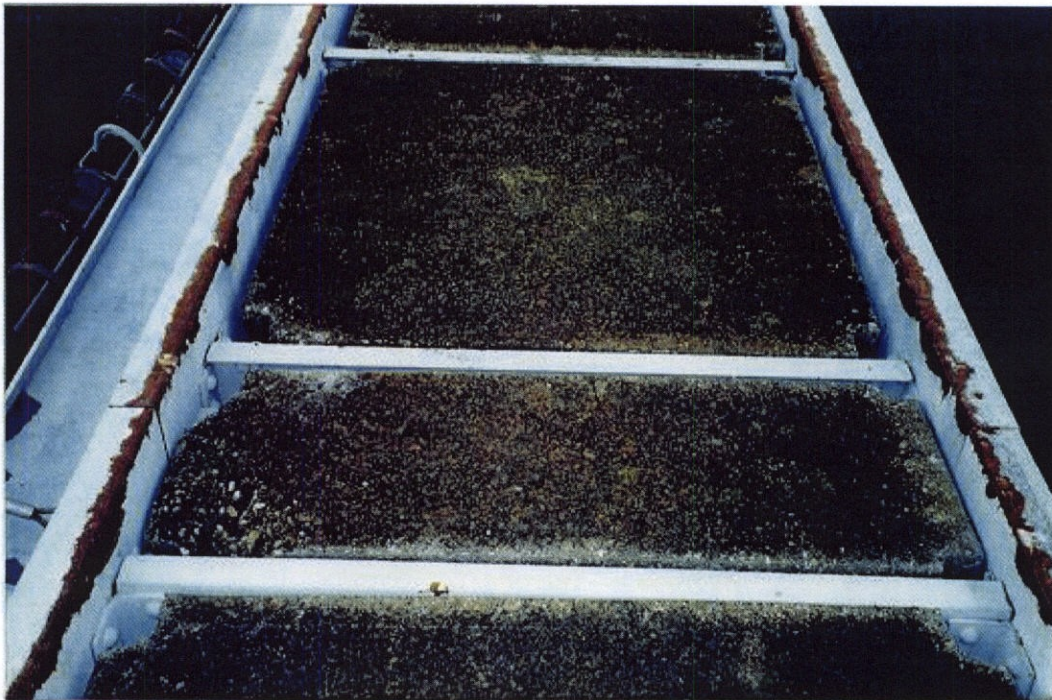
PHOTO 6 - Typical close up of concrete walkway panels, note top portion of the Channel beam (which the crane and engine driven rail car ride) are beginning to show signs of rust.

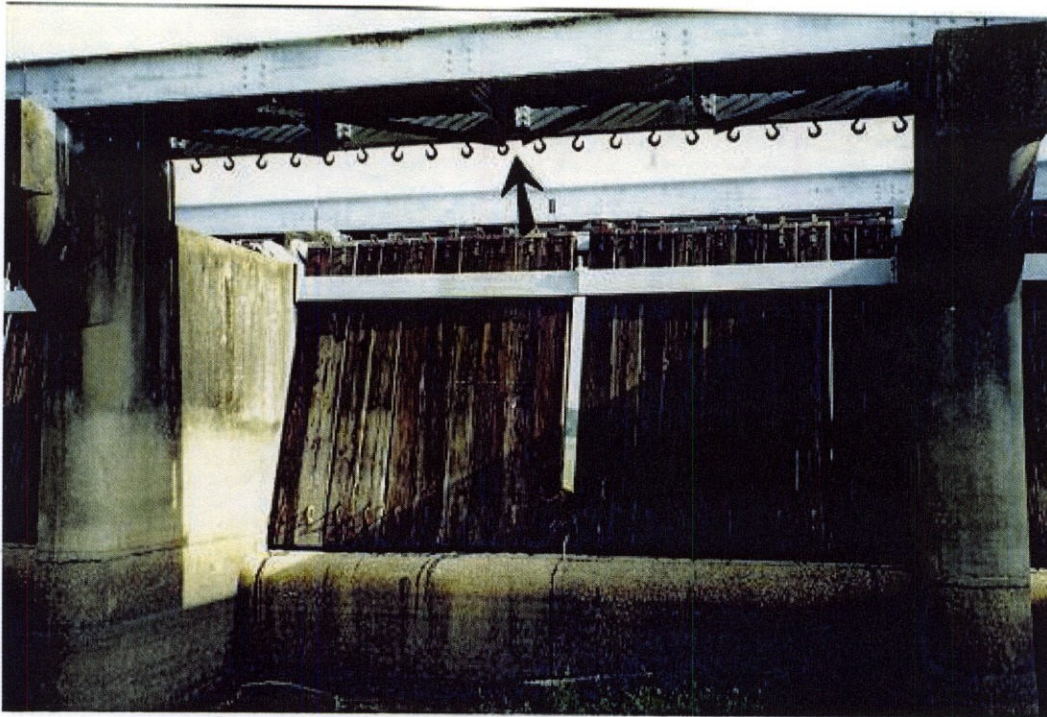
PHOTO 7 - Underside of the riverside bridge (areas of corrosion and peeling paint were noted on the stringers and lateral bracing as well as the connection angles between the two).

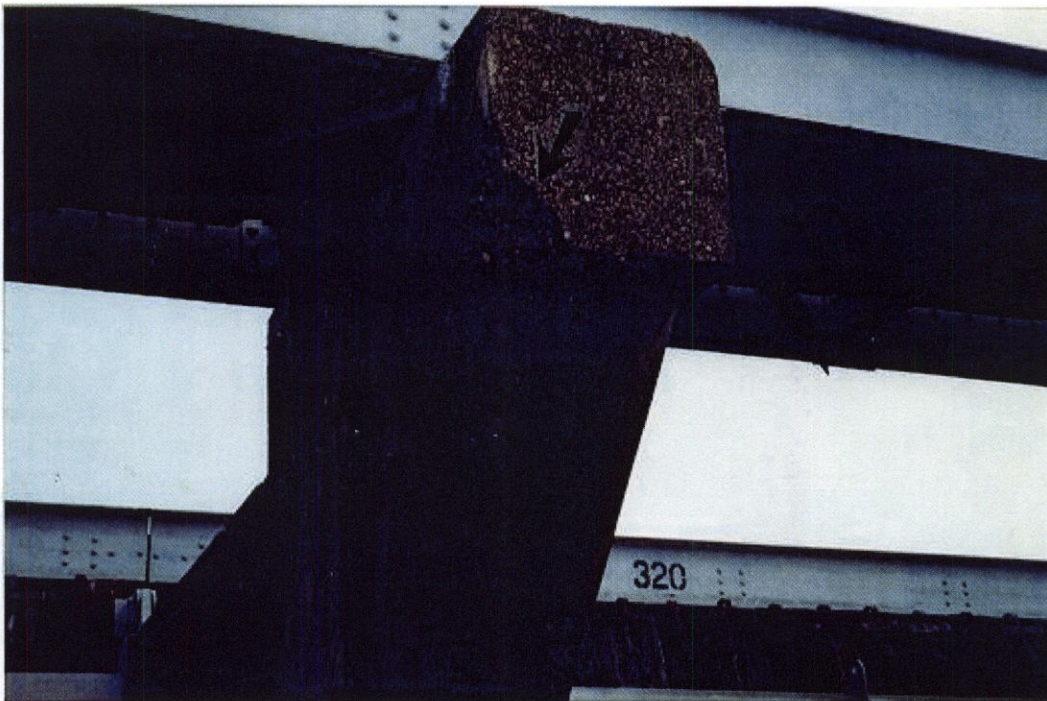
PHOTO 8 - Medium size spall on the riverside bridge bent of pier 319. The spall appeared to be old and no action is required at this time.

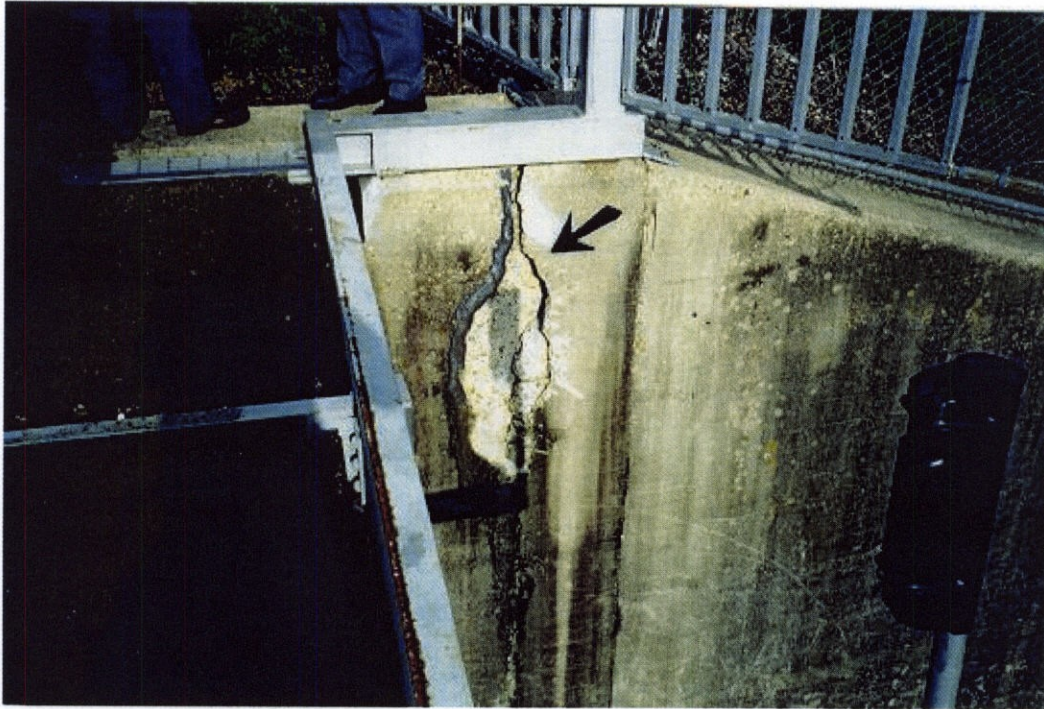
PHOTO 9 - Large spall on west abutment wall, noted during previous periodic inspections appeared to be the same. This spall is about 3 feet down-stream of the lakeside bridge where bridge span no. 1 channel beams rest on the abutment wall and should not affect the bridge.

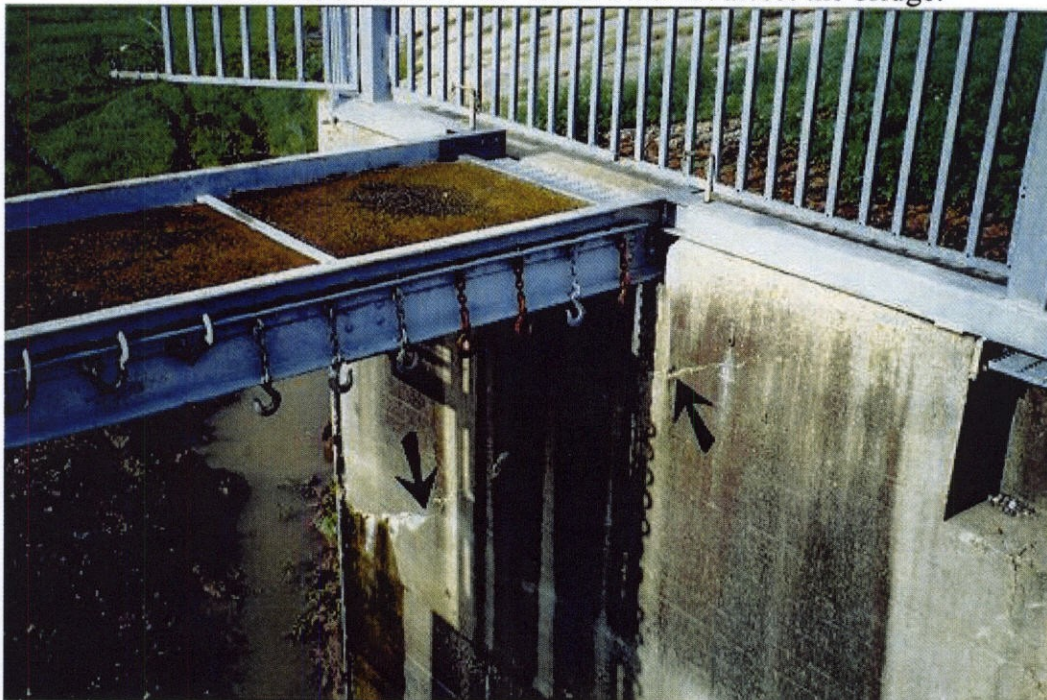
PHOTO 10 - The deep and fine arched crack under the riverside bridge, noted during previous periodic inspections has not changed.
