LAKE PONCHARTRAIN, LOUISIANA AND VICINITY

BAYOU DUPRE CONTROL STRUCTURE

PERIODIC INSPECTION REPORT NO. 7

29 APRIL 1993

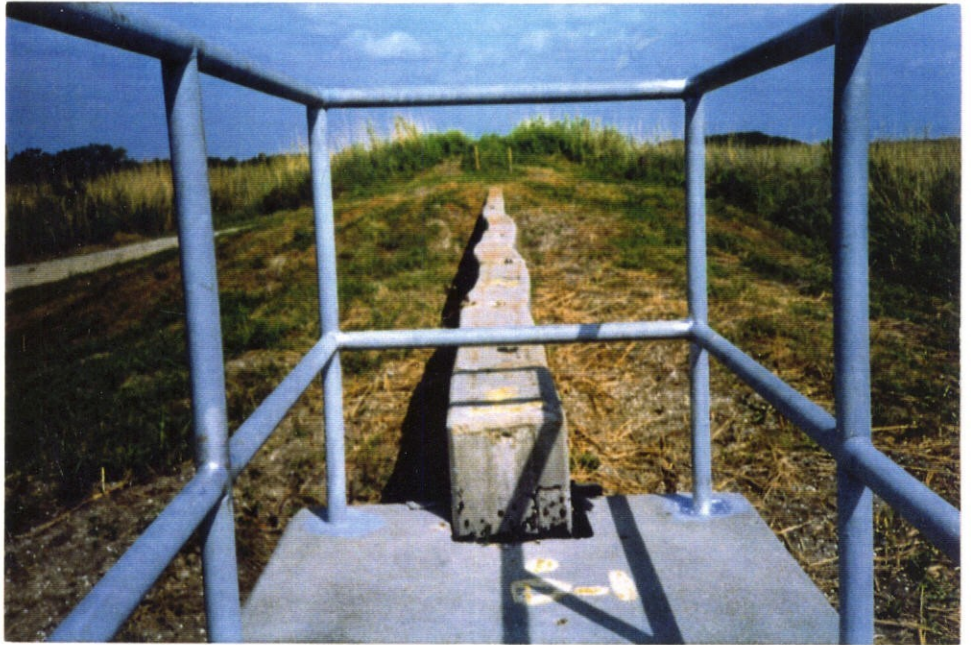
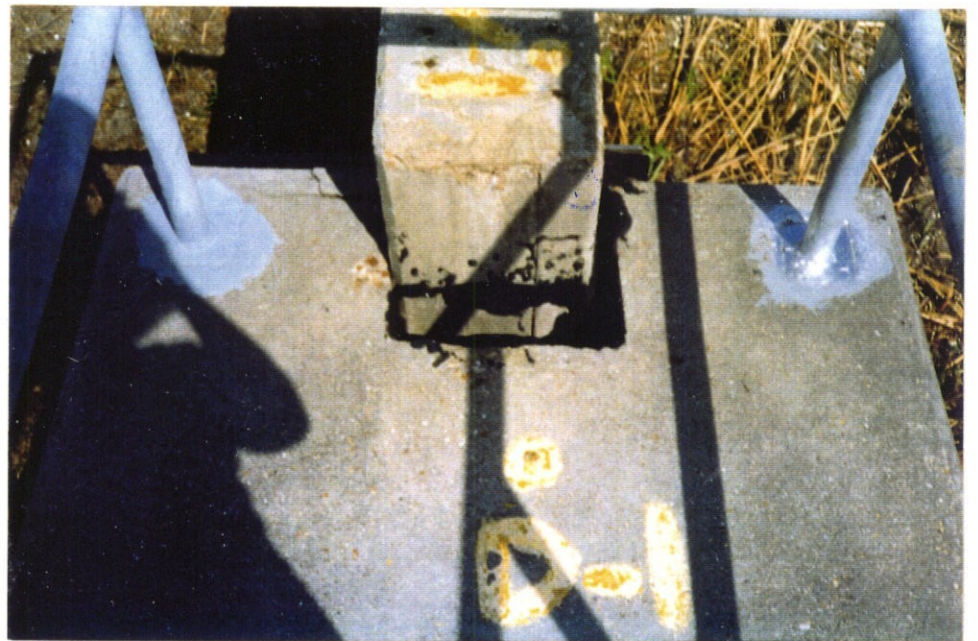
c. The concrete sheetpile on the west side is separated away from the T-wall toward the west and creating a gap where there is no sealant left between the joint. (See Photos 1 and 2).

PHOTO 1 - Separation of concrete sheetpile
from the T-wall on west side

PHOTO 2 - Separation of concrete sheetpile
from the T-wall on the west side

b. Missing joint sealant will be replaced and vegetation removed.

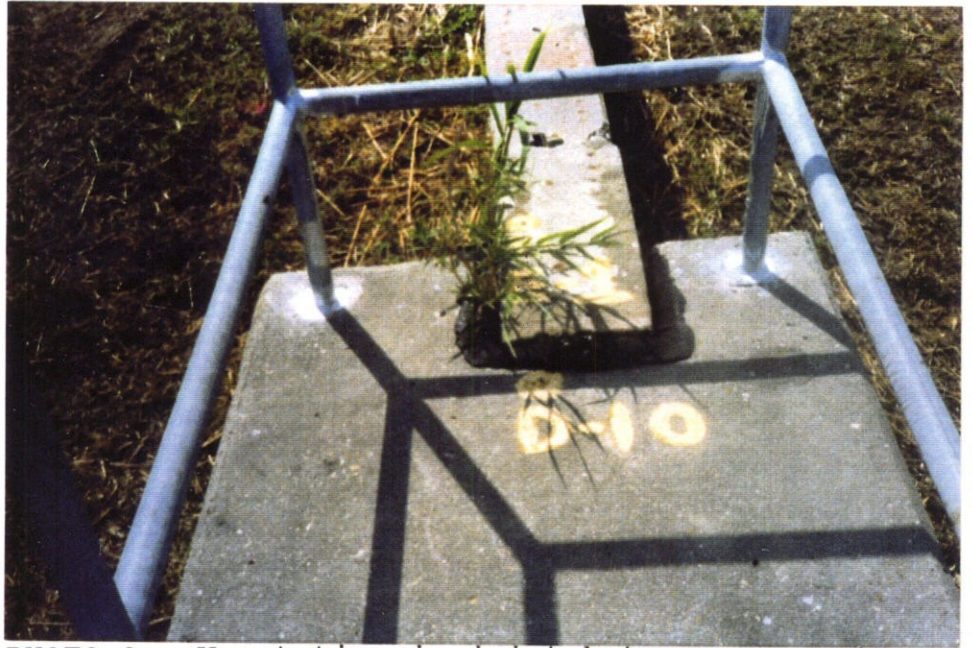
d. The expansion joint between the concrete sheetpile and the T-wall on the east side is in good condition but vegetation was noted in the joint sealant. (See Photo 3).

PHOTO 3 - Vegetation in joint between concrete sheetpile and T-wall on the east side

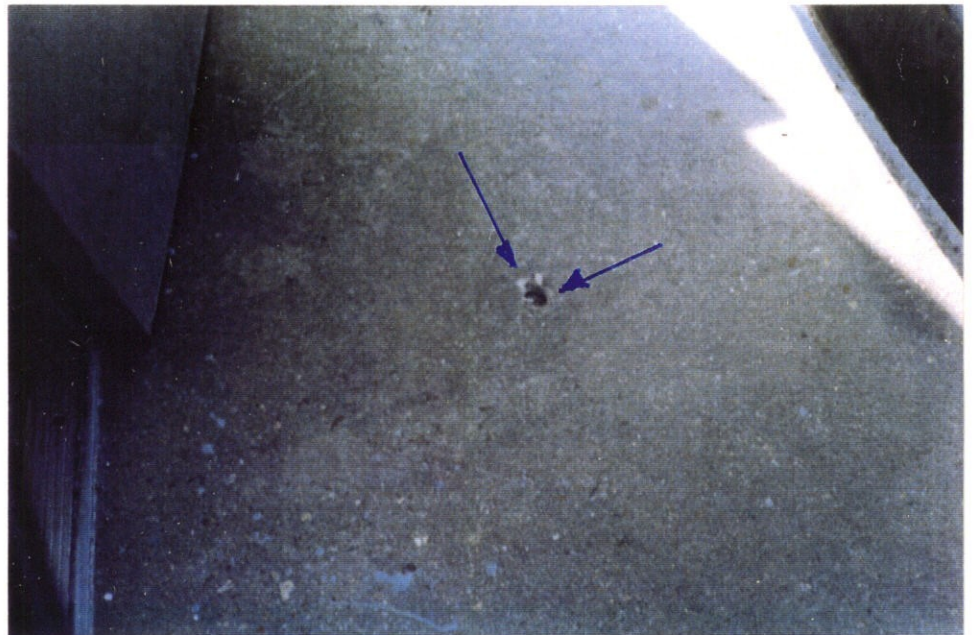
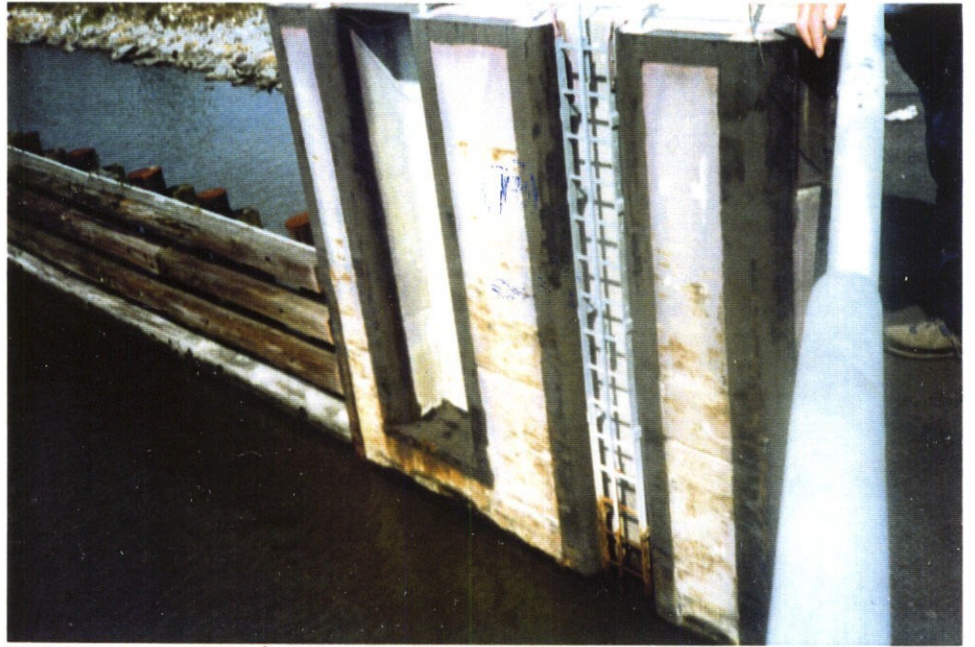
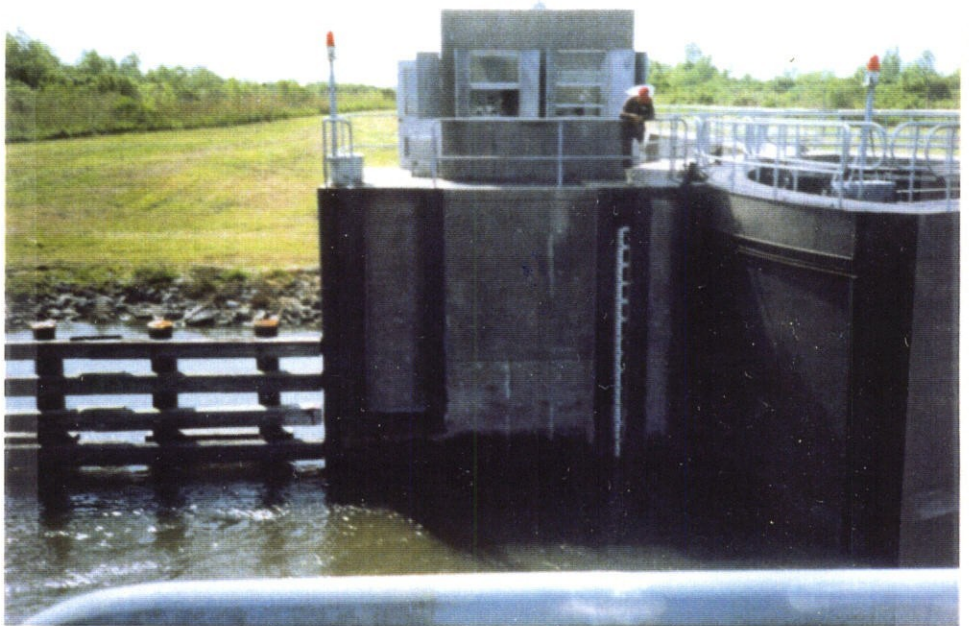
e. There are small spalls on the top surface of gatebay monoliths and on the channel walls on both east and west sides. (See Photos 4,5 and 6).

PHOTO 4 - Typical small spalls on top surface of gatebay monoliths and channel walls on both east and west sides

PHOTO 5 - Typical small spalls on top surface of gatebay monoliths and channel walls on both east and west sides

PHOTO 6 - Typical small spalls on top surface of gatebay monoliths and channel walls on both east and west sides

c. Small concrete spalls, hairline cracks and efflorescence will be monitored in future periodic inspections for further deterioration.

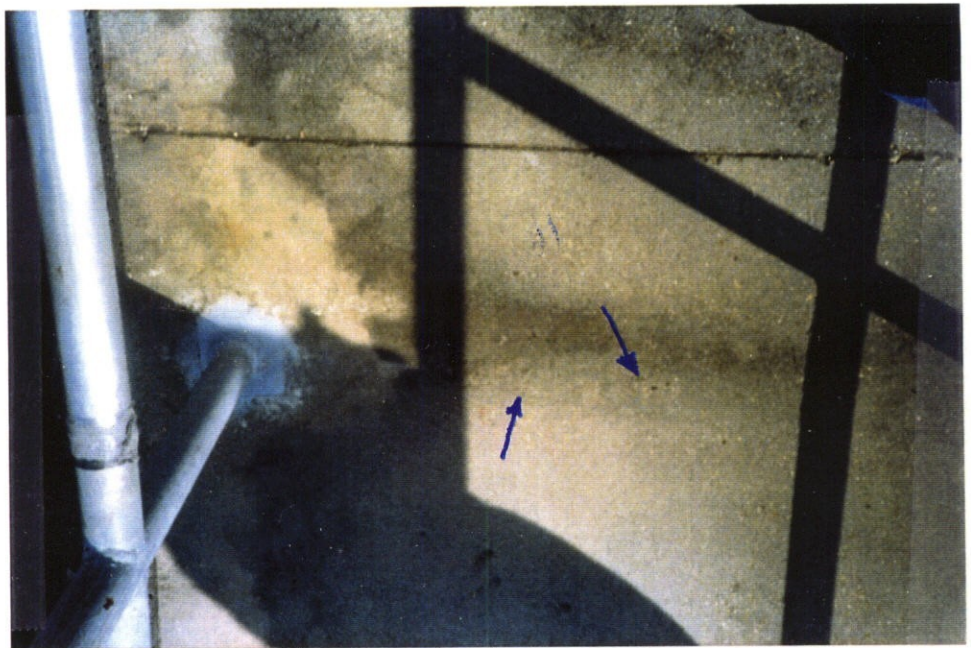
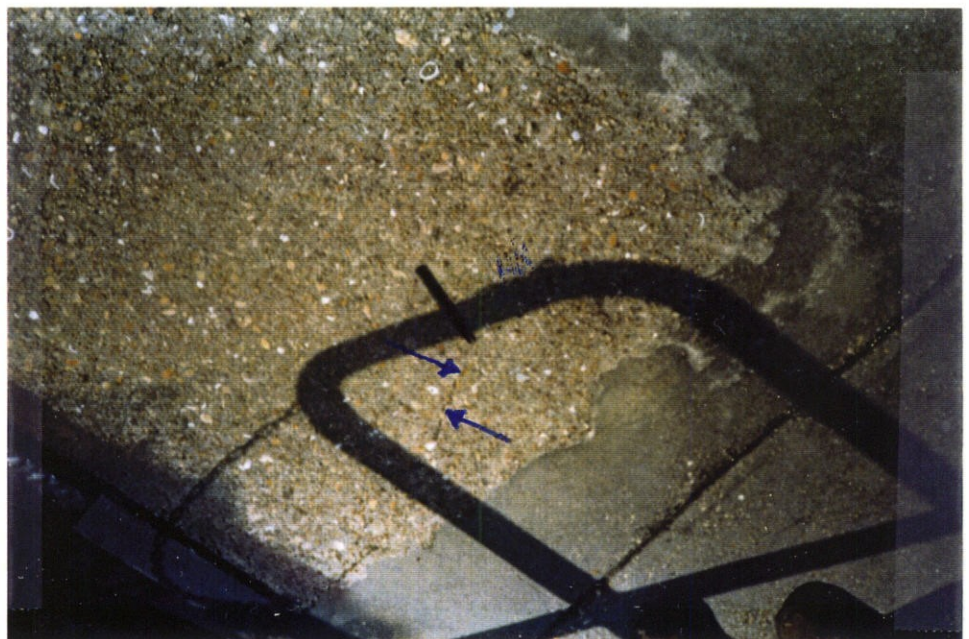
f. There are hairline cracks on top of gatebay monoliths and T-walls on both west and east sides. (See Photos 7 and 8).

Photo 7 - Typical hairline cracks on top of gatebay monoliths and T-walls on both west and east sides

Photo 8 - Typical hairline cracks on top of gatebay monoliths and T-walls on both west and east sides

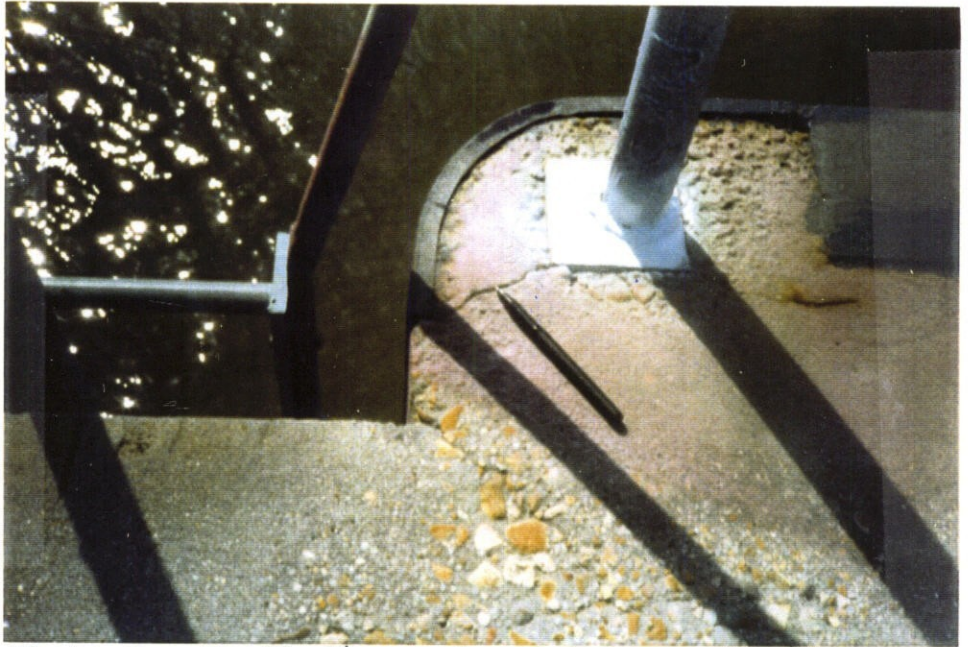
g. A small diagonal crack was observed on the west side near the edge of the gatebay structure and handrail.

Photo 9 - Small diagonal crack on west side near edge of gatebay structure and handrail

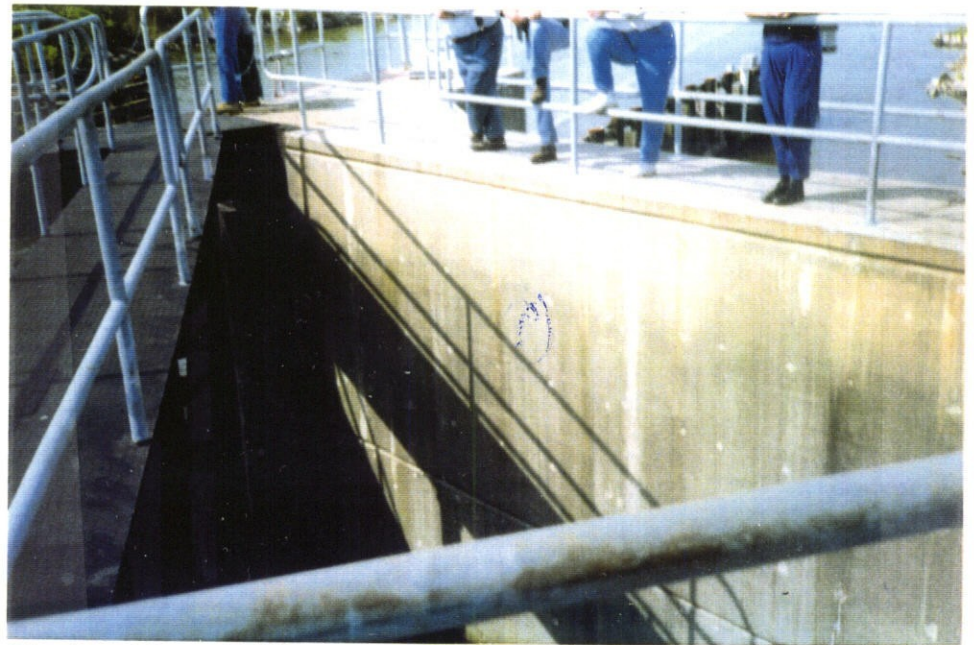
h. There is efflorescence on the channel walls and on both west and east sides of the gatebay structures. (See Photo 10).

Photo 10 - Efflorescence on channel walls and on both west and east sides of the gatebay structures
