HURRICANE PROTECTION

EMPIRE FLOODGATE

PERIODIC INSPECTION REPORT NO. 2

4 OCTOBER 1978

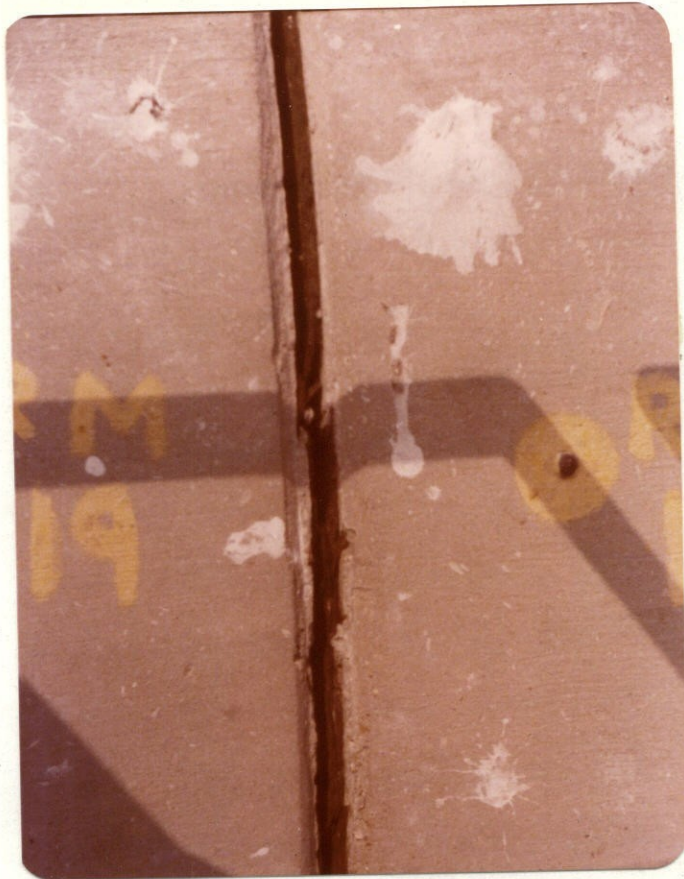
PHOTO NO. 1 - Joint Between Reference Mark RM18-RM19

(1) Floodwall. There were a few shrinkage and temperature cracks noted on top of the east and west walkways, but all exposed concrete surfaces were in satisfactory condition. The T-wall joints between instrumentation reference marks RM18-RM19, RM4-RM5 and RM2-RM3 appears to be enlarging at the walkway slab and had movements approximately 1/2 inch to 1 inch. These movements were larger at the walkway and appeared to be very small at the water line. See photo no. 1, 2, and 3.

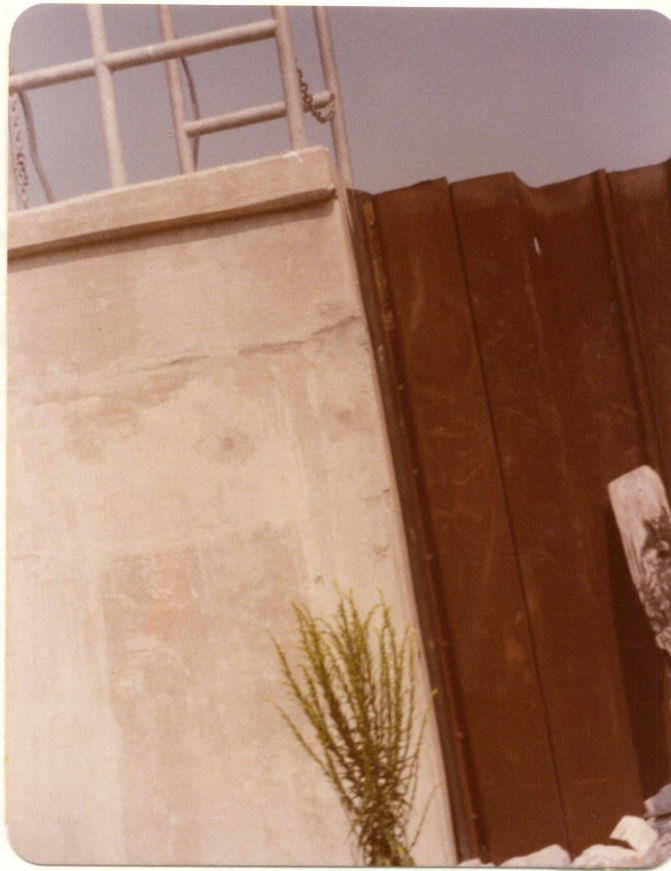
PHOTO NO. 4 - Location of Waterstop Between T-Wall Monolith and Sheetpiling

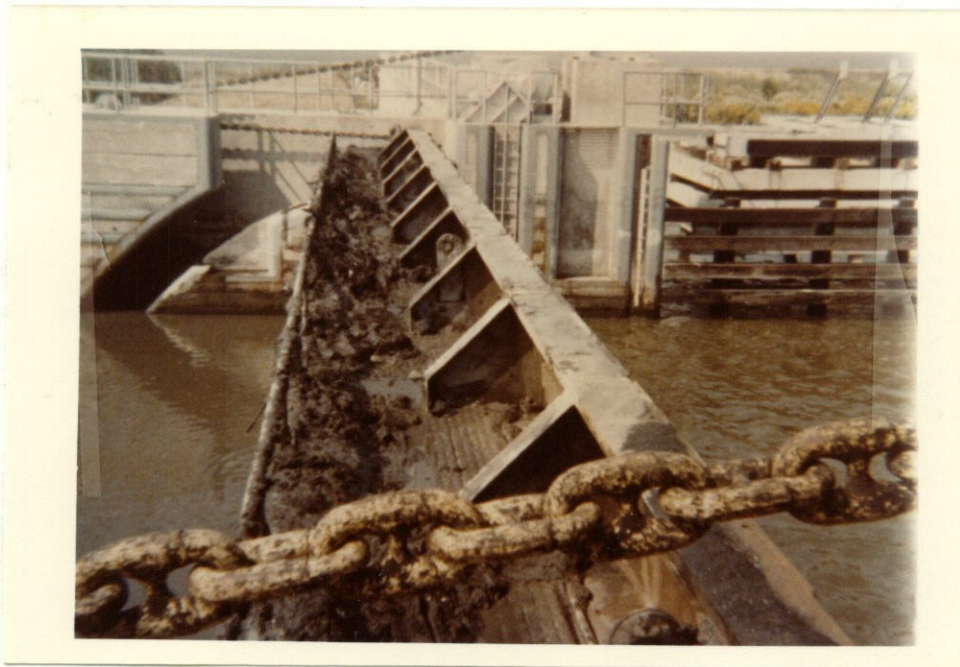
c. Flap gate. The flap gate was raised to closed position. The operation of gate was satisfactory. Only the portion of gate not covered by water was inspected. Overall, the gate was in good condition, the paint of the underside of the gate was discolored and a large amount of soil deposits was trapped on the walkway. See photo no. 5.

e. Operating Machinery. The operating machinery worked satisfactorily. Electrical system was also in good condition. The hoist and counterweight chains were rusted. They should be checked for loss of diameter on a 6 month bases. See photo no. 5 for rusted chain.

PHOTO NO. 5 - Trapped Soil Deposits on Walkway and Rusted Chain
