NEW ORLEANS TO VENICE, LOUISIANA

REACH B-1 - TROPICAL BEND TO FORT JACKSON

## EMPIRE FLOODGATE

### PERIODIC INSPECTION REPORT NO. 4

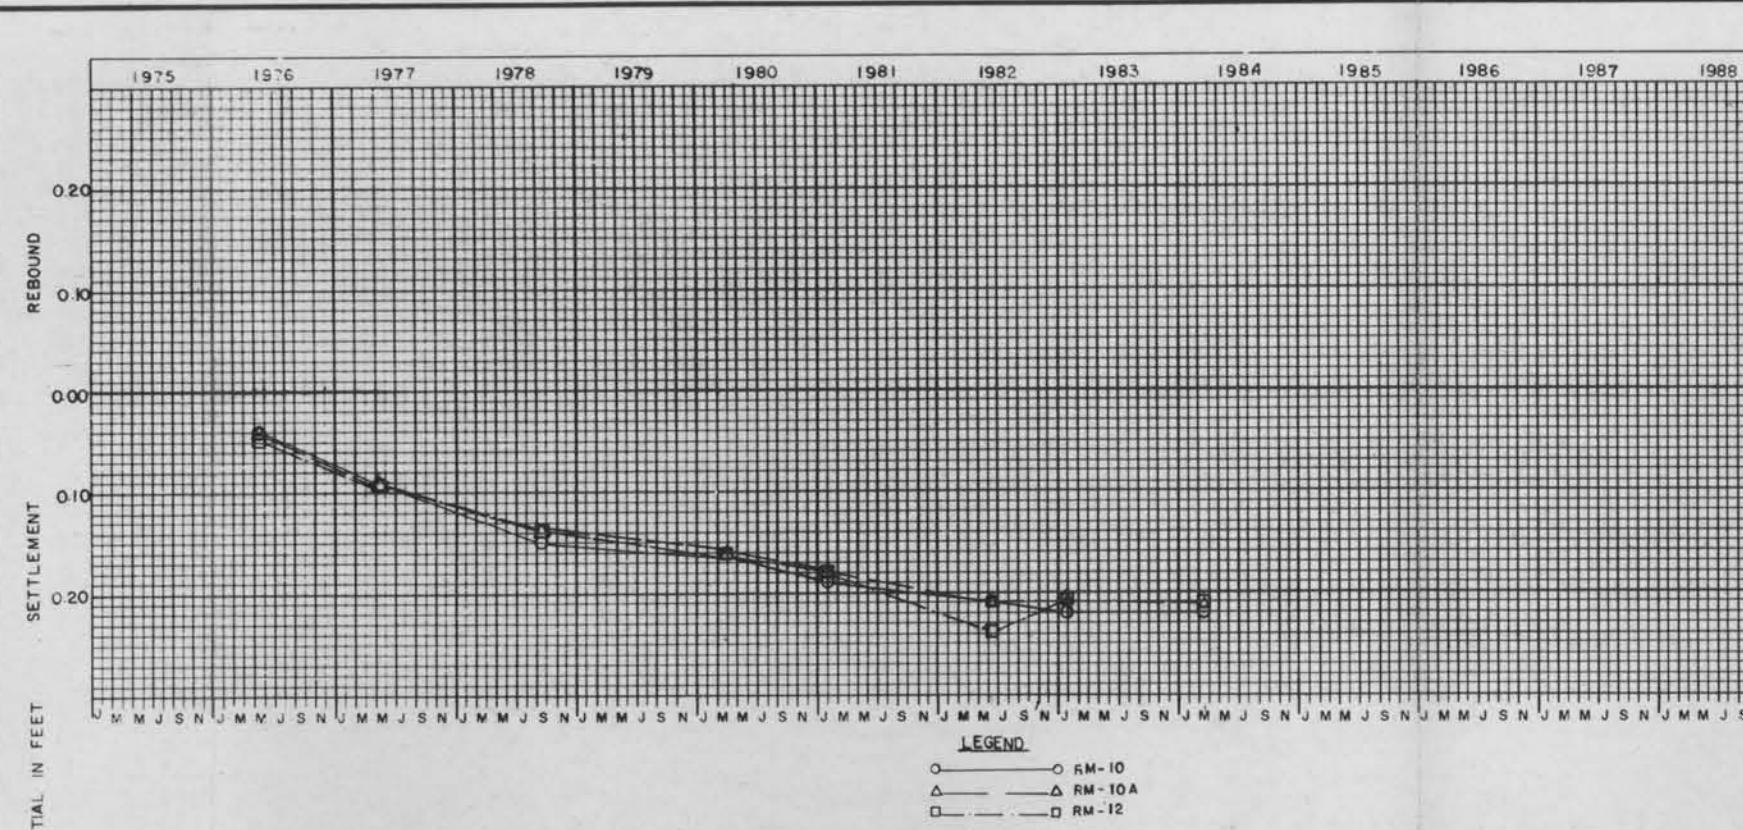
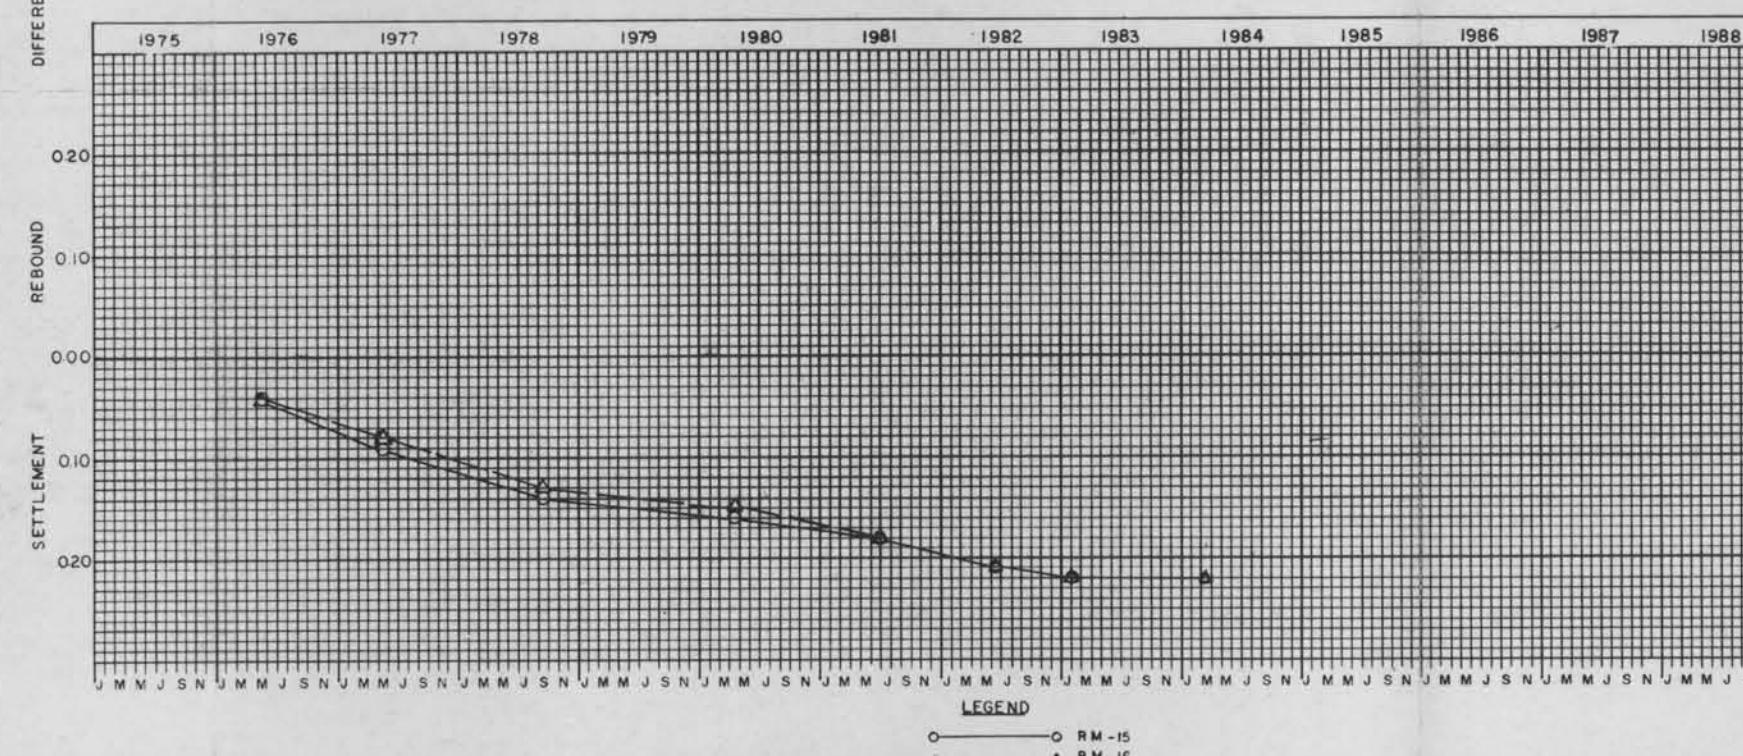
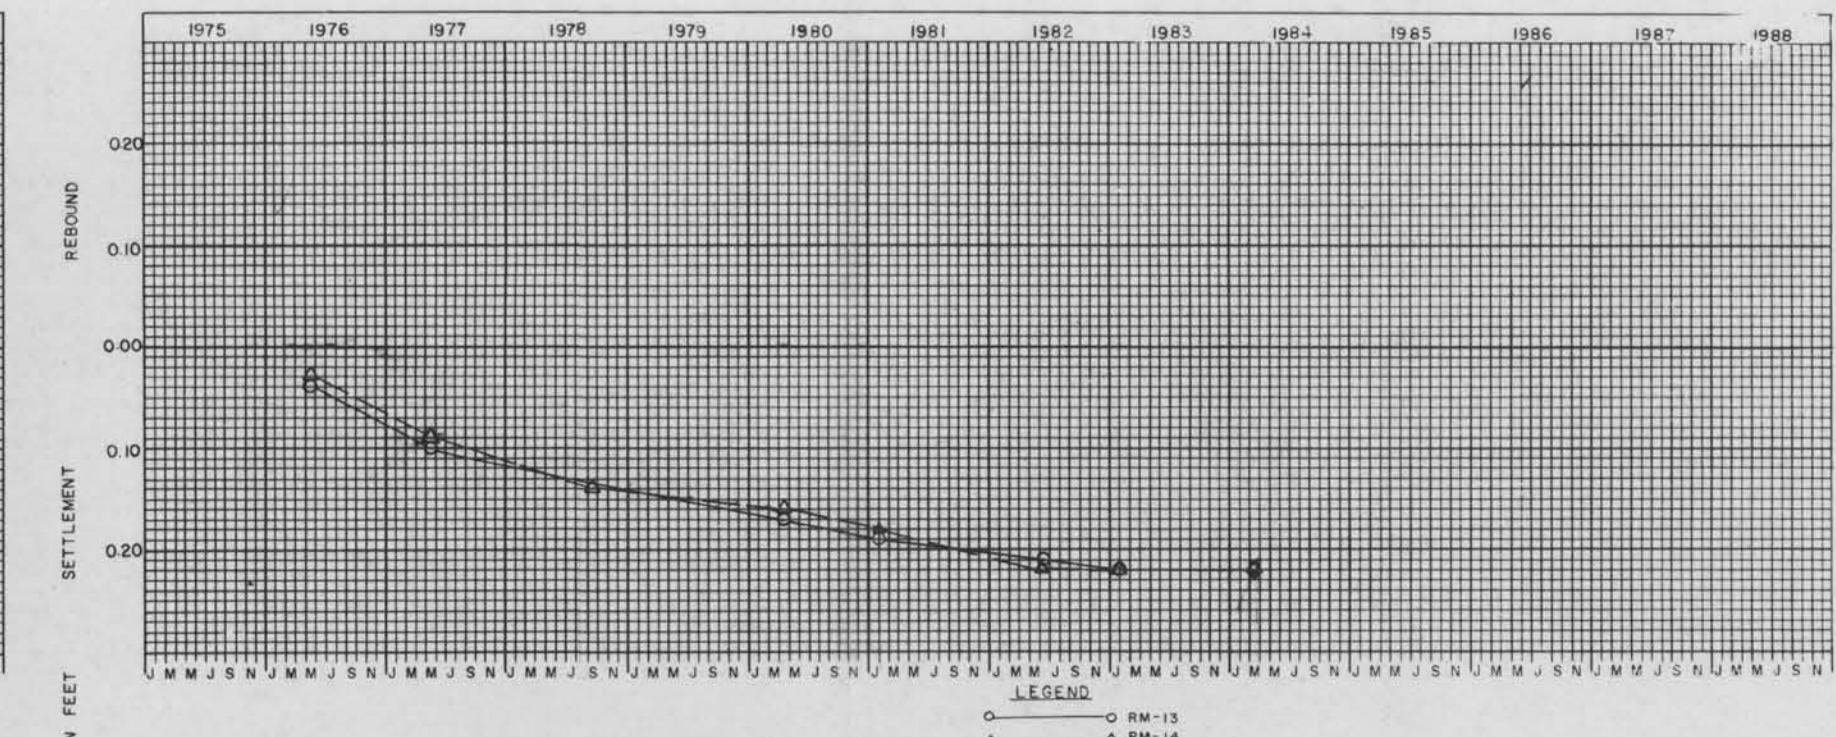
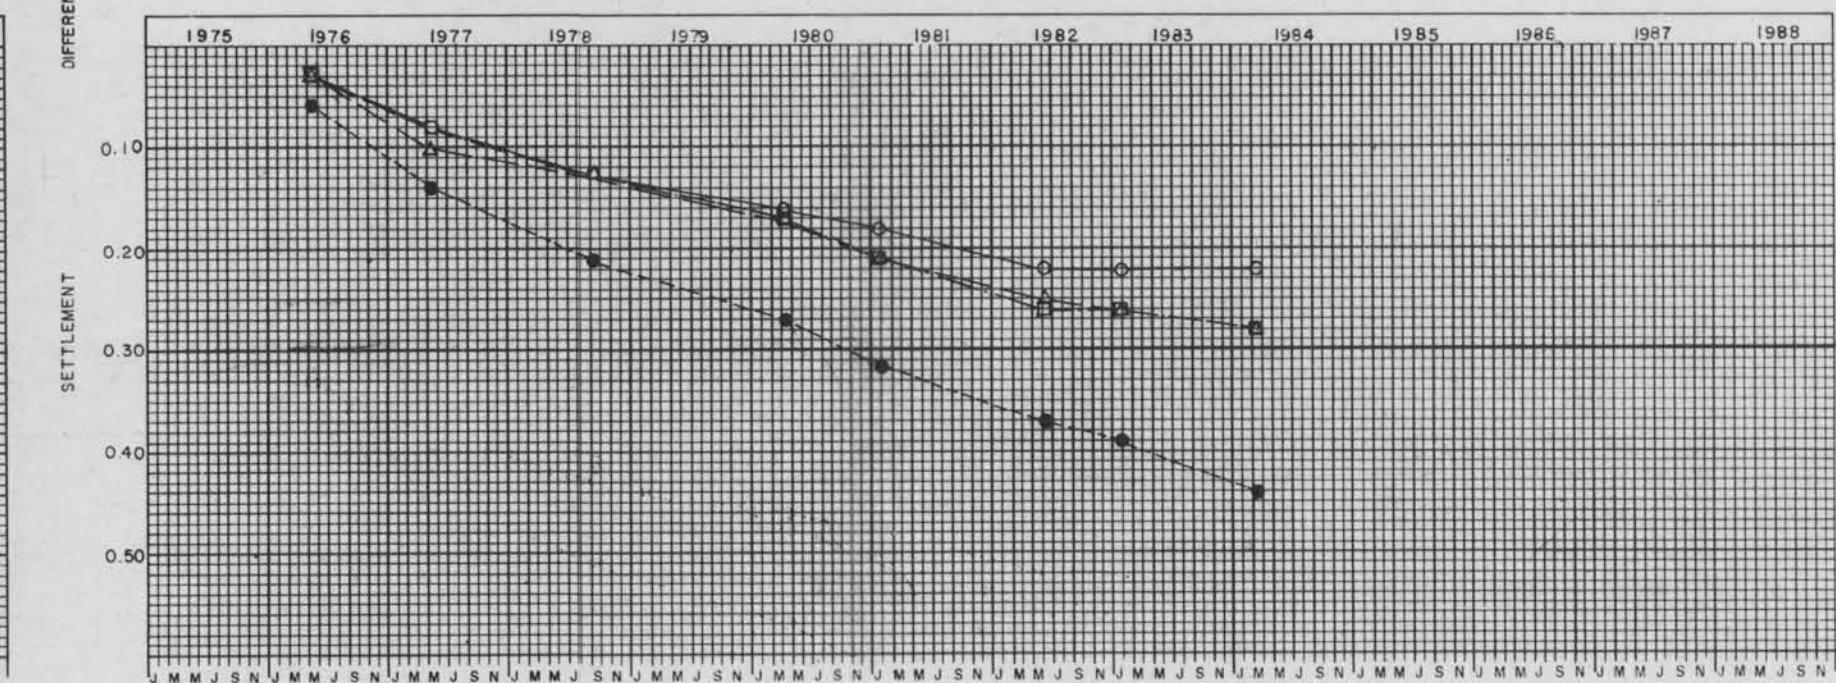
PLATE I-4

\* d. Settlement. Plates I-4 and I-4A indicate rather excessive settlement at reference mark 20 and the steel sheet piling at both ends of the structure. Settlement of the T-walls is essentially complete with the exception of settlement mark 20 which indicates that the east end of the east T-wall is continuing to settle. All settlement reference marks indicate that the levee supporting the sheet piling sections on each end of the structure is undergoing consolidation.

d. Settlement. Plates I-4 and I-4A indicate rather excessive settlement at reference mark 20 and the steel sheet piling at both ends of the structure.

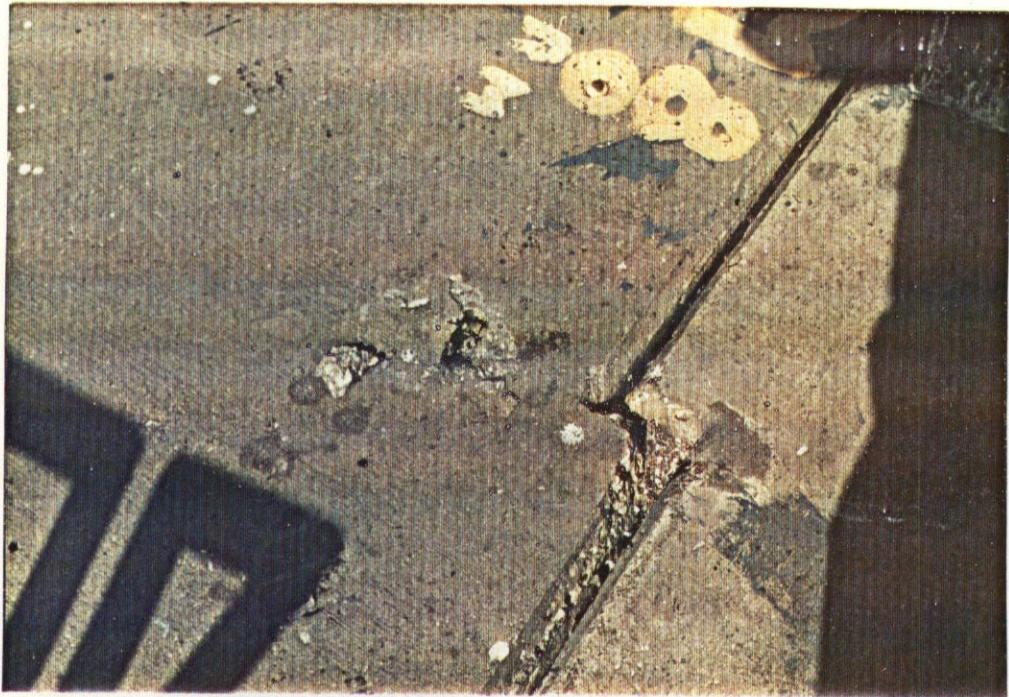
c. Gatebay Monolith. A minor concrete popout was noticed on the top surface of the west side wall (Photo 1). Some handrail post anchors and a safety chain at a bulkhead recess were missing. To avoid further deterioration of the concrete, the spall should be repaired with epoxy concrete. Also, the missing post anchors and chain should be installed to avoid hazardous conditions.

c. Gatebay Monolith. A minor concrete popout was noticed on the top surface of the west side wall (Photo 1). Some handrail post anchors and a safety chain at bulkhead recess were missing. To avoid further deterioration of the concrete, pot hole should be repaired with epoxy concrete. Also, the missing post anchors and chain should be installed to avoid hazardous conditions.

Photo 1: Concrete Popout on Top of West Side Wall

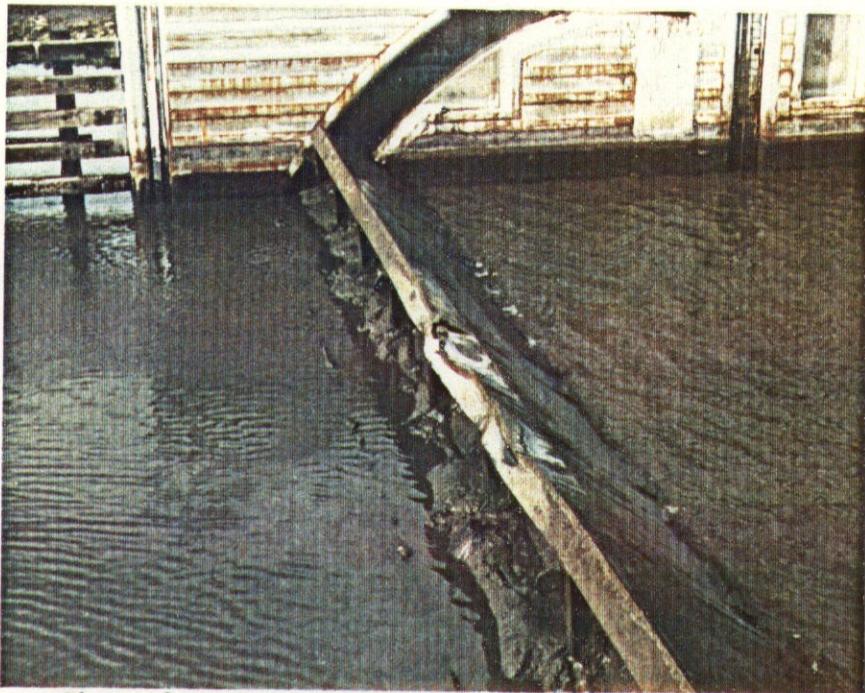
2. The gate seems to be in good condition except for damage to the gate skin plate due to an accidental impact by a vessel (Photo 2). This damage is not effecting the operational condition of the gate.

2. The gate seems to be in good condition except for damage to the gate skin plate due to an accidental hit by a vessel (Photo 2). This damage is not effecting the operational condition of the gate.

Photo 2: Damage to Gate Skin Plate

- a. The gate skin plate will be repaired.
- b. Riprap will be replaced at the breakwater dike on the west bank of the south approach channel.
- c. The staff gage on the guidewall will be repainted.

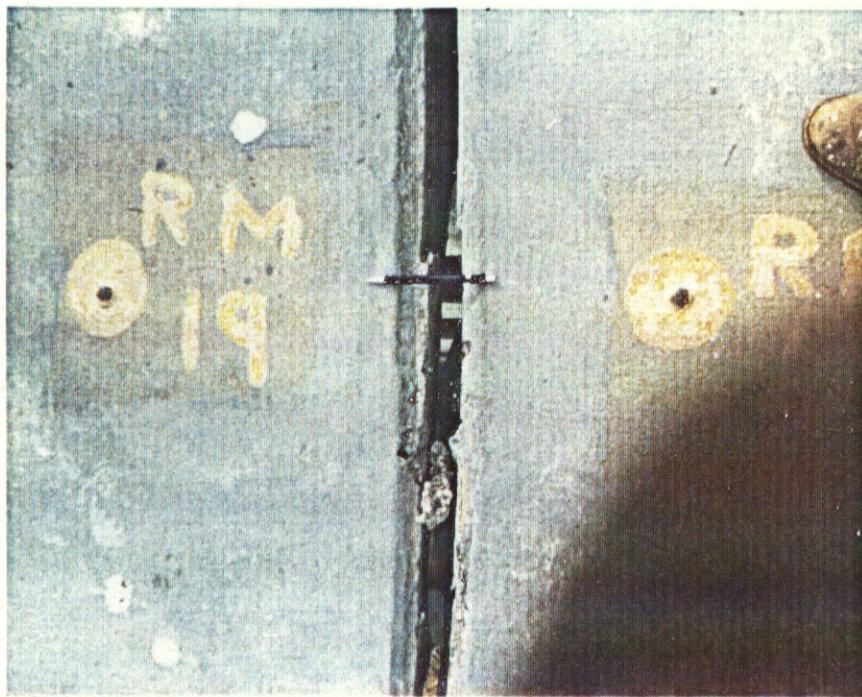
2. Reference mark No. 20 shows excessive settlement at the east edge of the outer T-wall monolith T-4R. It was observed that the joint between monolith T-4R and the adjoining T-3R is widening at the top as can also be seen from the measurements of distance between marks 18 and 19 (Photo 3) presented on Plate I-2. It appears from these observations that monolith T-4R is rotating due to settlement under its outermost edge. Minor cracks were also observed at the top of monolith T-4R, one of which continued down each side of the monolith. It is recommended that monolith T-4R be monitored closely in the future to determine if the rate of settlement of the monolith and its pile foundation will decrease as primary consolidation of the surrounding soils levels off. The waterstop at the joint between monoliths T-4R and T-3R was in good condition. If it becomes ruptured due to increased widening of the joint, this joint will be resealed.\*

3. Reference mark No. 20 shows excessive settlement at the east edge of the outer T-wall monolith T-4R. It was observed that the joint between monolith T-4R and the adjoining T-3R is widening at the top as can also be seen from the measurements of distance between marks 18 and 19 (Photo 3) presented on Plate I-2. It appears from these observations that monolith T-4R is rotating due to settlement under its outermost edge. Minor

cracks were also observed at the top of monolith T-4R, one of which continued down each side of the monolith. It is recommended that close attention be paid to monolith T-4R in the future to determine if the rate of settlement of the monolith and its pile foundation will decrease as primary consolidation of the surrounding soils levels off.

Photo 3: Excessive Gap Between RM 19 and RM **18**

- d. The temperature and shrinkage cracks on the stem and walkway area of the T-wall monolith T-4R will continue to be monitored for signs of activity.
- e. The measurements for RM2-RM3, RM4-RM5, RM18-RM19 and RM20 will be monitored for substantial changes.
- f. Monitoring of the sheet piling will be continued until primary consolidation has leveled off.
- g. Monolith T-4R will be monitored in the future for settlement as primary consolidation of the surrounding soils levels off.
