**US Army Corps
of Engineers**

New Orleans District

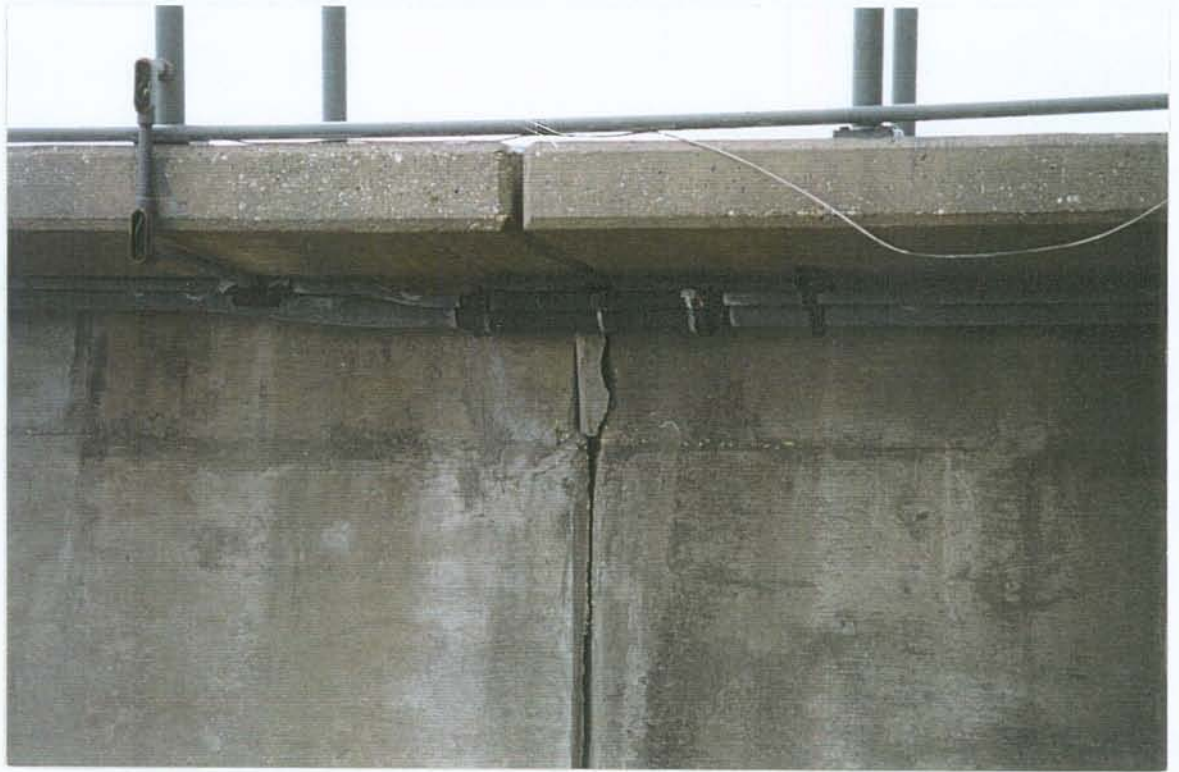
PHOTO NO. 1 – SPALL ON PROTECTED SIDE OF EAST "T" WALL AT JOINT BETWEEN MONOLITHS T-2R AND T-3R.

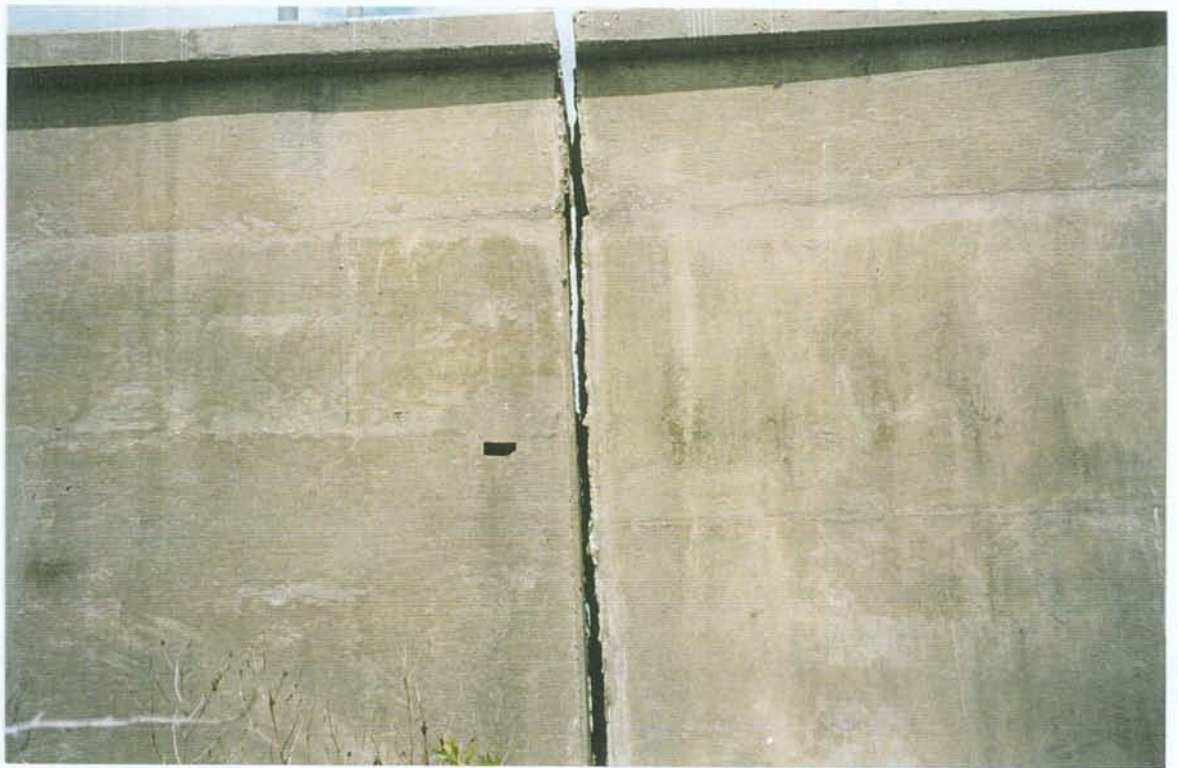
PHOTO NO. 2 – FLOODSIDE VIEW OF WEST "T" WALL AT JOINT BETWEEN MONOLITHS T-3L AND T-4L. NOTE OPEN JOINT AND TORN WATER STOP.

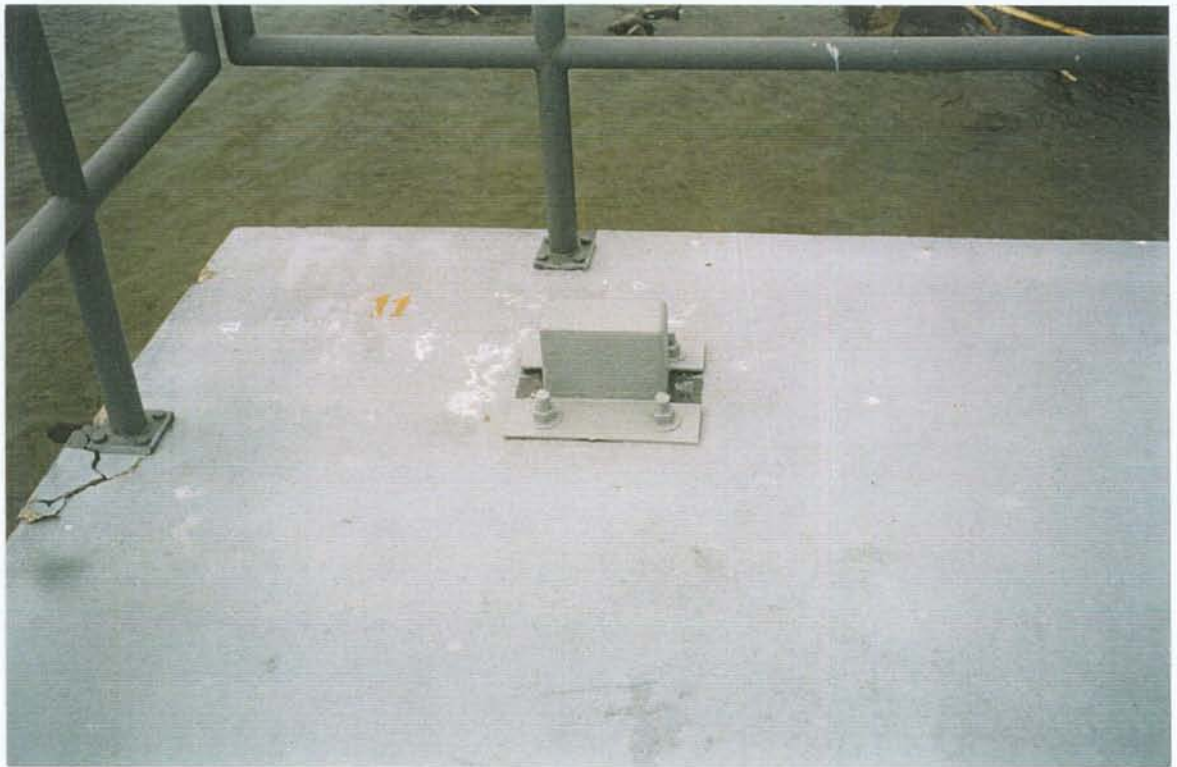
PHOTO NO. 3 – SPALL ON GATE BAY DECK AT HANDRAIL ANCHORAGE. NOTE COVER OVER OUTLET FOR LIGHT POLE THAT HAS BEEN RELOCATED.

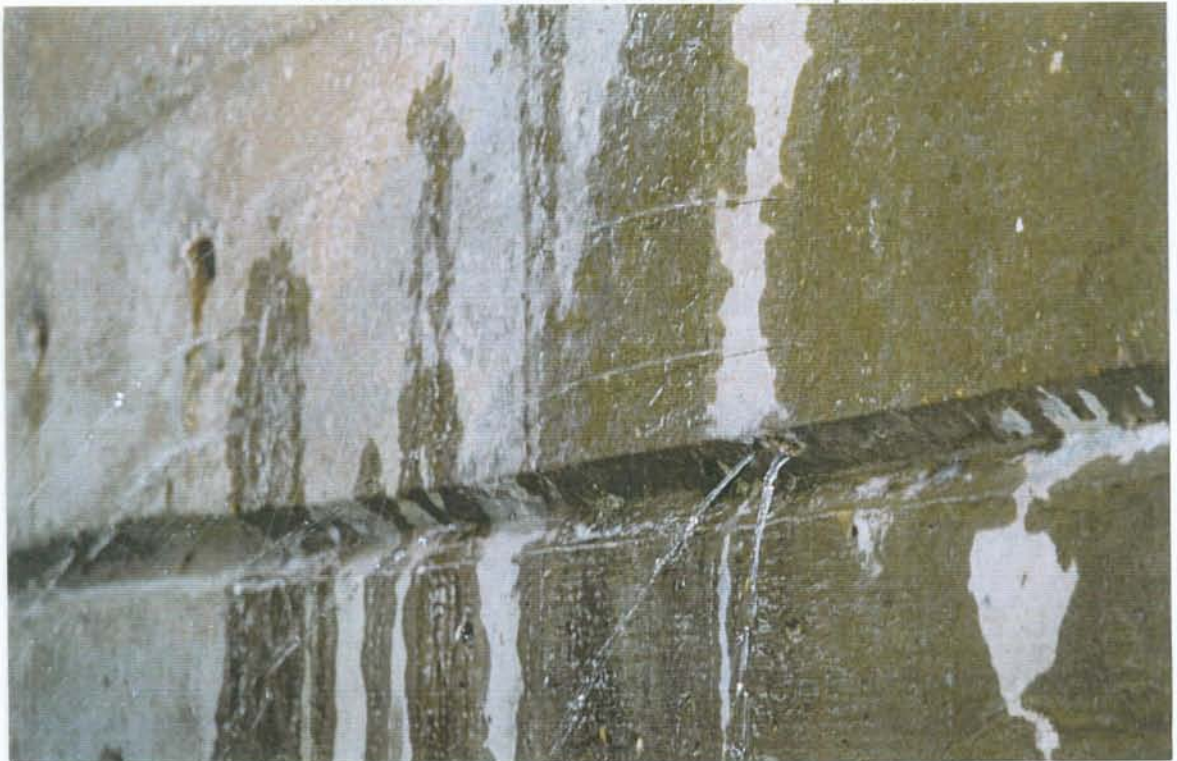
PHOTO NO. 4 – PROTECTED SIDE (NORTH FACE) OF EAST GATE BAY WALL OPPOSITE COUNTERWEIGHT RECESS WITH WATER SQUIRTING OUT.

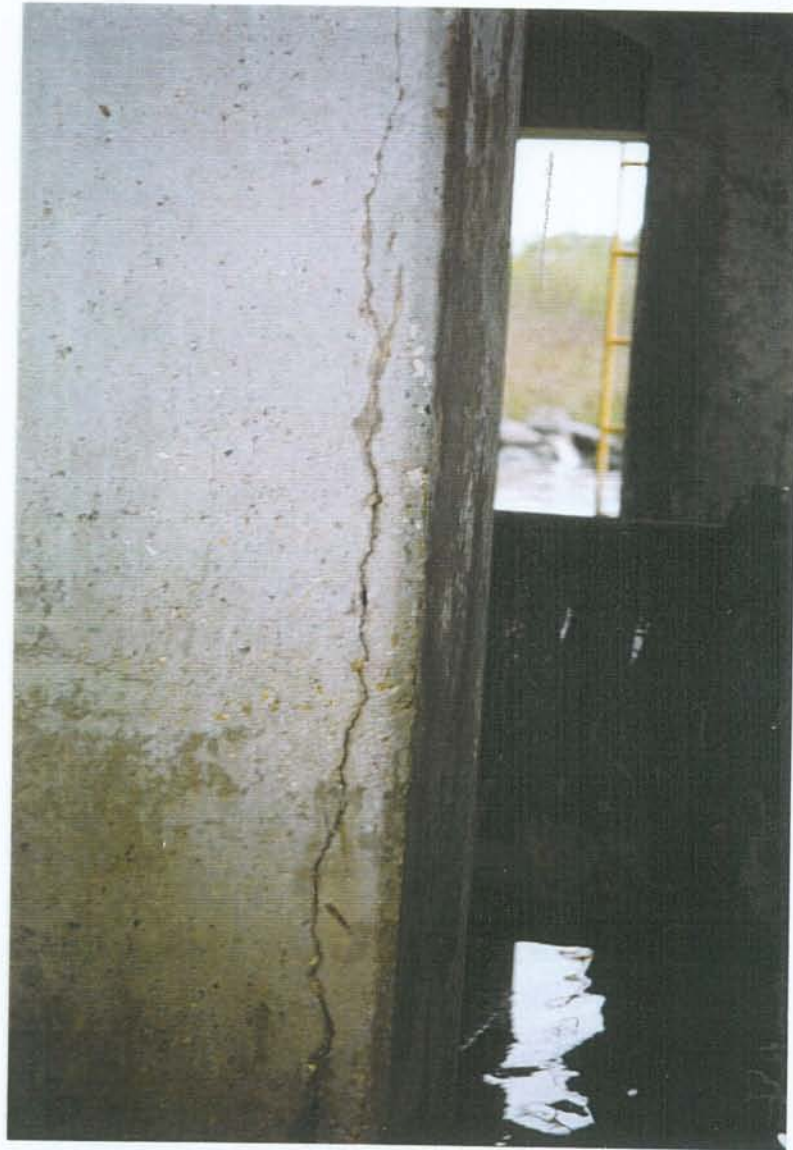
PHOTO NO. 7- LOOKING ENE AT CRACK IN WEST FACE OF PUMP
PLATFORM PILE NO. 3.

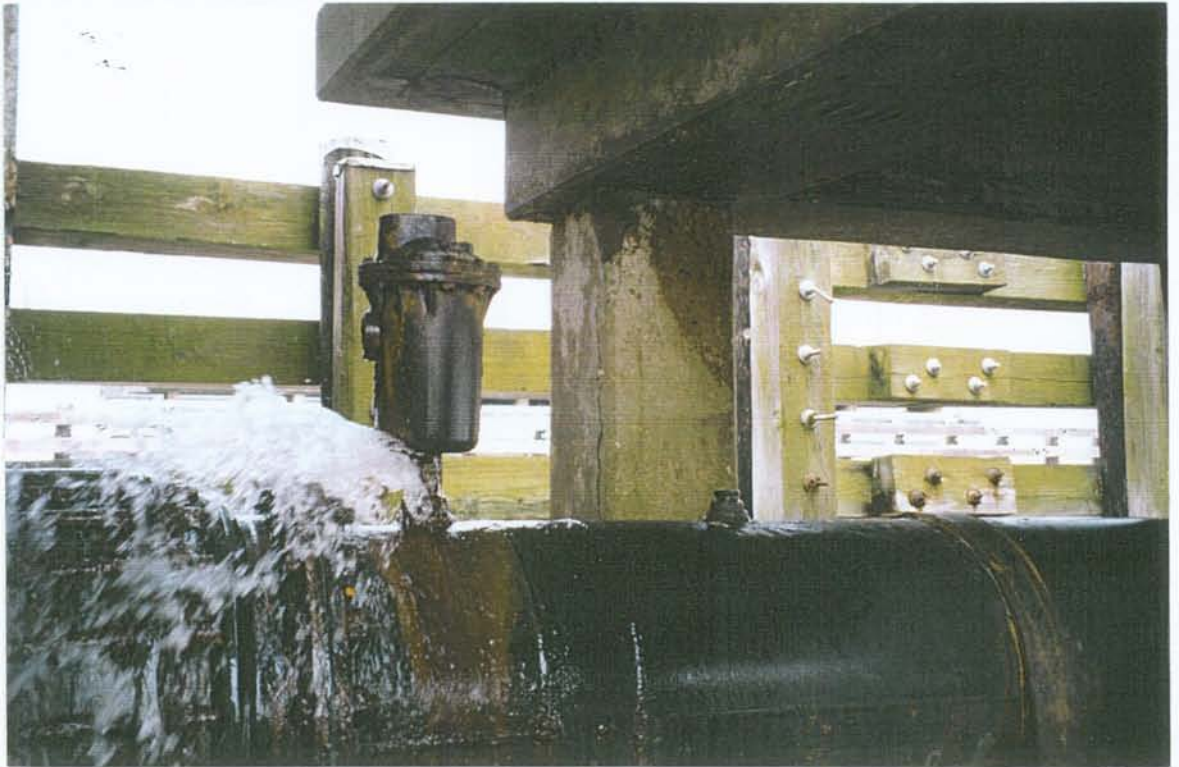
PHOTO NO. 8 – LOOKING WNW AT CRACKS IN SOUTH AND EAST
 FACES OF PUMP PLATFORM PILE NO. 3.

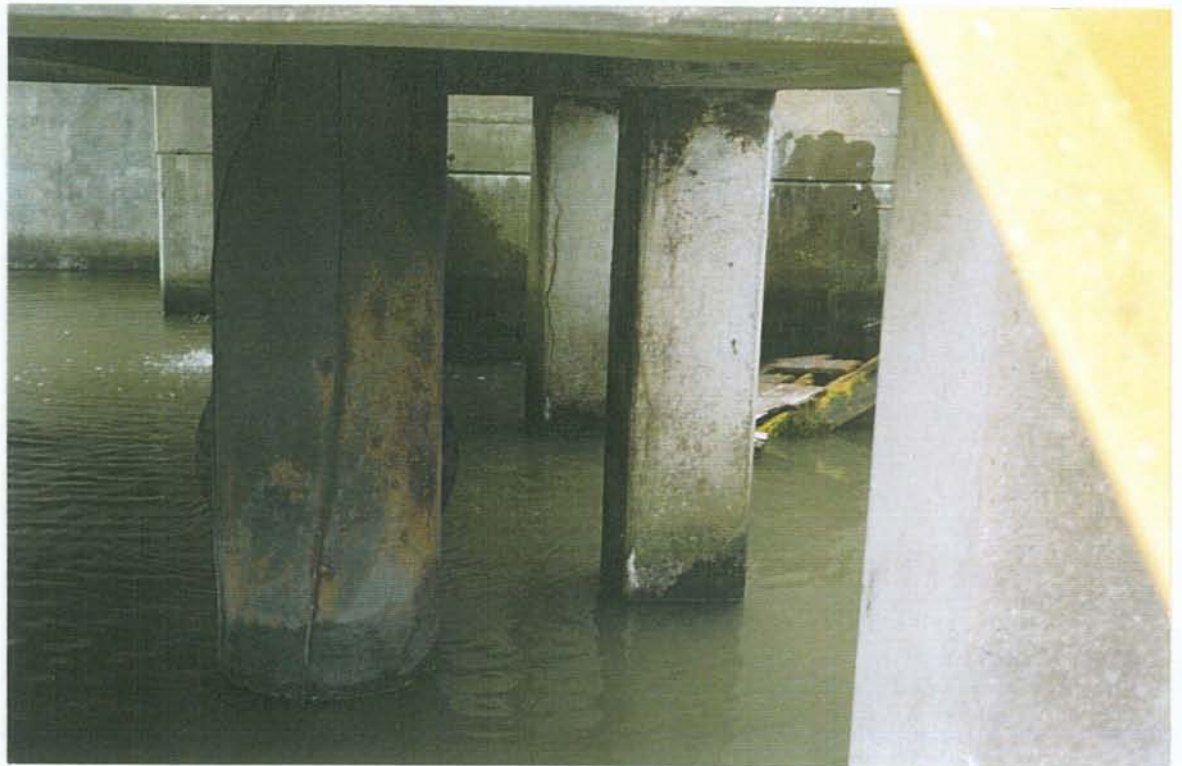
PHOTO NO. 9 – LOOKING SOUTH AT CRACKS IN NORTH FACES OF
 PUMP PLATFORM PILE NOS. 3 (BACKGROUND) AND
 5 (FOREGROUND)

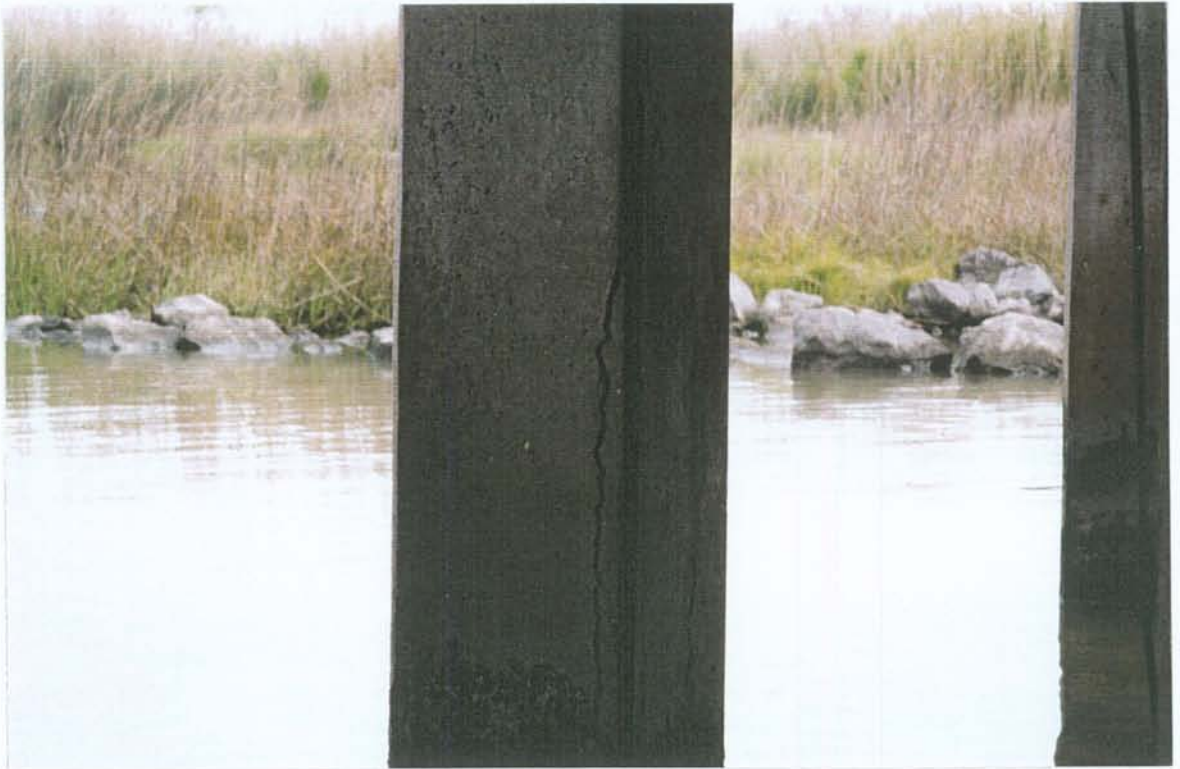
PHOTO NO. 10 – LOOKING ESE AT CRACK IN NORTH FACE OF PUMP PLATFORM PILE NO. 2.

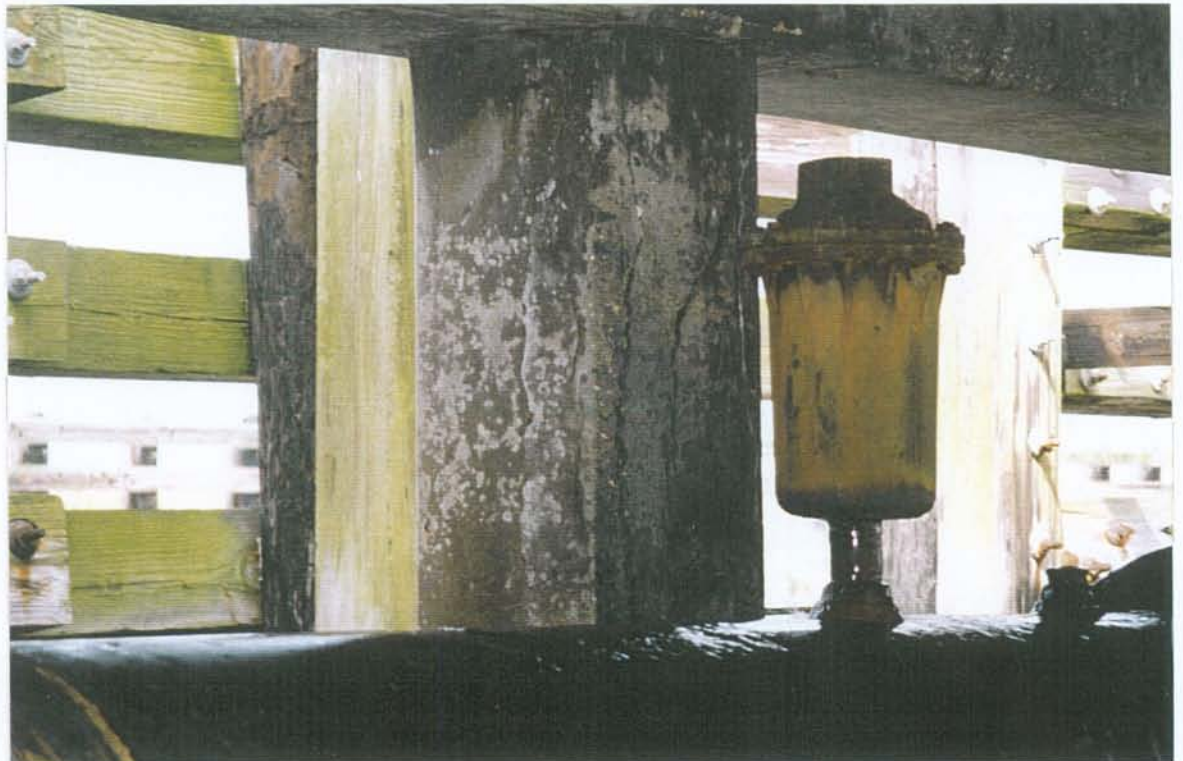
PHOTO NO. 11 – LOOKING NW AT CRACKS IN SOUTH AND EAST FACES OF PUMP PLATFORM PILE NO. 5.

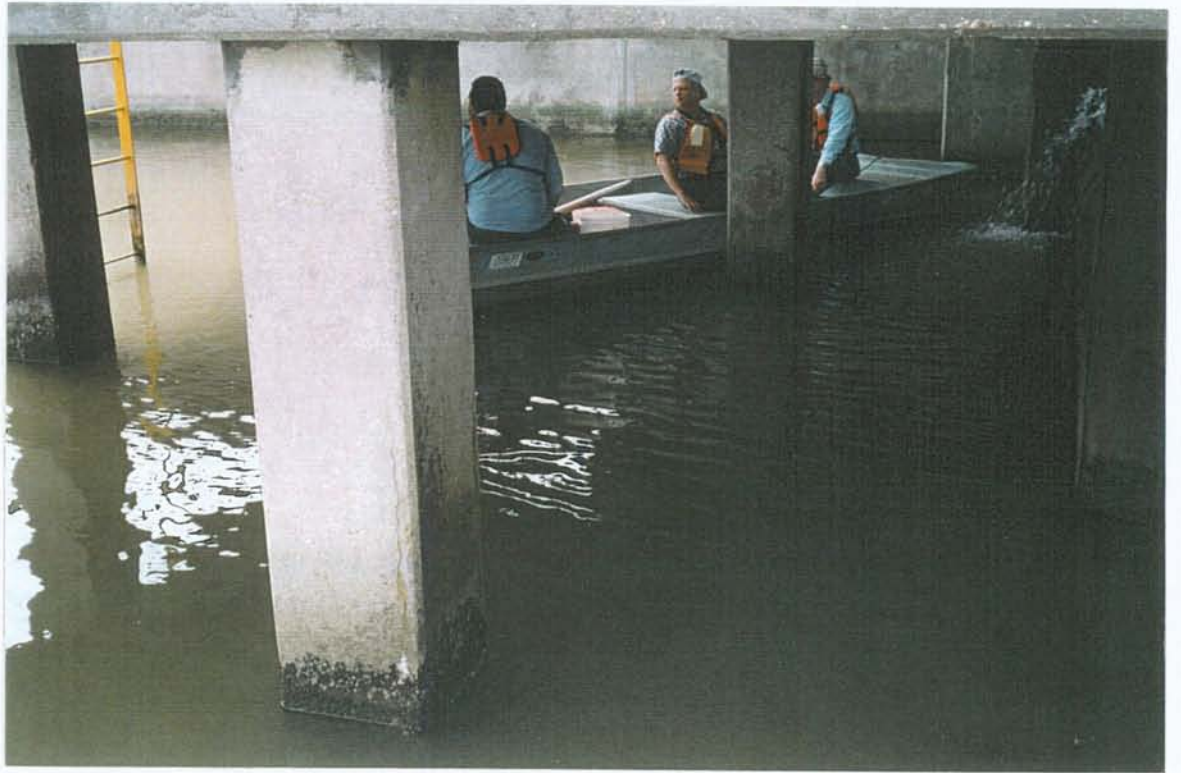
PHOTO NO. 12 – LOOKING SE AT CRACK IN NORTH FACE OF PUMP
 PLATFORM PILE NO 7.

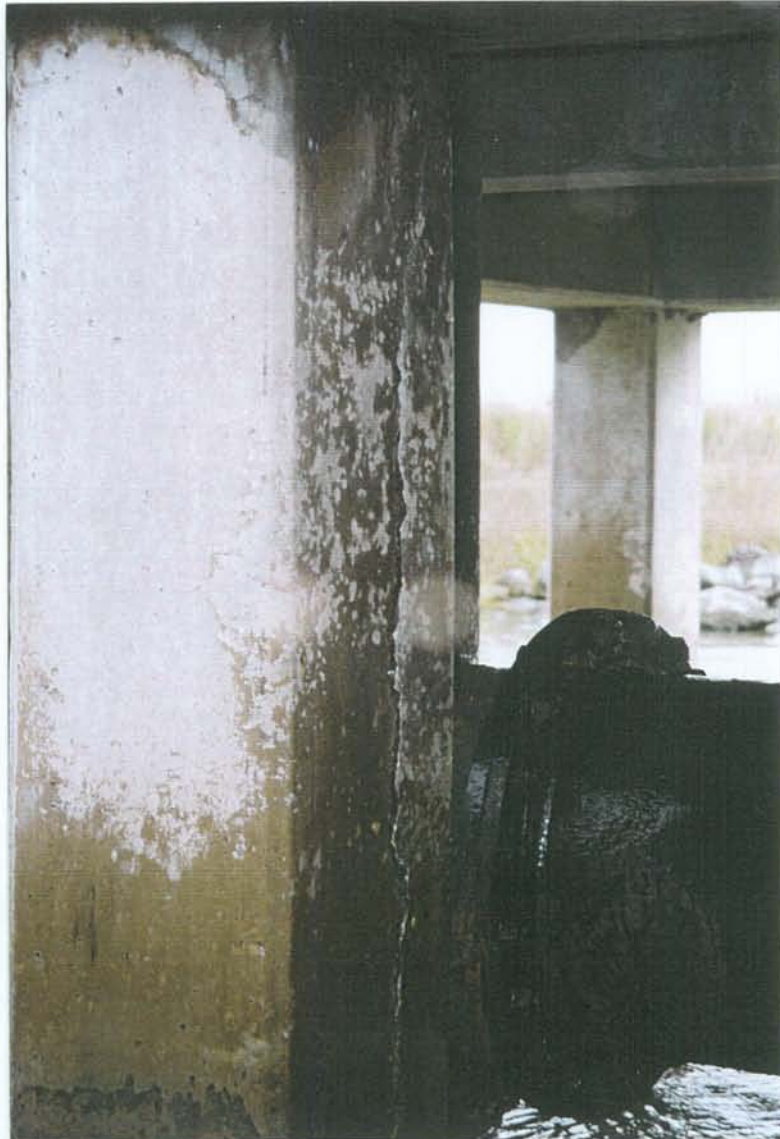
PHOTO NO. 13 – LOOKING ENE AT CRACK IN SOUTH FACE OF PUMP
PLATFORM PILE NO. 5.

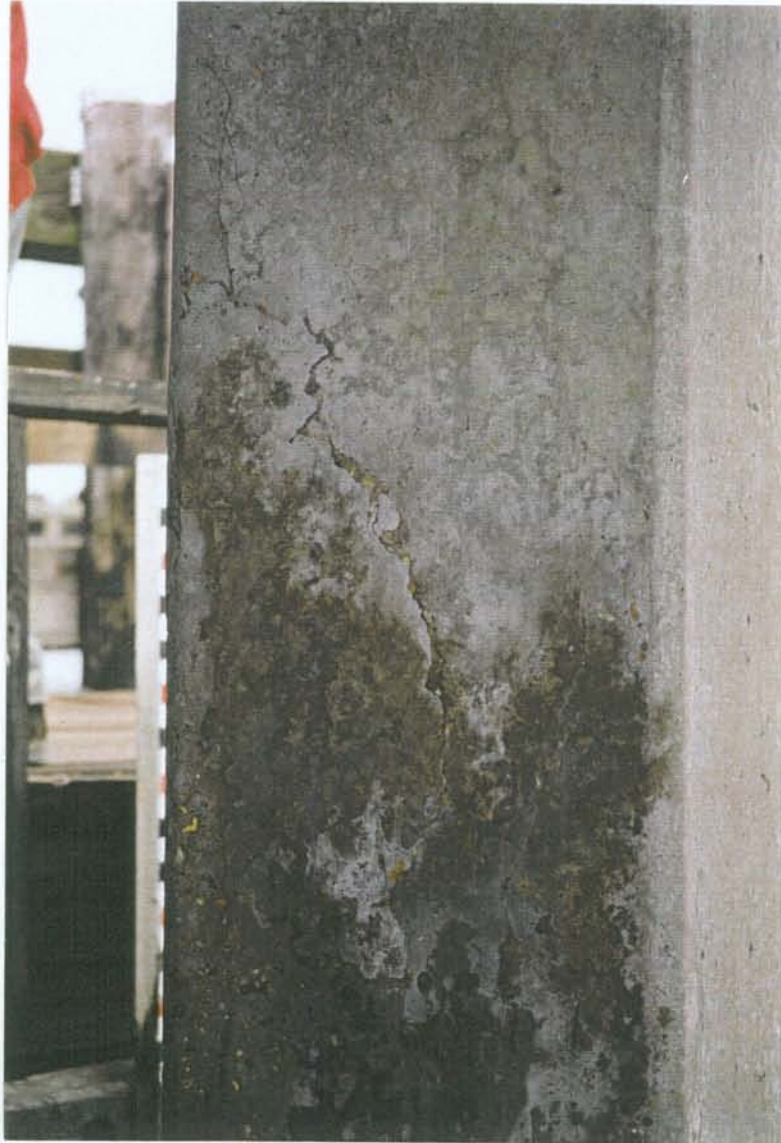
PHOTO NO. 14 – LOOKING NNW AT CRACK IN SOUTH FACE OF PUMP
PLATFORM PILE NO. 7.

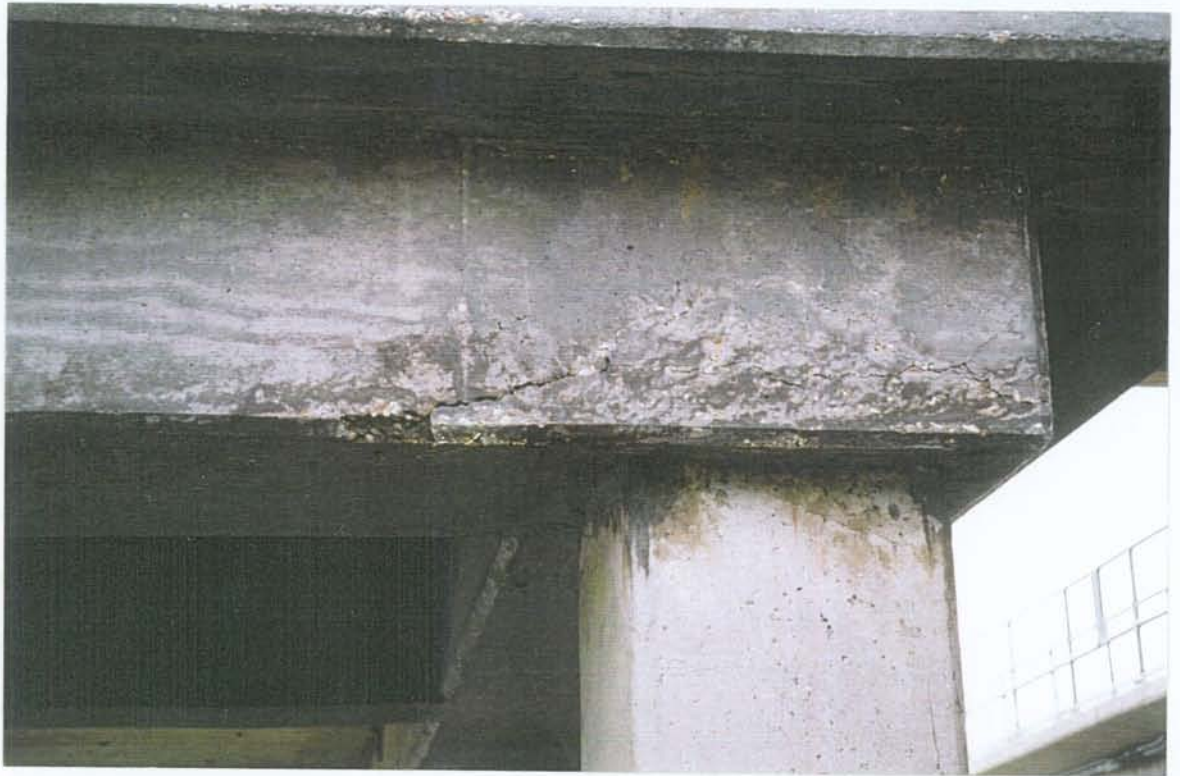
PHOTO NO. 15 – CRACK IN WEST FACE OF UPPER DECK PERIMETER SUPPORT BEAM AT SOUTH WEST CORNER OF PUMP PLATFORM.

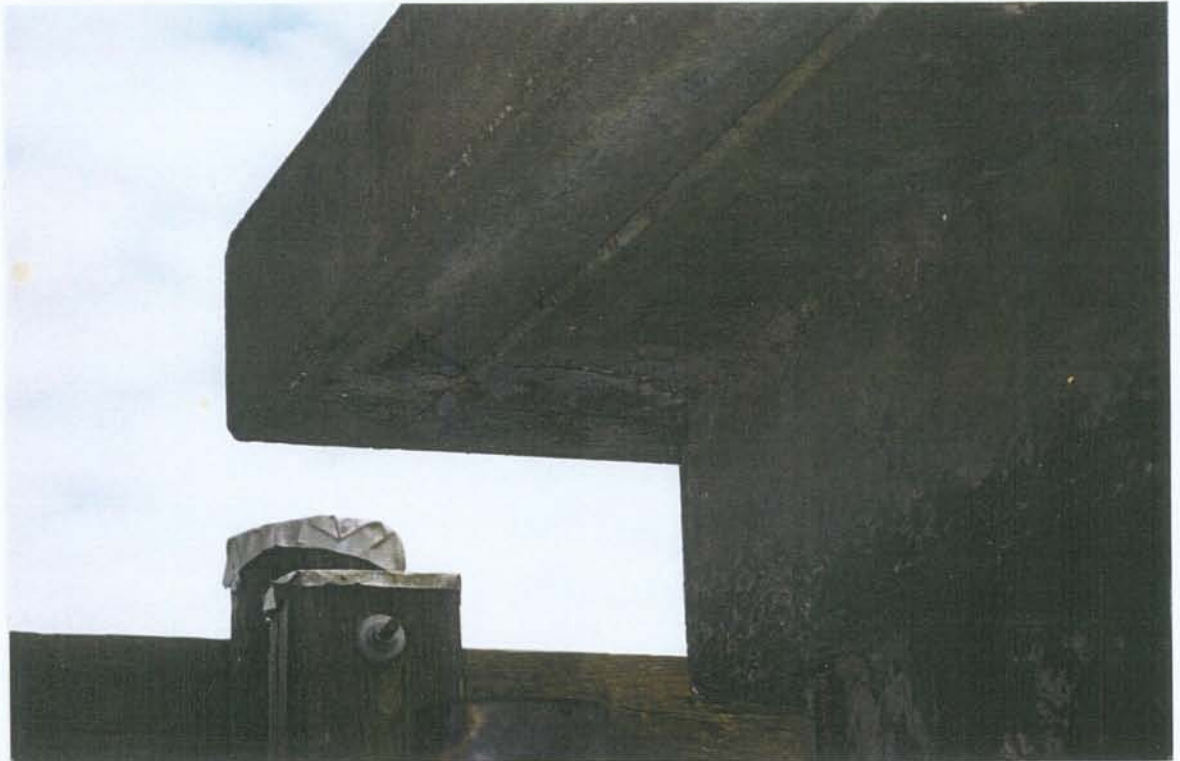
PHOTO NO. 16 – CRACK IN BOTTOM OF PUMP PLATFORM DECK AT SOUTHWEST CORNER.

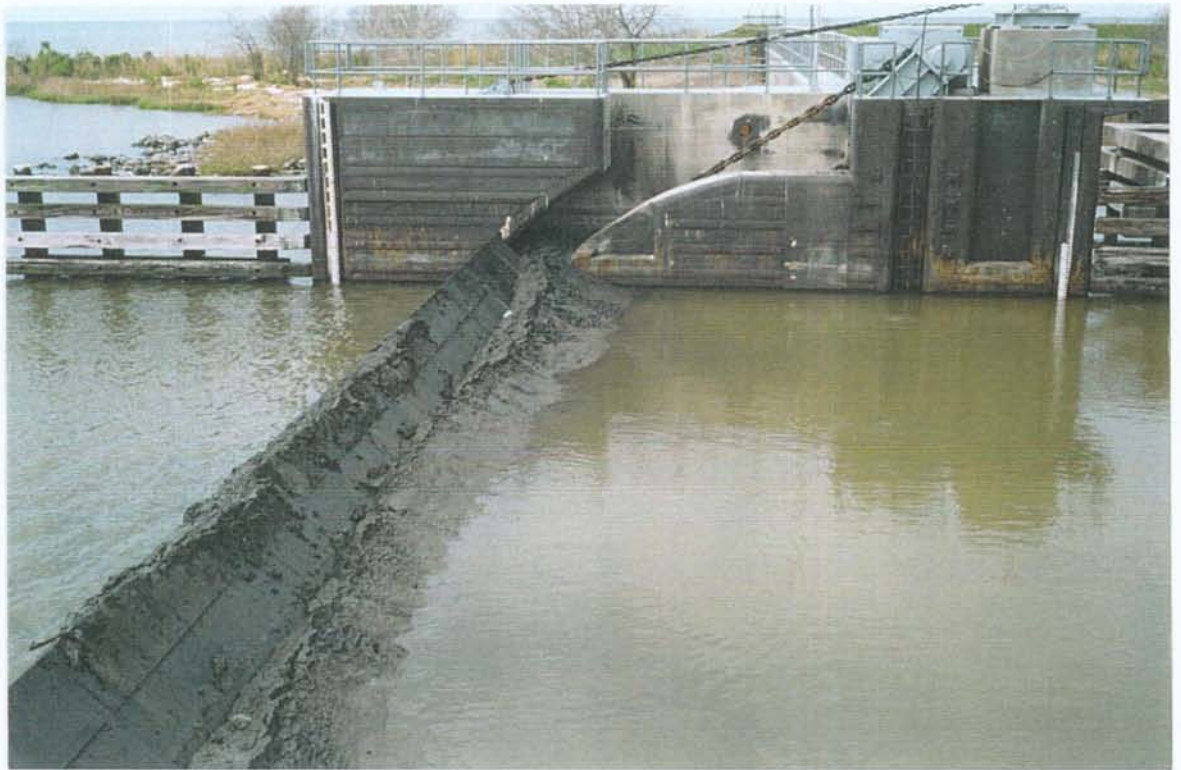
PHOTO NO. 17 – LOOKING WEST AT CHAMBER FACE OF WEST GATE BAY WALL. NOTE CORROSION ON EMBEDDED METAL AT SPLASH ZONE.

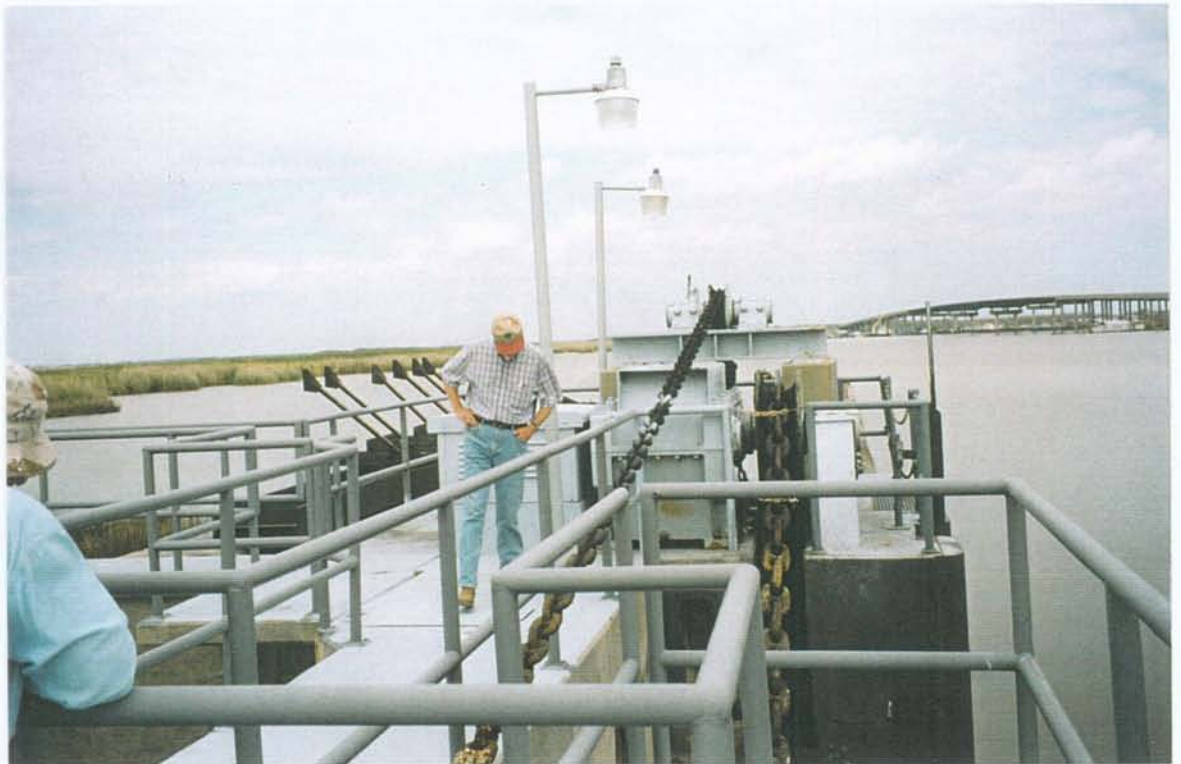
PHOTO NO. 18 – LOOKING NORTH ALONG TOP OF WEST SIDE GATE BAY WALL. NOTE GOOD CONDITION OF PAINT ON HANDRAILS.

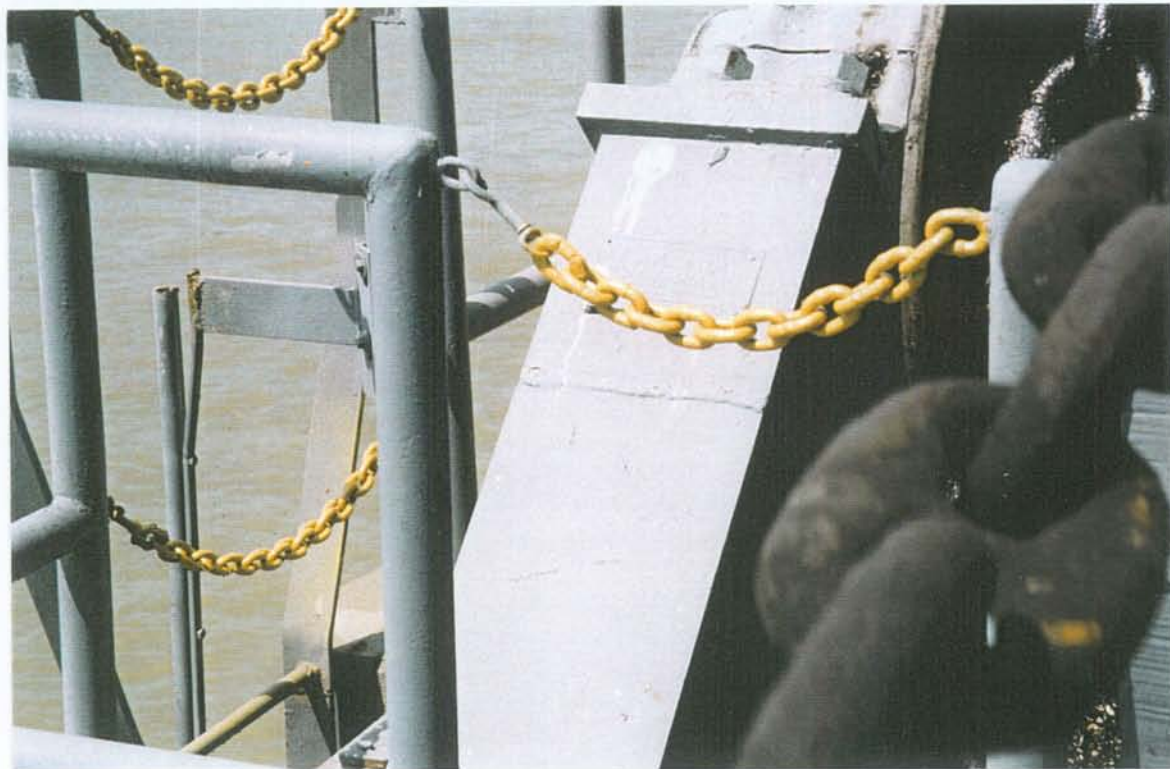
PHOTO NO. 19 – VIEWS OF SAFETY CHAINS ACROSS HANDRAIL OPENINGS. SAFETY CHAINS PAINTED AND IN GOOD CONDITION.

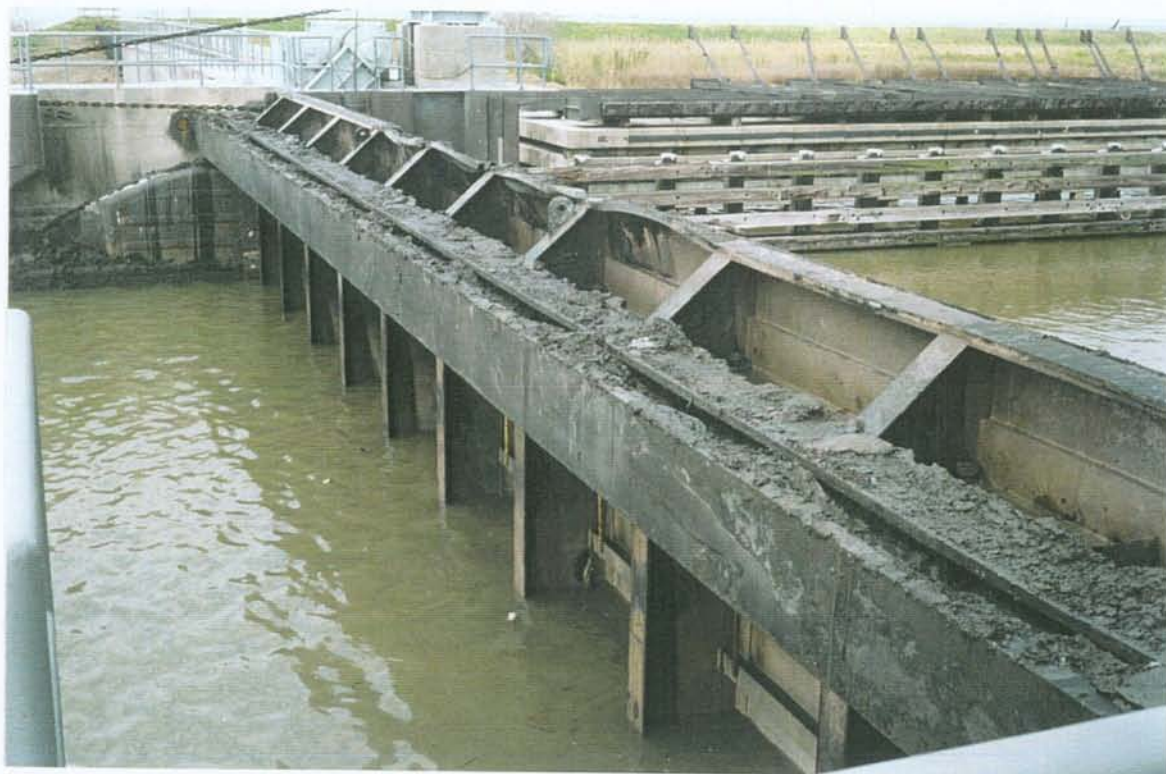
PHOTO NO. 20 – GATE IN FULLY CLOSED POSITION. PAINT SYSTEM IN GOOD CONDITION. NOTE DAMAGE ALONG TOP OF GATE. DAMAGE APPEARS TO BE SAME AS NOTED AT LAST INSPECTION.

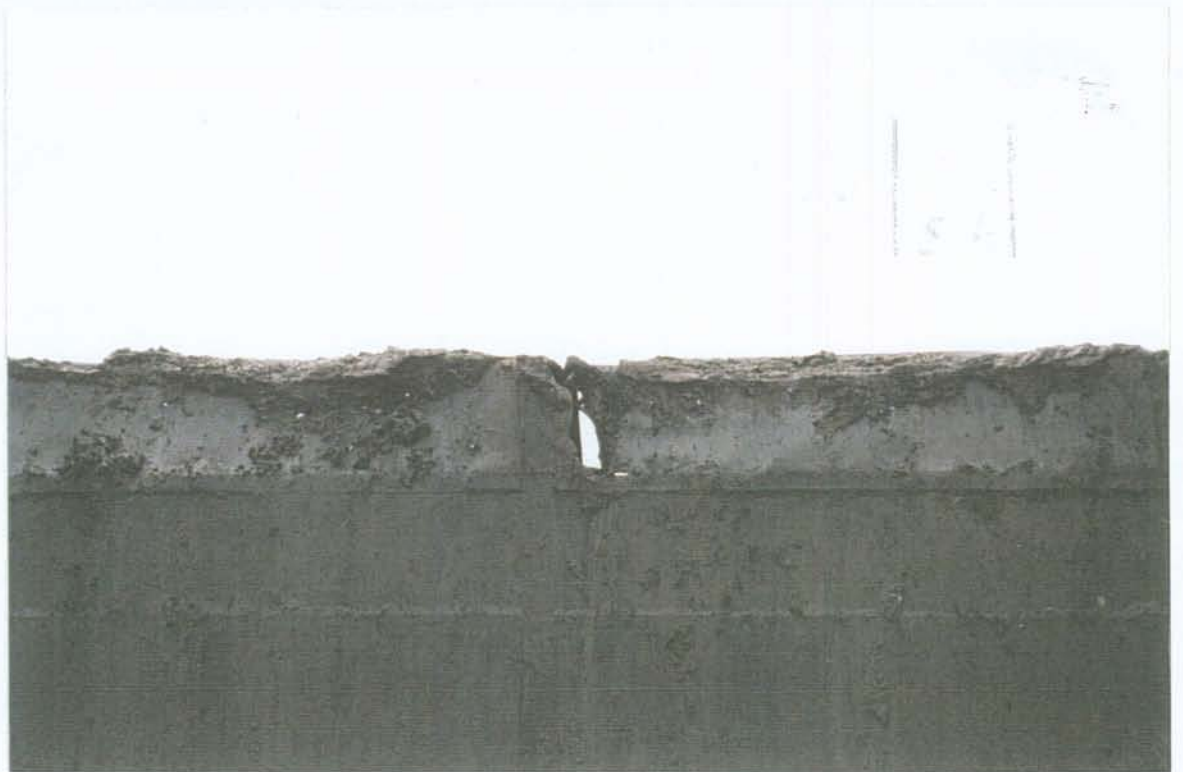
PHOTO NO. 21 - SKINPLATE SIDE OF GATE IN FULLY CLOSED POSITION. PAINT SYSTEM IN GOOD CONDITION. NOTE DAMAGE ON TOP OF GATE.

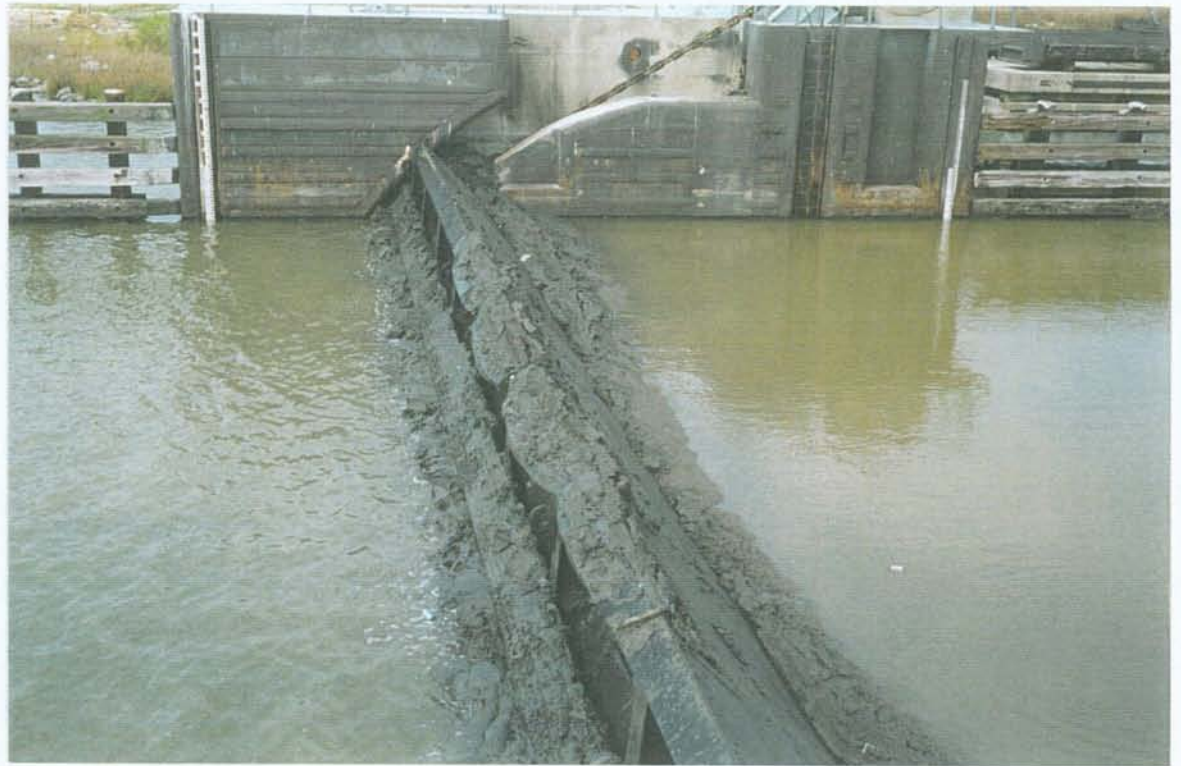
PHOTO NO. 22 - GATE BEING CLOSED (RAISED). NOTE SILT SLIDING OFF.

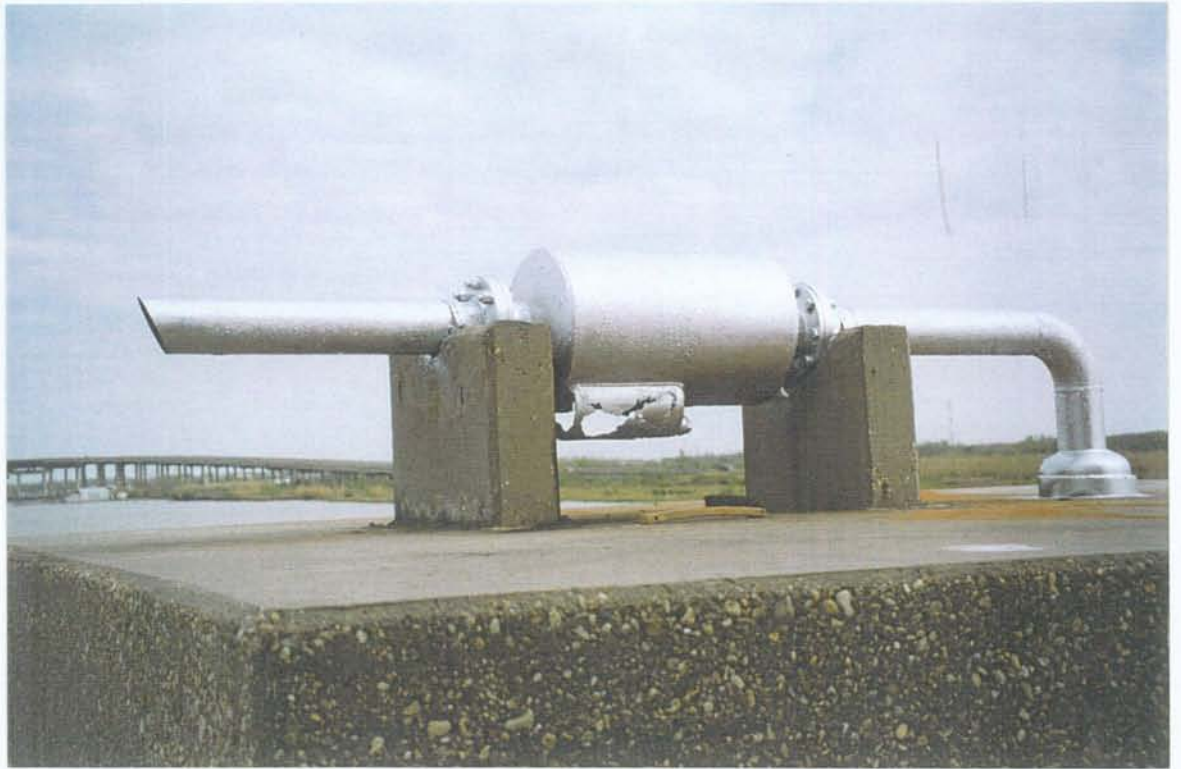
PHOTO NO. 29 – PUMP ENGINE MUFFLER ON TOP OF PUMP HOUSE. MUFFLER BADLY CORRODED ON BOTTOM AND LEAKING EXHAUST.

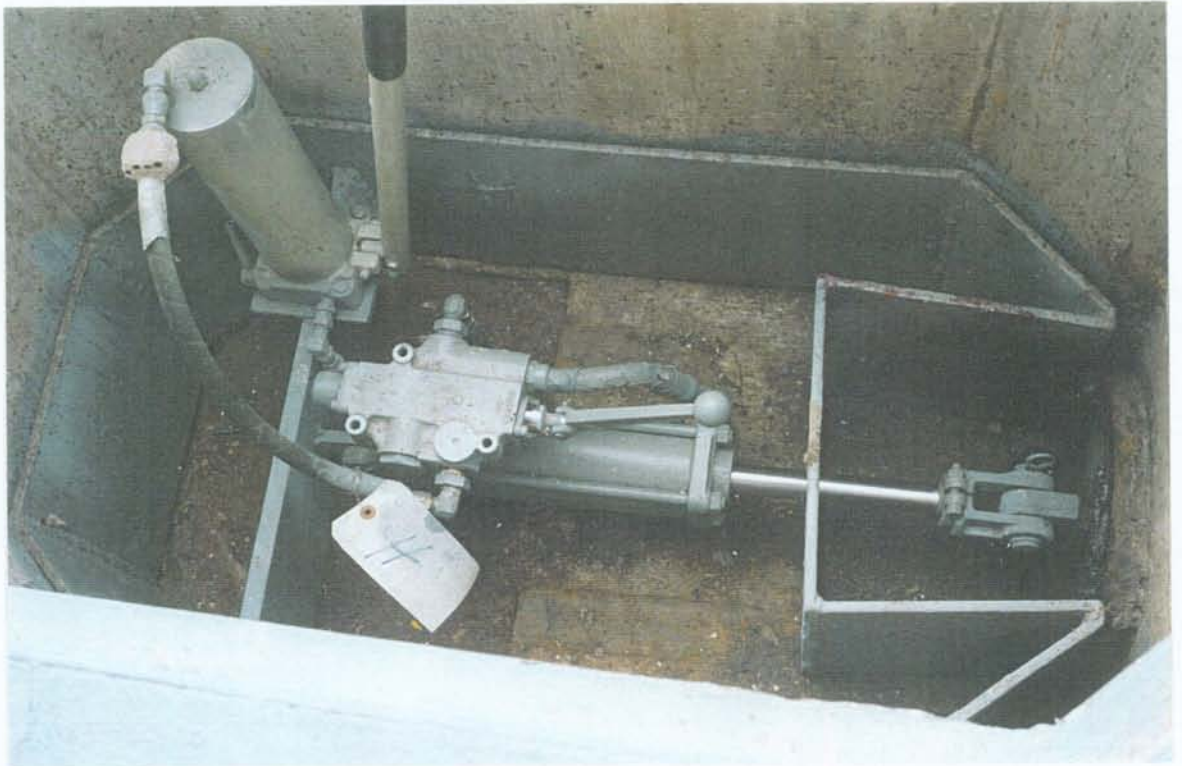
PHOTO NO. 30 – MANUALLY OPERATED GATE LATCHING MECHANISM.

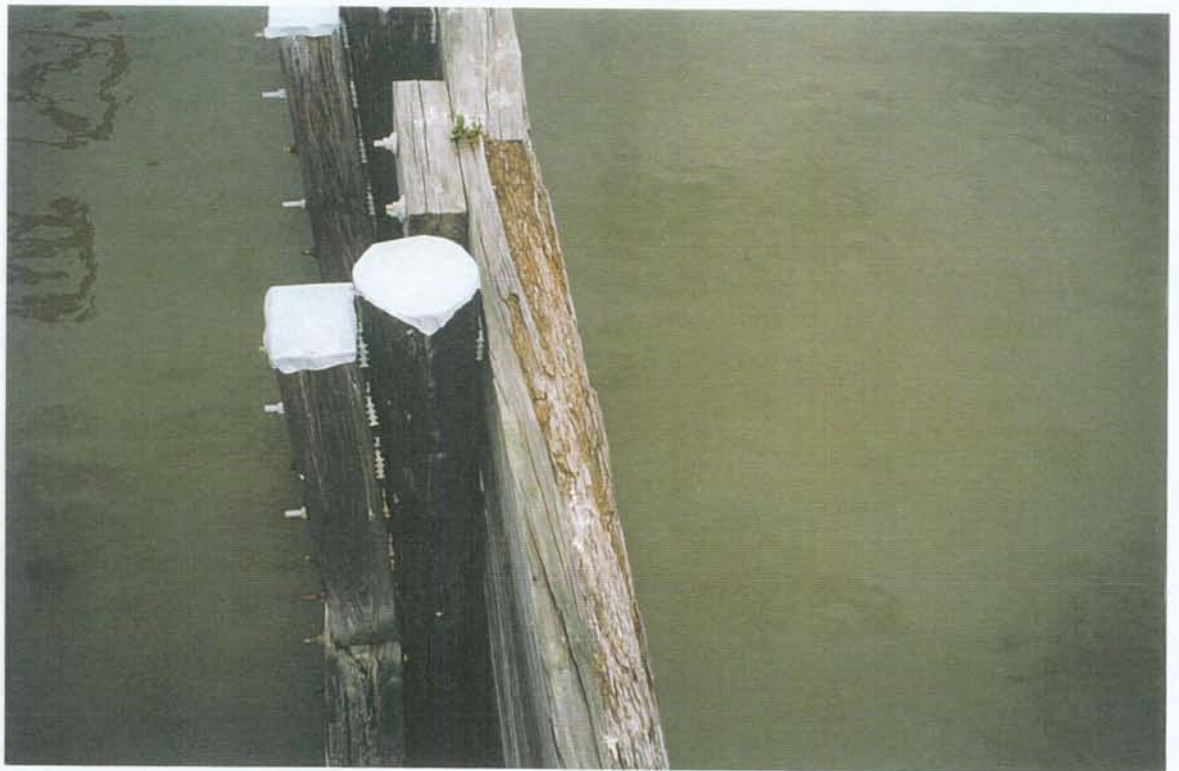
PHOTO NO. 34 – BADLY DETERIORATED TOP FENDER TIMBER ON NORTHWEST GUIDEWALL.

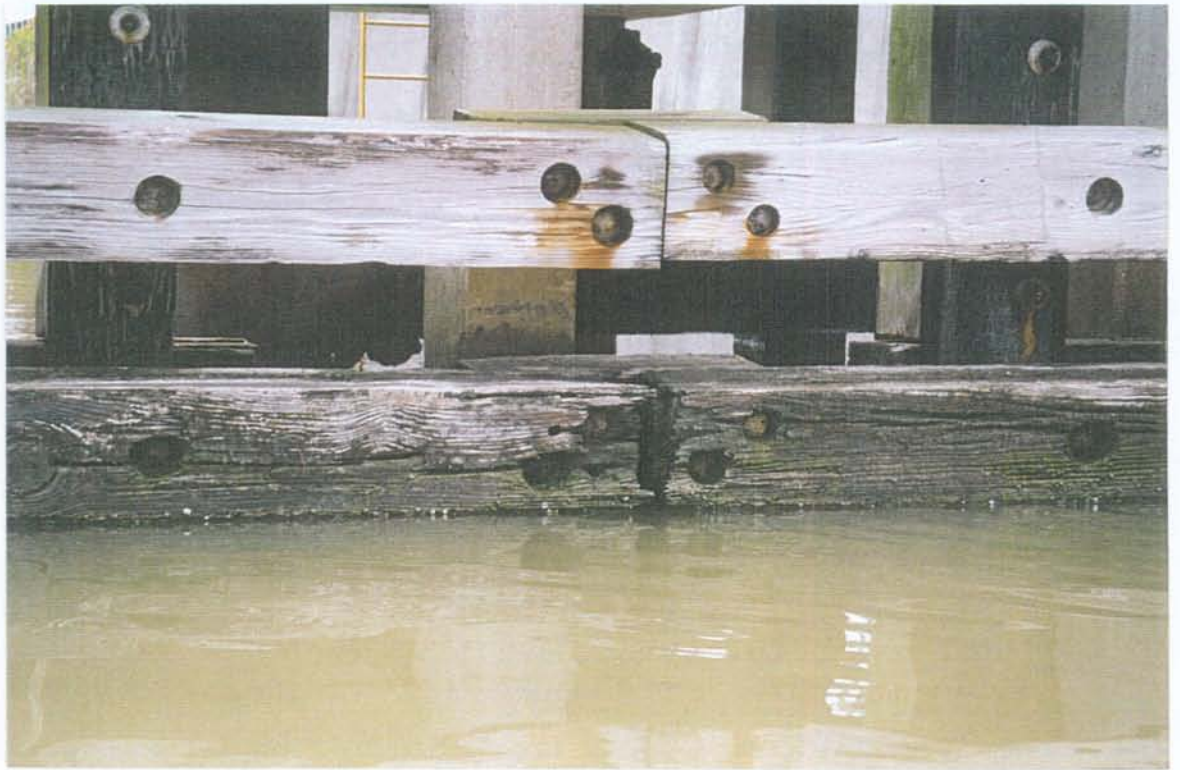
PHOTO NO. 35 – DETERIORATED FENDER TIMBER AT SPLASH ZONE.

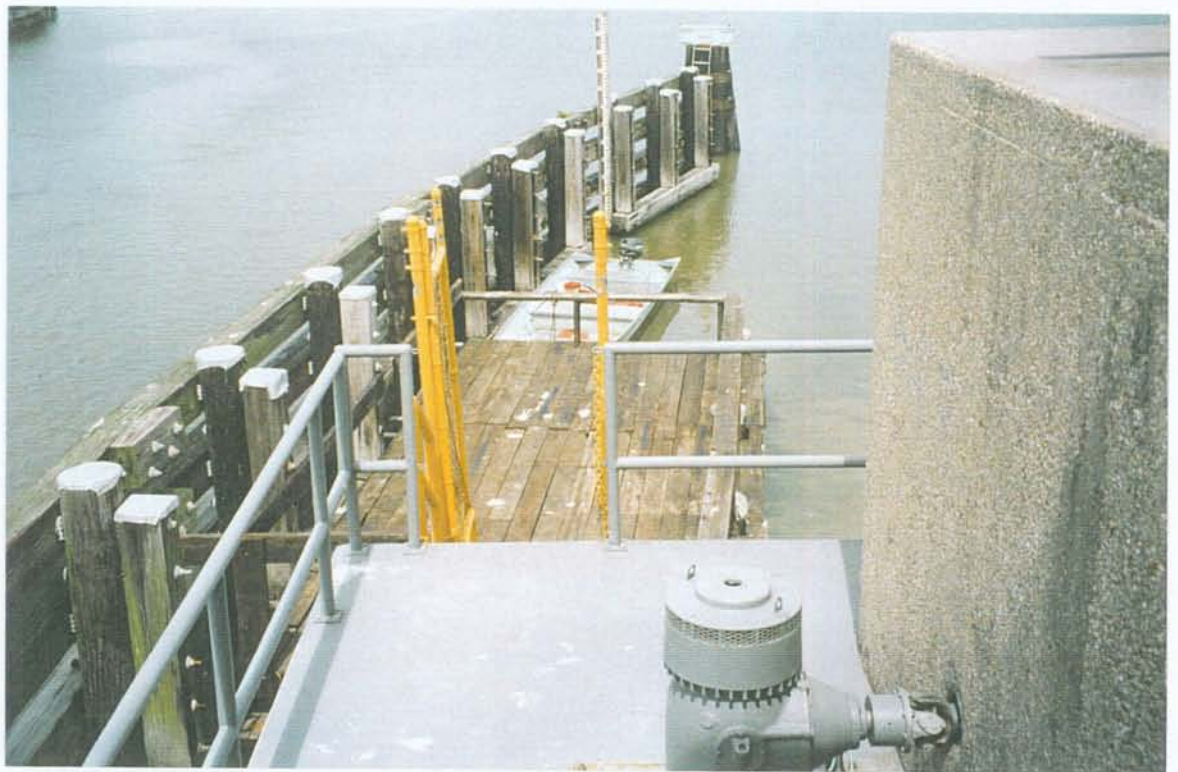
PHOTO NO. 36 – NEW BOAT DOCK DECK.
