**US Army Corps
of Engineers**

New Orleans District

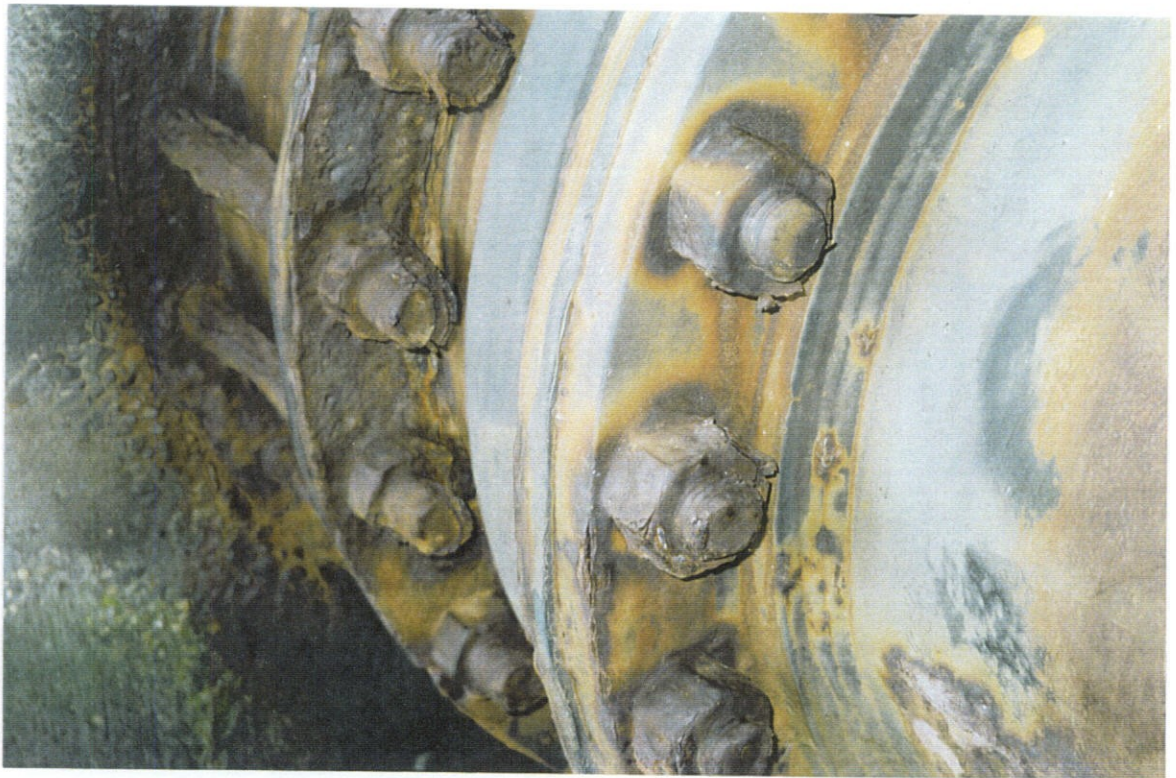
PHOTO NO. 44 - VIEW OF BADLY CORRODED ATTACHMENT RING AND ATTACHMENT BOLTS AND NUTS FOR 24-INCH CHECK VALVE AND EXPANSION COUPLING.

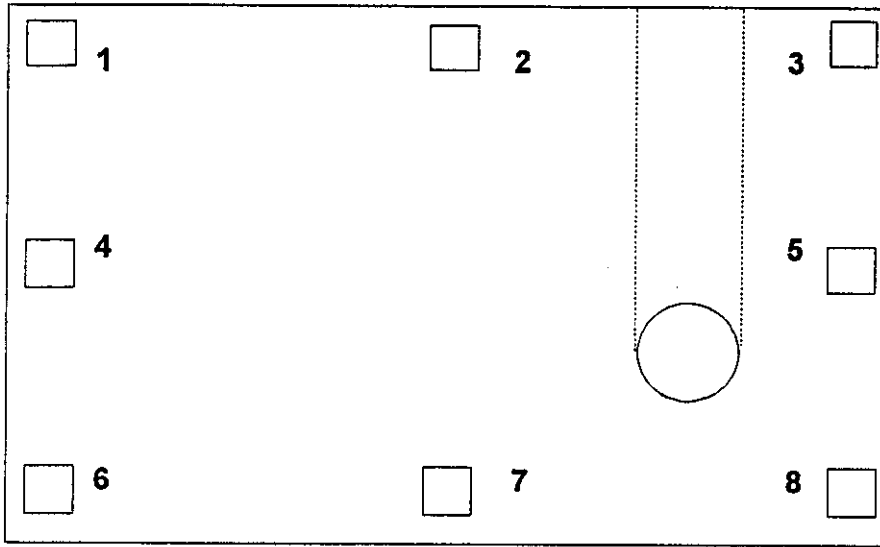
PUMP PLATFORM - PILE NUMBERS

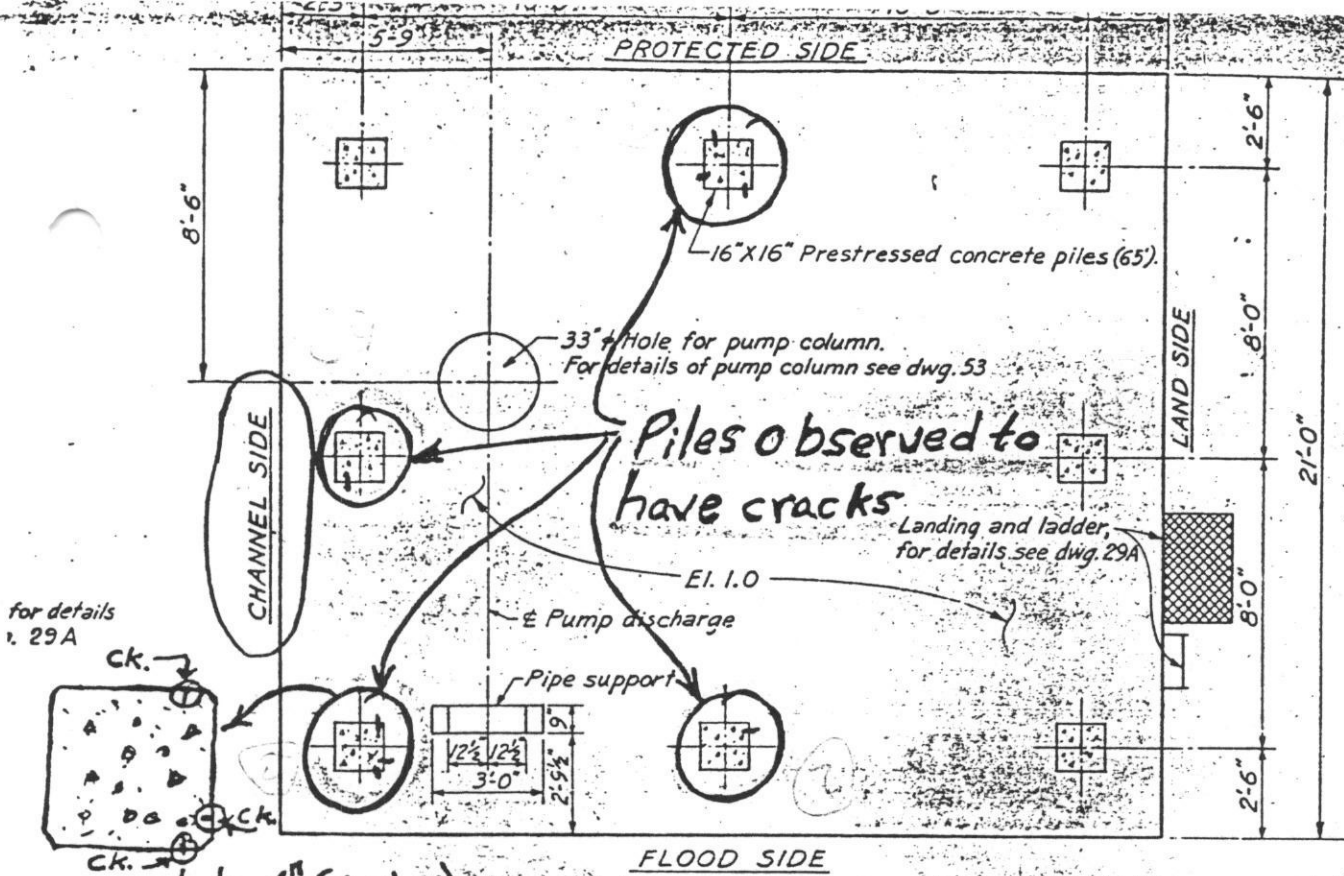
Piles observed to have cracks

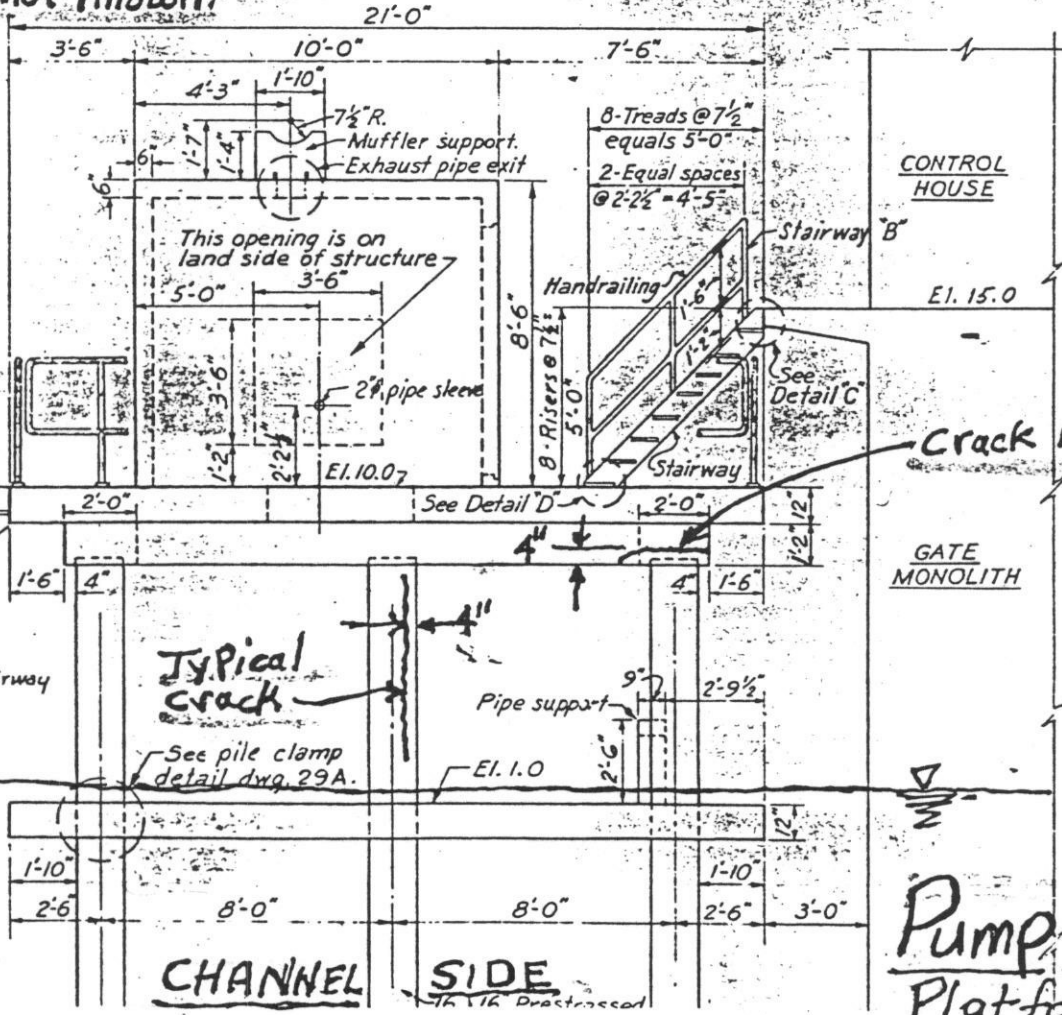
Total depth into pile not known

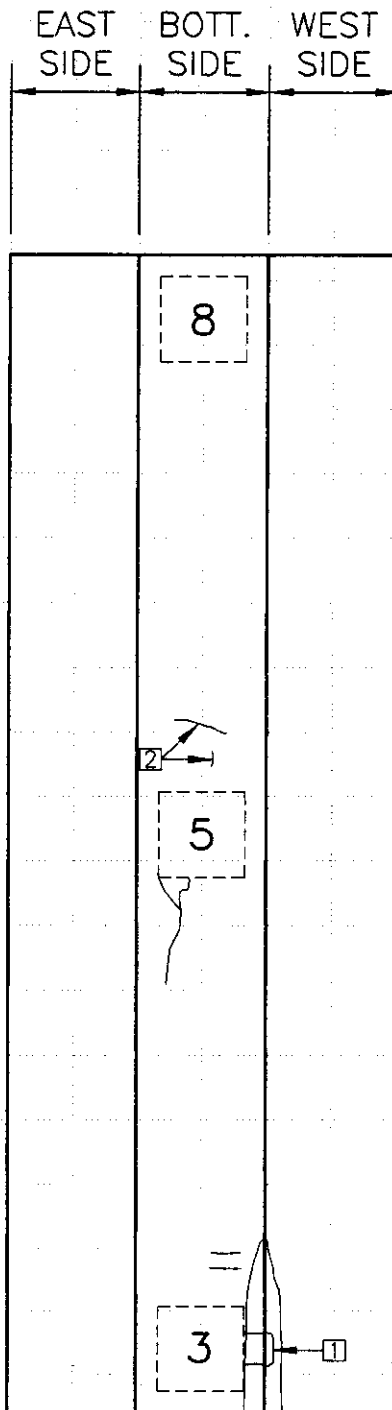
NORTH/SOUTH BEAM WEST

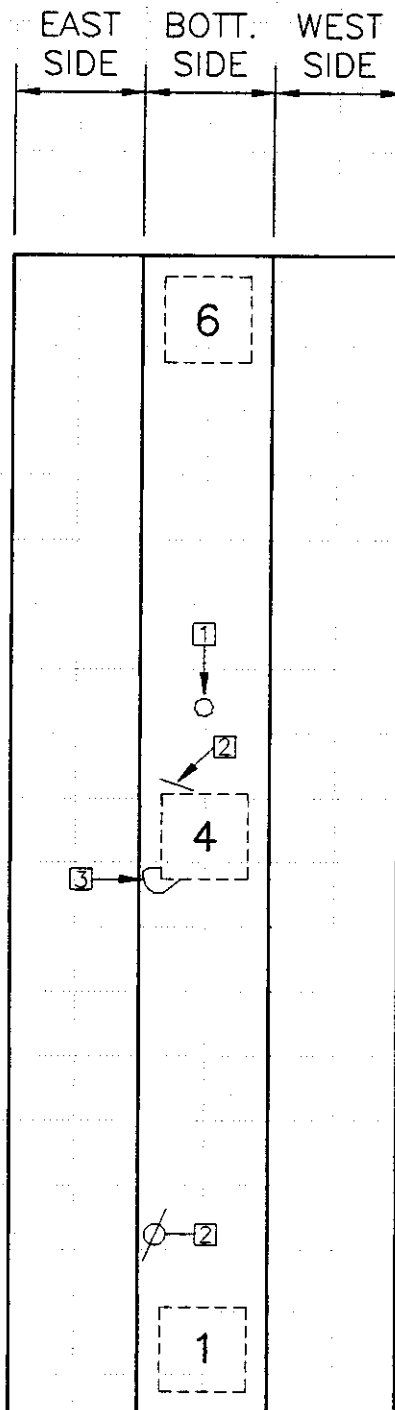
NORTH/SOUTH BEAM EAST

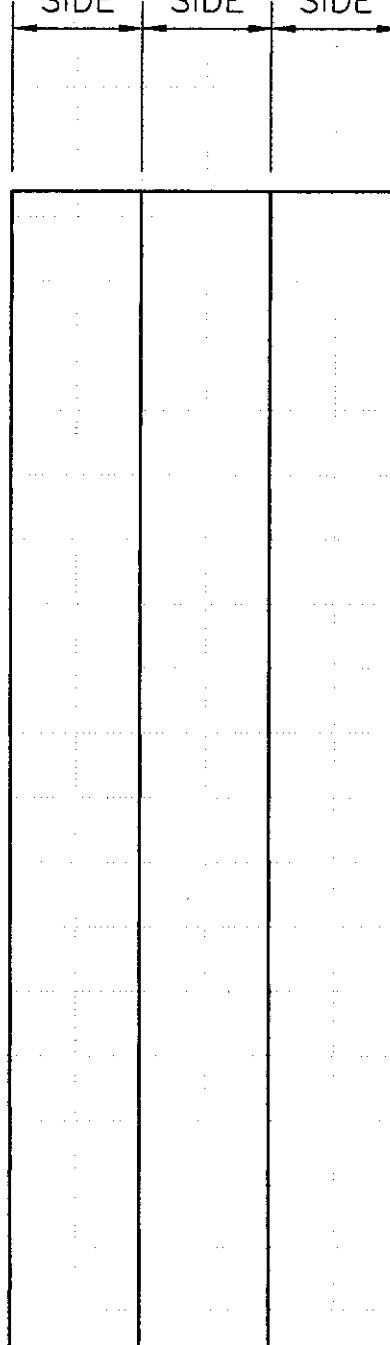
WEST SIDE BOTT. SIDE EAST SIDE

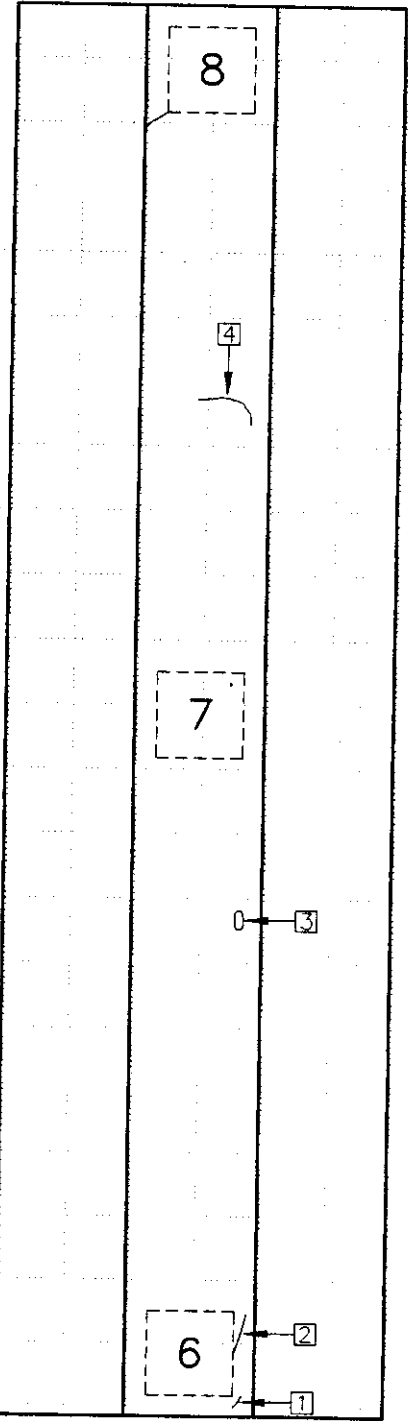
NORTH SIDE BOTT. SIDE SOUTH SIDE

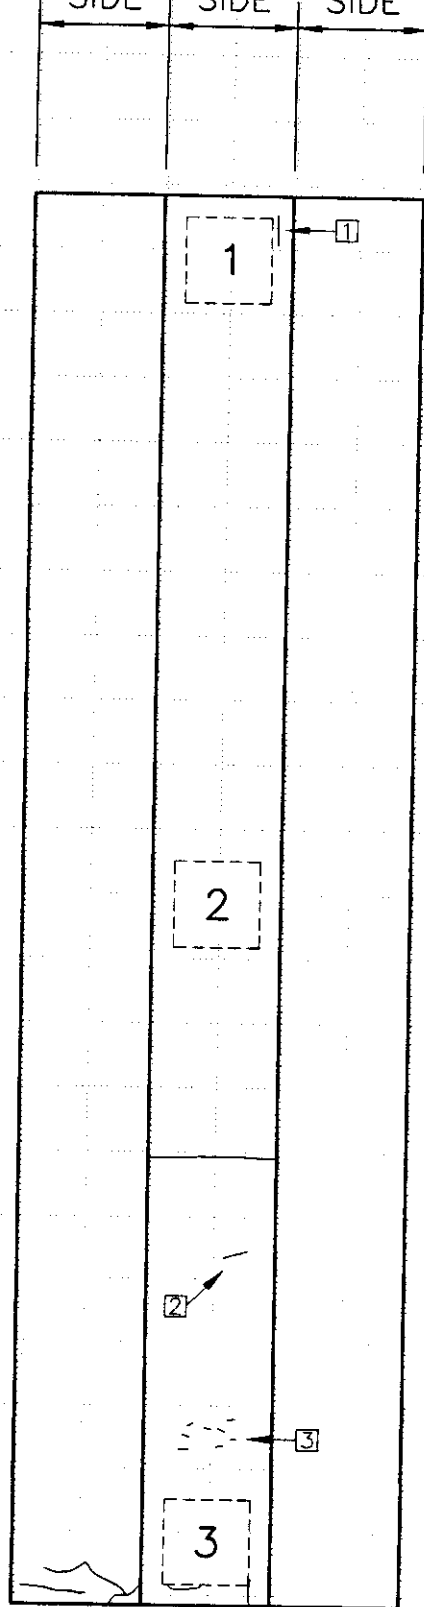
SOUTH SIDE BOTT. SIDE NORTH SIDE

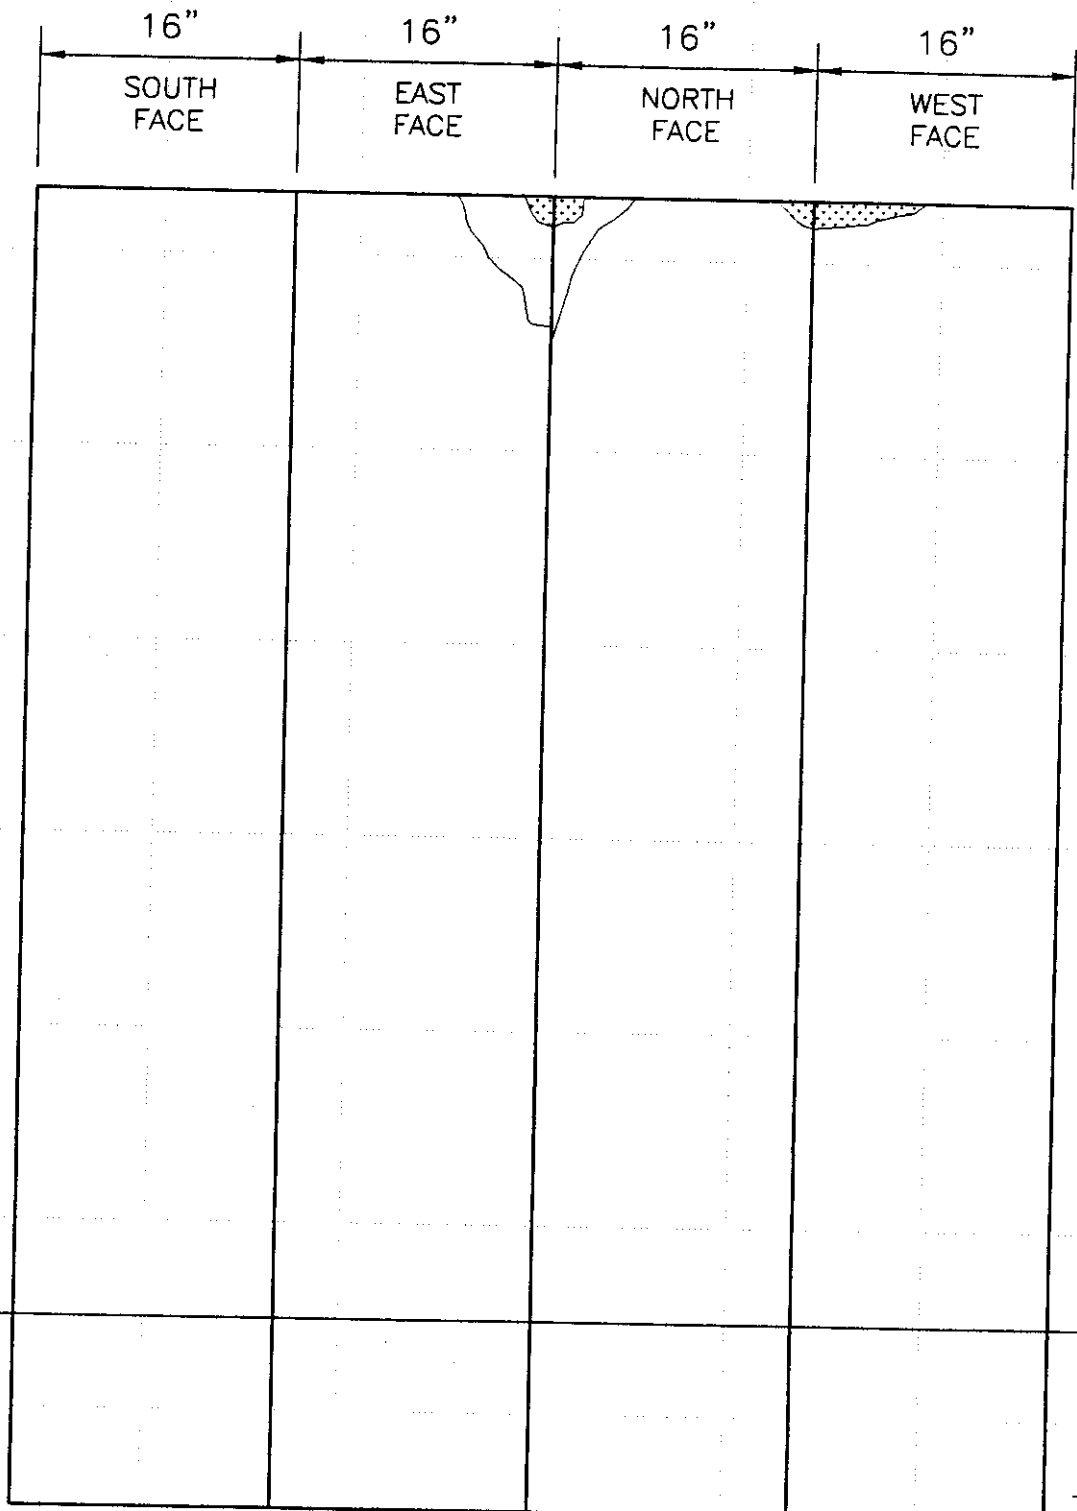
File: \\SERVER\CAD-PROJ\50000\50797-BA\FIELD-INFO.DWG, Layer, edited: NOV. 12, 99 @ 08:00 a.m.

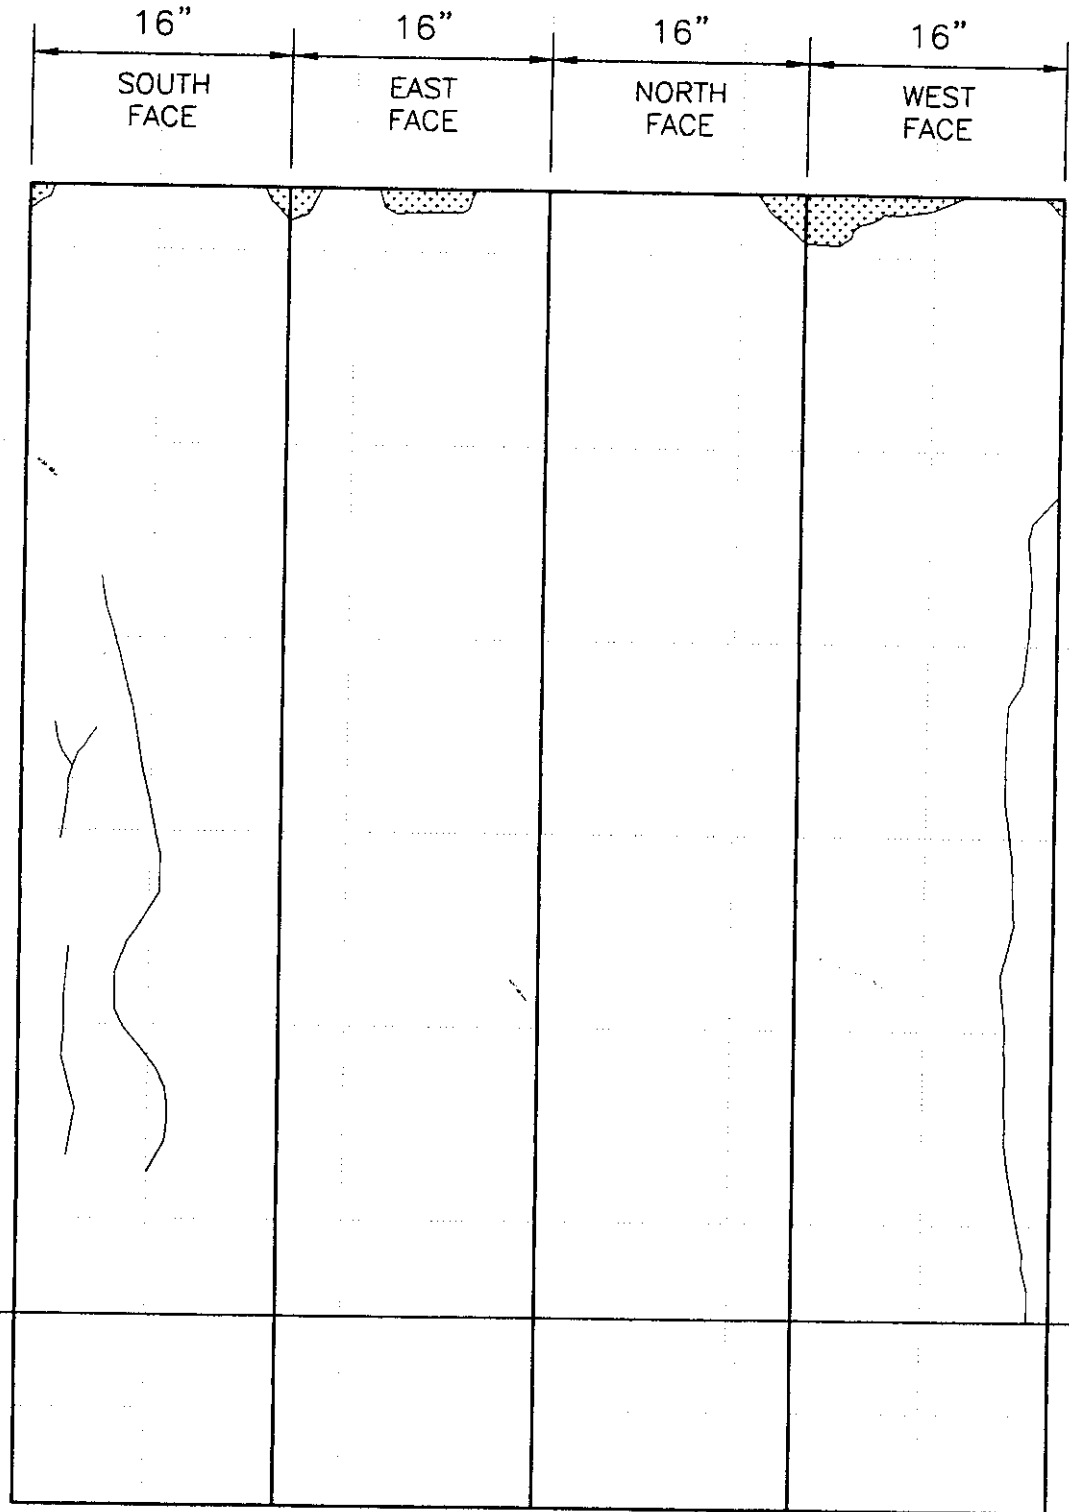
PILE ABOVE LOWER DECK

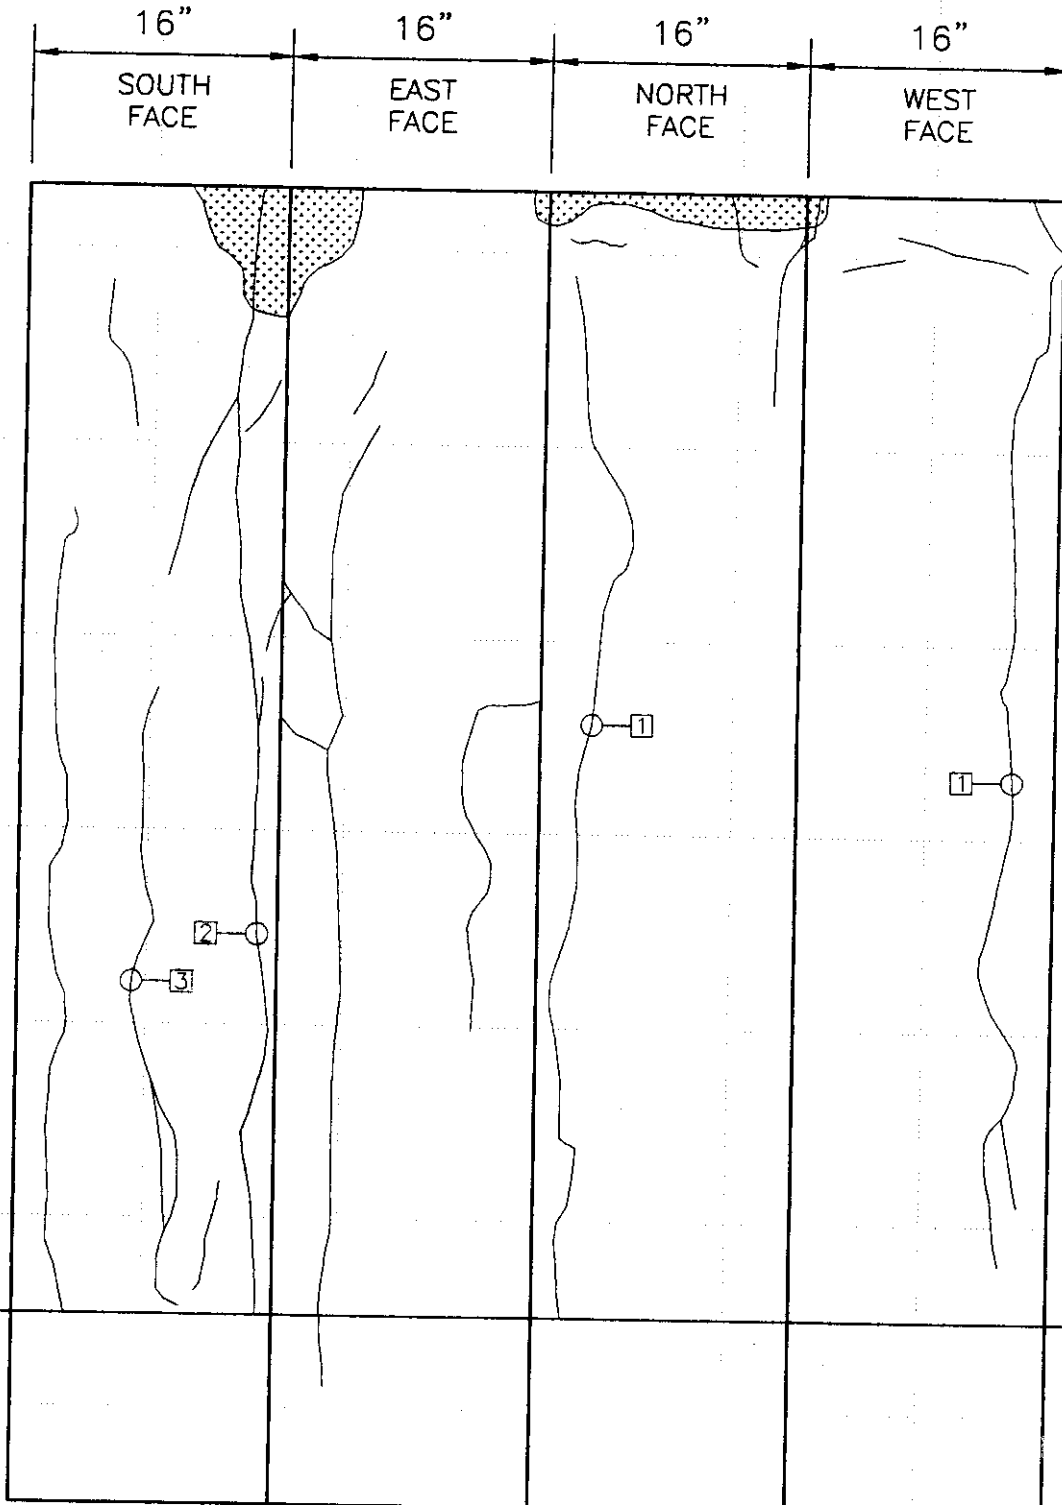
PILE ABOVE LOWER DECK

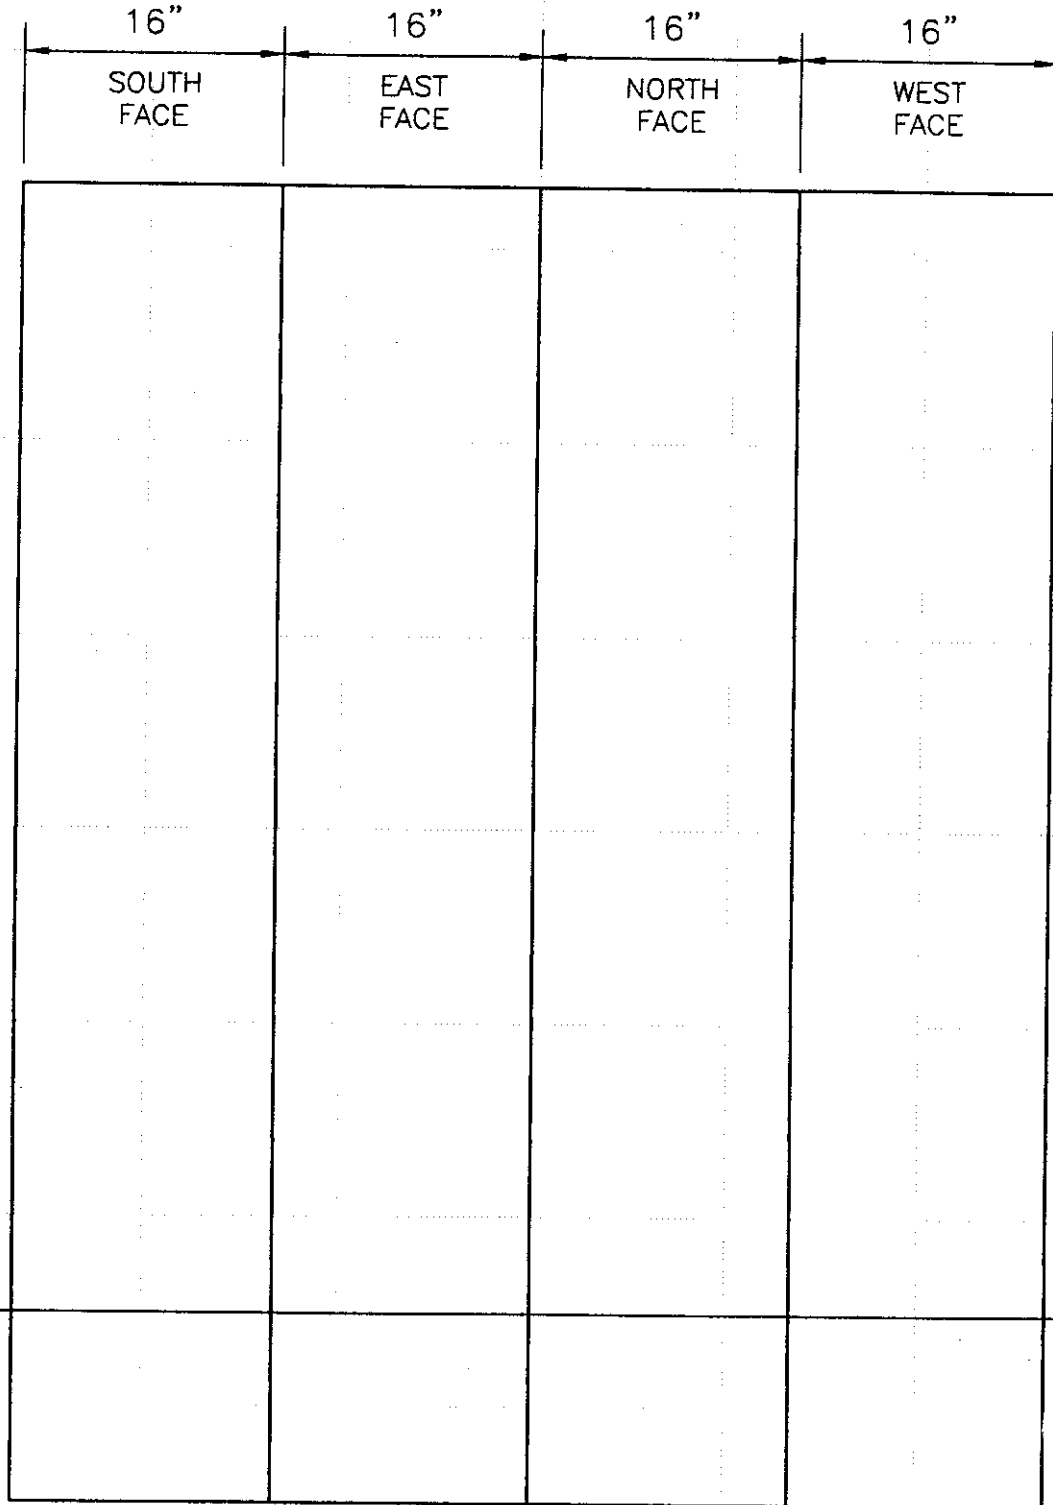
EMPIRE FLOODGATE PUMP PLATFORM
PILE ABOVE LOWER DECK

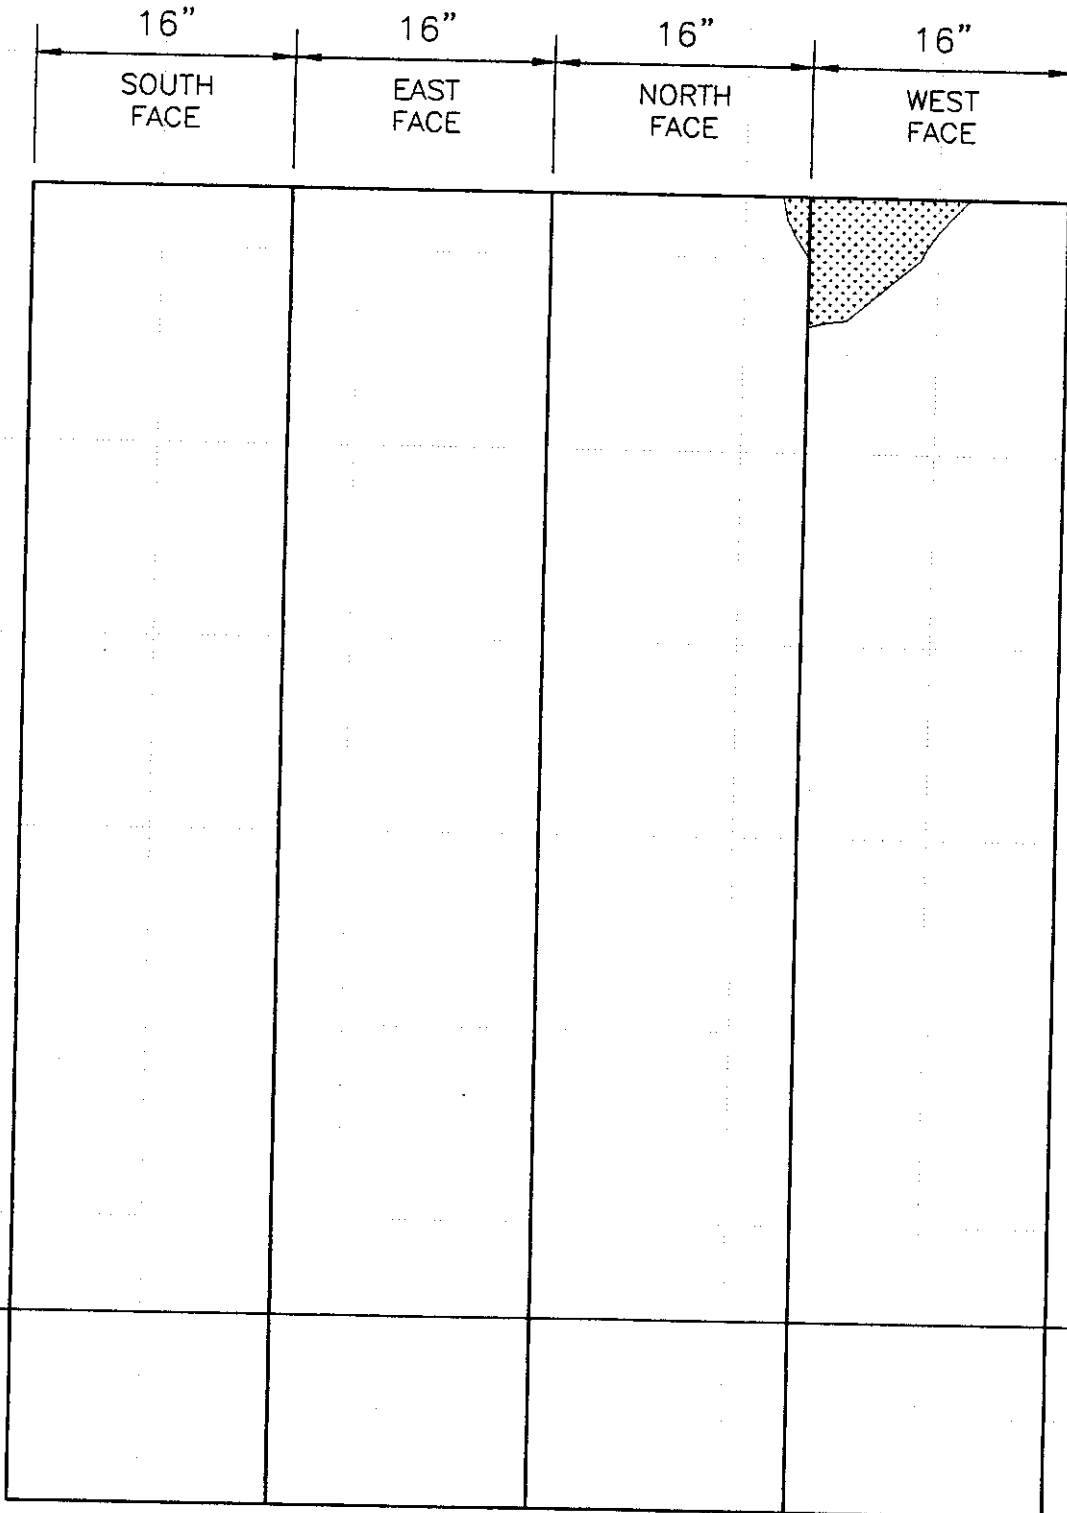
EMPIRE FLOODGATE PUMP PLATFORM
PILE ABOVE LOWER DECK

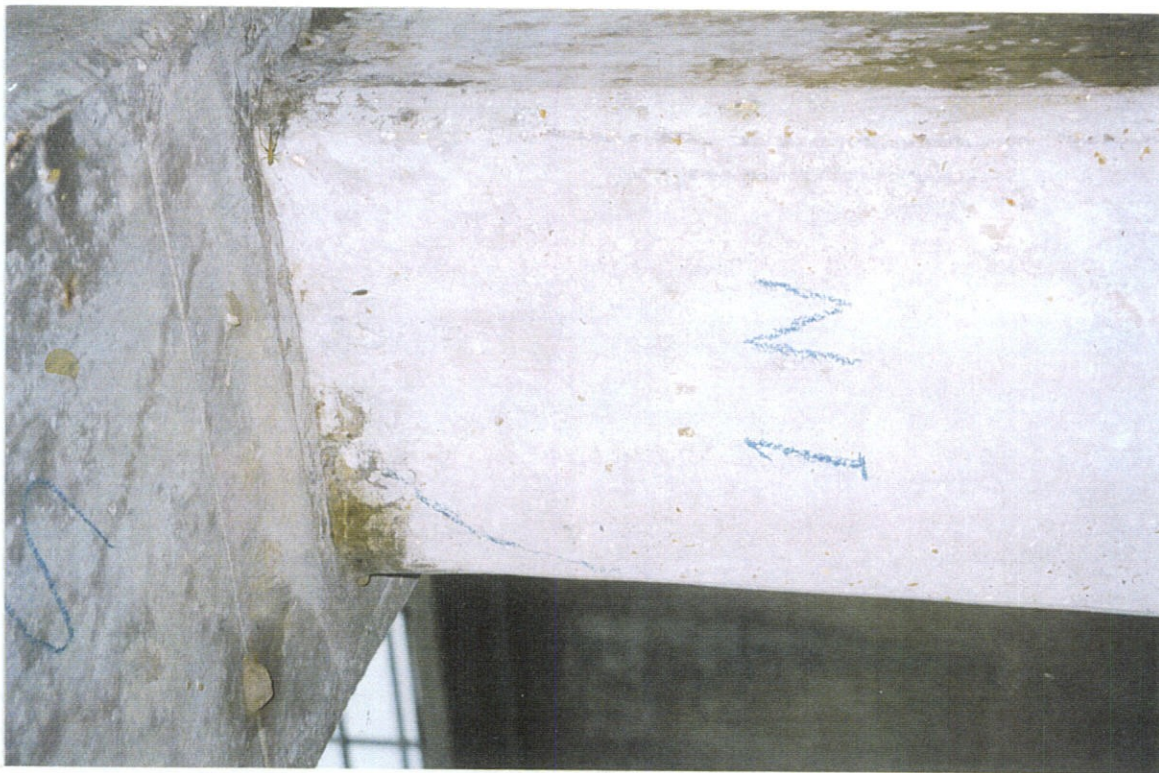
PHOTO NO. 1 - PILE NO. 1, NORTH FACE. NOTE SMALL CRACK (MARKED WITH LUMBER CRAYON) AND PATCH (UPPER LEFT CORNER).

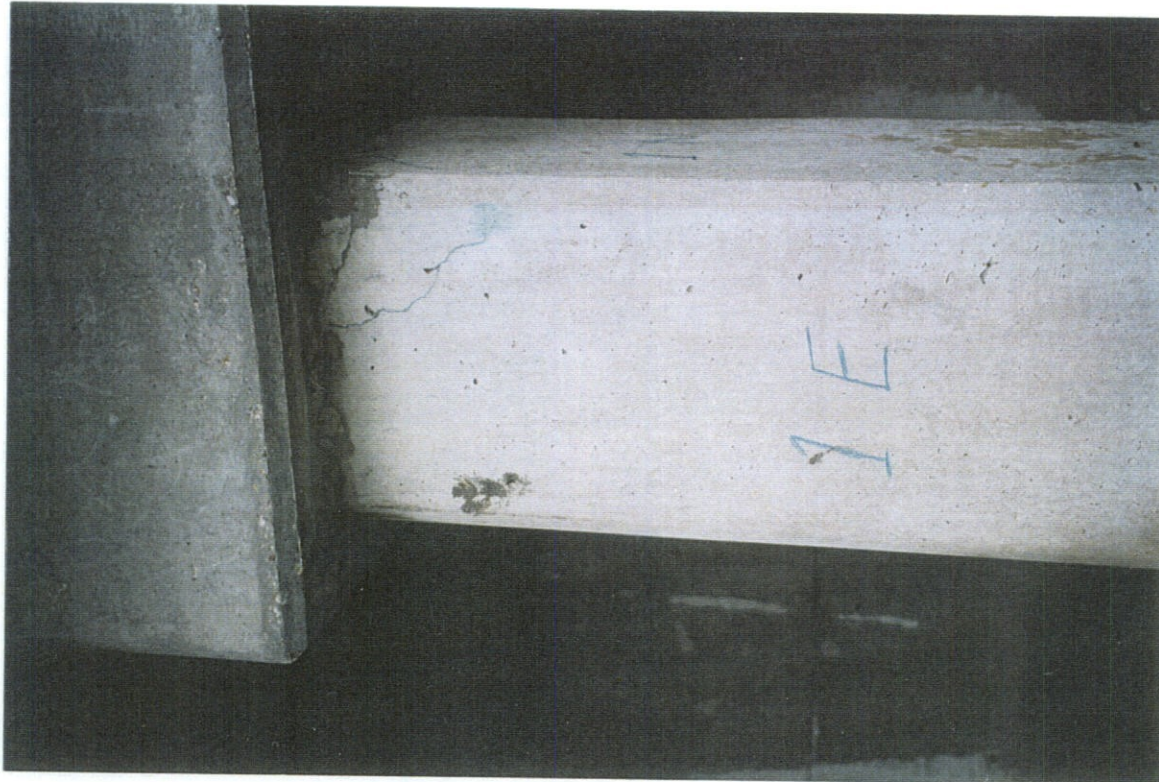
PHOTO NO. 2 - PILE NO. 2, EAST FACE. NOTE SMALL CRACK (MARKED WITH LUMBER CRAYON) AND PATCH (ALONG TOP AND UPPER RIGHT CORNER).

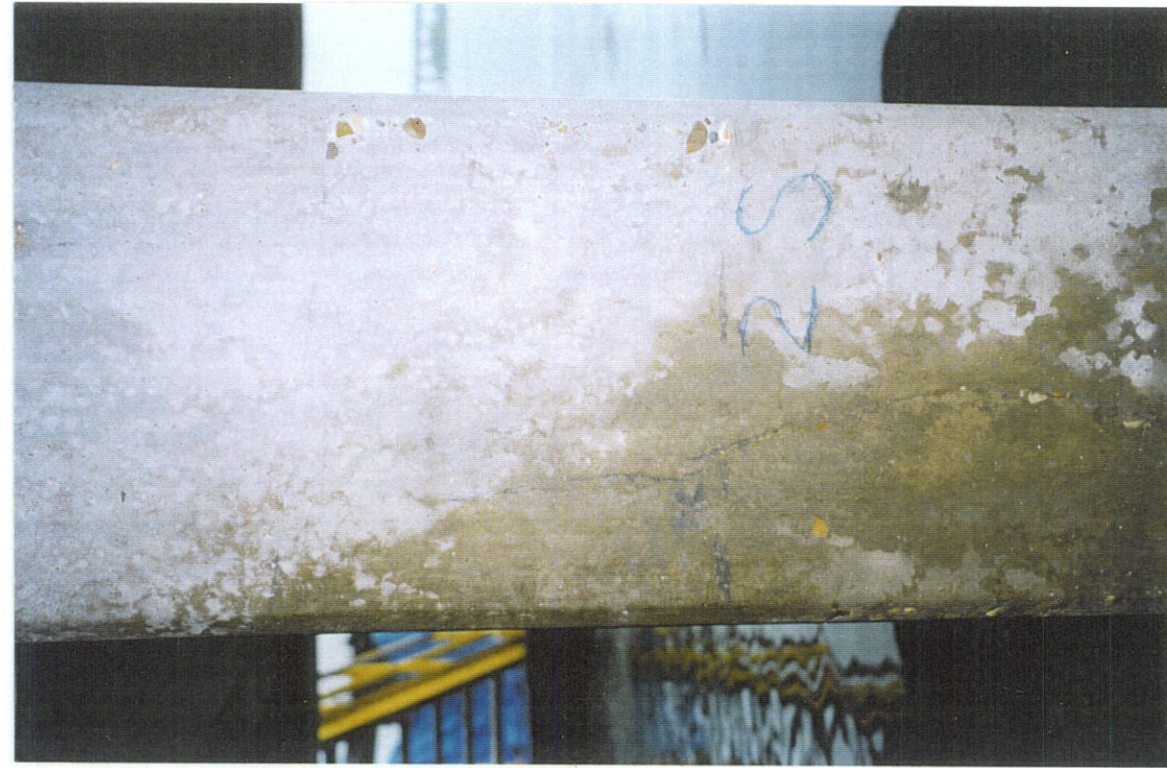
PHOTO NO. 3 - PILE NO. 2, SOUTH FACE. NOTE CRACK.

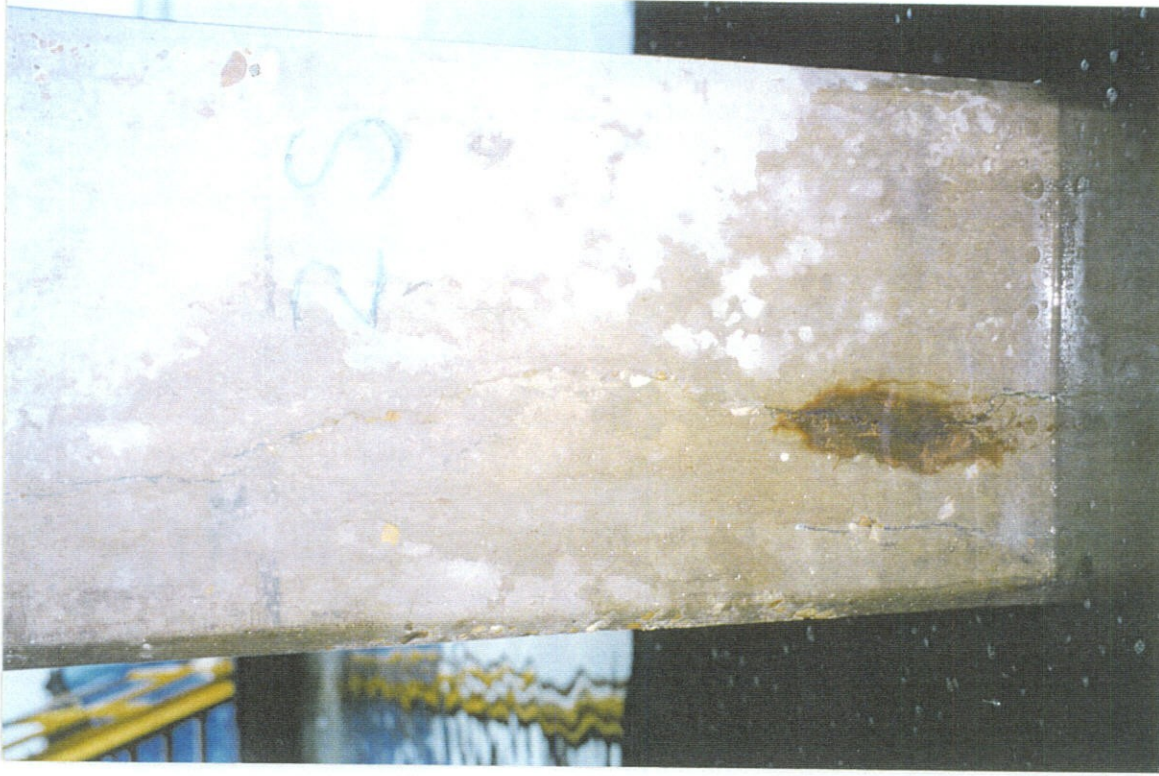
PHOTO NO. 4 - PILE NO. 2, SOUTH FACE. CONTINUATION OF CRACK SHOWN IN PHOTO NO. 3 AND ADDITIONAL CRACK.

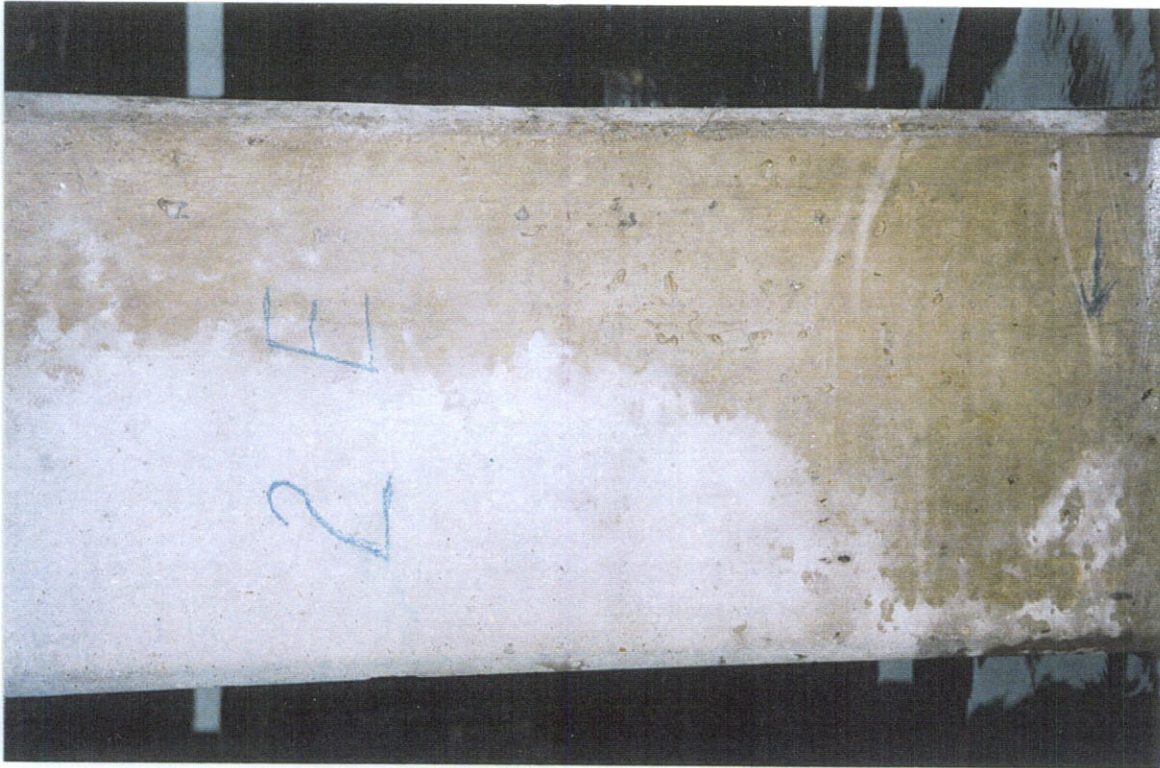
PHOTO NO. 5 - PILE NO. 2, EAST FACE. NO CRACKS. WHAT APPEARS TO BE CRACKS (ARROW) IS STAINS.

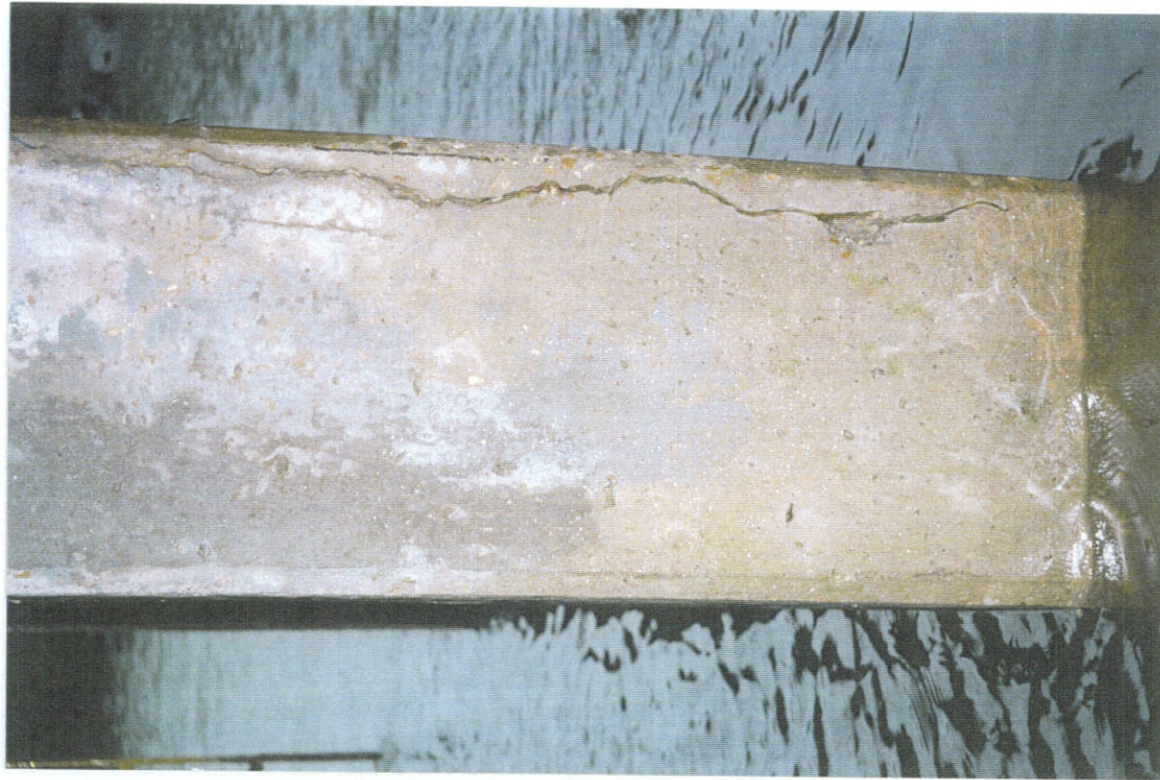
PHOTO NO. 6 - PILE NO. 2, WEST FACE. CRACKS NEAR SOUTHWEST CORNER OF PILE.

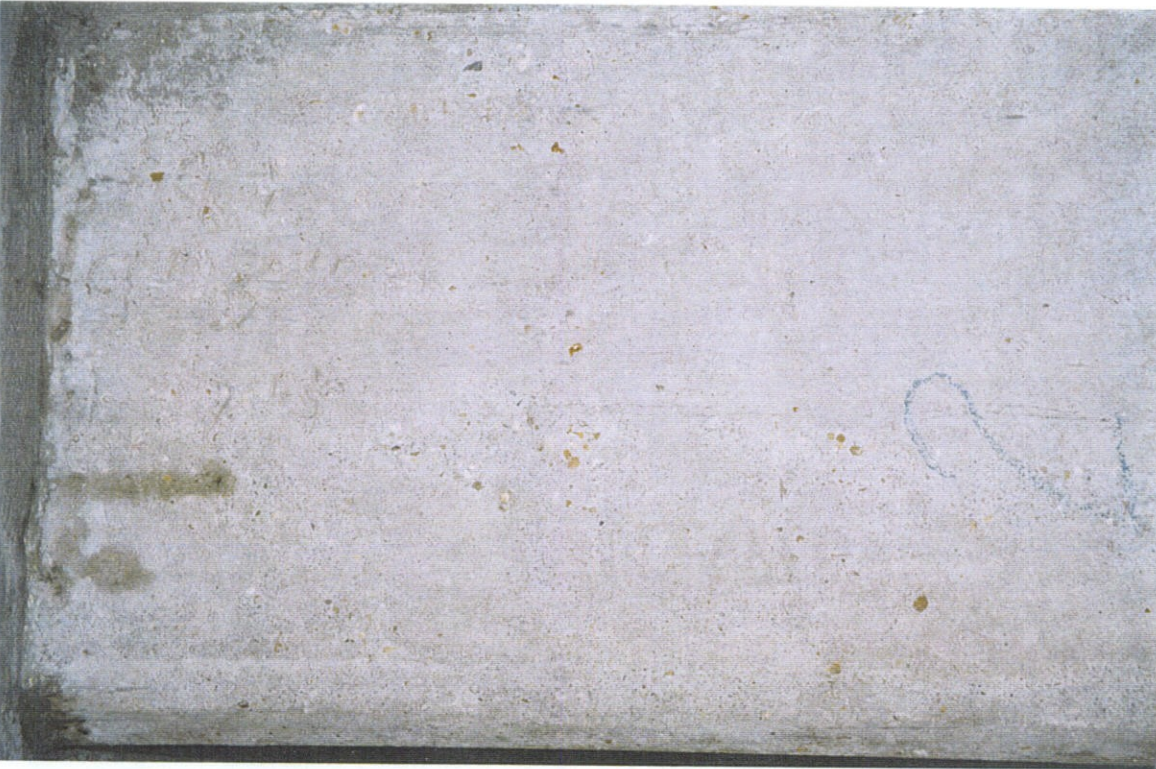
PHOTO NO. 7 - PILE NO. 2, NORTH FACE, UPPER PART OF PILE.
NO CRACKS.

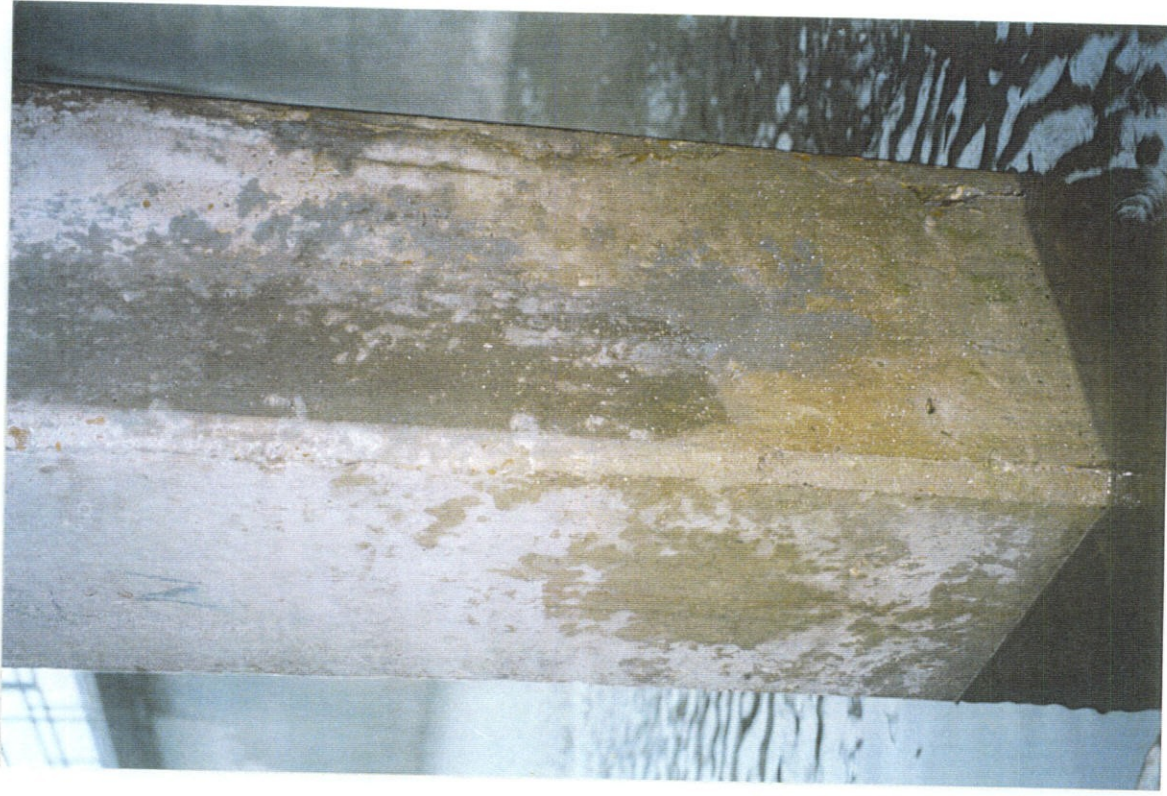
PHOTO NO 8 - PILE NO. 2, NORTH FACE ON LEFT, WEST FACE
ON RIGHT. NO CRACKS NOTED IN NORTH FACE. CRACKS IN
WEST FACE ALSO SHOWN IN PHOTO NO. 6.

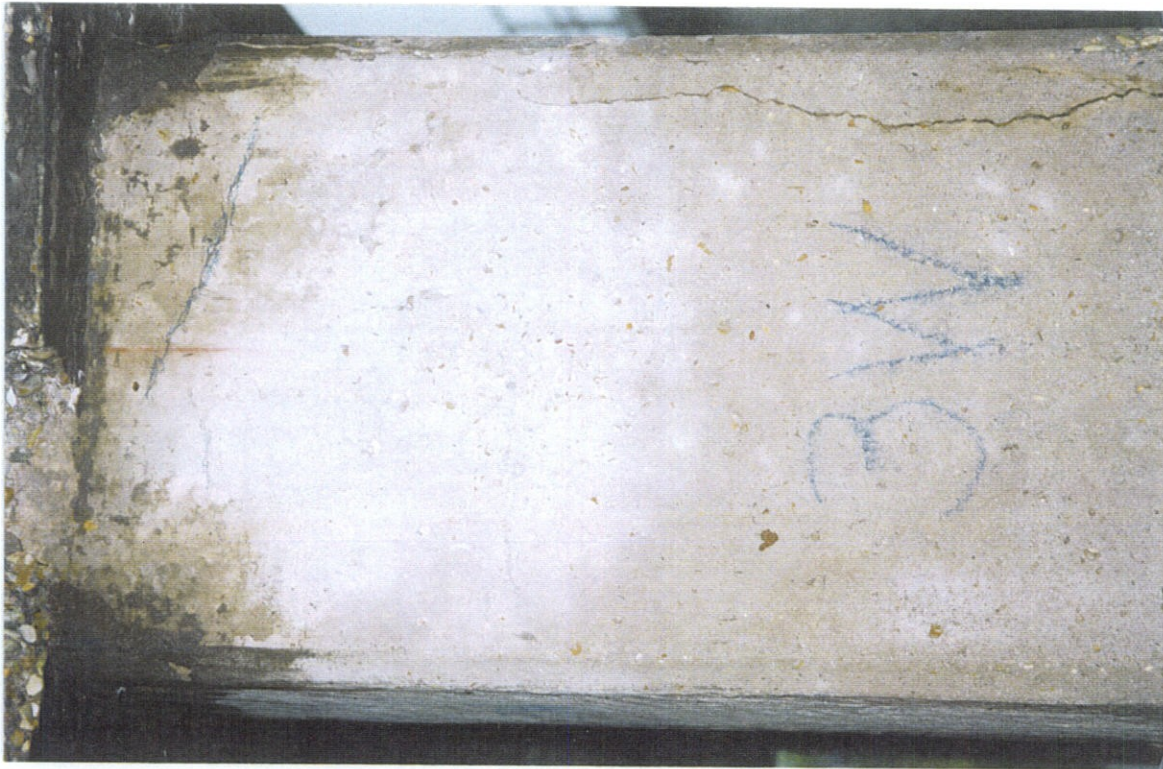
PHOTO NO. 9 - PILE NO. 3, WEST FACE. TOP PORTION OF PILE. SMALL DIAGONAL CRACK AT TOP (MARKED WITH LUMBER CRAYON) AND OPEN VERTICAL CRACK NEAR SOUTHWEST CORNER OF PILE.
