**US Army Corps
of Engineers**

New Orleans District

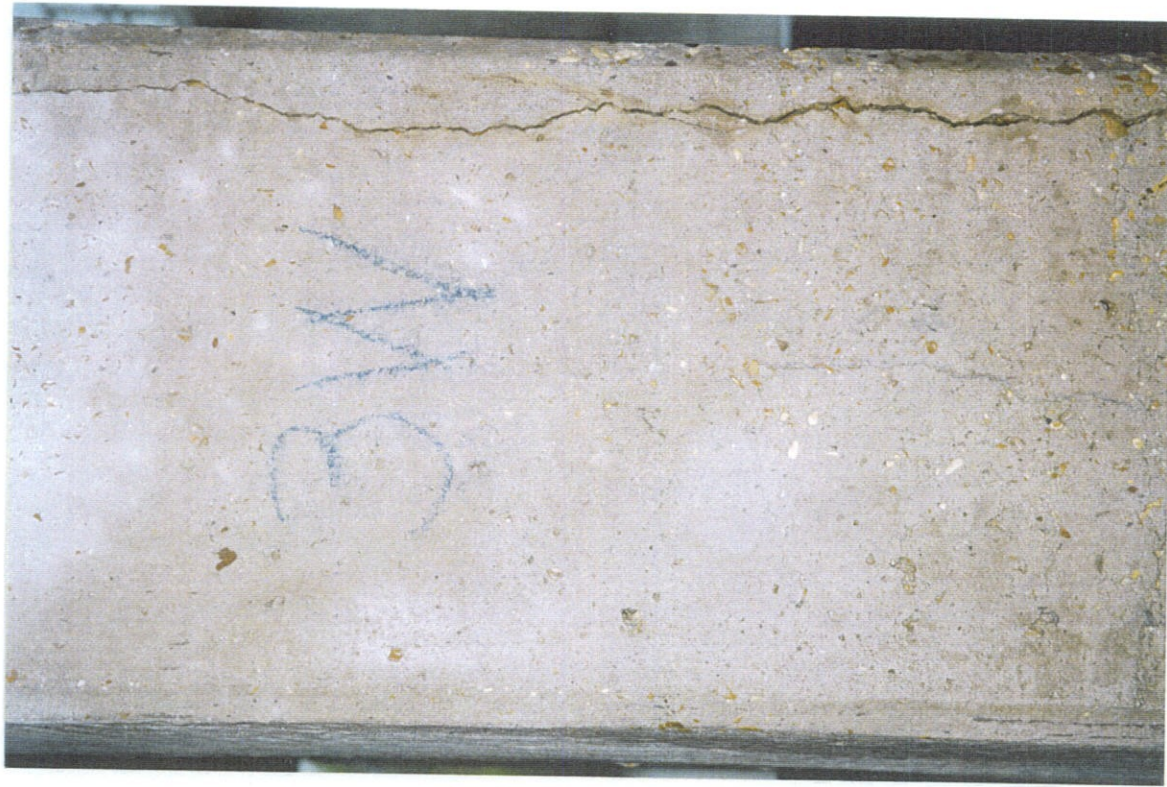
PHOTO NO. 10 - PILE NO. 3, WEST FACE. MIDDLE PORTION OF PILE. CONTINUATION OF OPEN CRACK SHOWN IN PHOTO NO. 9.

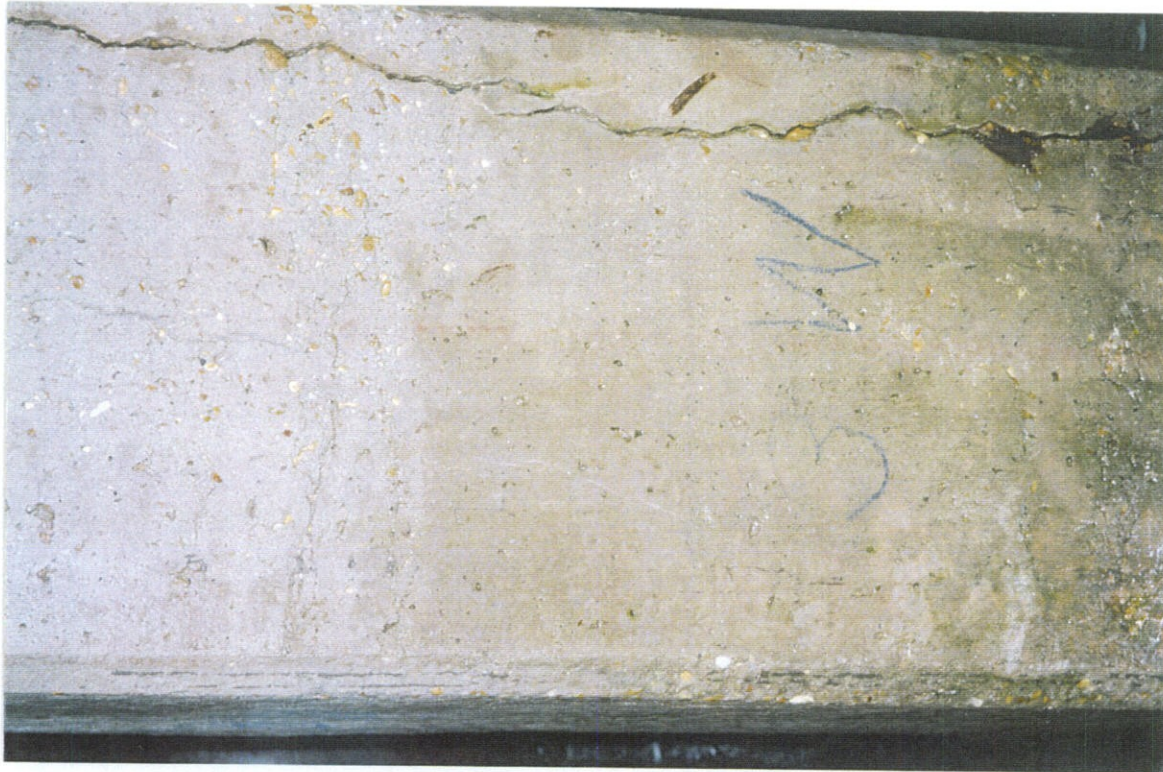
PHOTO NO. 11 - PILE NO. 3, WEST FACE. LOWER PORTION OF PILE. CONTINUATION OF OPEN CRACK SHOWN IN PHOTO NOS. 9 AND 10.

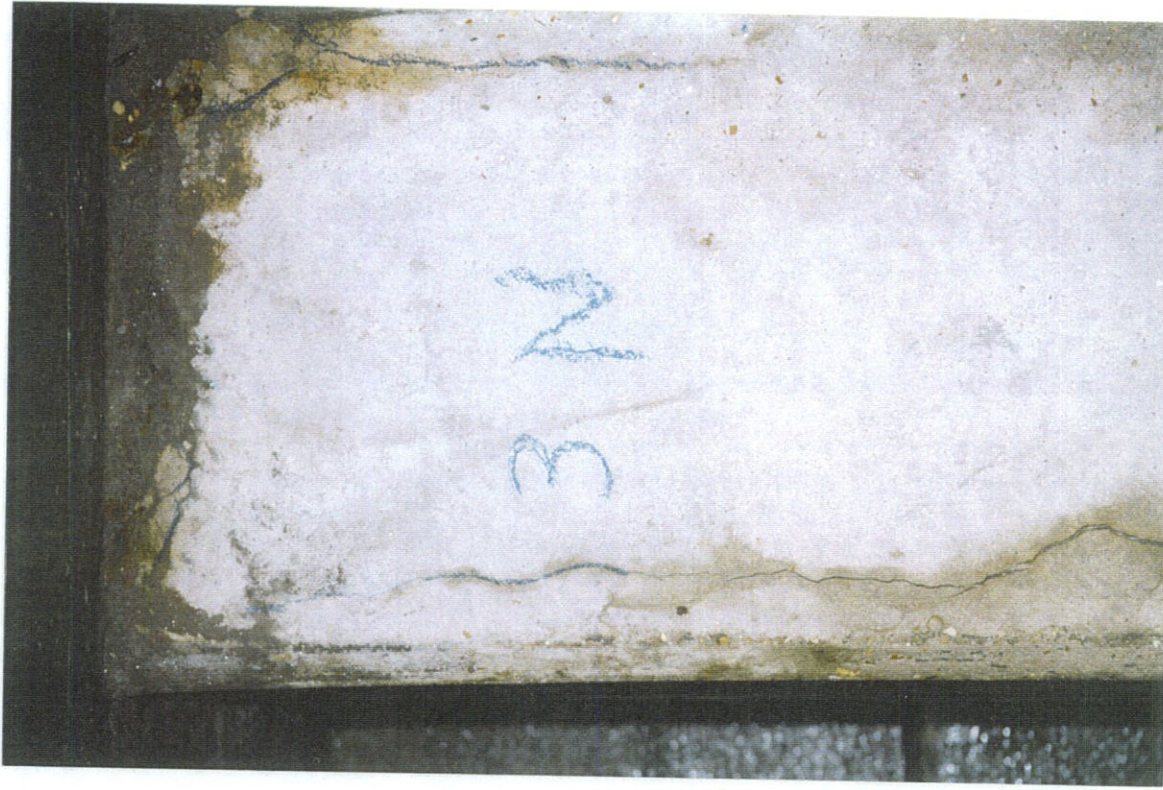
PHOTO NO. 12 - PILE NO. 3, NORTH FACE, TOP PORTION OF PILE. PATCH AT TOP OF PILE. CRACKS NEAR TOP OF PILE. VERTICAL CRACK ON RIGHT, AND UPPER PORTION OF VERTICAL CRACK ON LEFT MARKED WITH LUMBER CRAYON. CRACK ON LEFT IS OPEN EXCEPT UPPER PORTION.

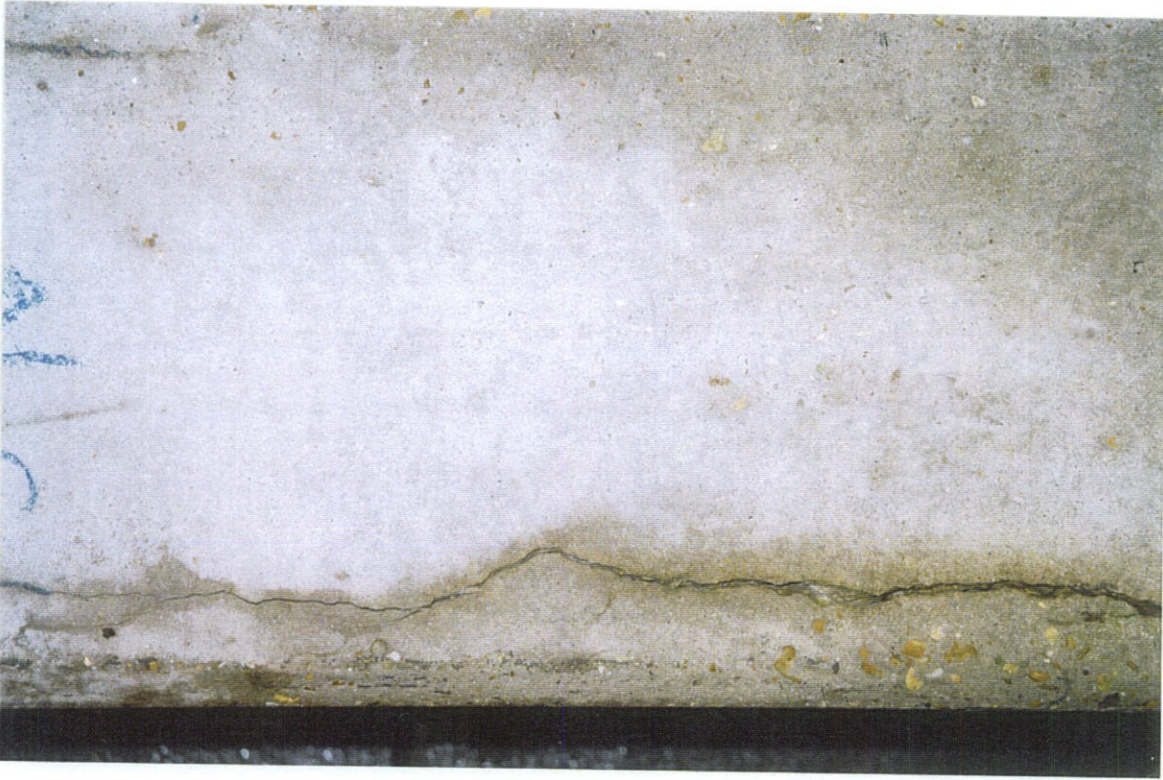
PHOTO NO. 13 - PILE NO. 3, NORTH FACE, MIDDLE PORTION OF PILE. CONTINUATION OF OPEN CRACK SHOWN IN PHOTO NO. 12.

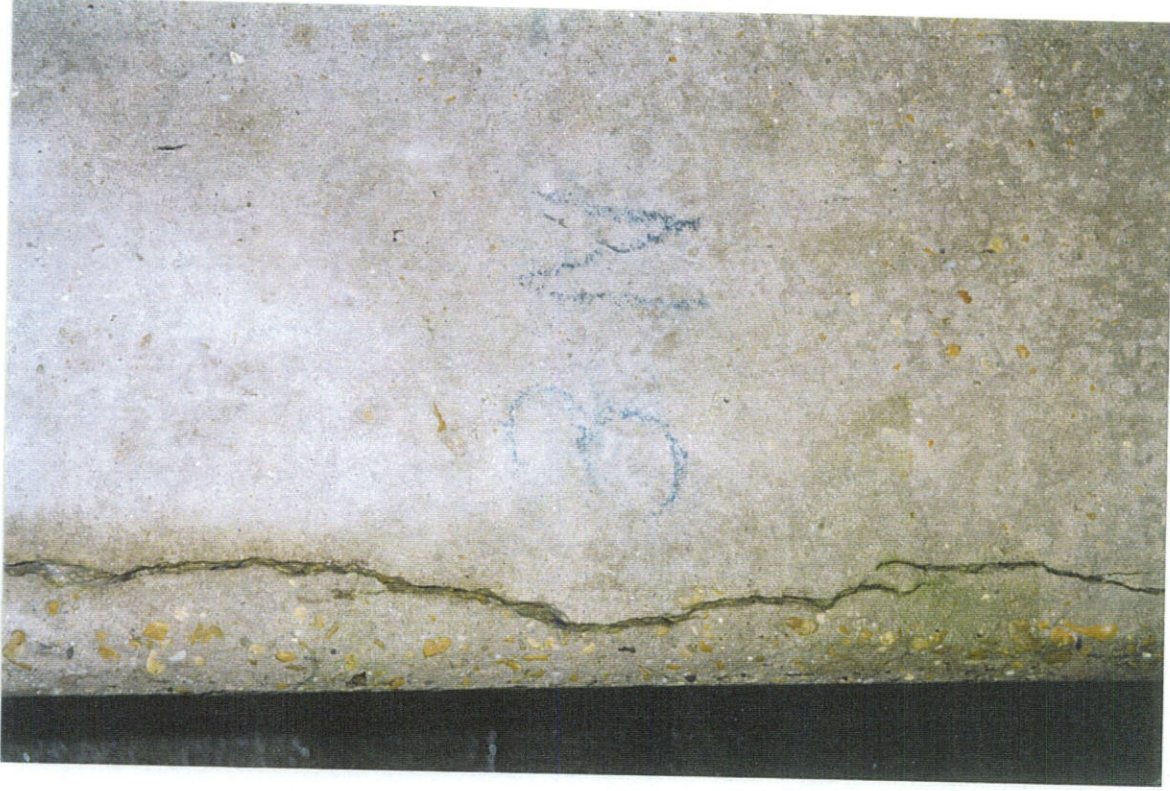
PHOTO NO. 14 - PILE NO. 3, NORTH FACE, LOWER PORTION OF PILE. CONTINUATION OF CRACK SHOWN IN PHOTO NOS. 12 AND 13.

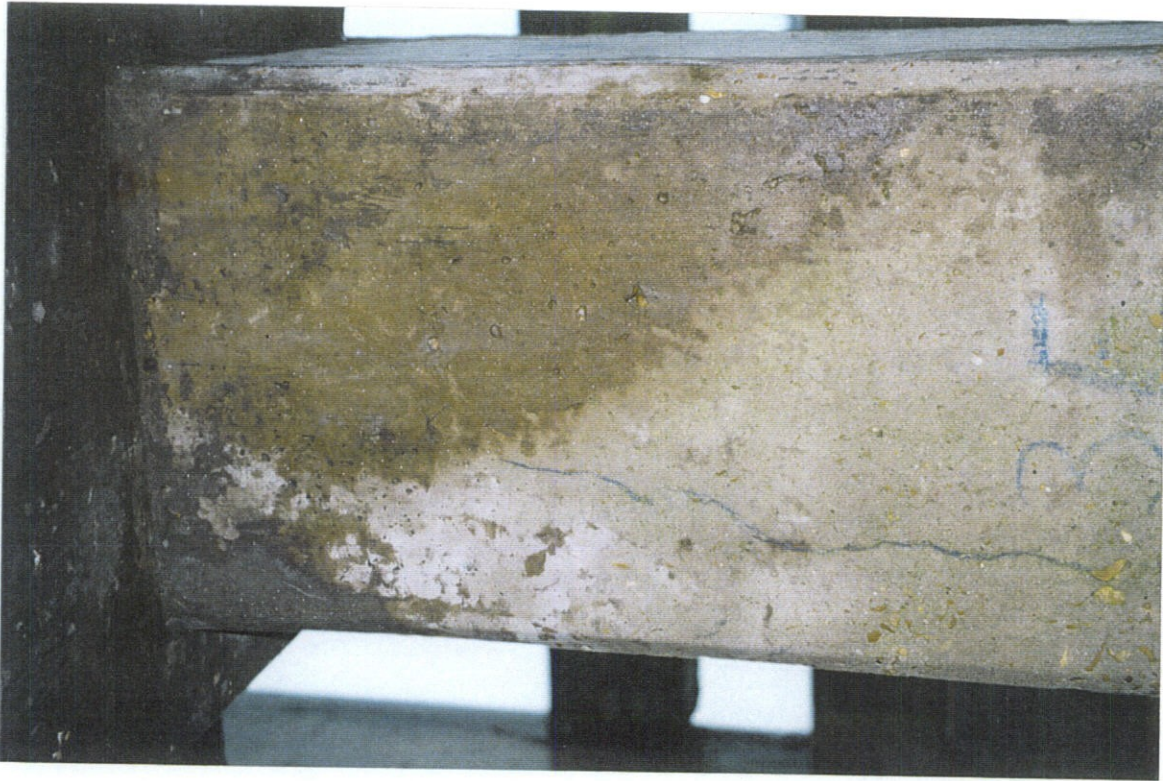
PHOTO NO. 15 - PILE NO. 3, EAST FACE, UPPER PORTION OF PILE. CRACK INCREASES IN SIZE (WIDTH) TOWARD BOTTOM OF PILE.

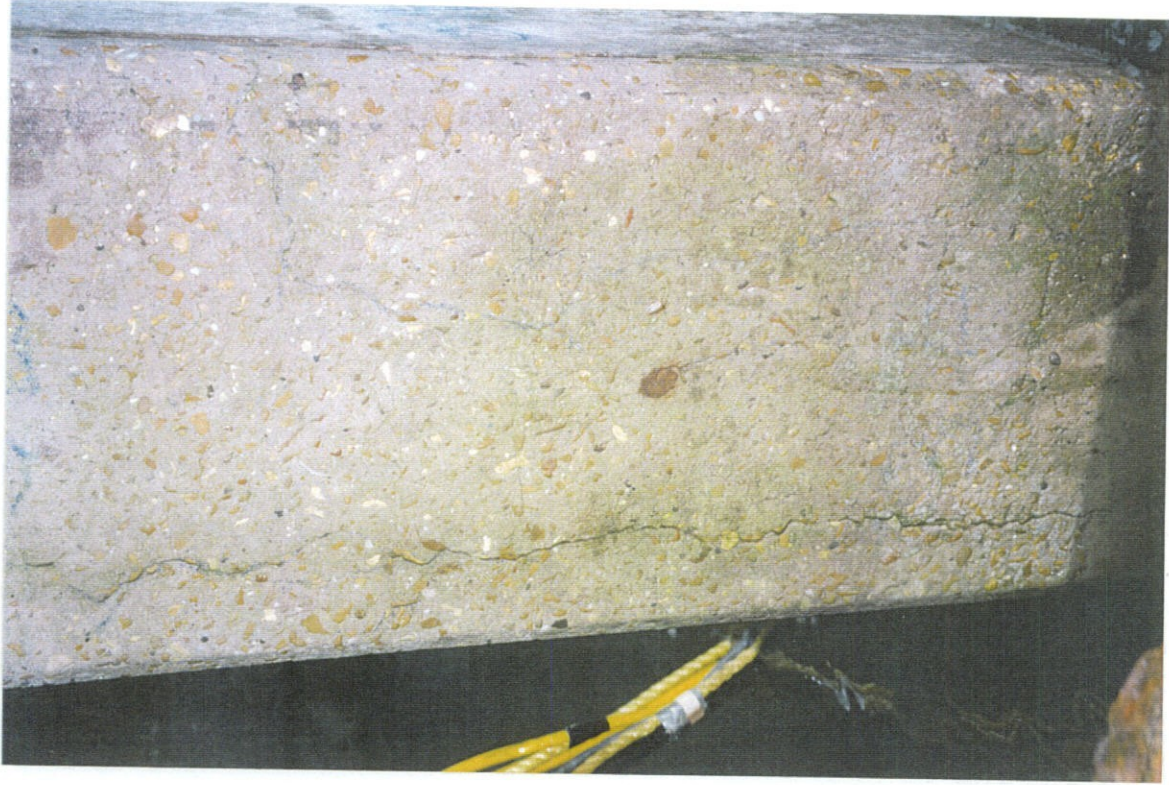
PHOTO NO. 16 - PILE NO. 3, EAST FACE, LOWER PORTION OF PILE. CONTINUATION OF CRACK SHOWN IN PHOTO NO. 15.

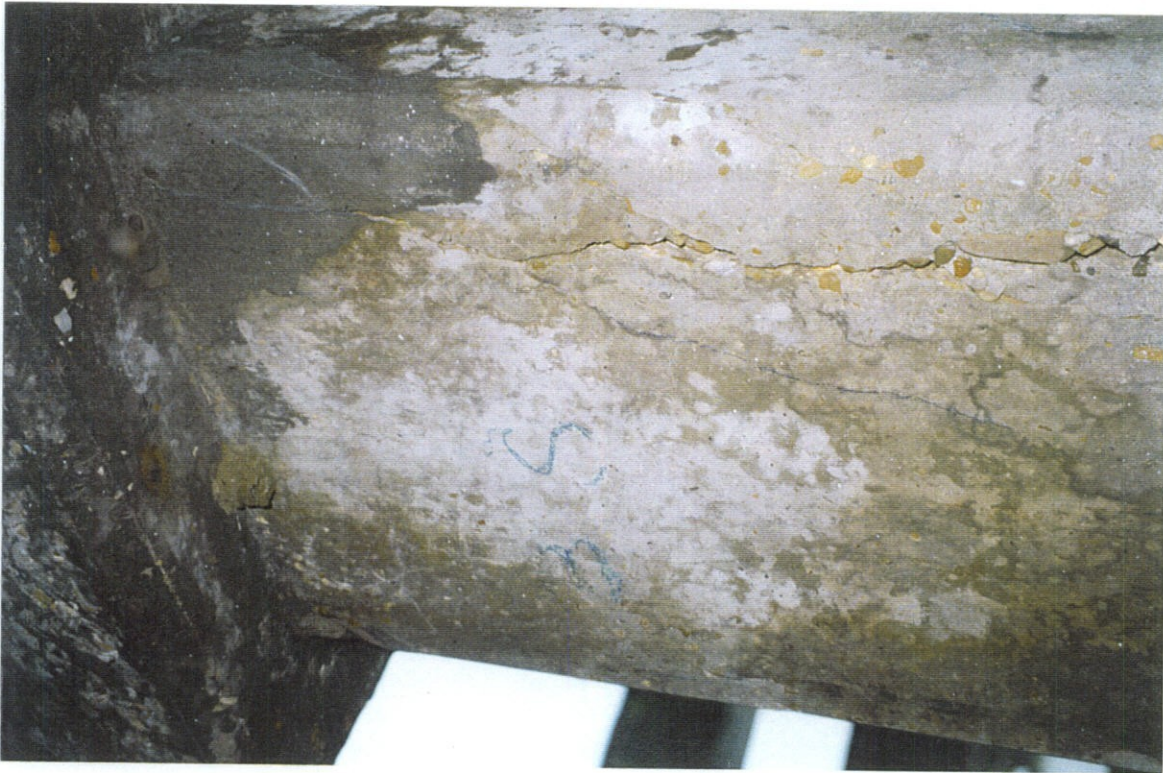
PHOTO NO. 17 - PILE NO. 3, SOUTH FACE, UPPER PORTION OF PILE. PATCH AT TOP OF PILE ON SOUTHEAST CORNER OF PILE. LARGER CRACK IS OPEN.

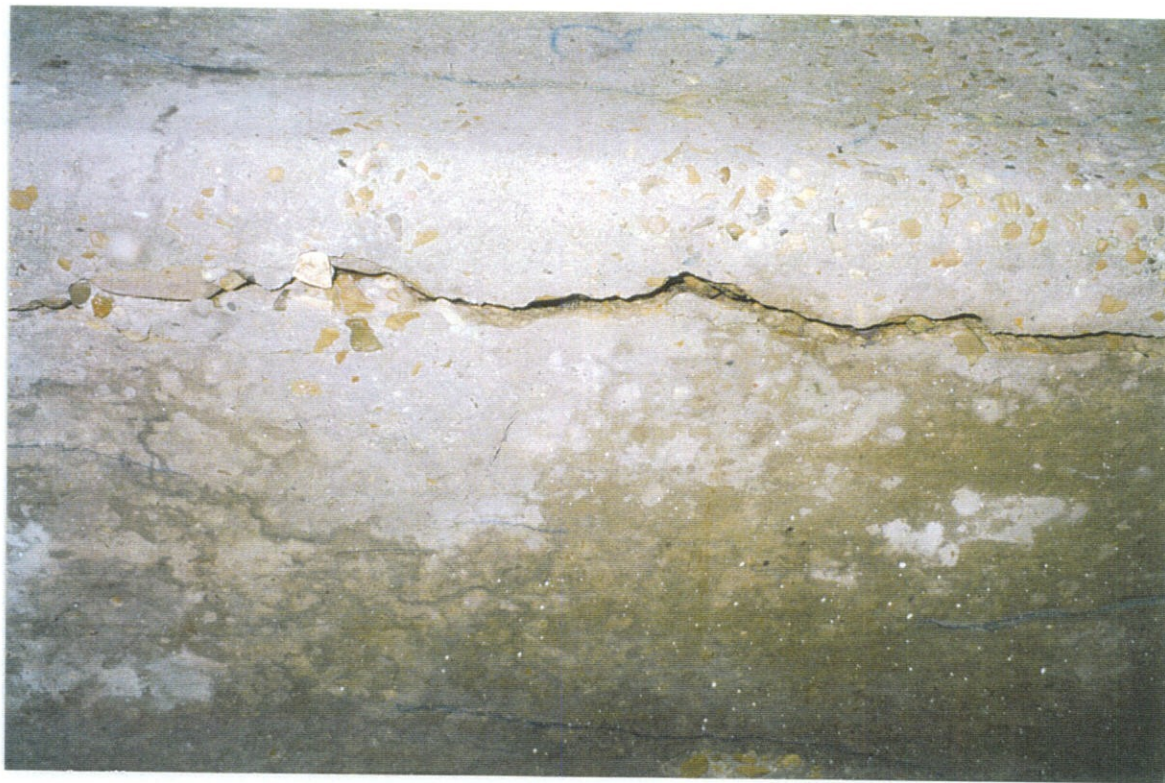
PHOTO NO. 18 - PILE NO. 3, SOUTH FACE, MIDDLE PORTION OF PILE. CONTINUATION OF CRACKS SHOWN IN PHOTO NO. 17.

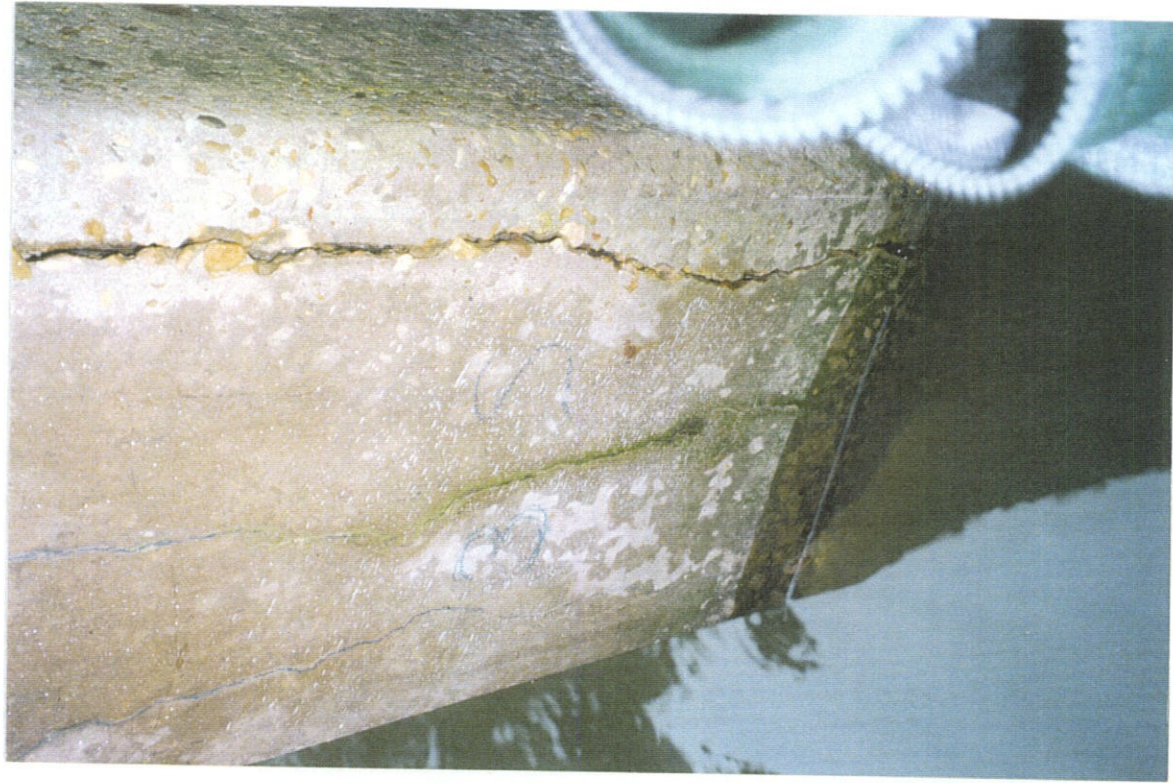
PHOTO NO. 19 - PILE NO. 3, SOUTH FACE, CONTINUATION OF
CRACKS SHOWN IN PHOTO NO. 18.

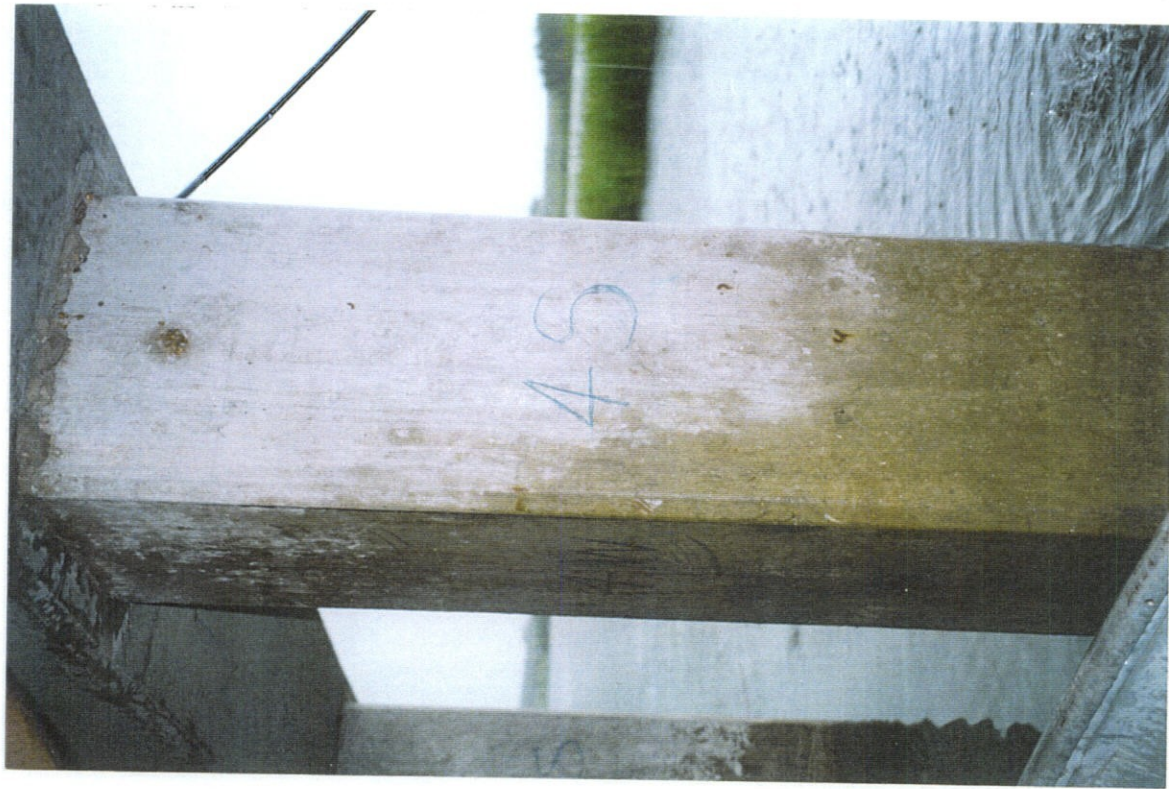
PHOTO NO. 20 - PILE NO. 4, SOUTH FACE, GOOD VISUAL
CONDITION. NO CRACKS NOTED ON PILE NO. 4

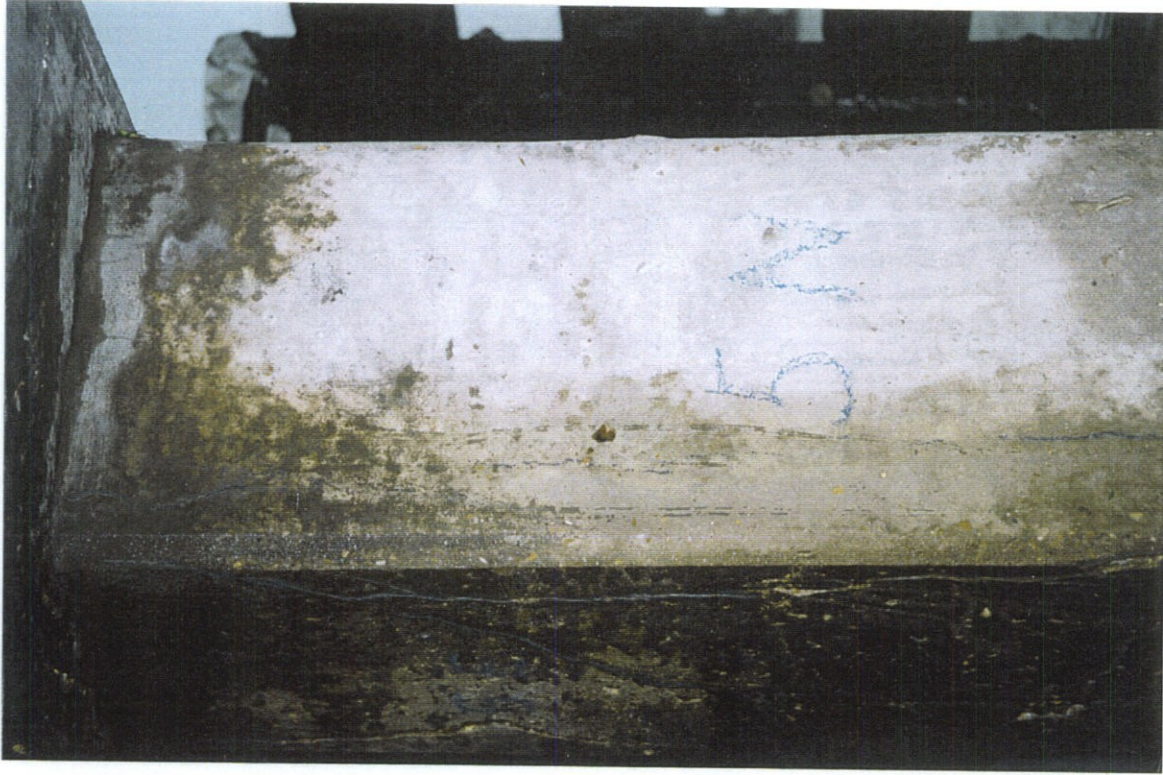
PHOTO NO. 21 - PILE NO. 5, NORTH FACE, UPPER PORTION OF PILE. PATCH AT TOP OF PILE. VERTICAL CRACKS ON LEFT SIDE.

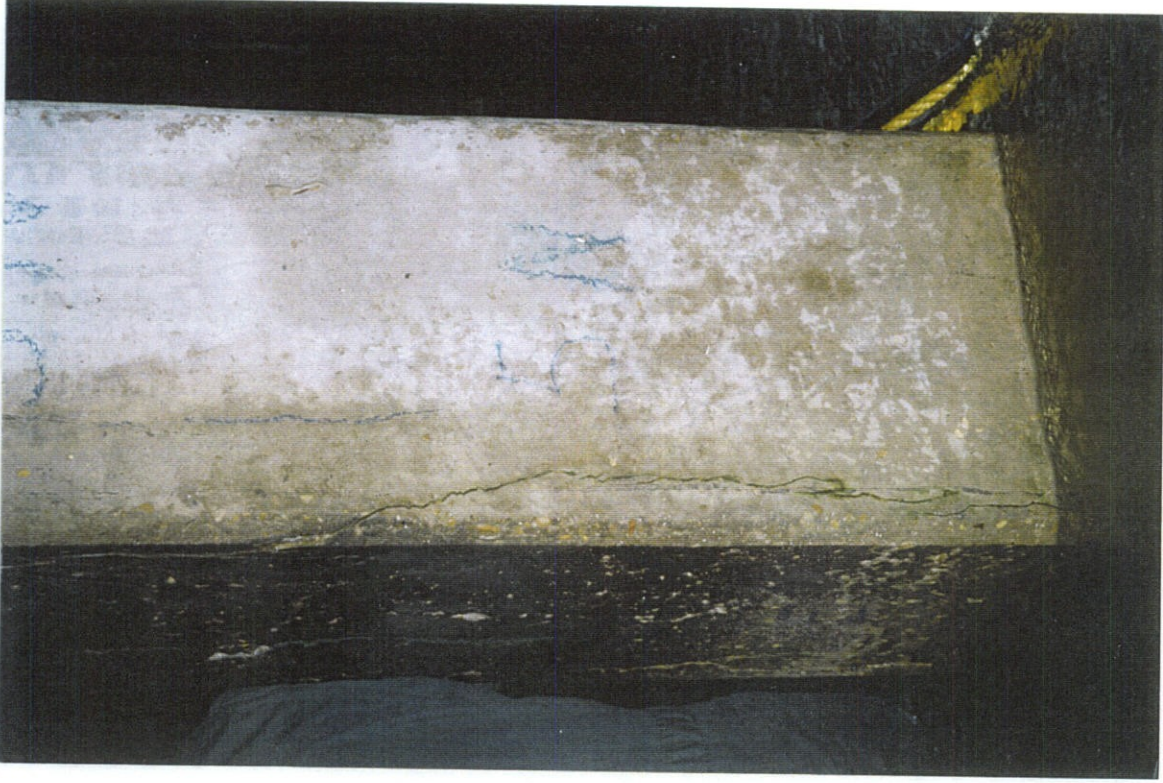
PHOTO NO. 22 - PILE NO. 5 NORTH FACE, LOWER PORTION OF PILE. CONTINUATION OF CRACK SHOWN IN PHOTO NO. 21 AND CRACK AT NORTHEAST CORNER OF PILE.

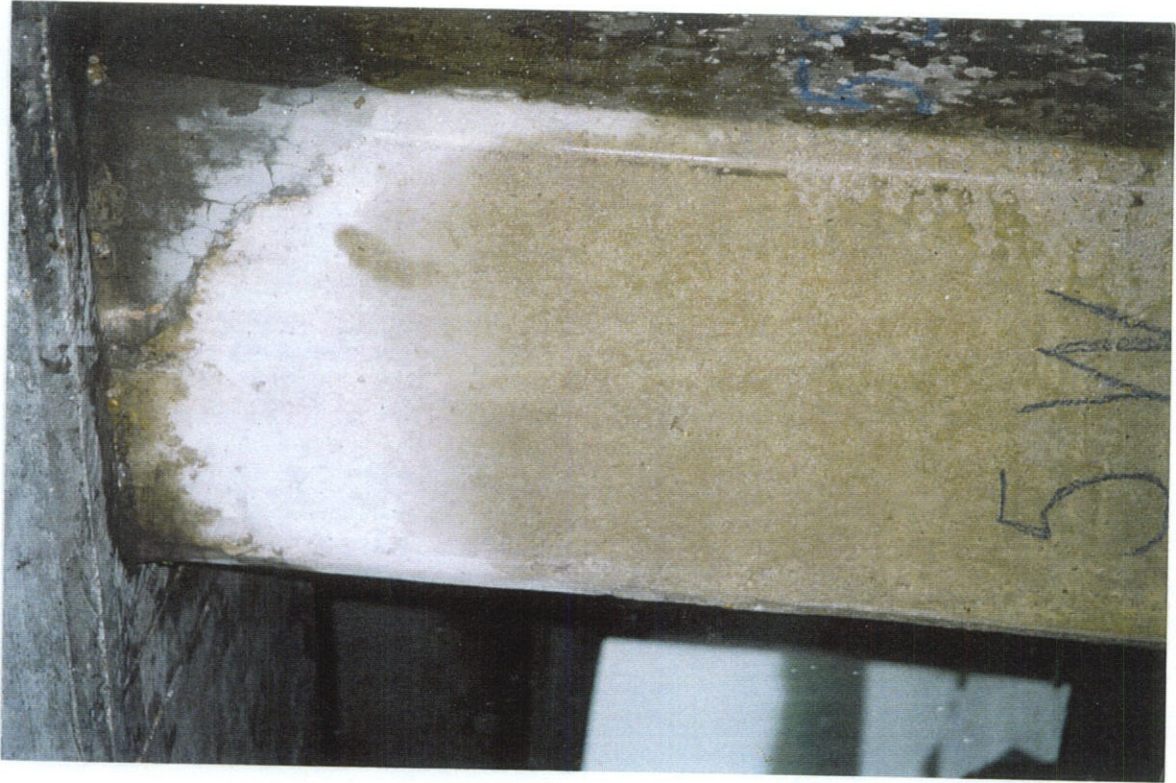
PHOTO NO. 23 - PILE NO. 5, WEST FACE, UPPER PORTION OF PILE. PATCHES AT TOP OF PILE AT BOTH CORNERS. NO CRACKS OBSERVED.

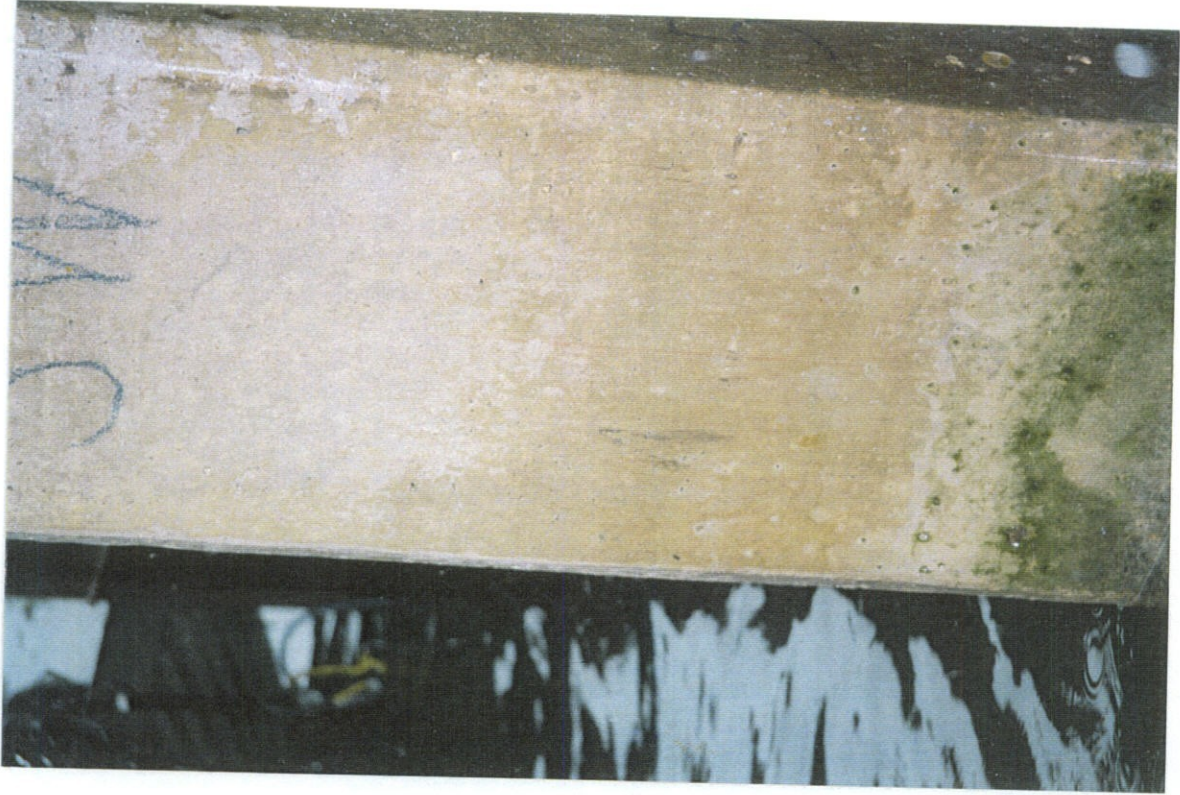
PHOTO NO. 24 - PILE NO. 5, WEST FACE, LOWER PORTION OF PILE. NO CRACKS OBSERVED.

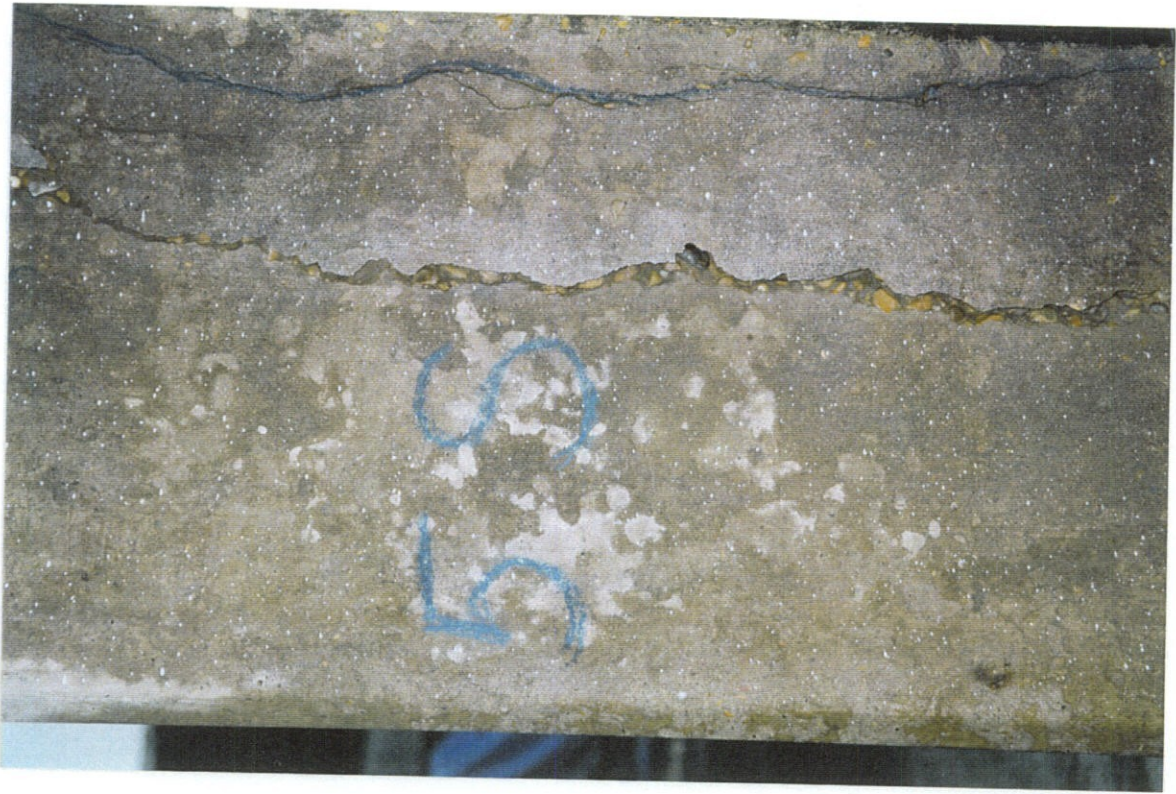
PHOTO NO. 26 - PILE NO. 5, SOUTH FACE, MIDDLE PORTION OF PILE. CONTINUATION OF CRACKS SHOWN IN PHOTO NO. 25.

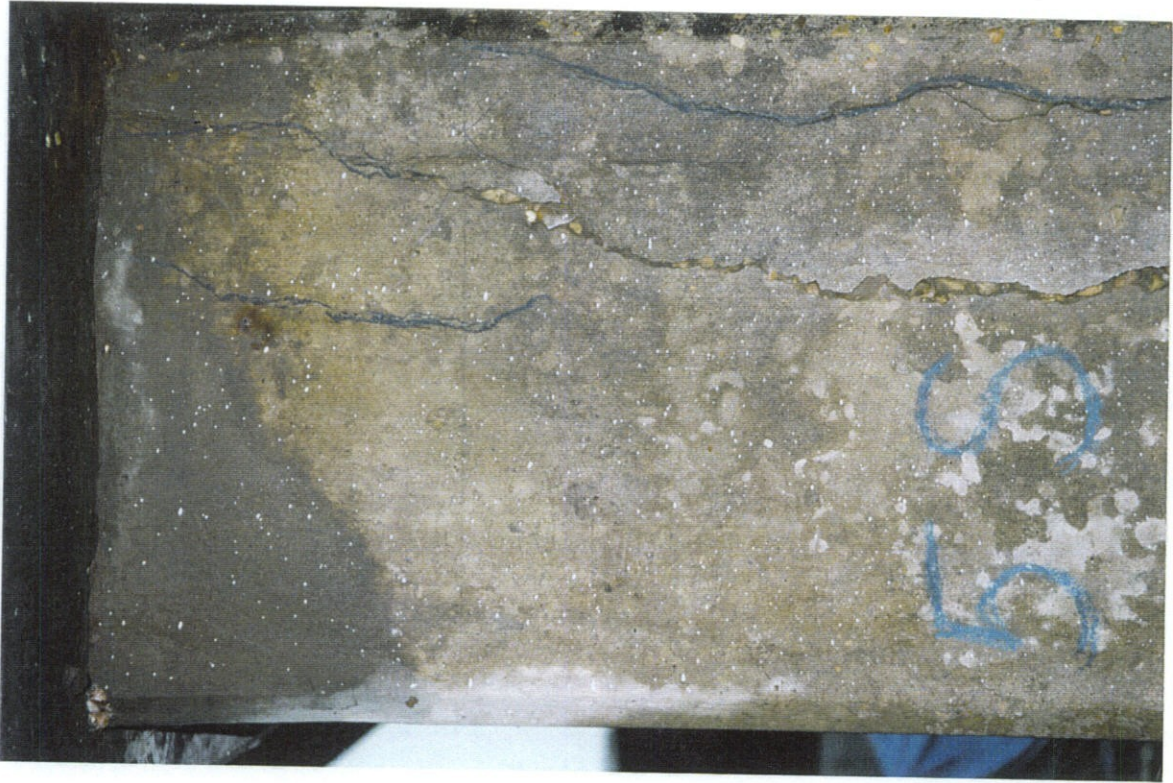
PHOTO NO. 25 - PILE NO. 5, SOUTH FACE, UPPER PORTION OF PILE. LARGE PATCH AT TOP, VERTICAL CRACKS ON RIGHT.

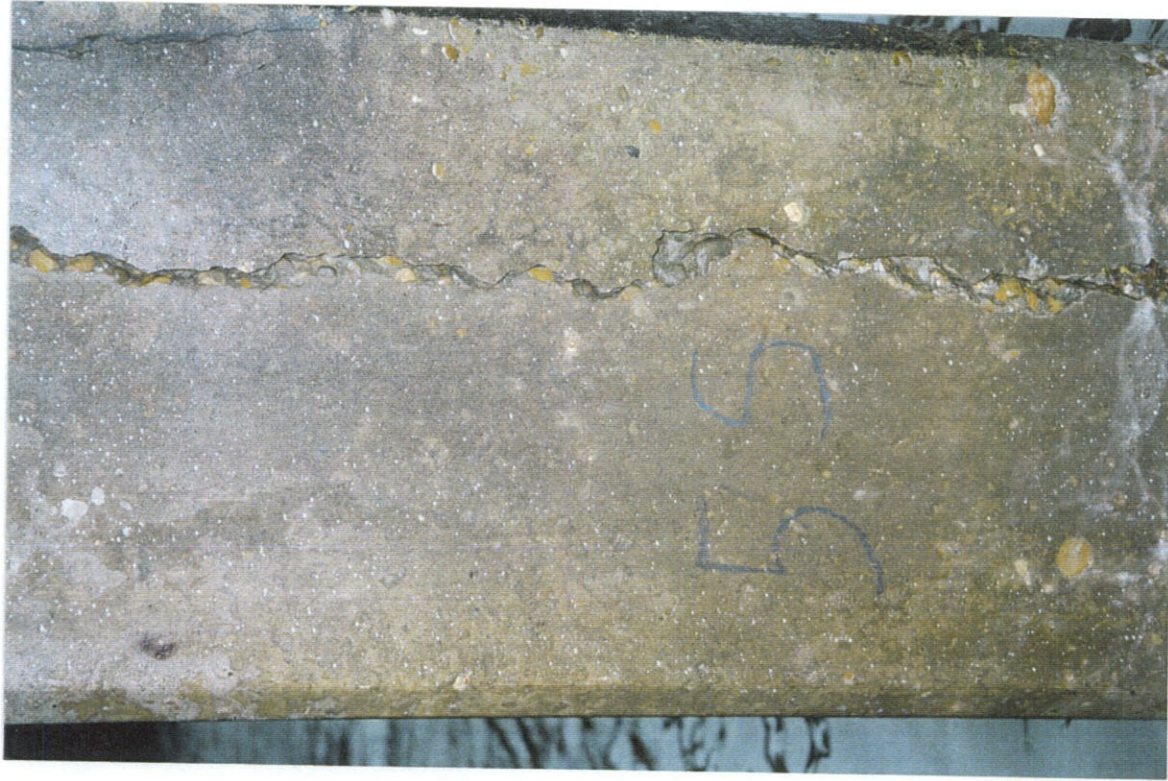
PHOTO NO. 27 - PILE NO. 5, SOUTH FACE, LOWER PORTION OF PILE. CONTINUATION OF CRACKS SHOWN IN PHOTO NO. 26.

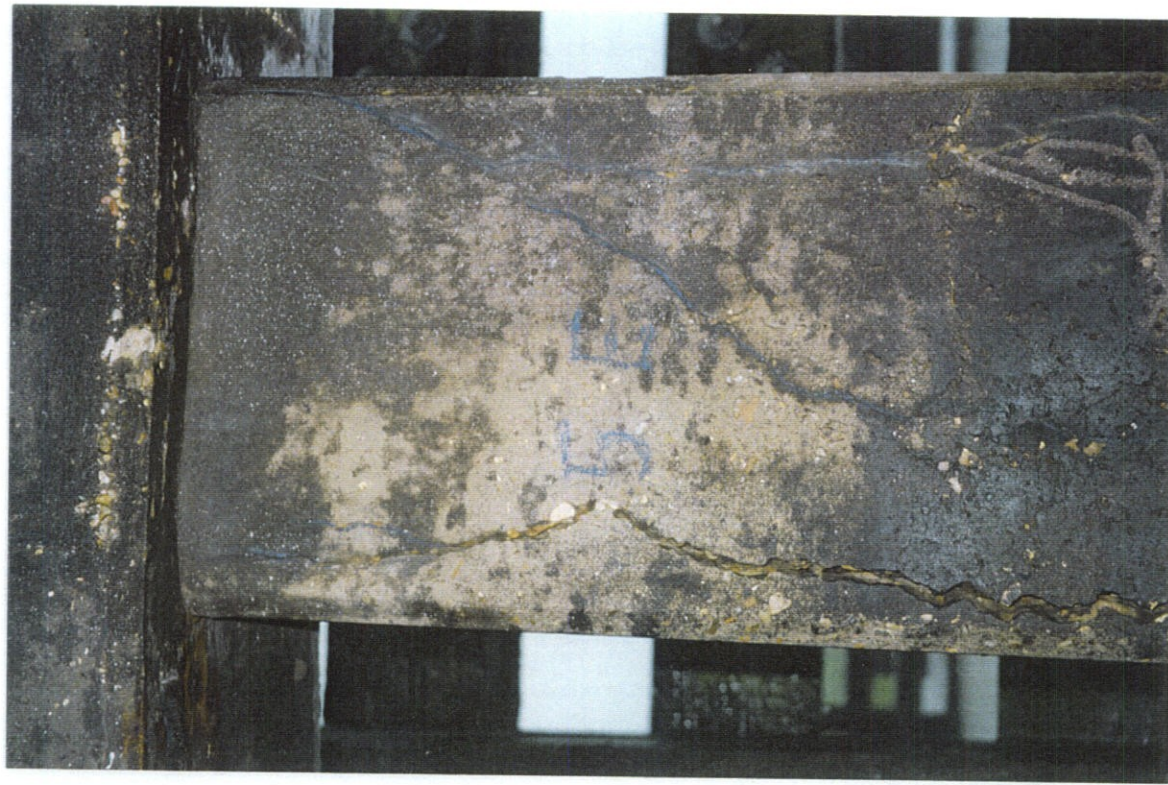
PHOTO NO. 28 - PILE NO. 5, EAST FACE, UPPER PORTION OF PILE. CRACK AT SOUTHEAST CORNER OPEN 1/4 INCH ±.

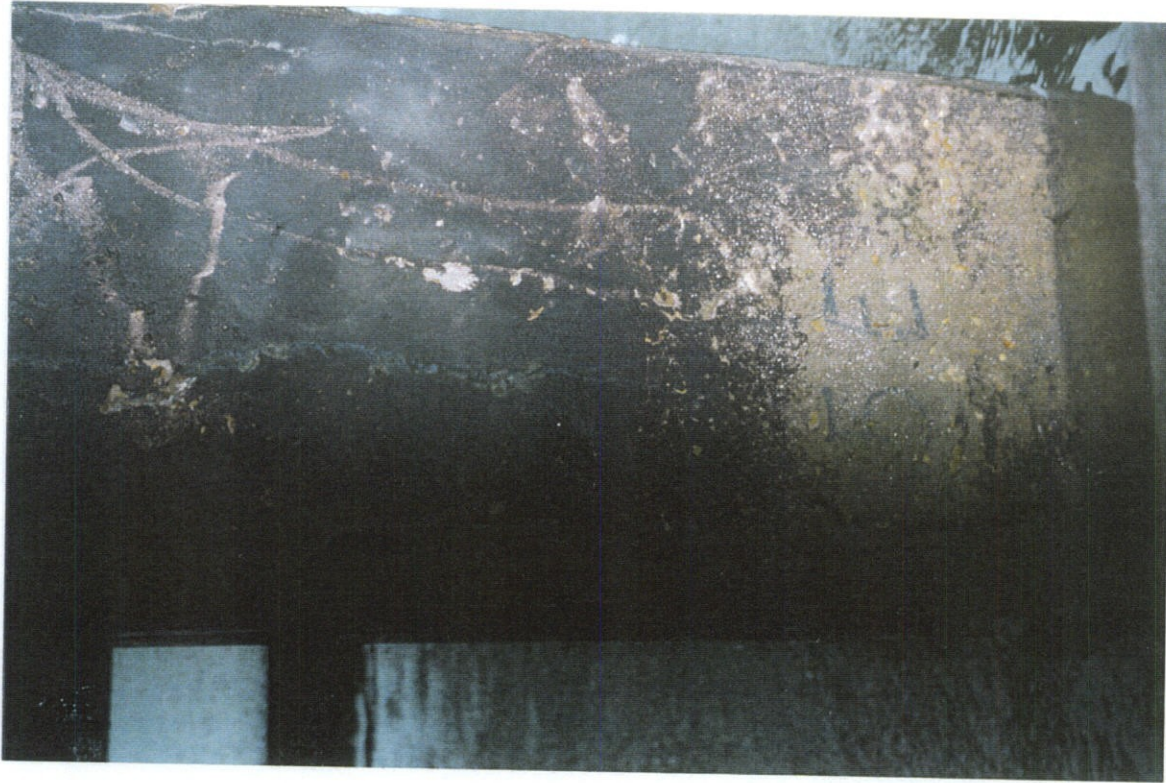
PHOTO NO. 29 - PILE NO. 5, EAST FACE, LOWER PORTION OF PILE. CONTINUATION OF CRACK AT SOUTHEAST CORNER (PHOTO NO. 28) TO WATER SURFACE DOES NOT SHOW EXCEPT NEAR WATER SURFACE DUE TO POOR QUALITY OF PHOTO.

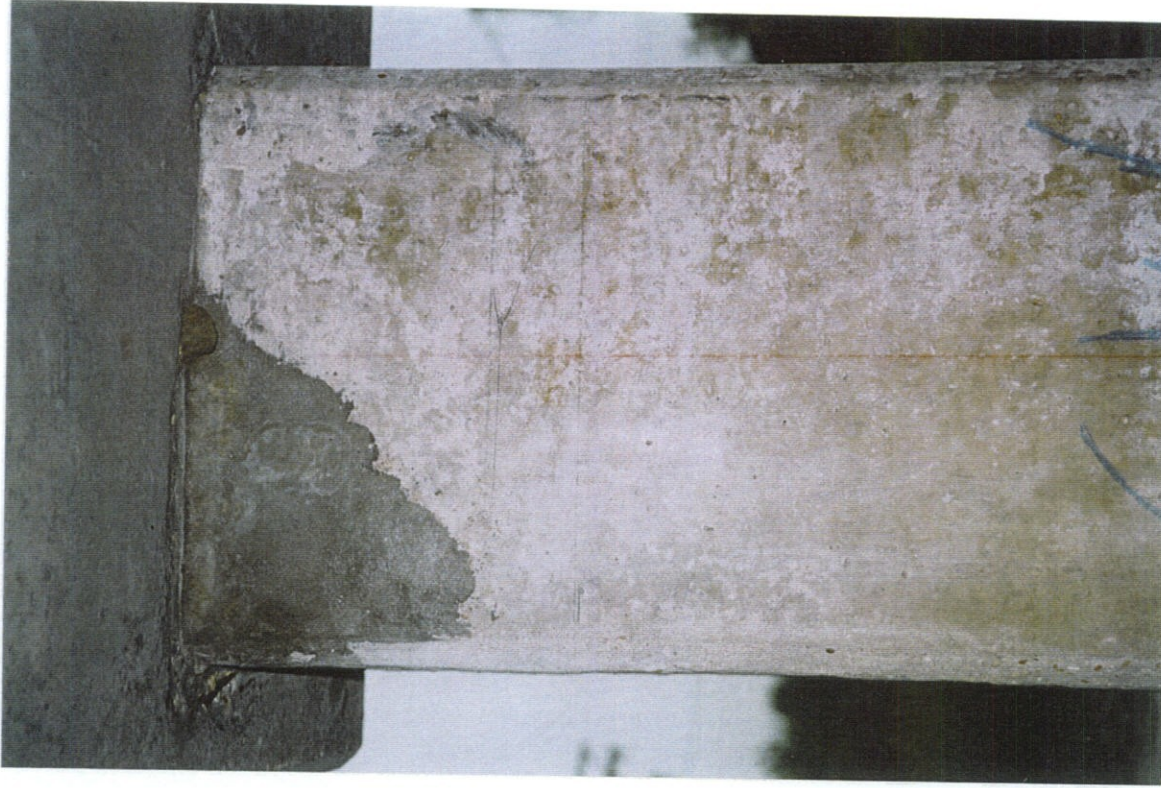
PHOTO NO. 30 - PILE NO. 6, WEST FACE. PATCH AT TOP AT NORTHWEST CORNER OF PILE. NO CRACKS OBSERVED ON PILE NO. 6.

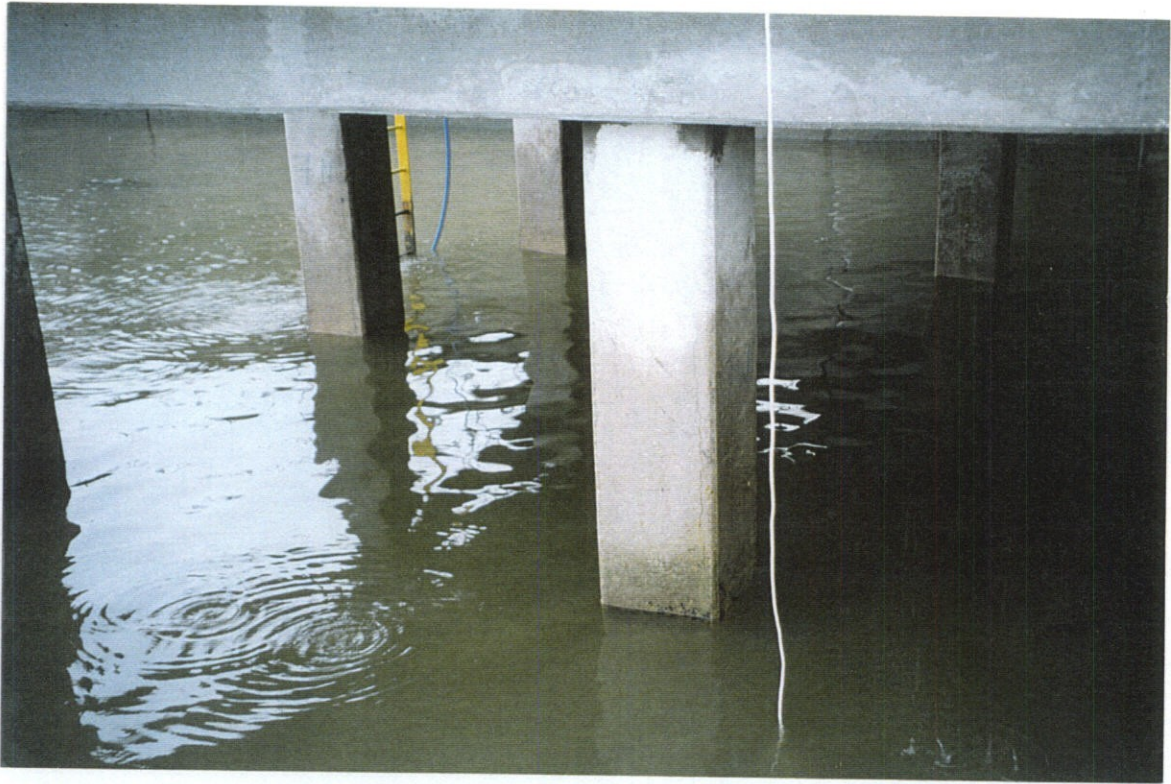
PHOTO NO. 31 - PILE NO. 7, NORTH FACE. VERTICAL CRACK NEAR NORTHWEST CORNER OF PILE.

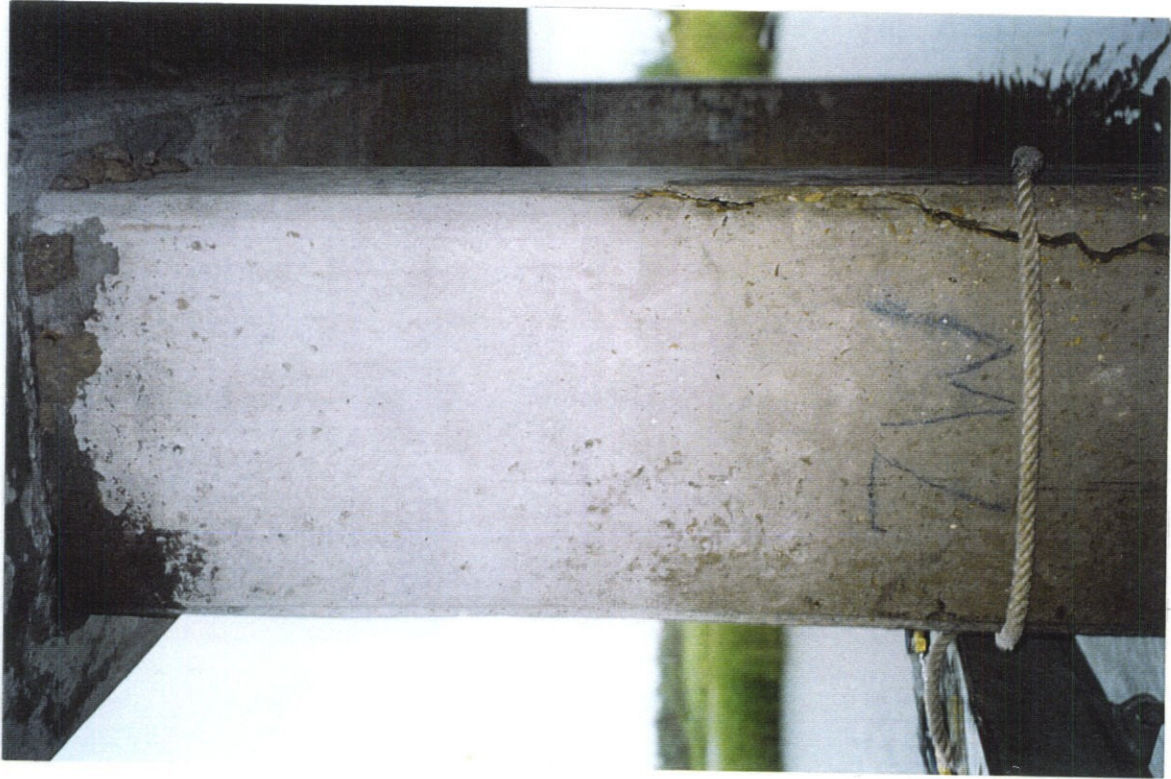
PHOTO NO. 32 - PILE NO. 7, WEST FACE, UPPER PORTION OF PILE. PATCH AT TOP OF PILE. OPEN CRACK AT SOUTHWEST CORNER OF PILE.

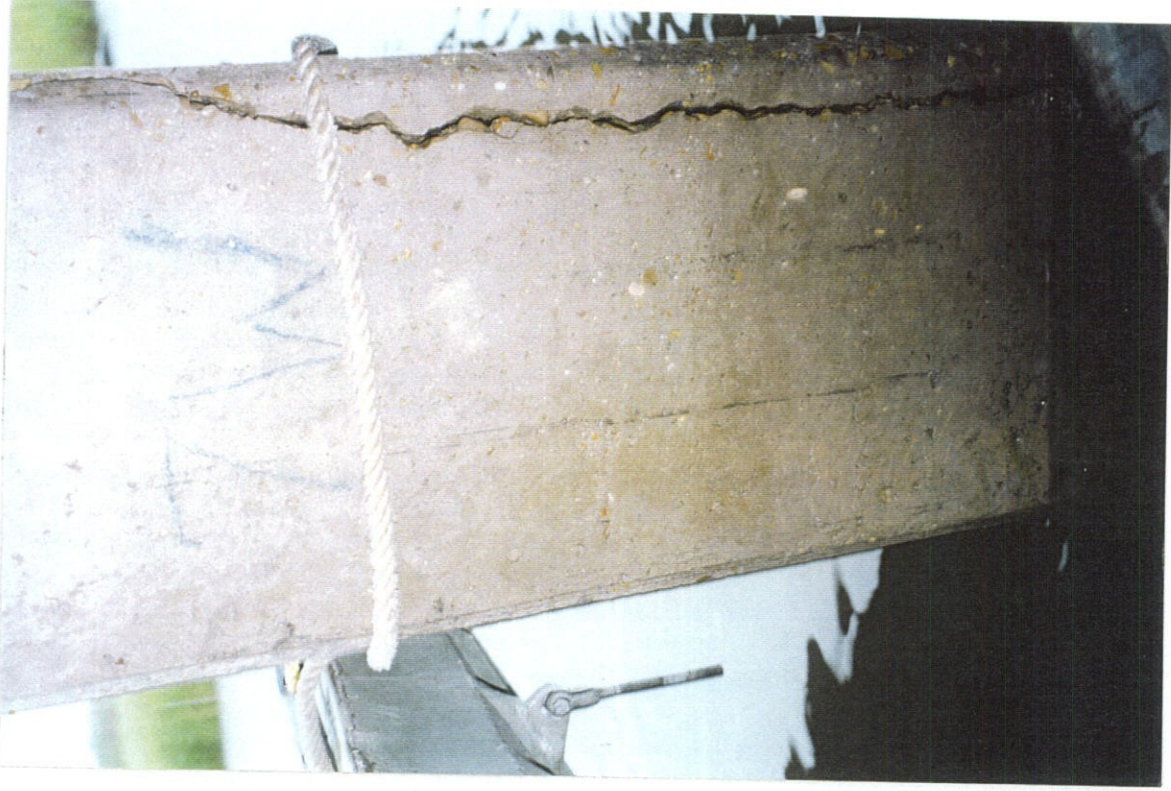
PHOTO NO. 33 - PILE NO. 7, WEST FACE, LOWER PORTION OF PILE. CONTINUATION OF OPEN CRACK SHOWN IN PHOTO NO. 32.
