**US Army Corps
of Engineers**

New Orleans District

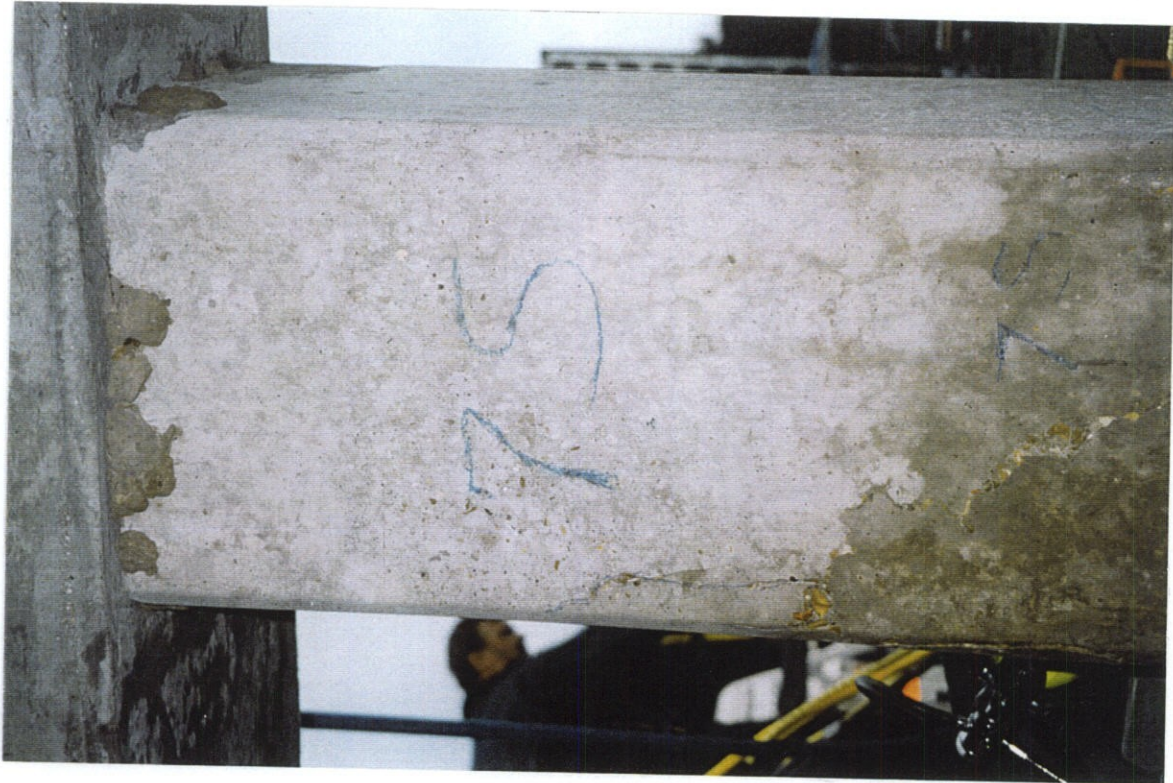
PHOTO NO. 34 - PILE NO. 7, SOUTH FACE, UPPER PORTION OF PILE. PATCHES AT TOP OF PILE. CRACK NEAR SOUTHWEST CORNER AND LEFT OF LOWER "7S."

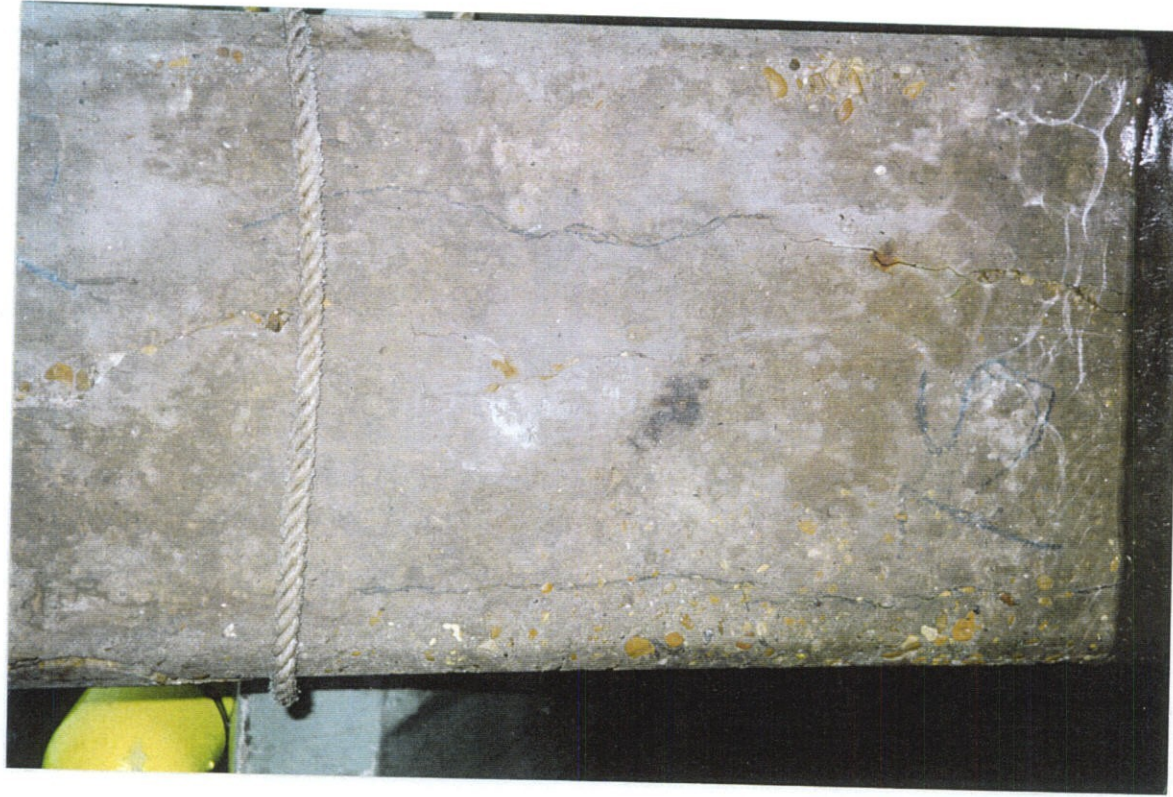
PHOTO NO. 35 - PILE NO. 7, SOUTH FACE, LOWER PORTION OF PILE. CONTINUATION OF CRACK NEAR SOUTHWEST CORNER OF PILE SHOWN IN PHOTO NO. 34 AND CRACK WEST OF CENTER OF PILE.

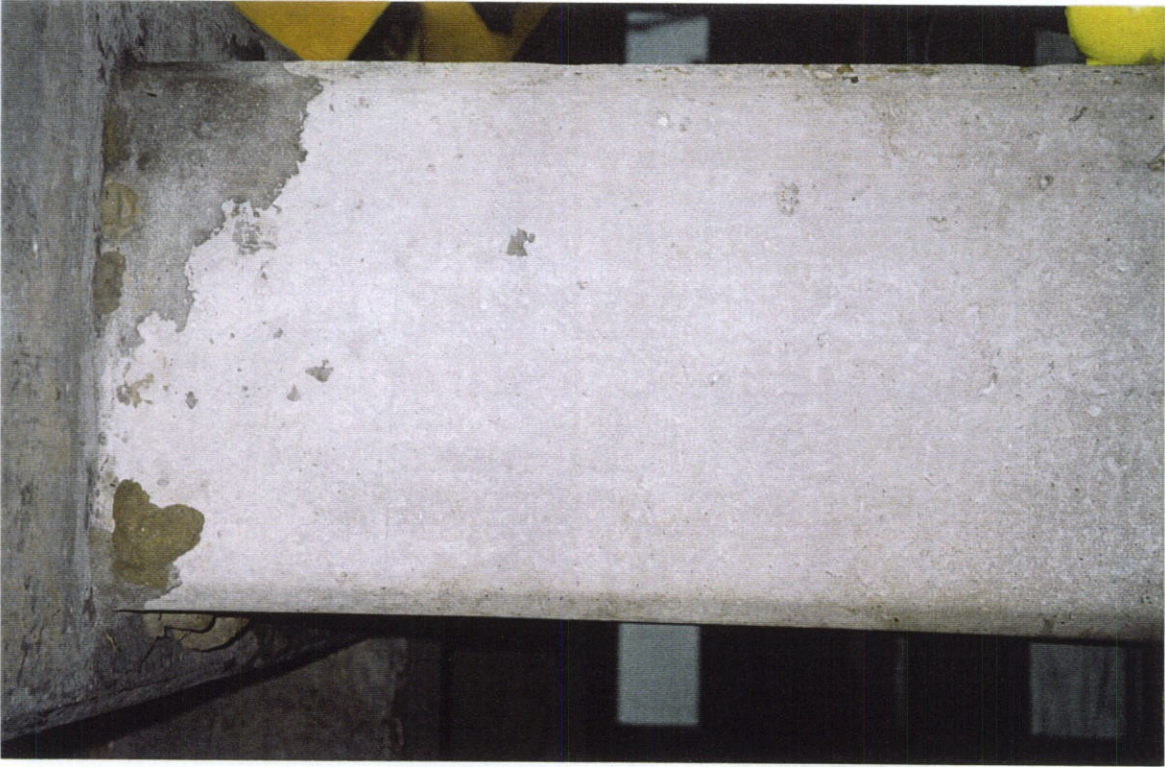
PHOTO NO. 36 - PILE NO. 7, EAST FACE. TOP PORTION OF PILE. PATCHES AT TOP OF PILE.

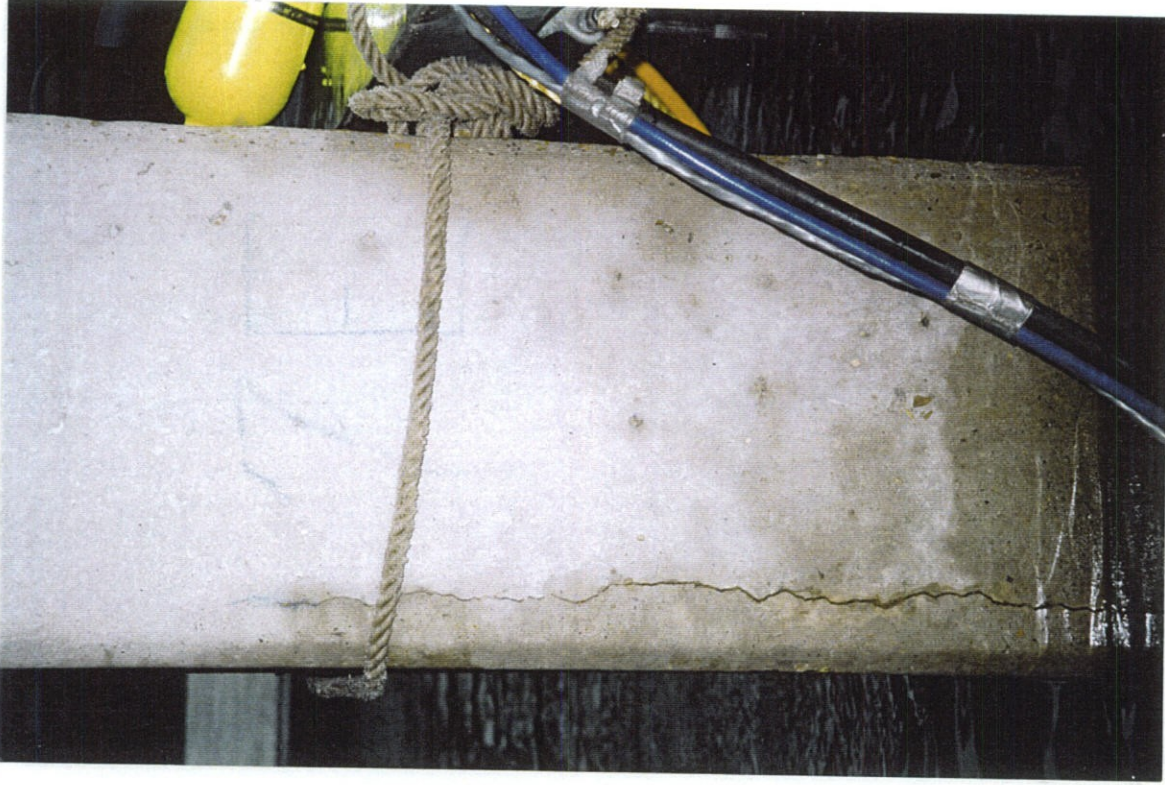
PHOTO NO. 37 - PILE NO. 7, EAST FACE. LOWER PORTION OF PILE. CRACK NEAR AND GENERALLY PARALLEL TO SOUTHEAST CORNER OF PILE.

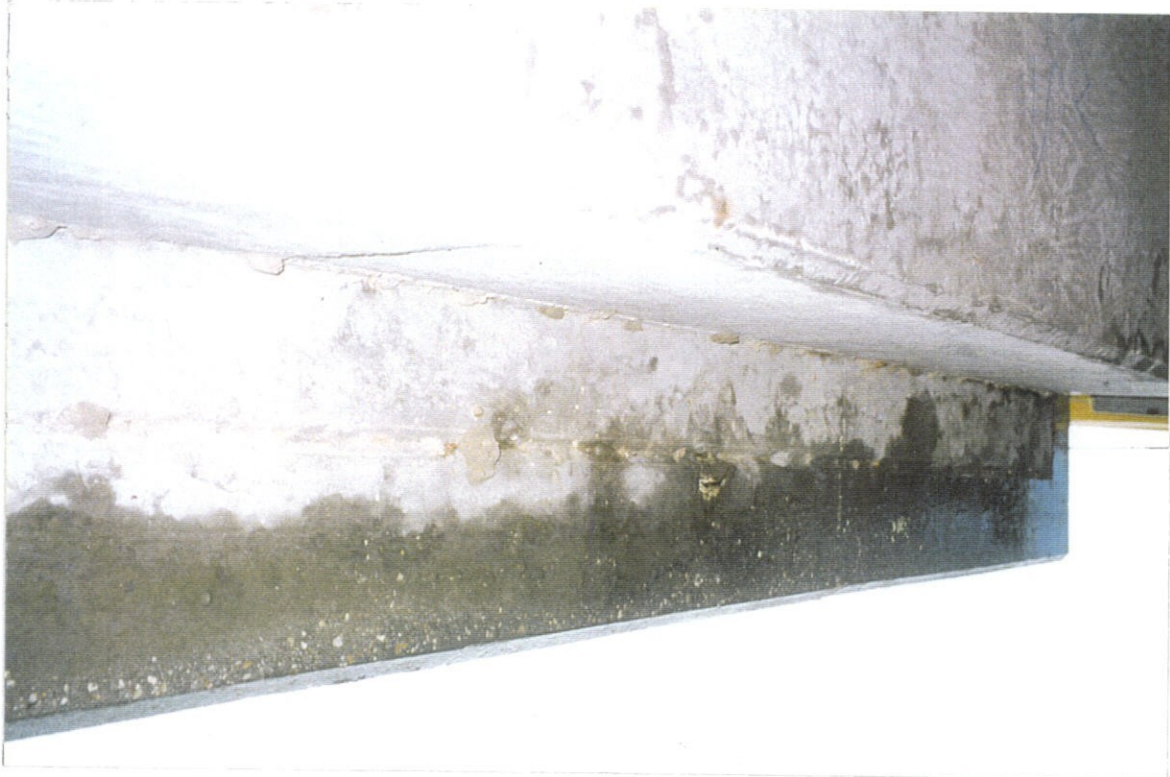
PHOTO NO. 39 - WEST UPPER DECK OVERHANG UNDERSIDE.
NOTE CRACK ALONG DRIP STRIP.

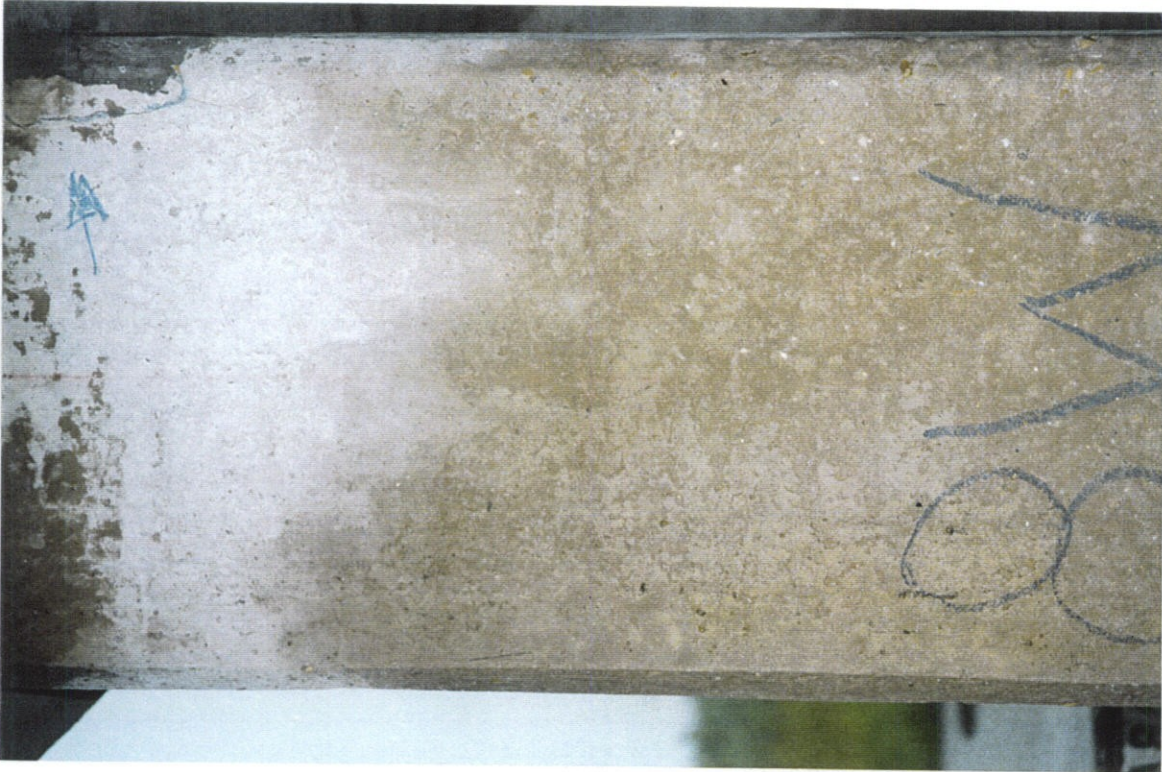
PHOTO NO. 38 - PILE NO. 8, WEST FACE. UPPER PORTION OF
PILE. HAIRLINE CRACK AT TOP OF PILE (ARROW). NO OTHER
CRACKS OBSERVED ON THIS PILE.

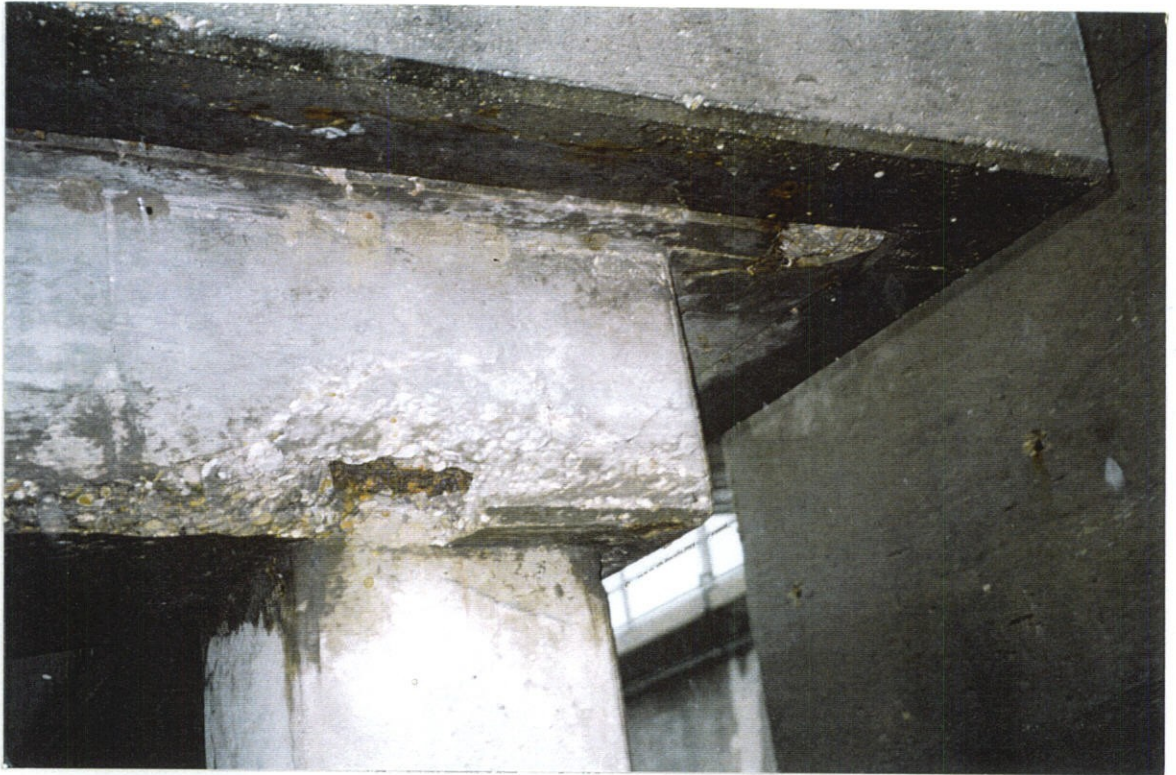
PHOTO NO. 40 – SOUTH END OF WEST NORTH/SOUTH BEAM AND UNDERSIDE OF TOP DECK OVERHANG. NOTE CRACKED AND SPALLED AREA ON BEAM WITH EXPOSED REINFORCEMENT AND SPALL AND CRACK IN DECK OVERHANG.

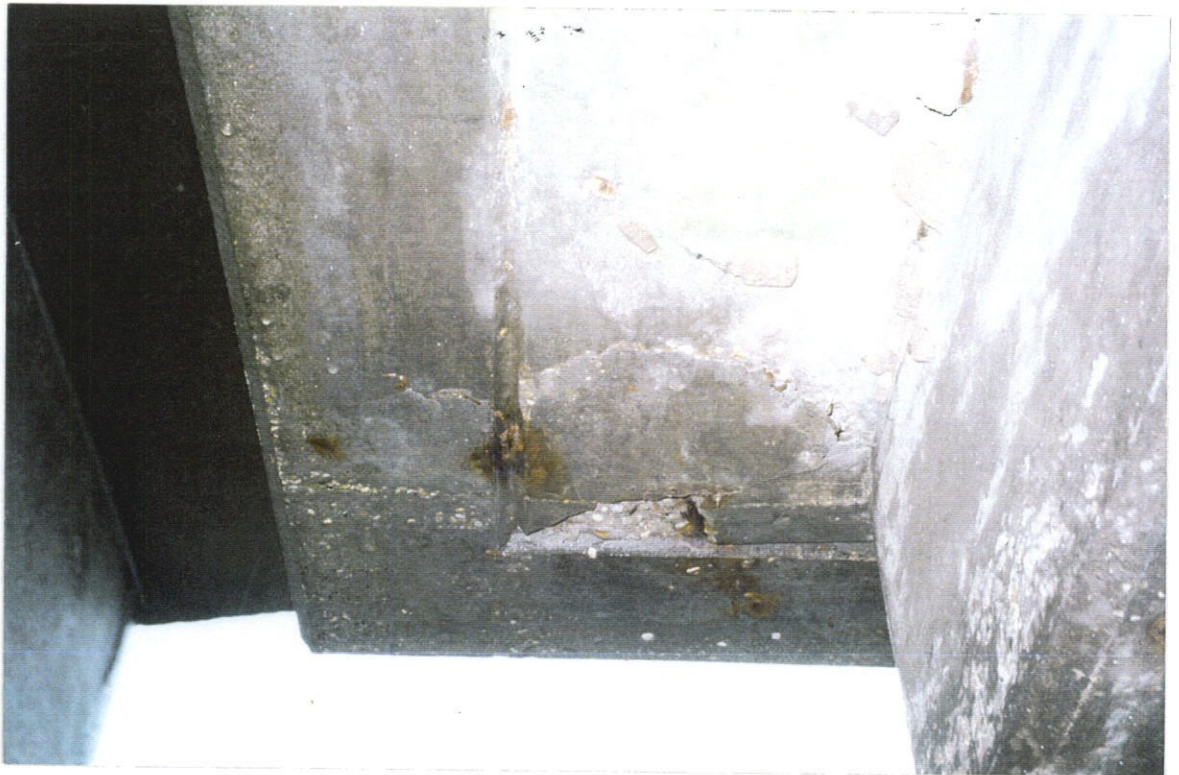
PHOTO NO. 41 – UNDERSIDE OF UPPER DECK SOUTH OVERHANG, PHOTO LOOKING WEST. NOTE SPALL AT DRIP STRIP (SHOWS IN PHOTO NO. 40) AND CRACKS IN UNDERSIDE OF DECK.

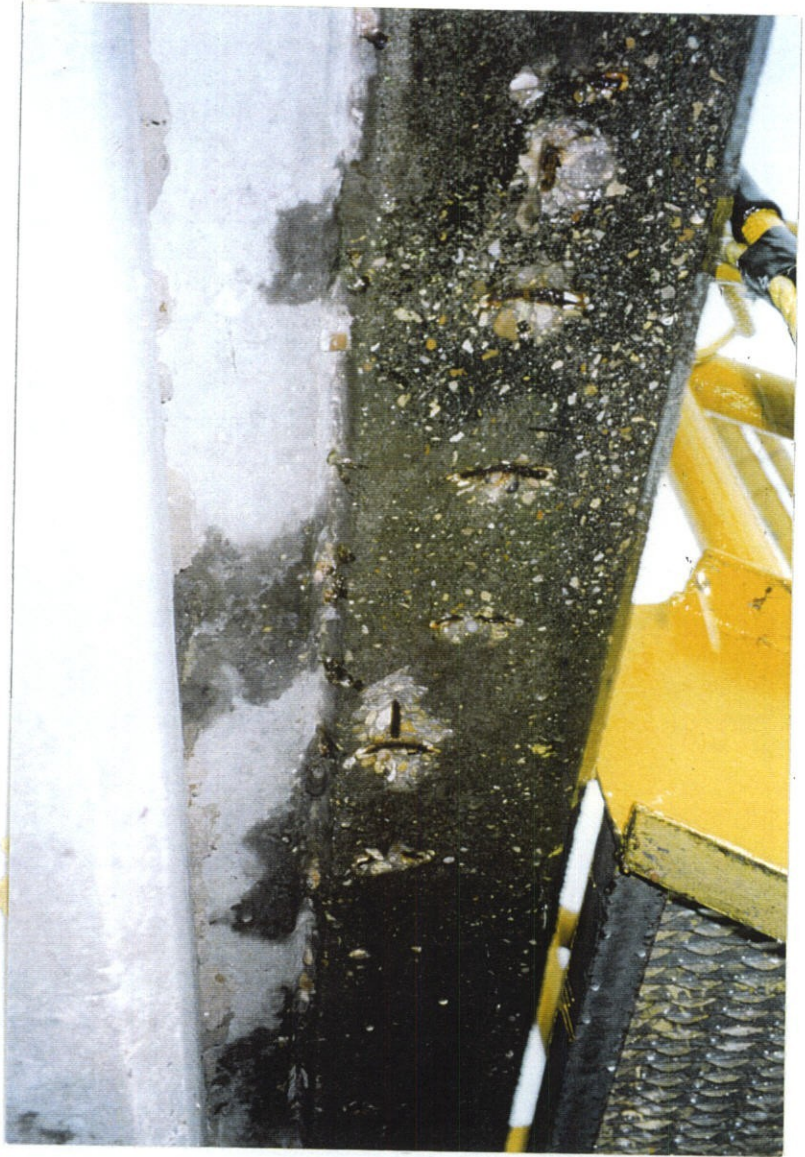
PHOTO NO. 42 - LOOKING WEST AT UNDERSIDE OF UPPER DECK NORTH OVERHANG. NOTE SHALLOW SPALLS WITH WHAT APPEARS TO BE EXPOSED REINFORCEMENT CHAIRS THAT ARE CORRODED.

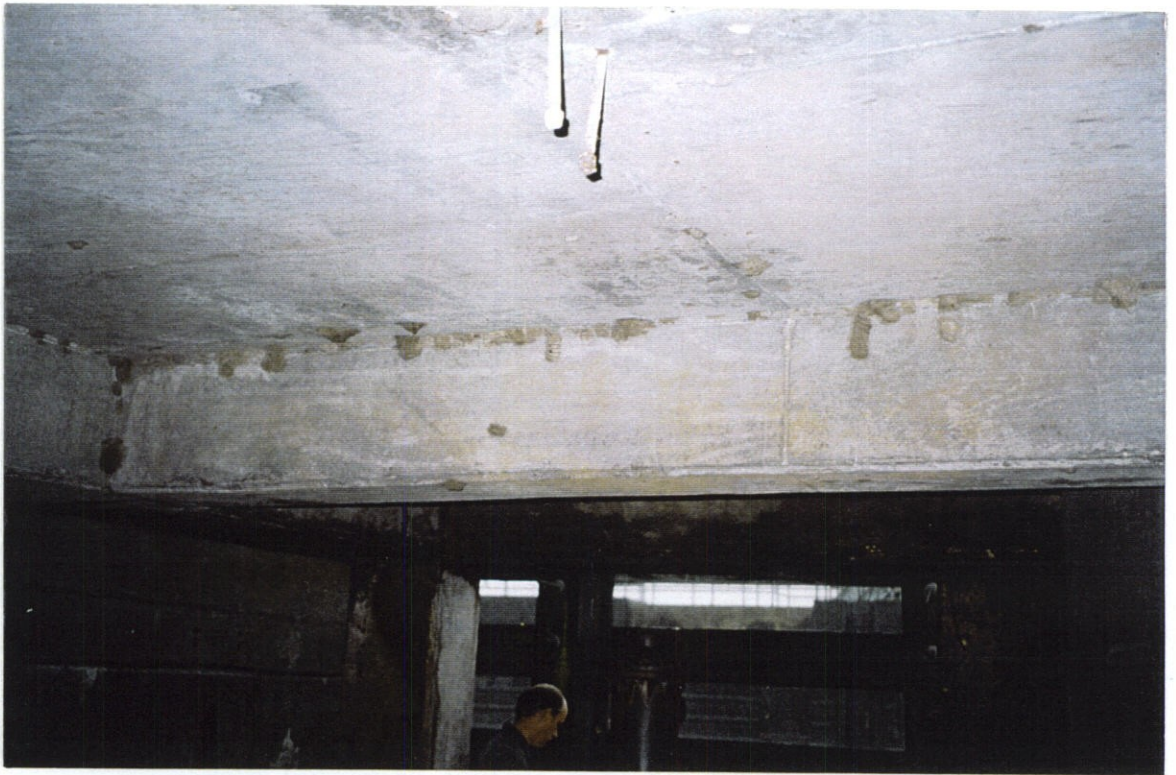
PHOTO NO. 43 - LOOKING WEST AT UNDERSIDE OF UPPER DECK (AREA A AS DENOTED ON CRACK SURVEY PLAN SHEET). NO CRACKS NOTED.

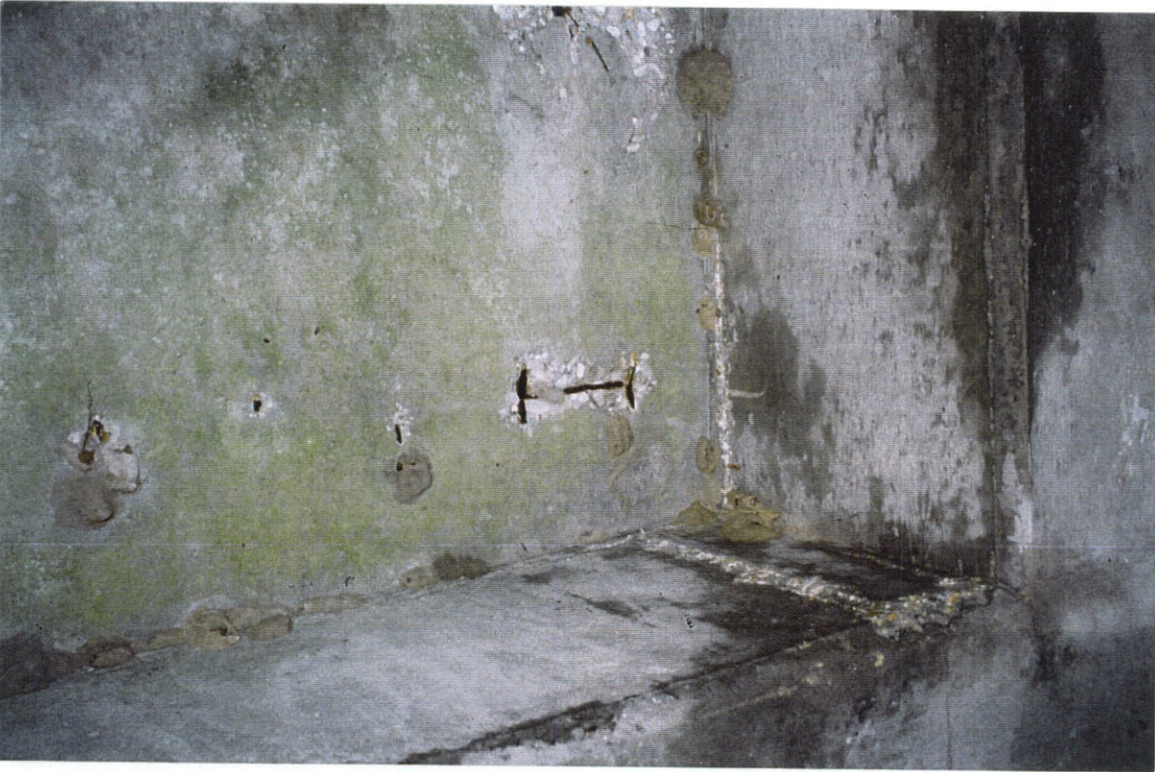
PHOTO NO. 44 - UNDERSIDE OF UPPER DECK, NORTHEAST CORNER OF AREA B (DENOTED ON CRACK SURVEY PLAN SHEET) LOOKING EAST.

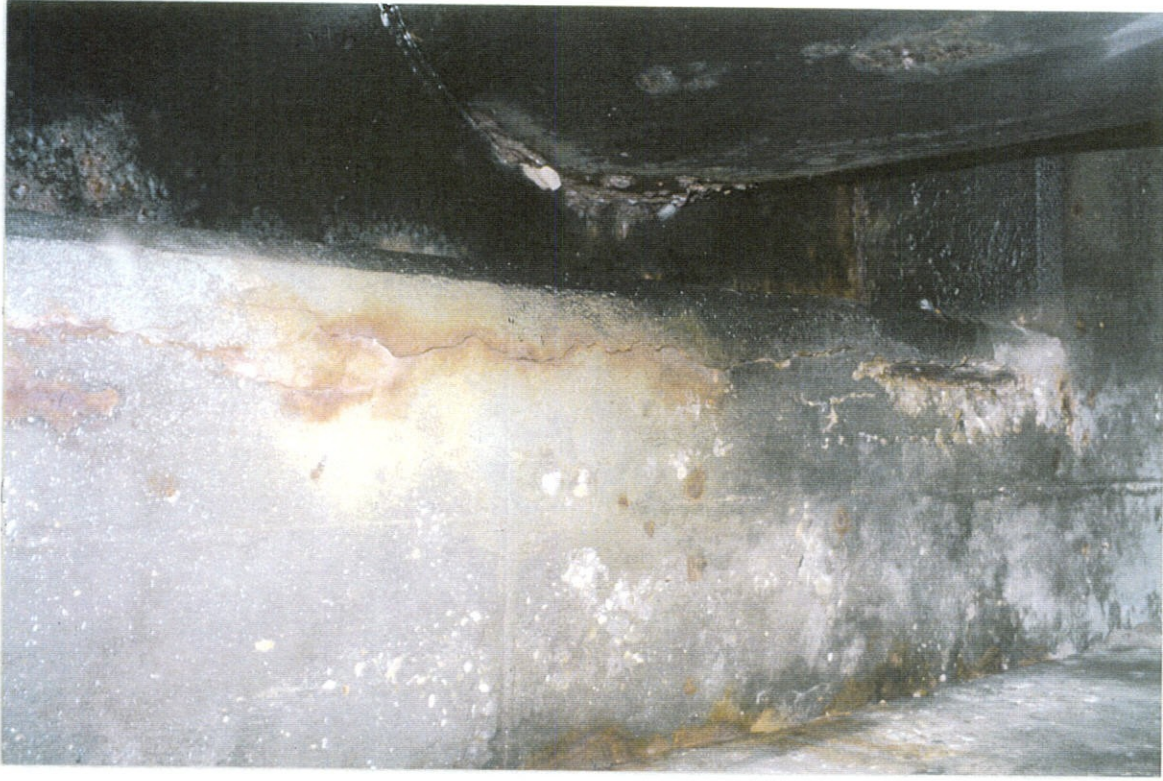
PHOTO NO. 45 - UNDERSIDE OF UPPER DECK, AREA B, JUST WEST OF PUMP COLUMN BLOCKOUT, LOOKING NORTH. PUMP COLUMN ON RIGHT.

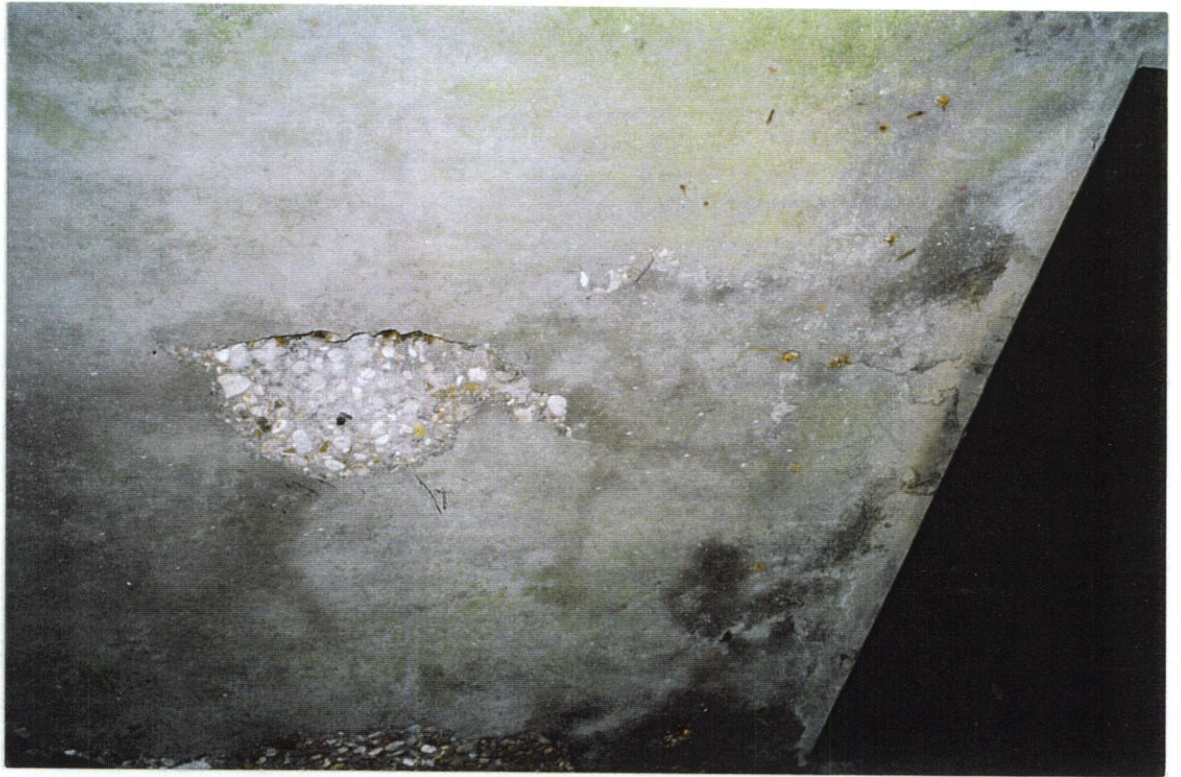
PHOTO NO. 47 - UNDERSIDE OF UPPER DECK, AREA B, LOOKING WEST AT AREA JUST SOUTH OF PUMP COLUMN RECESS. NOTE SPALL AND CRACK FROM PUMP COLUMN RECESS.

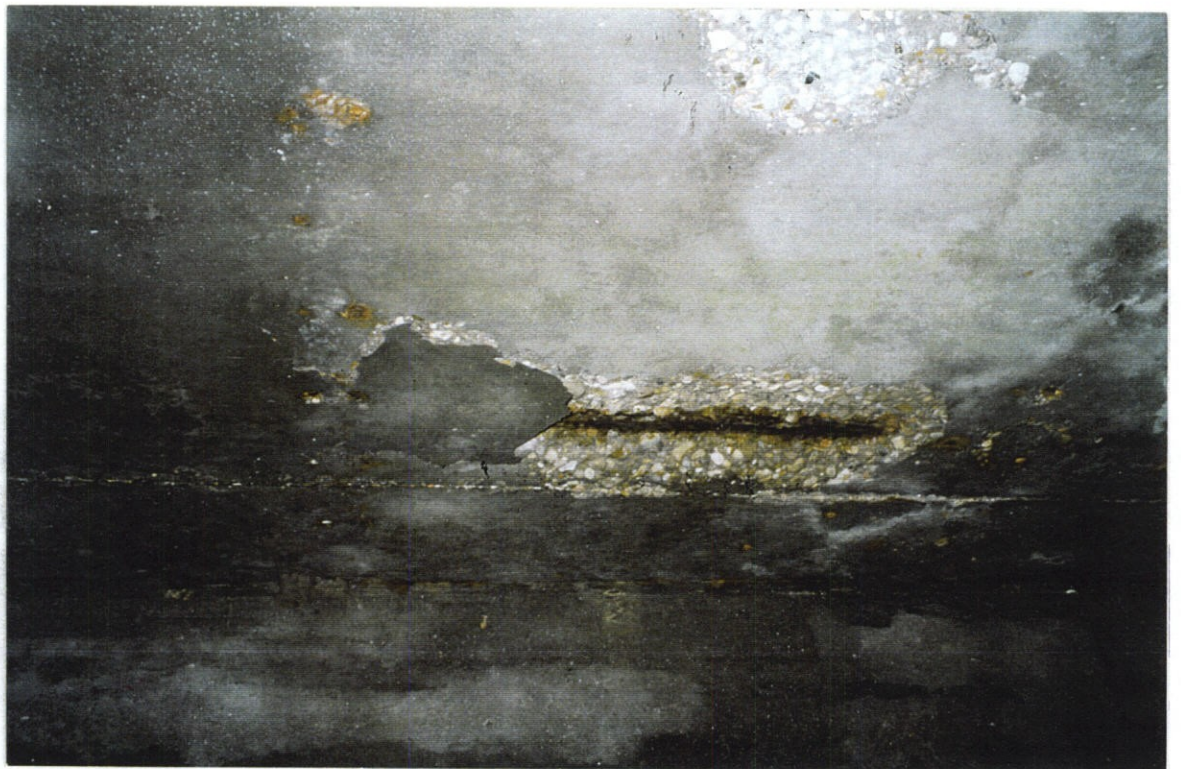
PHOTO NO. 48 - UNDERSIDE OF UPPER DECK, LOOKING WEST AT SOUTHWEST PART OF AREA B, WEST NORTH/SOUTH BEAM IN BACKGROUND. NOTE PATCH AT SOUTH (LEFT) END OF EXPOSED CORRODED REINFORCEMENT.
