# STATE FIRE MARSHAL'S OFFICE

## Firefighter Fatality Investigation

**Investigation Number 05-218-02**

**Captain Grady Burke**

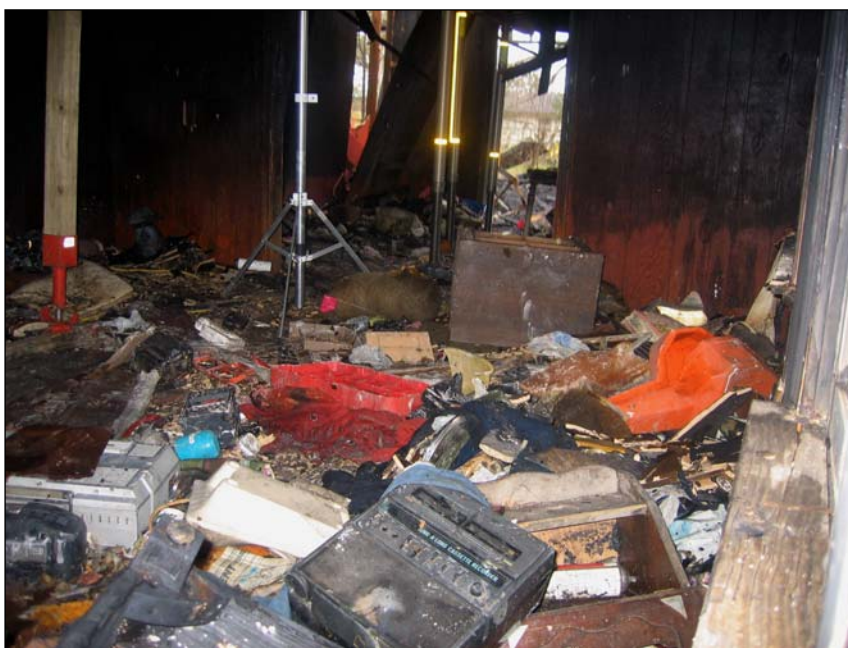
Interior of 8510 Brandon (post fire)

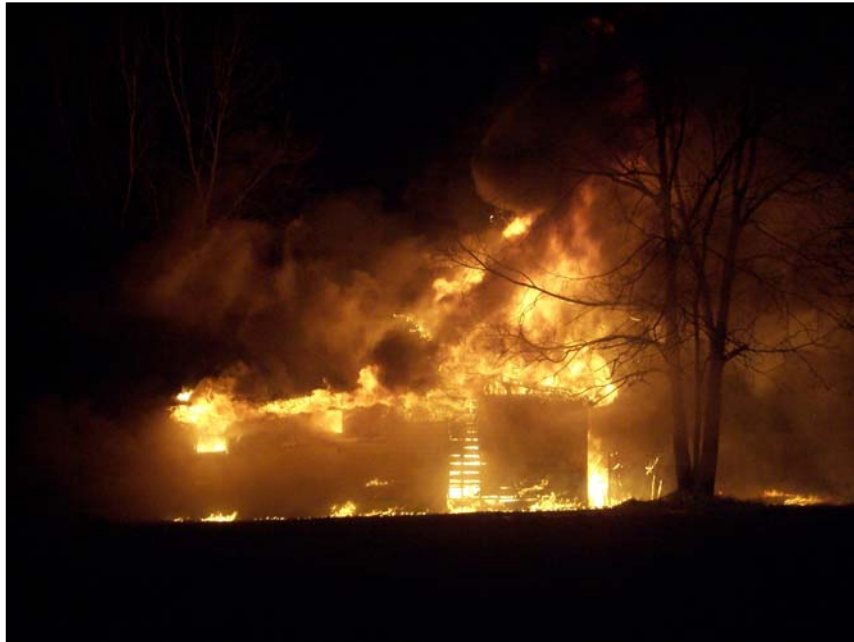
**North side of 8510 Brandon shortly after firefighters entered.  
(Houston Fire Department Photo)**

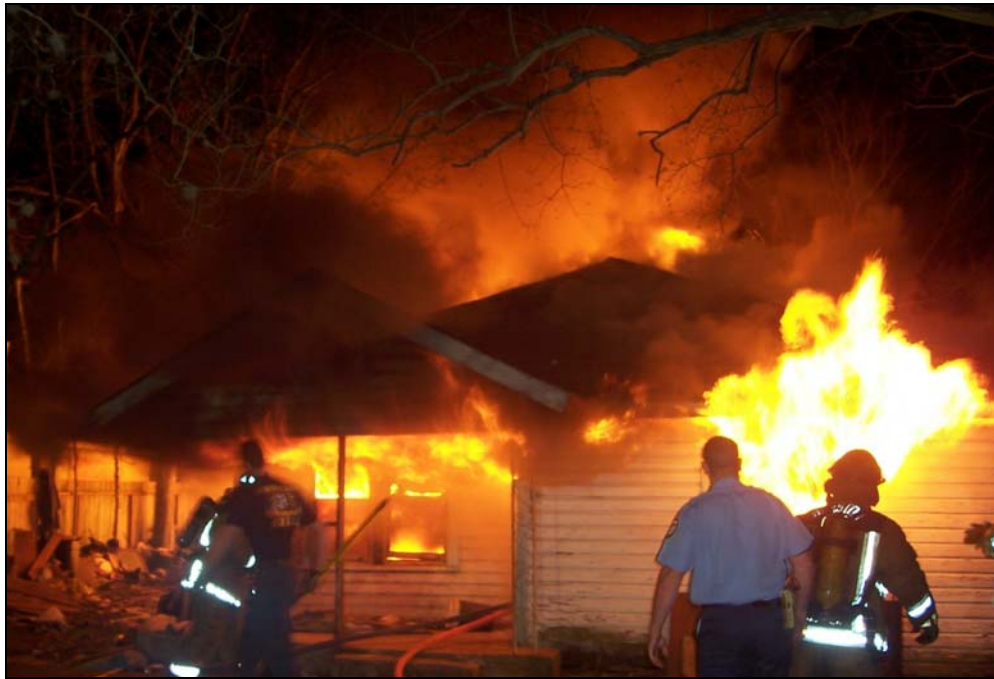
**Front (East side) of 8510 Brandon at the time the roof collapse forced smoke and burning gases throughout the building. E46 and L46 crews are inside the building at this time. (Houston Fire Department Photo)**

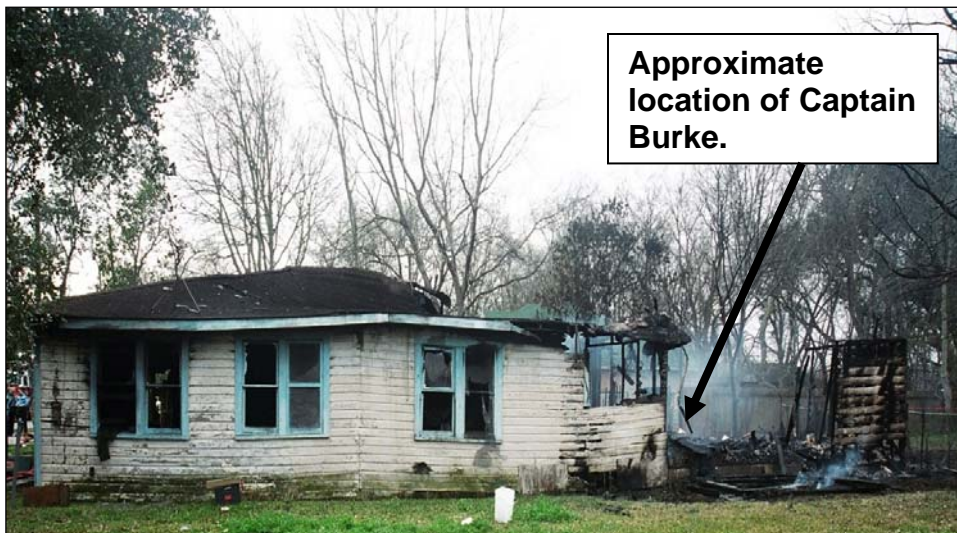
**North side of 8510 Brandon (post-fire) (Houston Fire Department Photo)**
