STATE FIRE MARSHAL'S OFFICE

Line of Duty Death Investigation

Investigation Number 02-251-02

Fire-Rescue Officer Vincent Davis

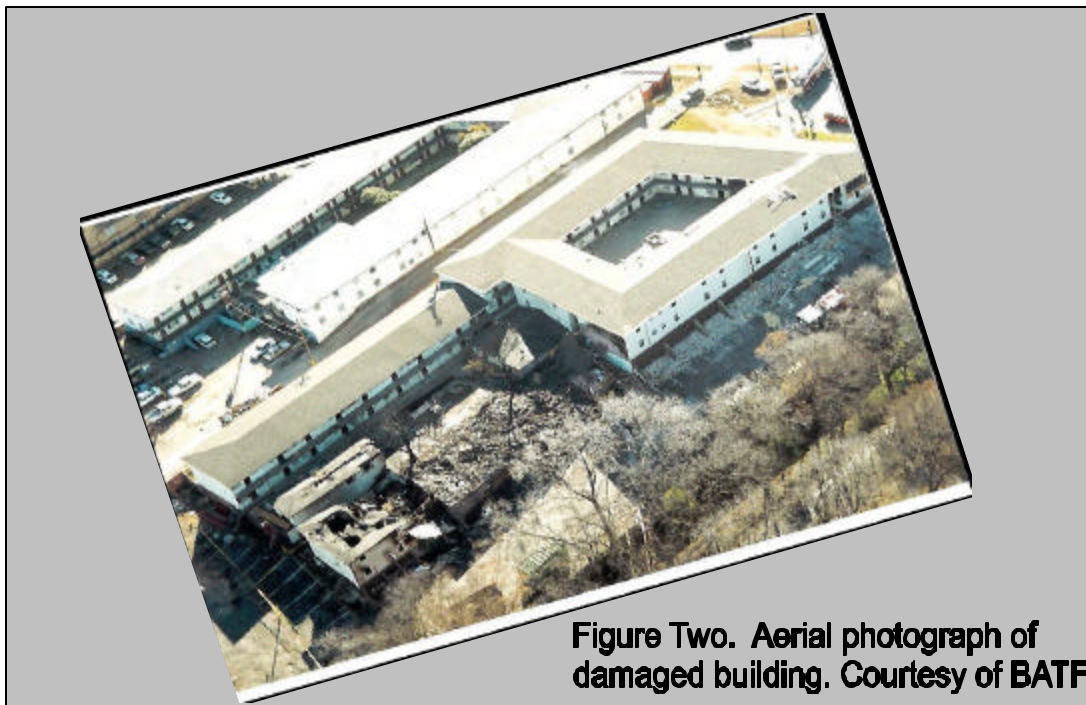
**Figure Two. Aerial photograph of
damaged building. Courtesy of BATF**

Section 2, north of the breezeway had totally collapsed. A portion of Section 1, north of the grade change, was standing but was heavily damaged. **(Figure Two)** Sections 8 and 9, located north and south of the open courtyard/play area sustained extensive damage from radiant heat.

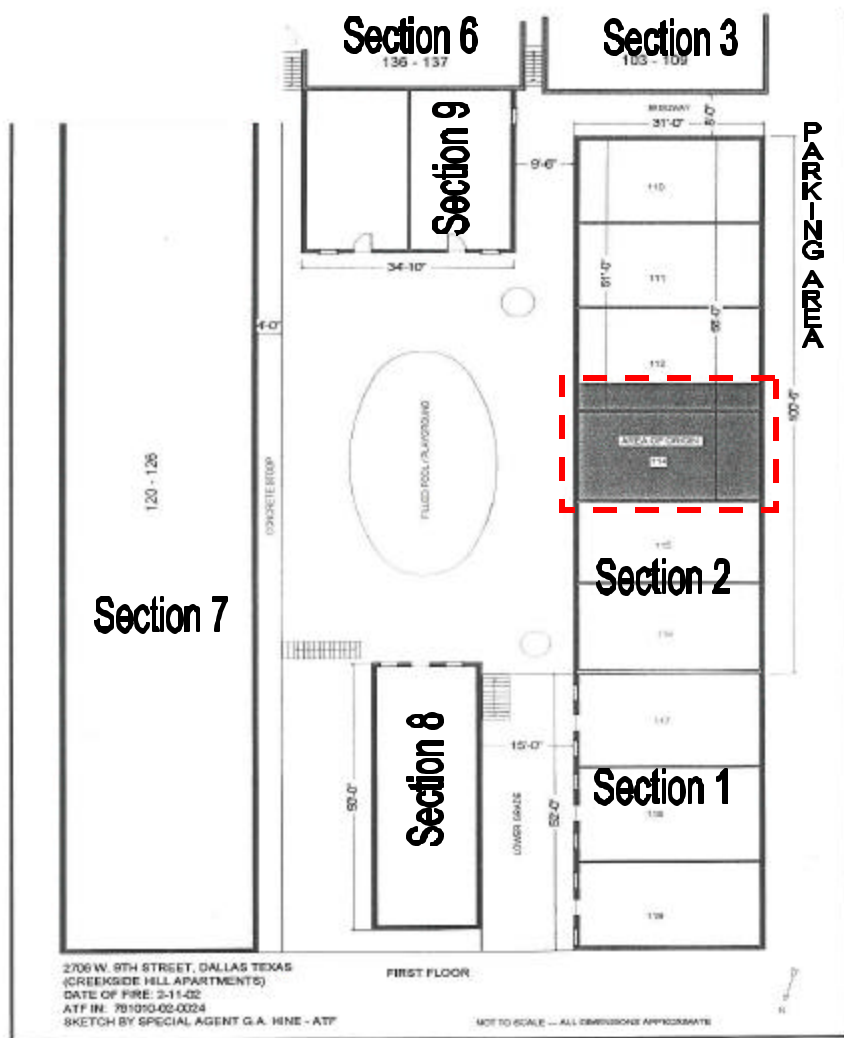
Investigators determined the fire originated in the area of apartment 114 in section 2 of building 2. **(Figure Three)** This building was undergoing extensive renovation. Cutting of metal guard rails with cutting torches and pipe soldering operations using open flame torches had been conducted in the building in the areas of apartments 114 and 214 on the afternoon of the day of the fire.

**Figure Three. Building Floor Plan
Courtesy of BATF.
Notations by SFMO.**

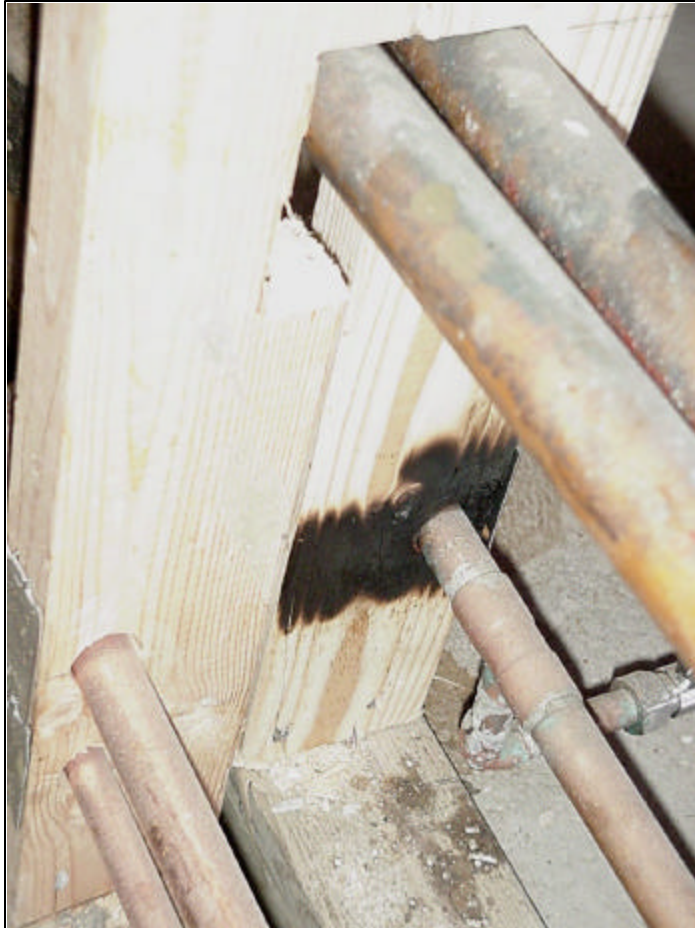
Figure Four. Charred wood observed in adjacent building undergoing renovation.

Evidence of careless cutting and pipe soldering operations was observed in adjacent buildings under renovation by the same contractor. **(Figures Four and Five)** Many areas of charred wood were observed where copper pipes had been sweat-soldered by the renovation contractor's employees. These areas of charred wood had the potential for smoldering for long periods before breaking out into open flame. Pipe soldering operations with open flame torches have been attributed to the fire cause of many large-loss fires.

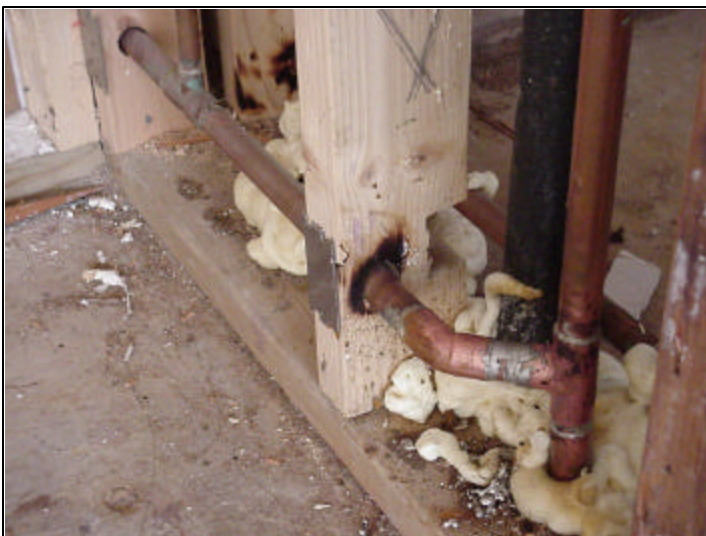
Figure Five. Charred wood observed in adjacent building undergoing renovation.

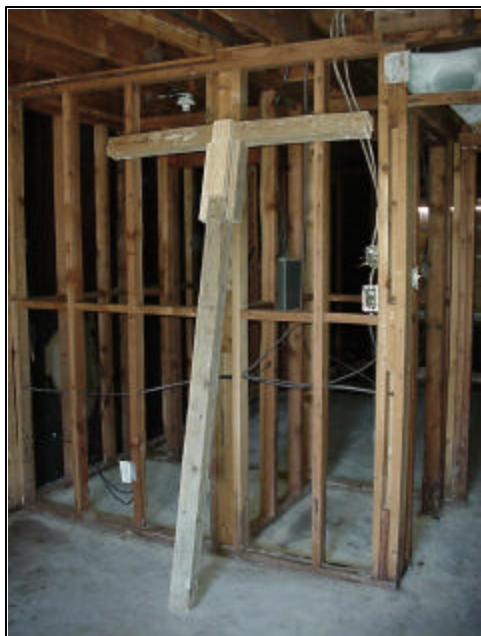
The walls of the apartments were originally covered with gypsum drywall, but the drywall had been removed from many apartments during the renovation process, exposing the wood structural members of the building. Replacement of deteriorated load bearing wood structural members was in progress and temporary "T"-shaped floor jacks were in use. **(Figure Six)** At least one burned "T-jack" was recovered from the fire debris.

The exposed wood structural members, combined with multiple horizontal and vertical openings, led to rapid fire spread through the structure after ignition. Temporary braces for load bearing walls, combined with the rapid failure of other exposed structural members led to a progressive collapse of section 2 of Building 2.

Figure Six. "T"-shaped floor jack found in area adjacent to fire.

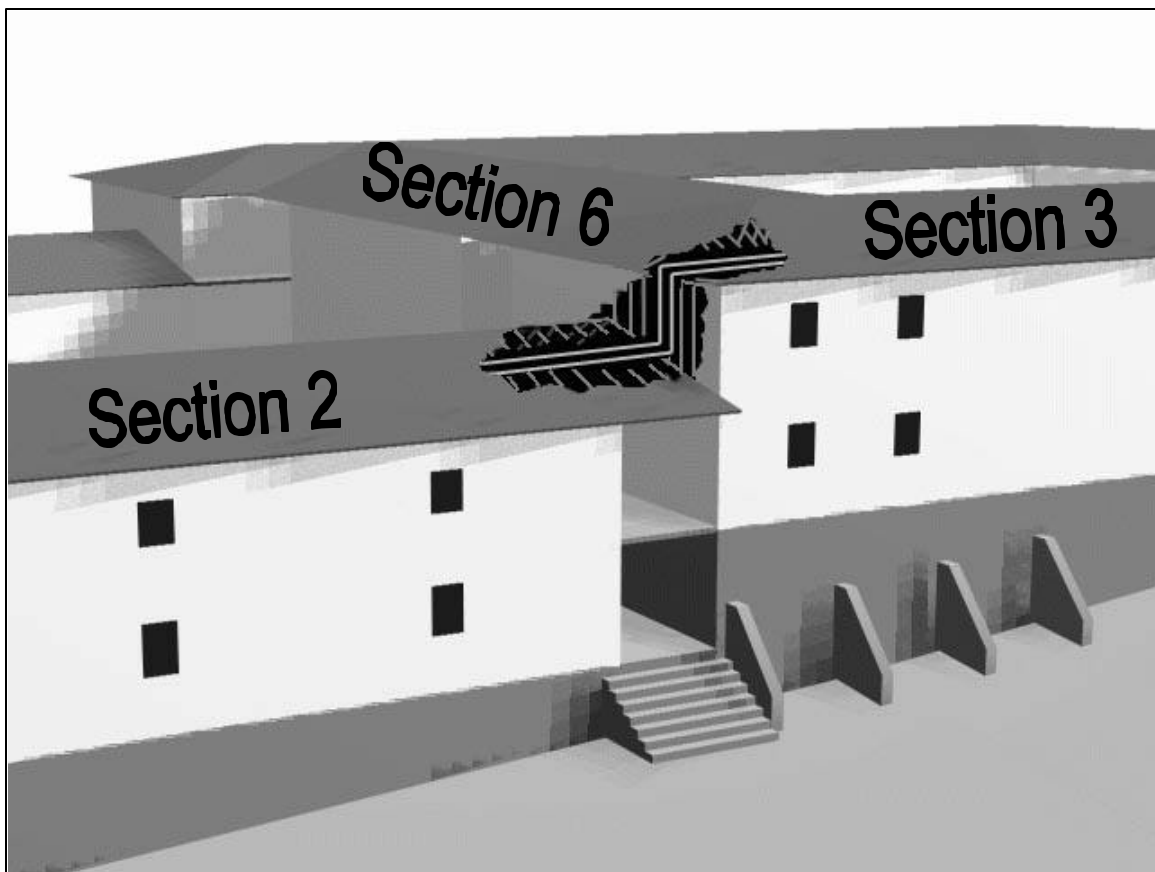
There is a significant change of grade from the south end of Section 2 to the north end of Section 3. Proceeding south from Section 2, the water supply piping first passed through a double wythe (Each continuous vertical section of masonry one unit in thickness) veneer brick wall, extended horizontally through a continuation of the peaked roof over the breezeway between Sections 2 and 3, and entered a double wythe brick veneer wall of adjacent section 3. The piping made a 90-degree turn to the vertical and continued vertically in a void behind the double wythe brick veneer wall toward the attic area of Section 3, where the piping turned again and took on a horizontal aspect. **(Figure Seven)**

Figure Seven. Arrangement of HVAC piping in attics and wall. Illustration provided by Dallas Fire-Rescue. Notations by SFMO

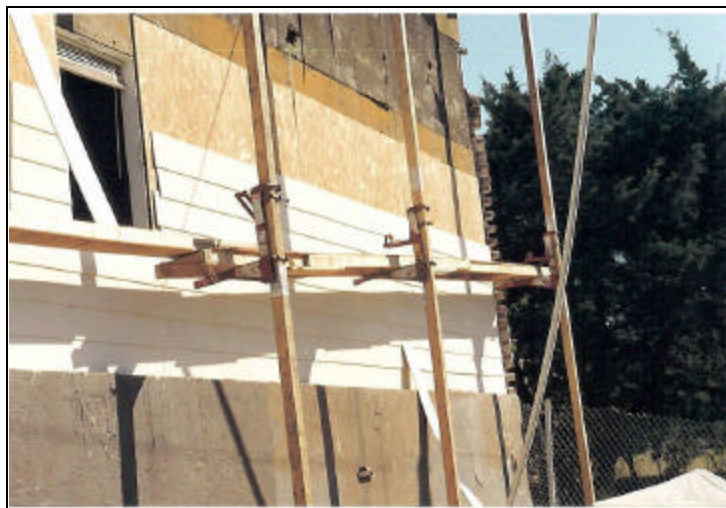
As part of the renovation project, all brick had been stripped from the west side of Section 3 and had been replaced by composition siding. **(Figure Eight)** This eliminated the tie-in between the double wythe brick veneer wall on the north end of Section 3 and the double wythe brick veneer on the west side of Section 3 that provided some structural stability. This created a freestanding double wythe wall over 15 feet tall that was separated from the structural members of Section 3 by a void of several inches.

Figure Eight. Southeast end of Section 3 showing brick removal. Photo by BATF.

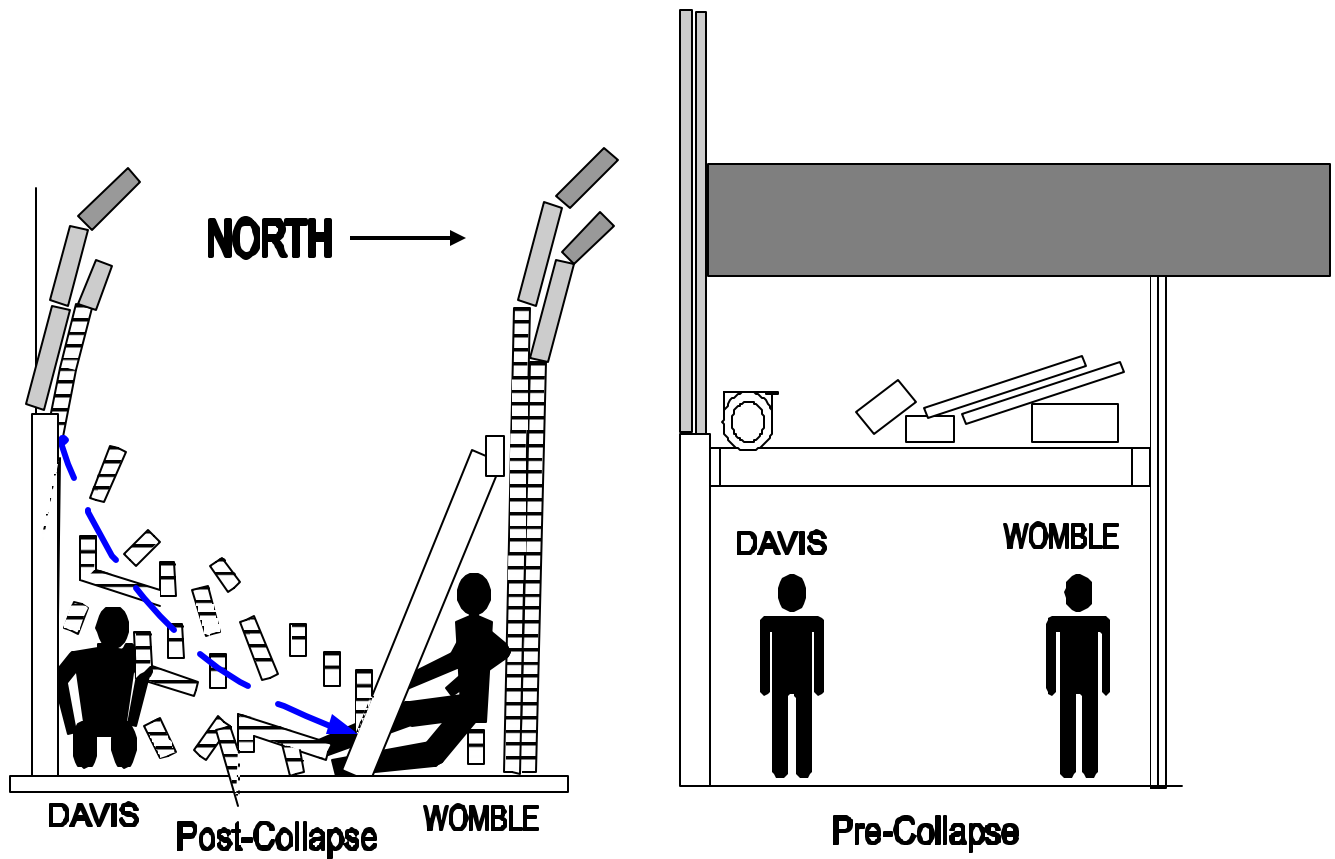
The falling bricks impacted upon the breezeway roof, shearing the ribbon board from the west end of the south wall causing a lean-to type collapse as the breezeway roof, still firmly attached on the north side, rotated downward. **(Figure Nine)** The falling breezeway roof impacted upon E 33's Vincent Davis' head and shoulders, driving him to a sitting position. Bricks continued to fall, completely covering Davis with bricks and wood. The falling breezeway roof knocked down E33's Chuck Womble and pinned his leg. Womble was located in the void space of the lean-to collapse and was shielded from most of the bricks. **(Figures Ten/Eleven)** E33 Captain Creager was grazed by the falling bricks and knocked down the breezeway steps, and onto his knees in the west parking area.

Figure Nine. Graphic depicting wall and breezeway roof collapse.

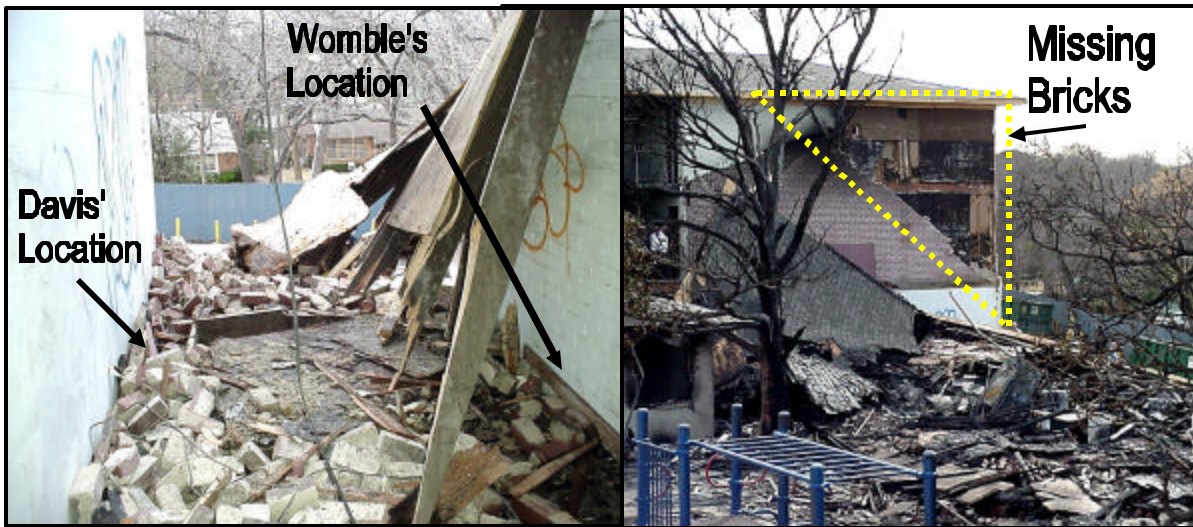
Figure Ten. Breezeway collapse area

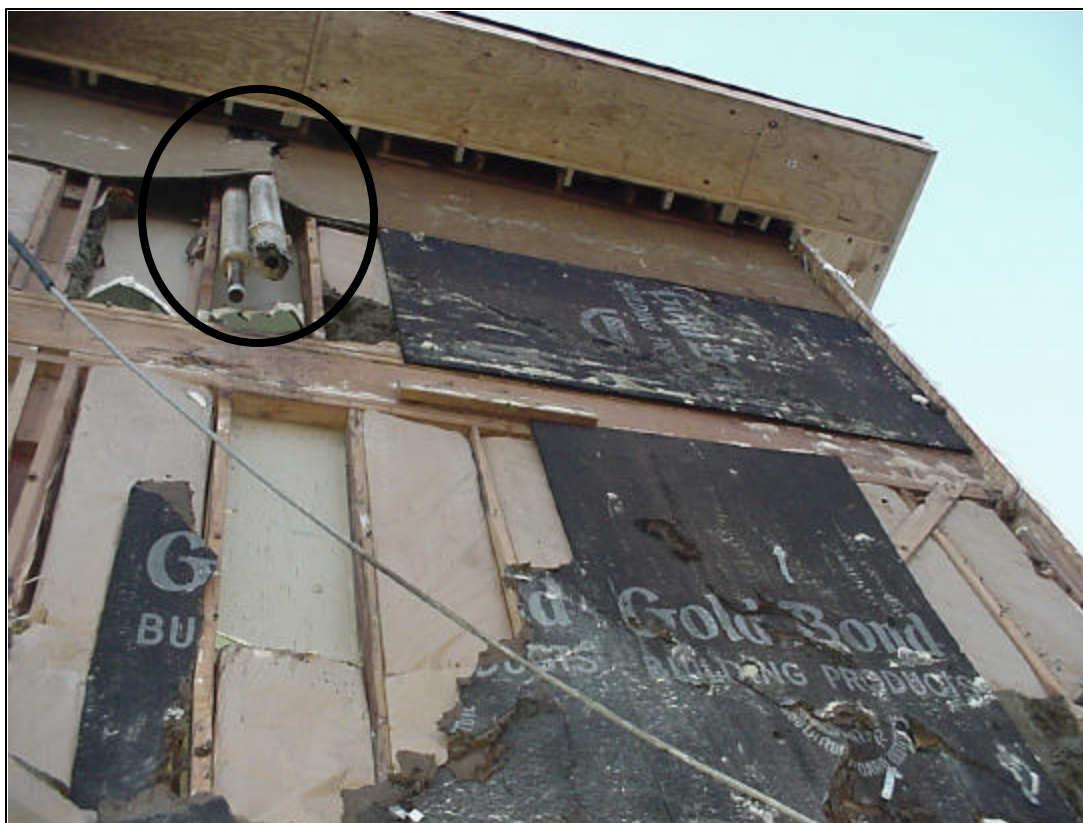
Figure Twelve. HVAC pipes on north end of Section 3.

Section 2 progressively collapsed from fire damage and as it collapsed, the framework of Section 2 shifted toward the north. The shifting of the collapsing section to the north exerted a lateral tension on the horizontal water supply piping for the ventilation system. When the south part of Section 2 collapsed, the south double wythe brick veneer wall fell to the north and impacted on the horizontal piping. This suddenly increased the tension on the water supply piping where it entered the double wythe brick veneer wall of Section 3. The lower part of the vertical section of piping was suddenly pulled several inches toward the north. **(Figure 12)**

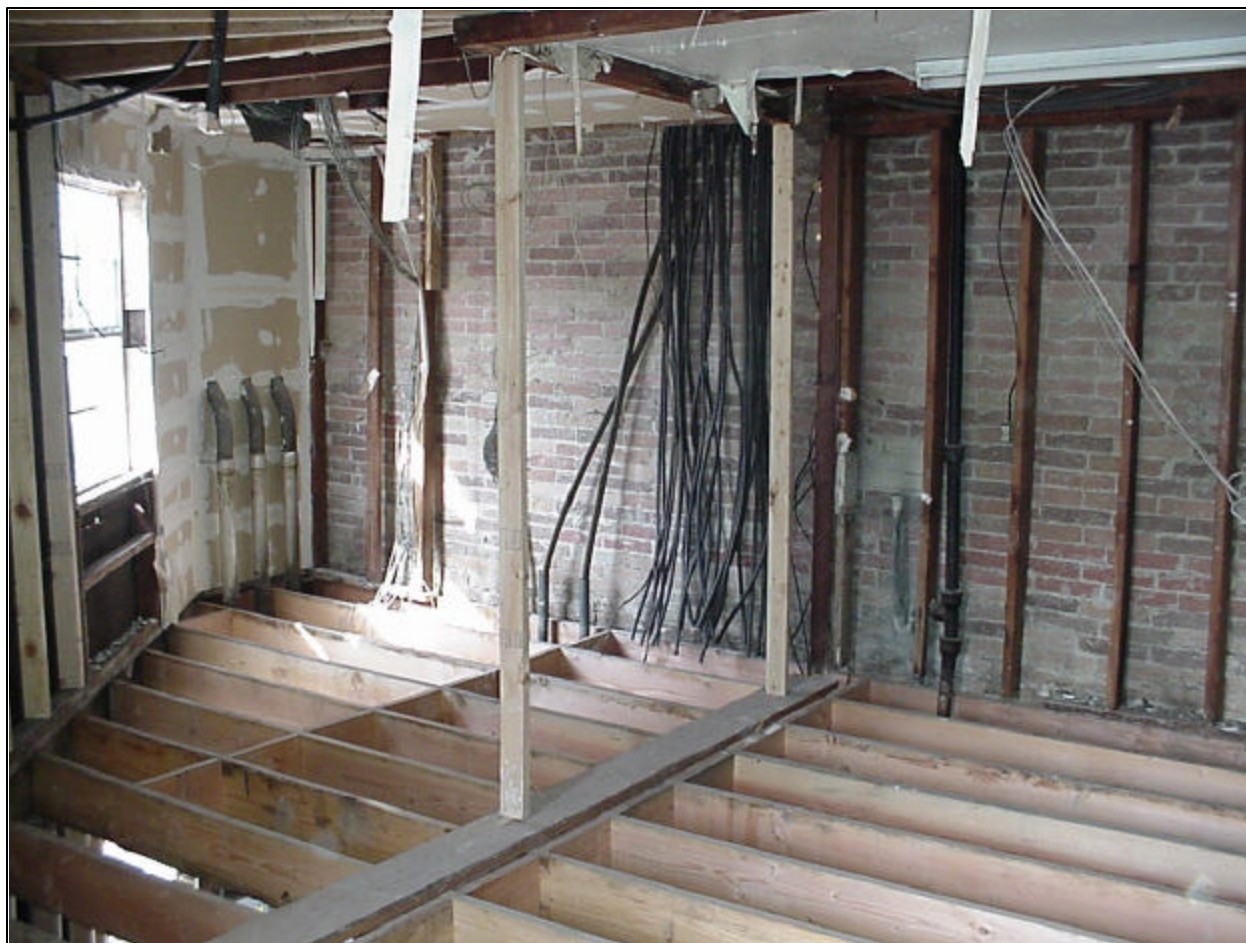
The fire was determined to have originated in the area of apartment 114 of Section 2. Apartments in this area had gypsum drywall removed as part of the renovations of electrical and plumbing systems. Wood structural members were exposed to direct flame contact. Some load bearing structural members may have been temporarily replaced with jacking posts as rotten studs were replaced. The jacking posts that were observed in other areas undergoing renovation provided only minimal support for the building. **(Figure Thirteen)**

Figure Thirteen. Jacking posts used in second floor of adjacent building undergoing renovation.

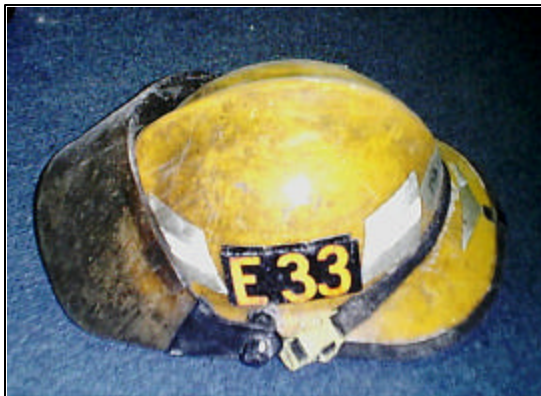
Davis' helmet was scratched and dirty, and when examined, was found with the chinstrap in the stowed position, wrapped around the back of the helmet. **(Figure 14)** Although not a factor in this incident, failure to wear the chinstrap may lead to loss of the helmet during firefighting operations, exposing the user to injury. There was no significant damage observed to the external shell or internal shock-absorbing cap assembly.

Figure 14. Fire helmet with stowed chin strap.

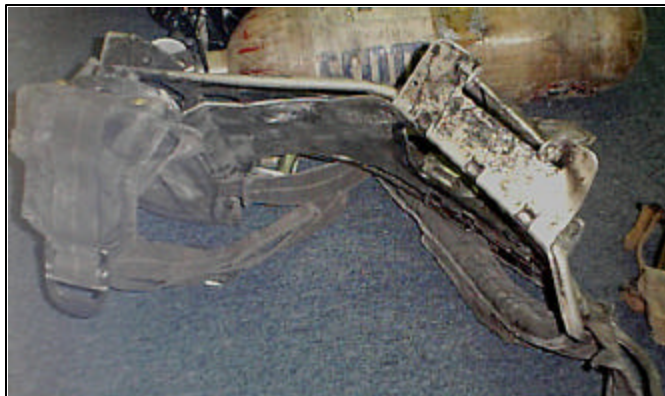
The SCBA backpack assembly was severely bent, probably by impact with falling bricks and structural members. **(Figure 15)** Firefighters that found Davis noted he was in a sitting position with outstretched legs and was bent over under the weight of the debris.

Figure 15. Bent SCBA backpack assembly.
