STATE FIRE MARSHAL'S OFFICE

Firefighter Fatality Investigation

Investigation Number 05-307-04

Firefighter Christopher Brian Hunton

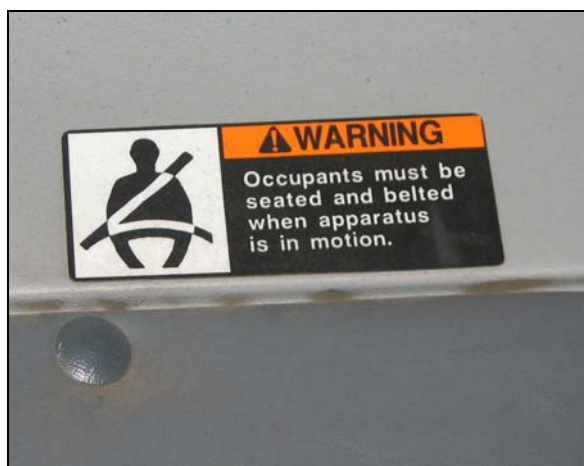
The lap belt on the seat in which firefighter Hunton was riding was unbuckled and retracted. The safety belt appeared to be in functional condition with no binding or other impediments to use. The safety belt on the right rear-facing crew seat was buckled around the seat cushion in a manner that indicated it was not customarily worn. There are warning signs in several location in the cab area emphasizing the need to be seated and to wear safety belts when the vehicle is in motion.

(Left) Left rear crew seat and (above) warning label in crew compartment. (Below) Right rear seat.

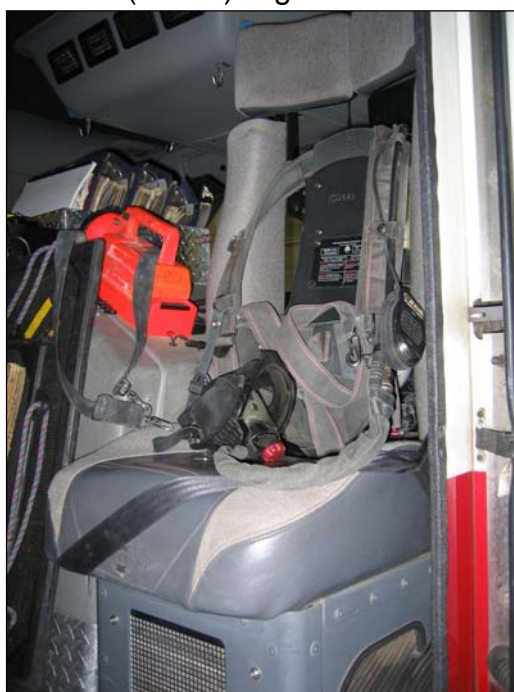
Ladder 1 is equipped with a safety belt monitoring system with an audible and visual alarm to indicate if a safety belt is not fastened in an occupied crew seat. The monitoring system was not functioning and the sensor wiring on the right rear jump seat was disconnected. No further examination of the system and seat sensors was conducted by SFMO, pending an engineering evaluation of the vehicle and left rear door latching mechanism.

Recommendation: Existing safety monitoring systems on apparatus, while not required, should be maintained in operable condition to enhance personnel safety and to avoid a false perception of safety. All fire apparatus should be inspected at least

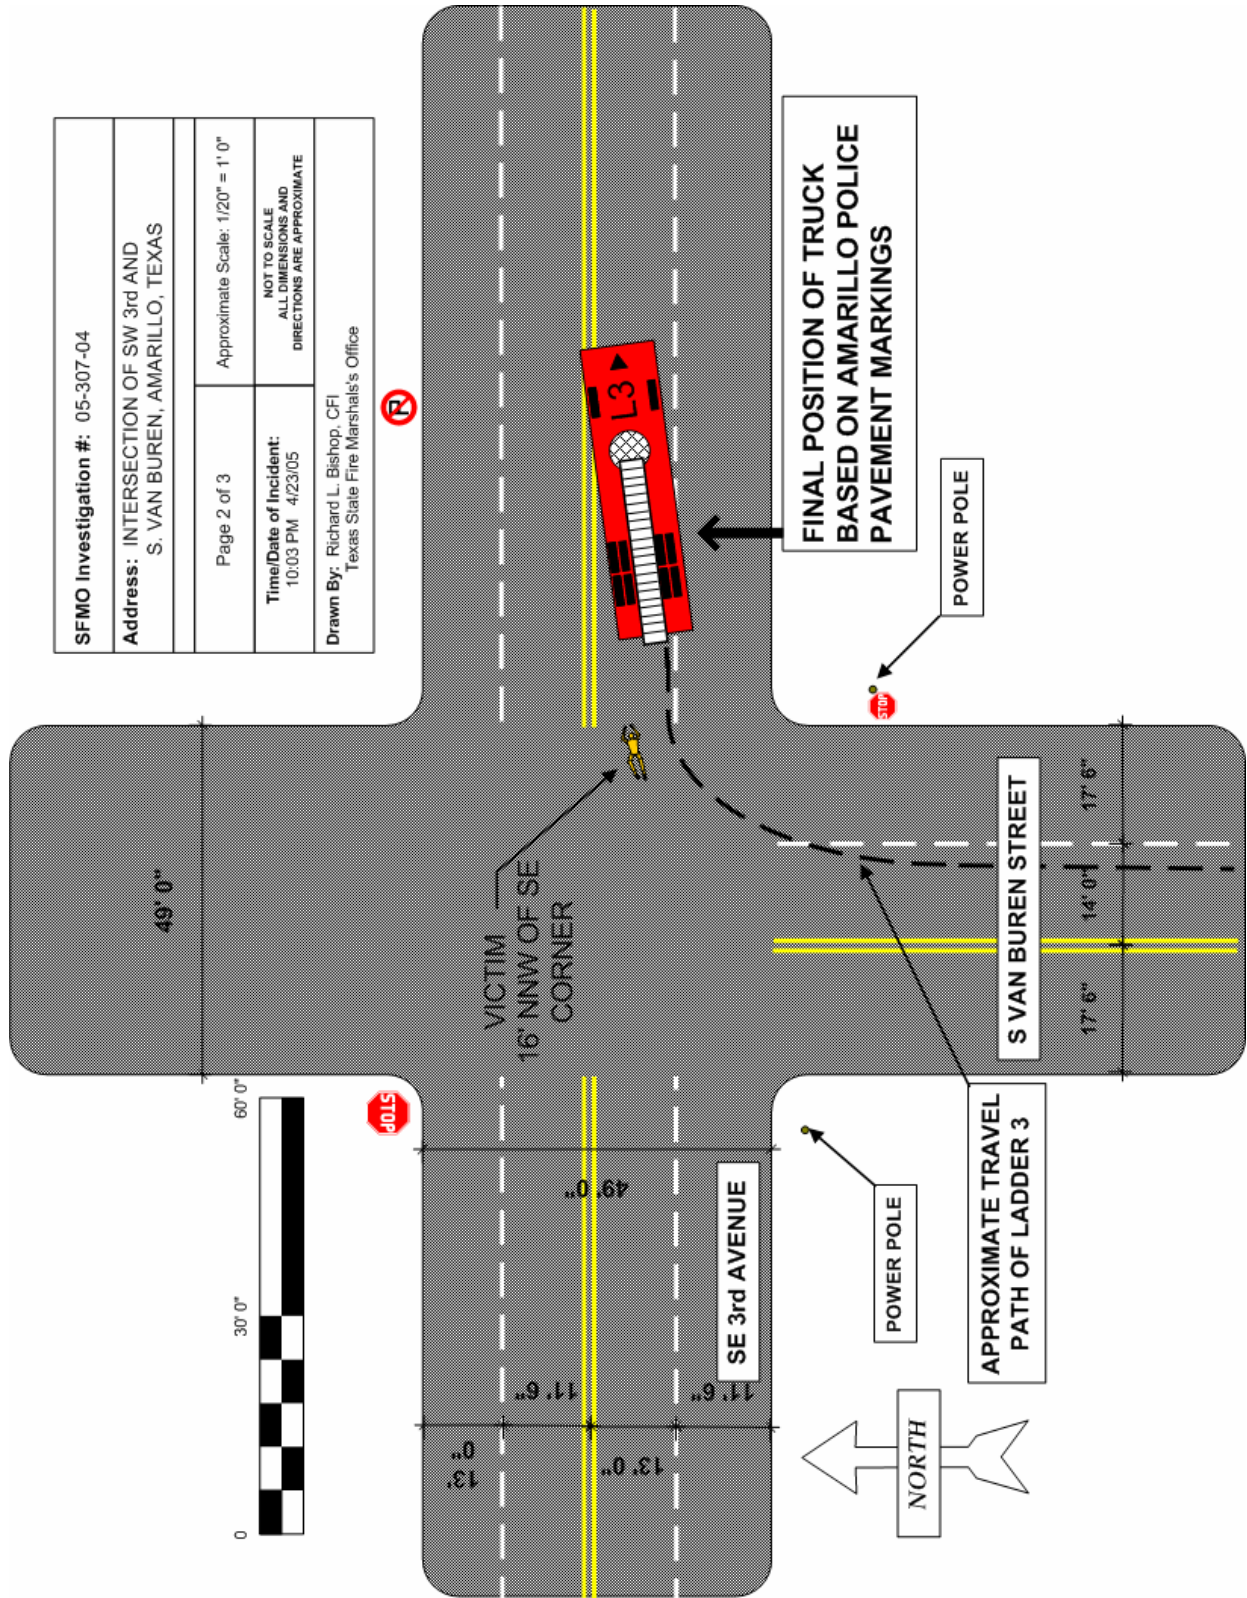
The Amarillo Police Department did not make any measurements at the incident scene other than those used to construct a diagram showing the location of firefighter Hunton in the intersection of 3rd and Van Buren. The Police Department did mark the location of the tires of Ladder 1 after it stopped, and these markings, combined with the police report diagram, were used to construct the SFMO diagram of the scene on April 28, 2005. (Diagram located at the end of this report)
