STATE FIRE MARSHAL'S OFFICE

Line of Duty Death Investigation

Investigation Number 02-50-10

Captain Jay Jahnke

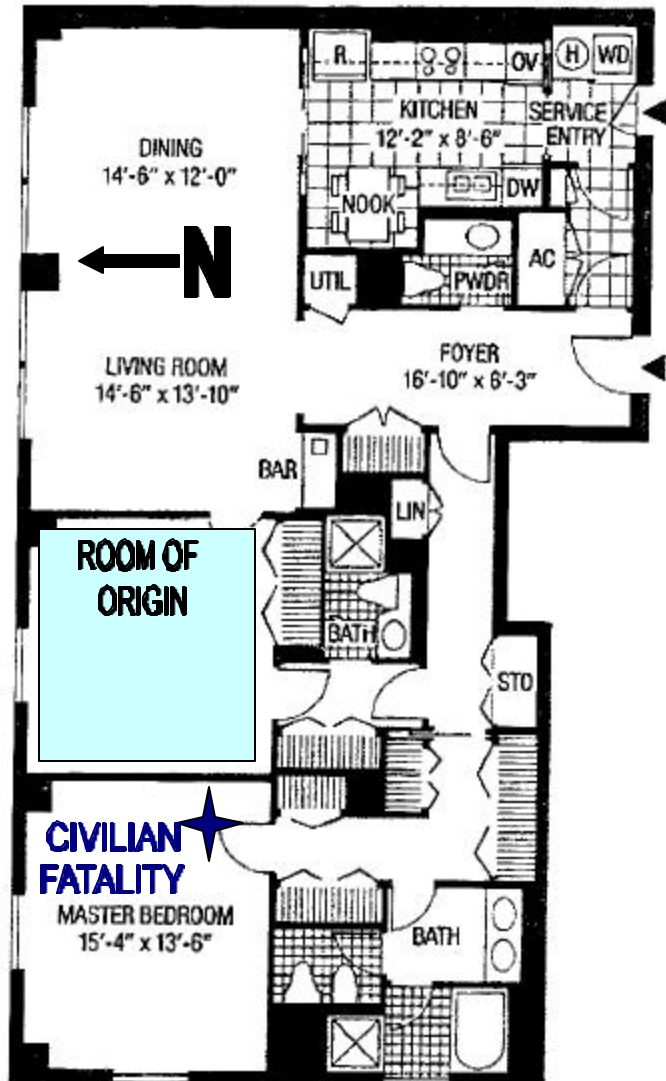
Figure 1-Unit 52

The HFD Arson Bureau had almost completed the scene excavation portion of their origin and cause investigation prior to the arrival of SFMO investigators. SFMO did not participate in the scene excavation or in the follow up phases of the investigation. HFD investigators determined the fire originated in a bedroom of Unit 52 used as a television and computer room. **(Figure 1)**

On April 2, 2002 the HFD Arson Bureau ruled the fire as accidental in origin, with the probable cause being carelessly discarded smoking materials ¹. The origin and cause report reported an ashtray was located near a sofa in the area of origin in the television room. Additional testing of electronic equipment in the room of origin may be conducted by an outside research firm at a later date.

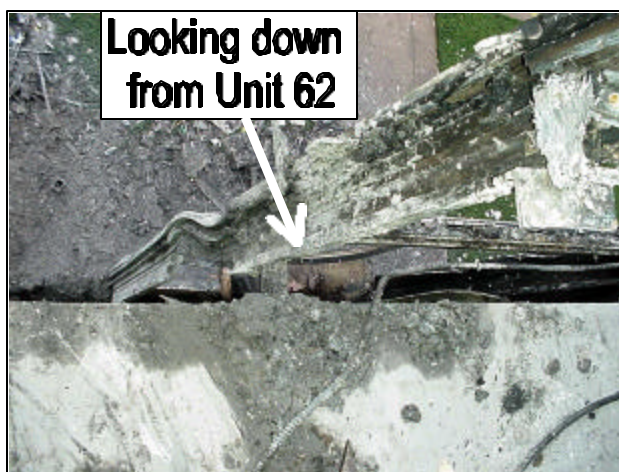
Figure 2-Northwest Corner of Building **Figure 3-Curtain Wall-Floor Slab Gap**

The fire and products of combustion began to spread vertically through openings between the concrete floor slabs and the glass curtain wall. In addition, some flame and smoke spread may have occurred through unsealed vertical floor openings between the fifth and sixth floor. The openings, which may have been made during initial construction, were located in the bathrooms, near heating and air conditioning units, and in other areas. The openings were exposed when the gypsum board ceilings of Unit 52 failed. **(Figure 9-unsealed vertical penetration from Unit 62 bathroom looking down into Unit 52 bathroom)** These unsealed penetrations were found in several areas of the building. Unsealed openings, in combination with the lack of sprinkler protection, can allow flames and products of combustion to spread rapidly, endangering residents above the fire.

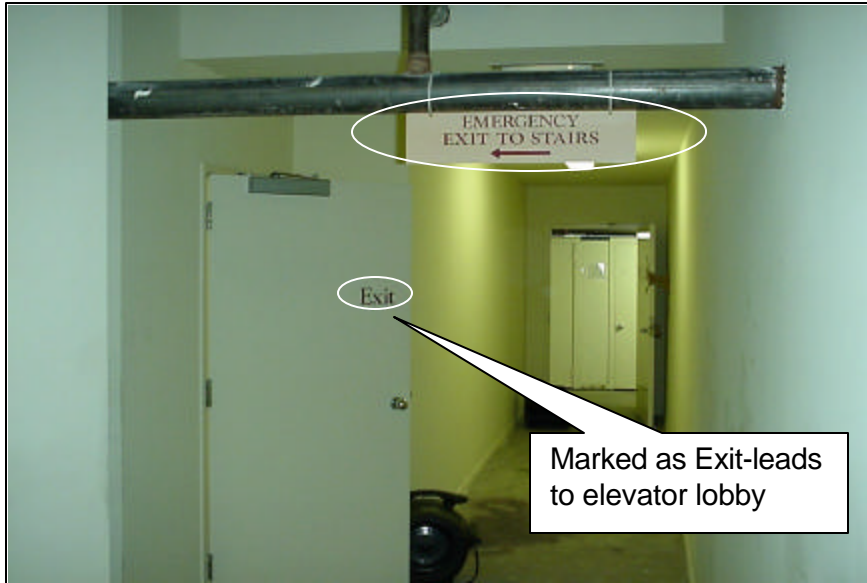
Users of Stair C must negotiate a winding path through an exit passageway to reach the exterior. The path begins at the end of stairway C on the second floor and travels through the second floor to reach the top of a straight run of stairs that discharges directly to the outside. This winding 100'+ path includes three 90-degree left turns and one 90-degree right turn combined with inadequate and confusing exit signage. (Figure 4)

Figure 4-Confusing and inadequate exit signage in Stair C exit pathway

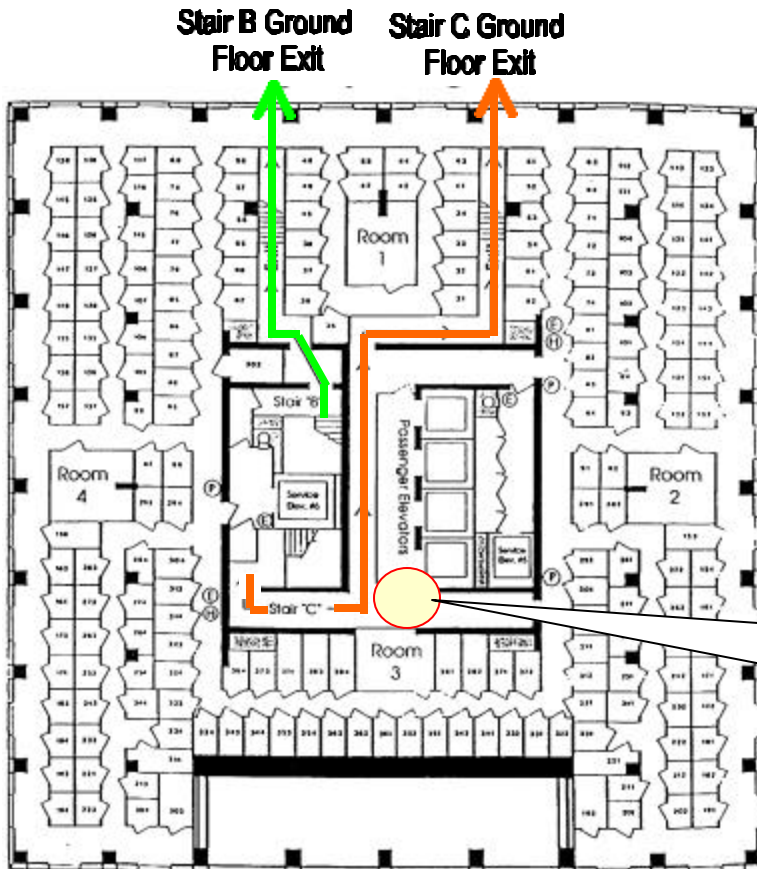
Both firefighters and residents reported confusion in traveling through this area, aggravated by smoke^{2,3,4}. (Figure 5)

Figure 5-Second Floor Exit Routes

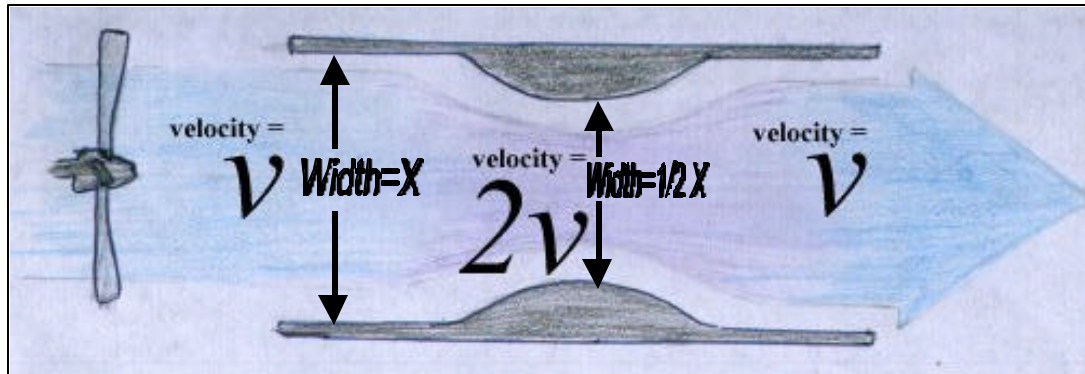
This intensification in heat may be due in part to the Venturi Effect. The gusty north winds entering the large opening created by the broken north and west windows would tend to accelerate as the air currents passed through the significantly smaller door opening into the corridor. The rate of wind acceleration is inversely proportional when comparing the speed of the wind passing through the large open windows to the speed of the wind passing through the small doorway opening. **(Figure 6)**

Figure 6-Illustration of Venturi Effect

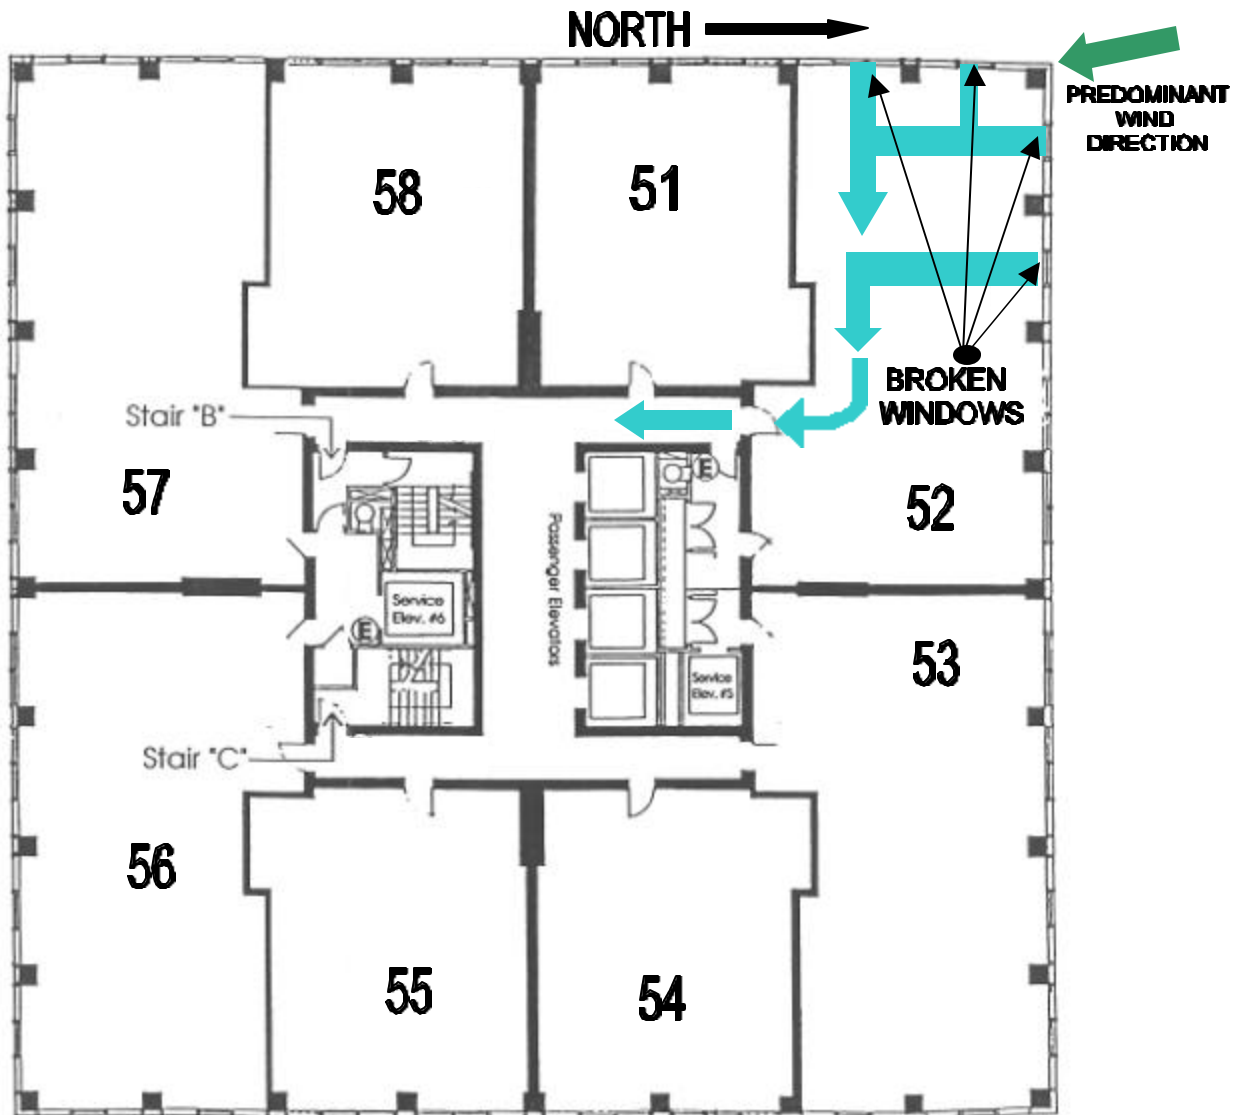
For example: Under laboratory conditions, a 30 mph wind passing through a 60 square foot opening into a confined area would tend to accelerate to 90 mph when passing through a 20 square foot opening at the other end of the confined area (30/60 → 90/20.) As the air moving through the doorway of Unit 52 into the corridor increased in velocity, the air at the doorway would decrease in pressure, causing even more heat, smoke, and fire gases to be pulled from the interior of the condominium and expelled into the corridor. **(Figure 7)**

Figure 7-Wind driven air currents in Unit 52 and corridor

The Venturi Effect may be partially responsible for the amount of smoke that quickly filled the main corridors of the fifth floor and entered the B stairway, overcoming the protection provided by the vestibule exhaust and stairway pressurization fans. News video footage shows pressurized smoke venting from the stairway exit at grade level ¹². Firefighters and residents reported they experienced near zero visibility inside stairway B.

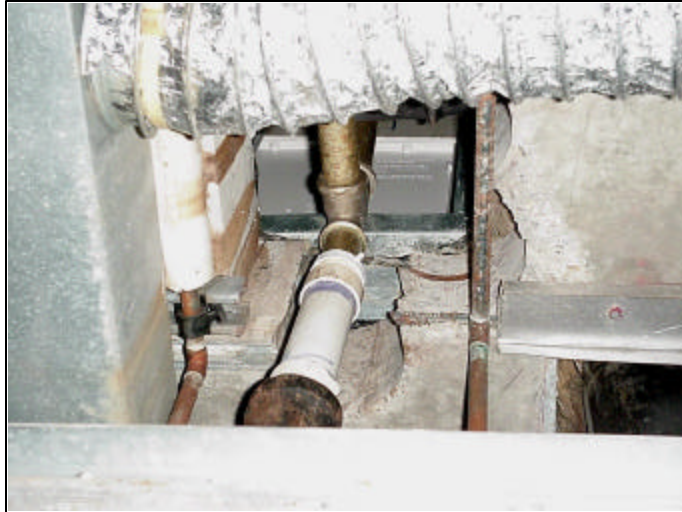
Figure 10

Unsealed vertical penetrations were observed in other condominiums, indicating that this was a common practice when the building was constructed. **(Figure 10-looking up into ceiling/floor penetration)**

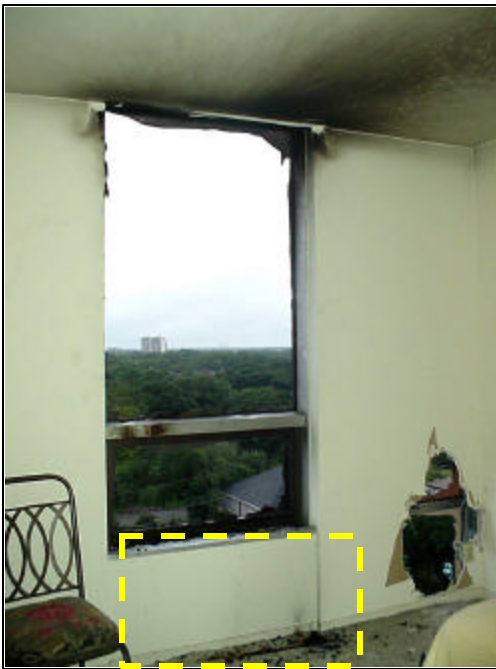
Figure 11

As fire and smoke spread vertically from Unit 52, contents of Unit 62 ignited, resulting in heavy damage to that unit. Flames continued to spread vertically and began to enter Unit 72, resulting in broken windows and scorching of carpet in areas where the curtain wall-floor slab gap was sealed with lightweight materials. **(Figures 11 and 12)** The vertical spread of fire was stopped at this level by both a master hose stream from an aerial platform and the use of a standpipe cabinet hose by firefighters checking for extension from the sixth floor.

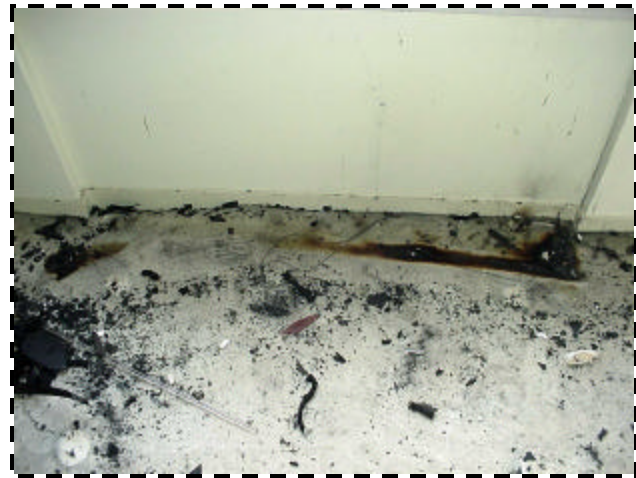
Figure 12-close-up of scorched carpet in dashed area from Figure 11

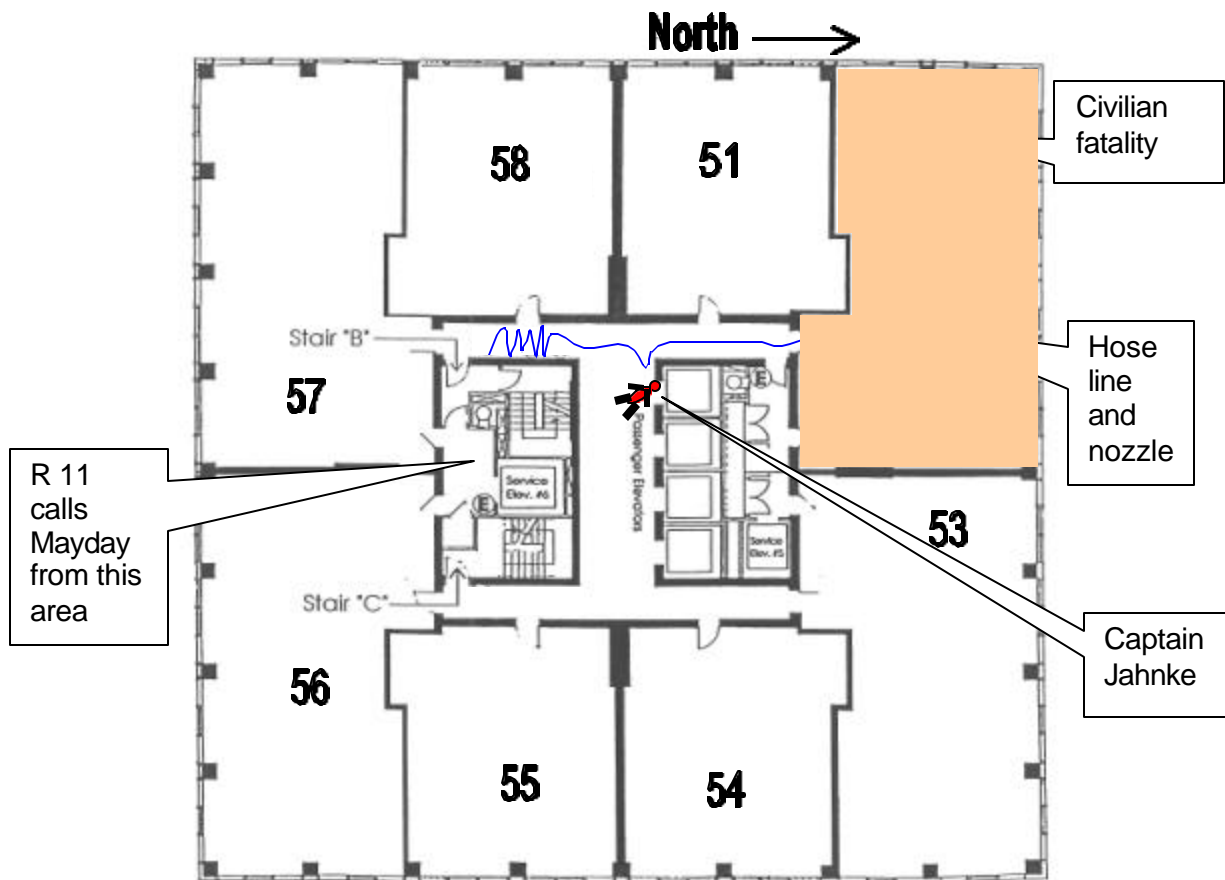
Figure 13-Fifth floor layout. Locations of civilian victim, Captain Jahnke, and fire hoseline are approximate and based on firefighter interviews.

Approximately 5:30 AM, Jahnke was located by the rescue team of Mathison, Kahney, and Parry in the elevator lobby, halfway between Unit 52 and the exit stair door. He was approximately 25 feet from the B stair vestibule door and 50 feet from the C stair door. (Figures 13 and 14)

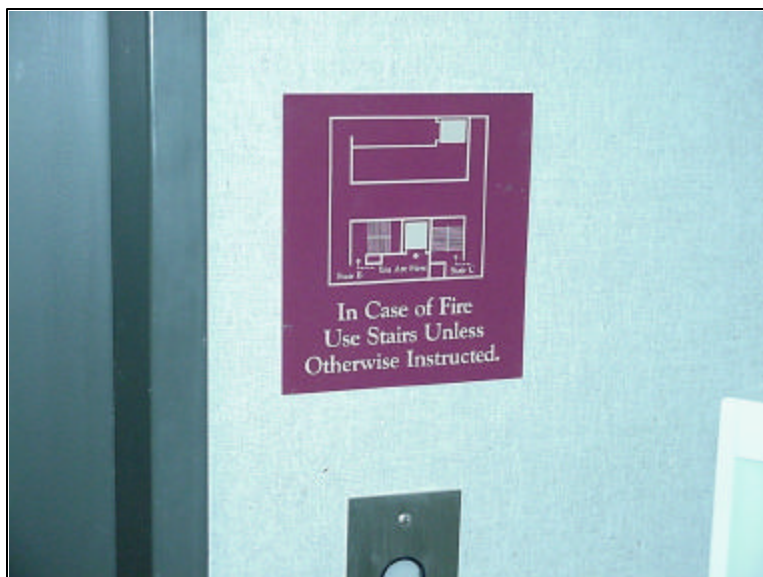
Figure 15-Floor plan sign located in all south service elevator lobbies.

AT 05:35:41 HFD Dispatch tried to call R11 on channels A2 and A4 and received no response. As he searched for the exit, Kahney found a building floor plan adjacent to the service elevator **(Figure 15)** and used it to reorient himself and he then led Mockler to the door from the service lobby to the vestibule. Kahney recalled that there was a large group of firefighters in the vestibule area and that he and Mocker were pushed into the stairway. Kahney and Mocker made their way to the outside of the building without assistance.
