STATE FIRE MARSHAL'S OFFICE

Firefighter Fatality Investigation

Investigation Number 04-285-04

Firefighter Kevin W. Kulow

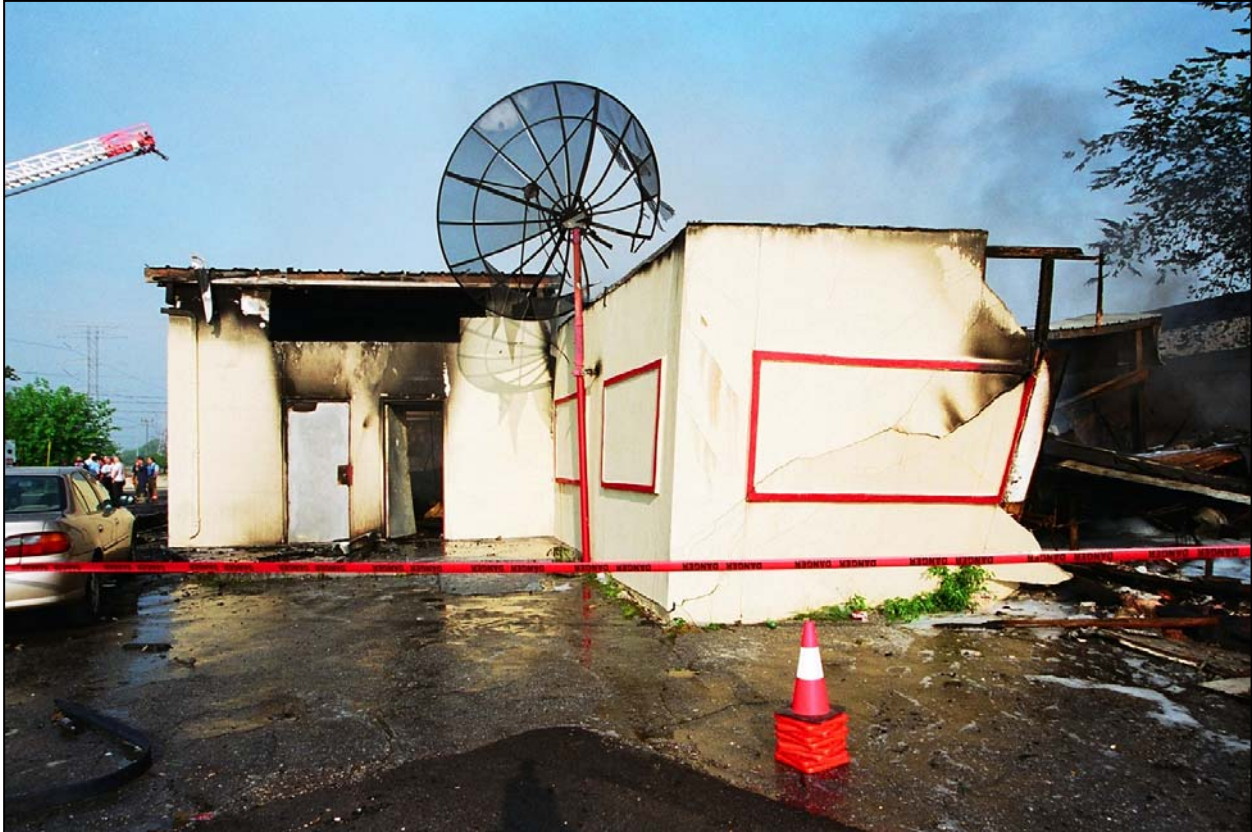
Southeast corner and main entrance, El Festival Ballroom, 7610 Kempwood

The exterior walls of the original (middle section) building consisted of concrete blocks with a stucco finish. Steel I-beams supported the gable design (with limited slope) roof system that consisted of metal affixed to “S” channel. The interior wall and ceiling finish could not be conclusively determined; however, a portion of this wall appeared to be made of concrete blocks.

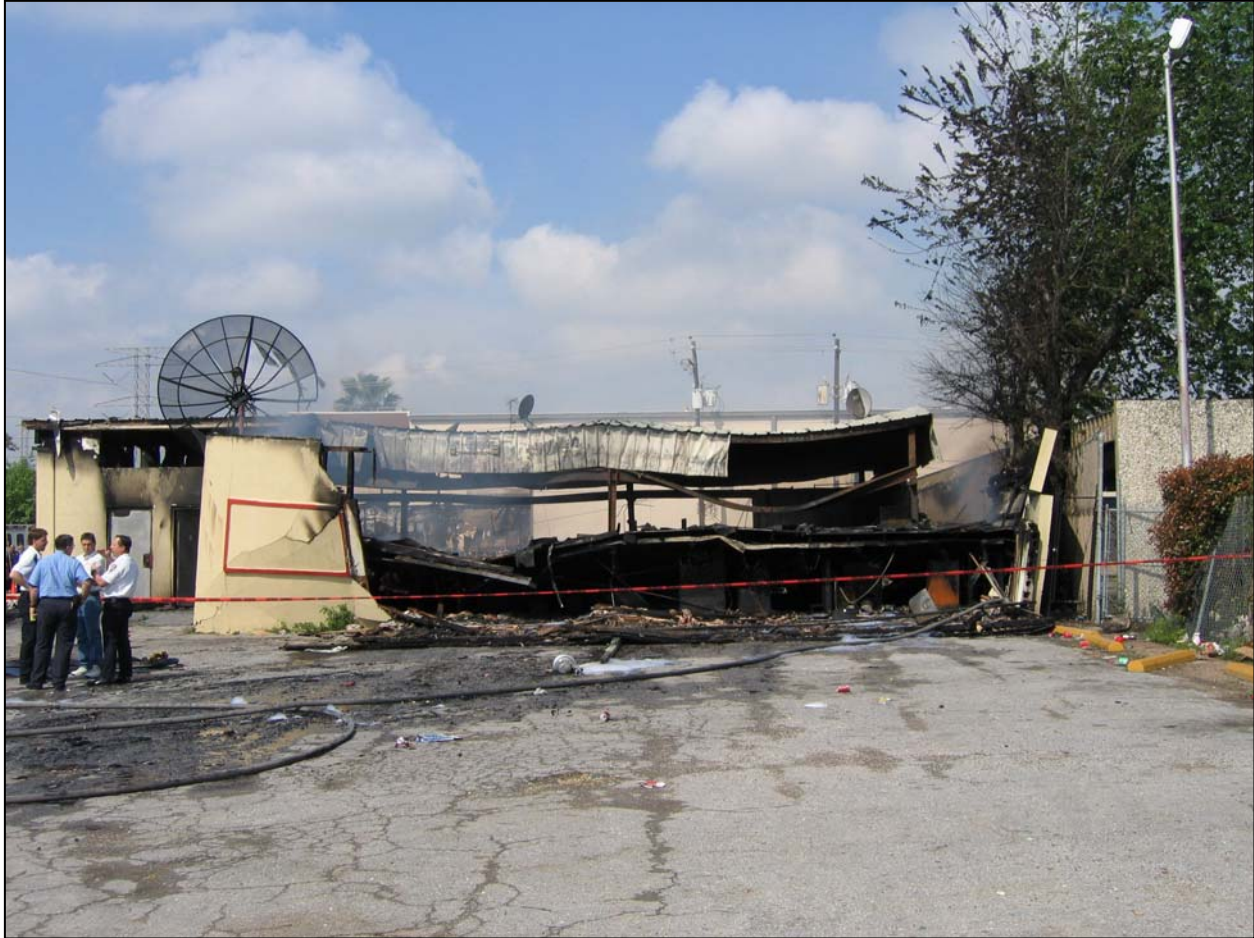
East side, El Festival Ballroom, 7610 Kempwood

Note: The two additions collapsed prior to recovering the victim. The victim was found in the original (middle section) building that had not collapsed.
