STATE FIRE MARSHAL'S OFFICE

Line of Duty Death Investigation

Investigation Number 03-262-03

Lieutenant Charles Lance Mathew LaBelle-Fannett Volunteer Fire Department March 18, 2003

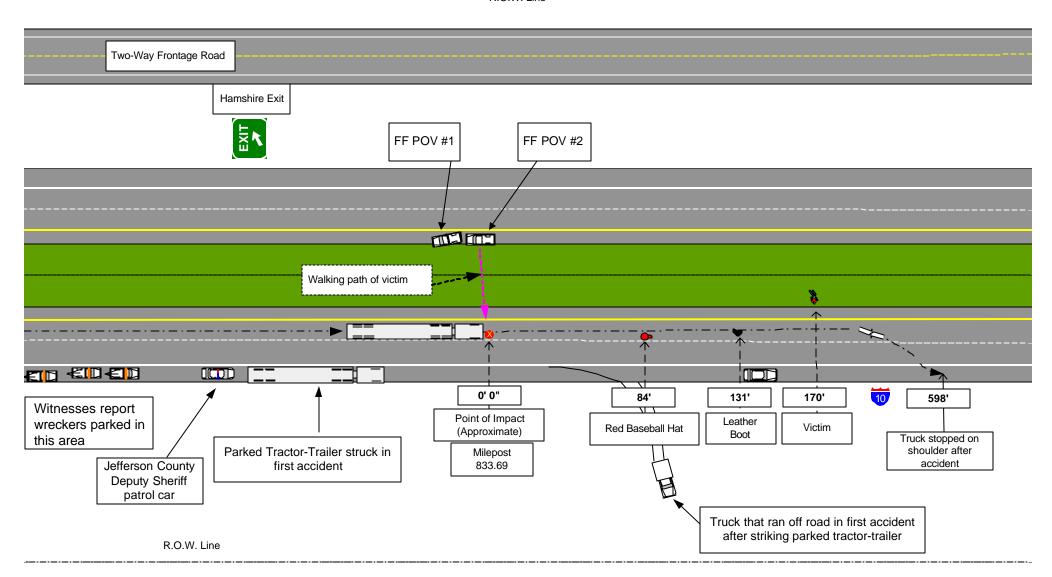
As he passed the incident scene, the truck driver checked his right mirror to see if he had cleared the scene and when he looked back to the front he saw Lieutenant Mathew step out into the eastbound lane of traffic. The driver of the tractor-trailer was unable to stop and struck Mathew with the right front part of the truck-tractor just to the left of the center divider line. The driver came to a controlled stop on the shoulder approximately 598 feet past the point of impact. There were no skid marks left during the stop.

Lieutenant Mathew was thrown by the impact to the grassy median approximately 170 feet east of the point of impact. Firefighter Dearborne and others on the scene checked Mathew, but he had sustained catastrophic injuries and was obviously deceased.
