STATE FIRE MARSHAL'S OFFICE

Firefighter Fatality Investigation

Volunteer Firefighter James McMorries

Howardwick Volunteer Fire Department

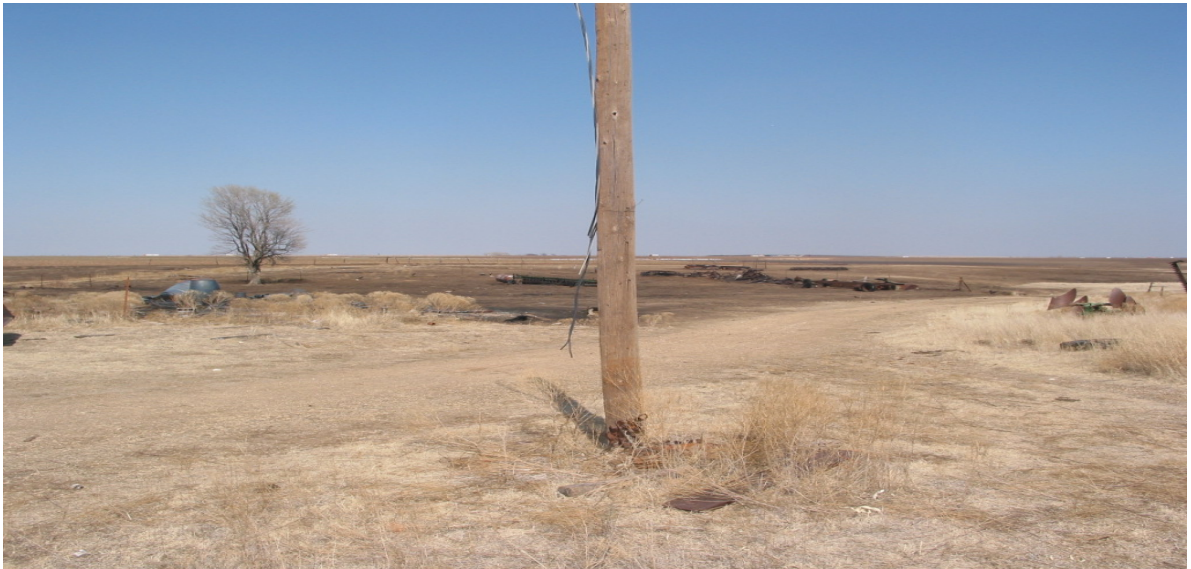
Area of Origin

Deputy State Fire Marshal Kelly Vandygriff conducted an origin and cause investigation on March 24, 2006. Vandygriff concluded that the fire originated on property owned by Dan Steed of Groom, Texas approximately six miles east of the city of Groom and one mile south of Interstate 40 in Donley County. Vandygriff concluded the fire was the result of electrical wires touching causing arcing in forty to fifty mph winds.

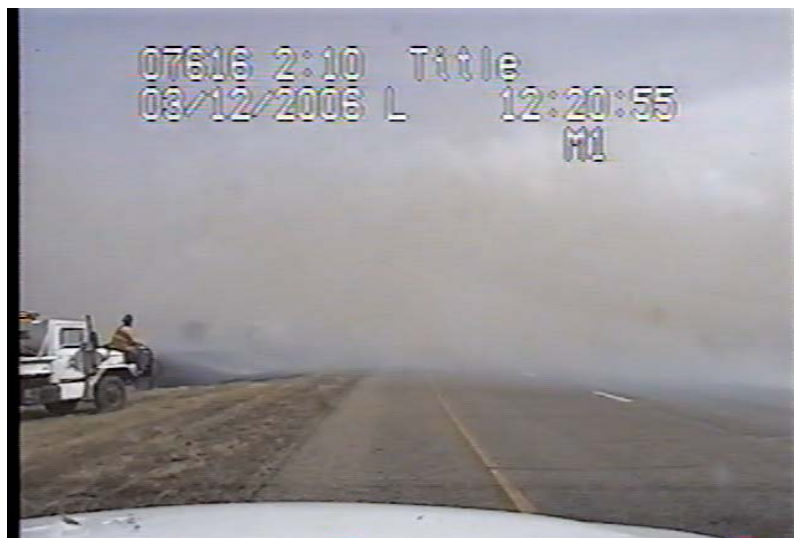
View of smoke obscuring visibility on IH 40 from DPS dash camera
