STATE FIRE MARSHAL'S OFFICE

Firefighter Fatality Investigation

Investigation Number FY 07-02

Captain Kevin Williams
Firefighter Austin Cheek

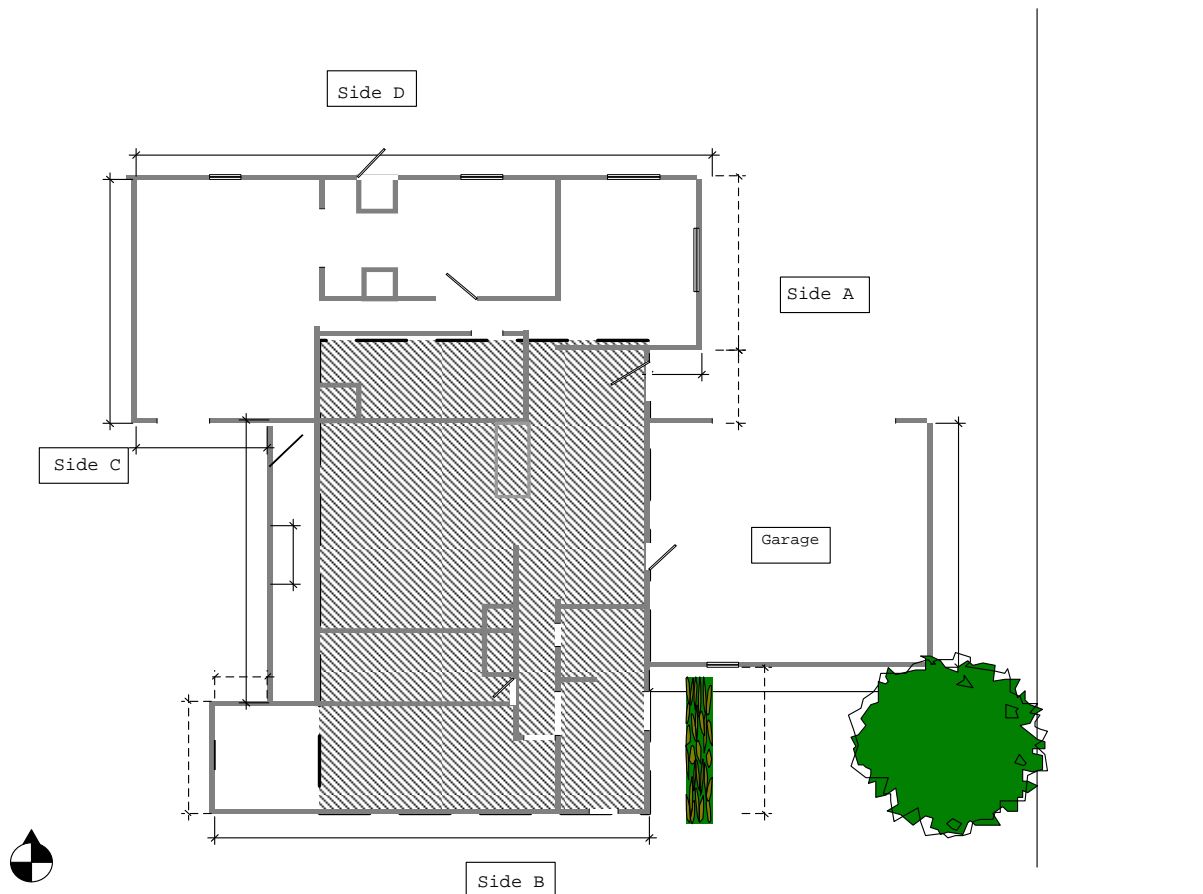
Diagram 1

The house was of wood frame construction, approximately 65 feet wide and 80 feet long from the front of the garage to the rear of the master bedroom. It was built on a concrete slab foundation with a composition roof. Electrical service was supplied through a meter located at the southwest corner area. The exterior walls were unprotected wood siding. The interior finish was wood paneling or gypsum board walls and ceilings. The house consisted of four bedrooms, two bathrooms, an attached garage, and an enclosed patio with approximately 2700 square feet of living space. The house had extensive additions since its construction in the 1970s. The original house was pre-fabricated and site constructed, with exterior walls and roof consisting of structural insulated panels (wood panels over polyurethane foam). The original construction included the living room, dining room, kitchen, one bathroom, and three bedrooms approximately 30 feet by 50 feet (See Diagram 1). The new construction included combining the two small bedrooms at the southeast corner by removing the separating wall. Additions to the original structure involved the removal of the roof overhang and construction of a new roof over the entire structure resulting in a double roof over the original structure. New construction included the addition of the garage and north end of the house consisting of the master bedroom, master bathroom, study/office, and bedroom. Three-quarter inch plywood sheets were added over the ceiling joists in the attic space of the new construction for a future second floor addition.

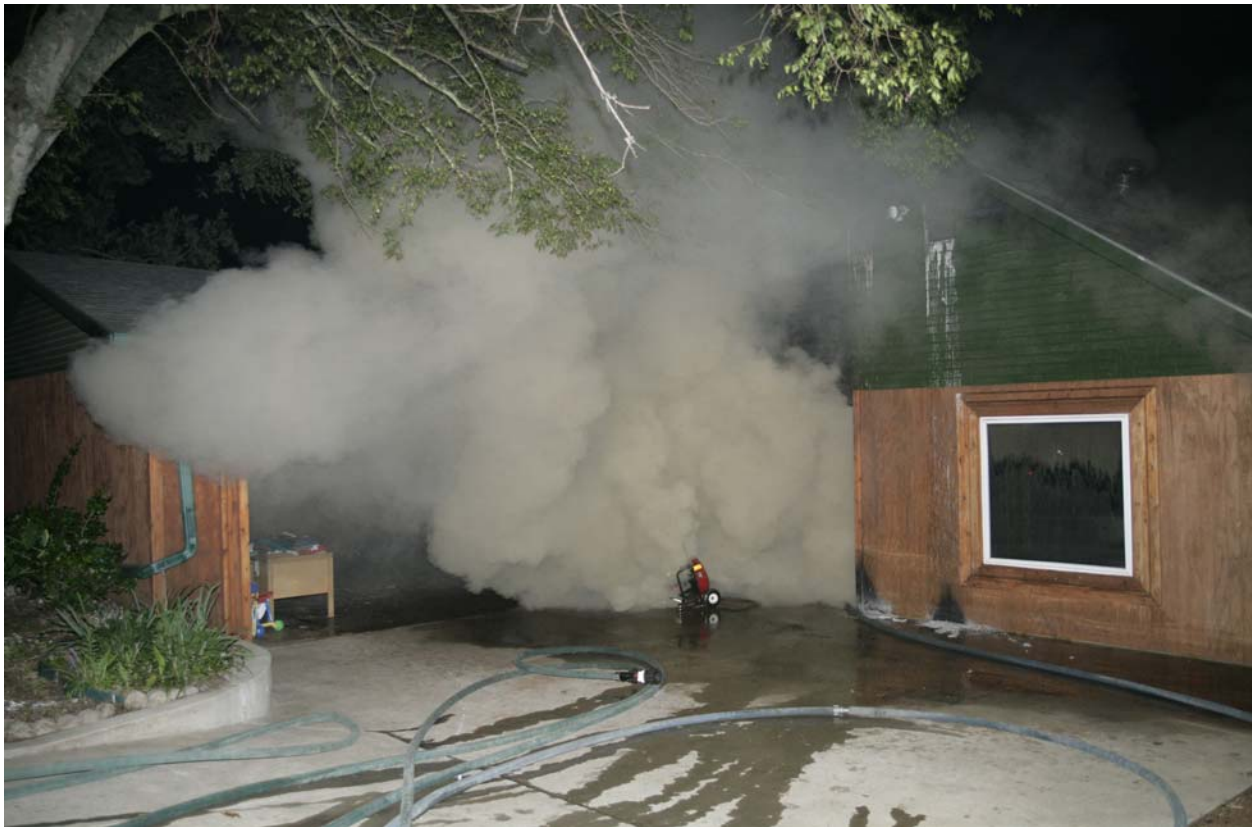
This photo at 02:17:40 shows white-gray smoke exiting the front door, overpowering the PPV fan. Safety line is unstaffed. Williams and Cheek have been inside for four minutes. (Photo Courtesy of Bullard FD)

02:17	Window on side D broken by Asst. Chief Timmons (Noonday)
02:18	Super heated smoke and steam seen exiting under pressure approximately 15 feet from front door. PPV fan is ineffective, smoke color light gray – Safety line is no longer staffed

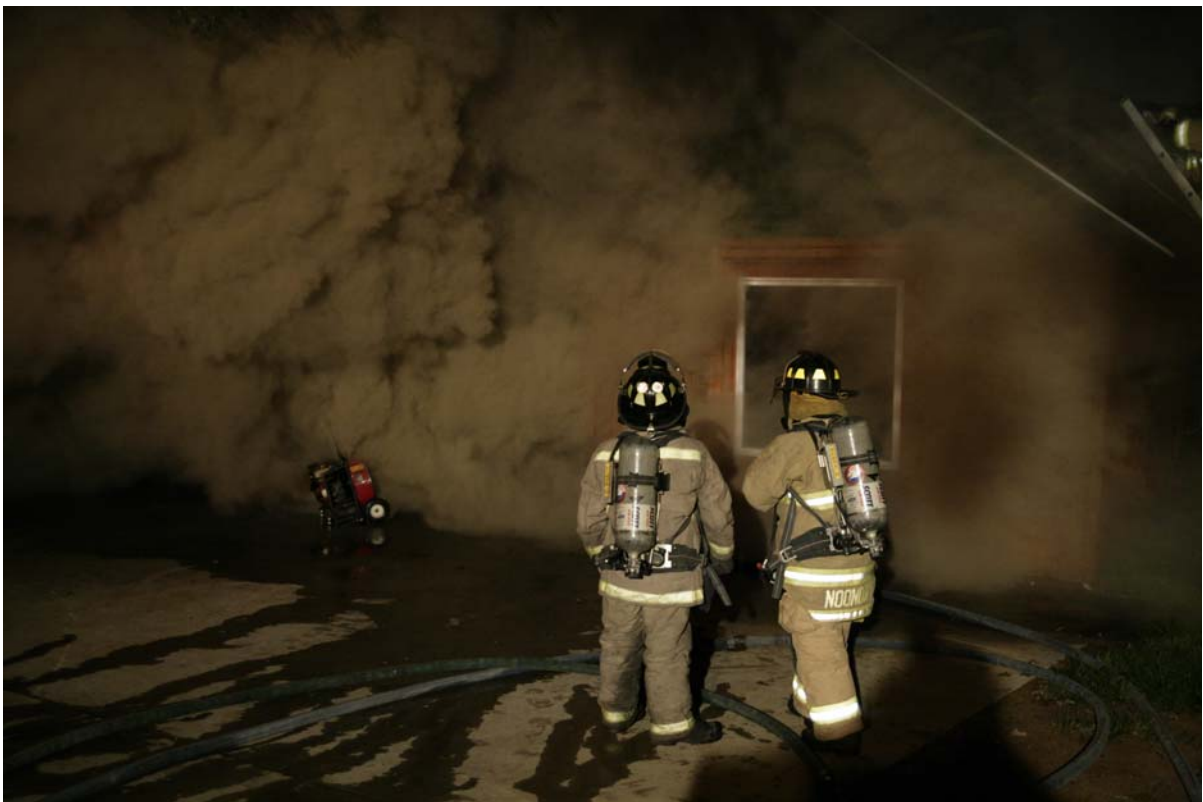
This photo at 02:23 shows thick, black smoke exiting the front door under pressure. Williams and Cheek have been in for 11 minutes. (Photo courtesy of Bullard FD)

02:21	First chain saw fails to cut roof and a second is requested
02:22	Second chain saw arrives – vertical ventilation continues
02:23	Smoke conditions change drastically, smoke now thick and black with sharp edges, PPV fan obscured

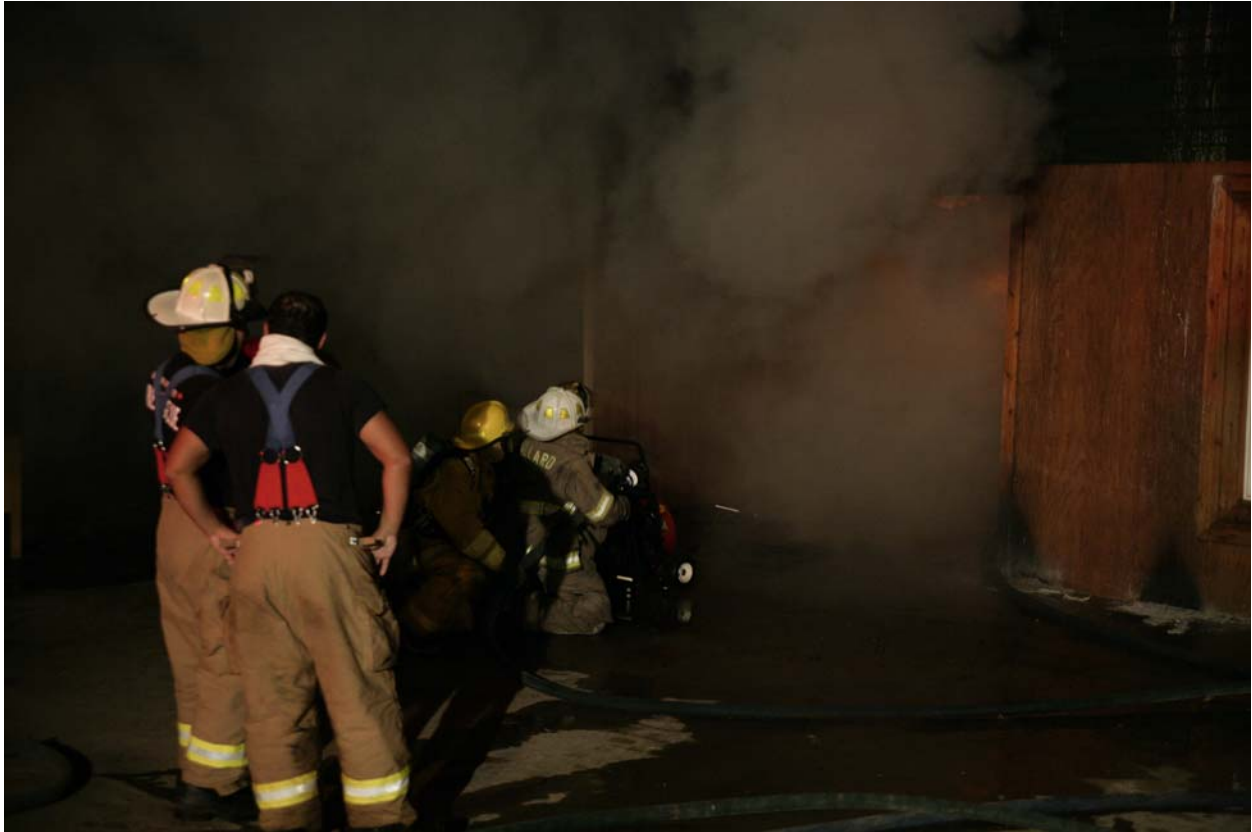
**At 02:30:49 the safety line is staffed at the front door as smoke and flames vent from the front door. Captain Williams and Firefighter Cheek have been inside for 16 minutes.
(Photo by Bullard FD)**

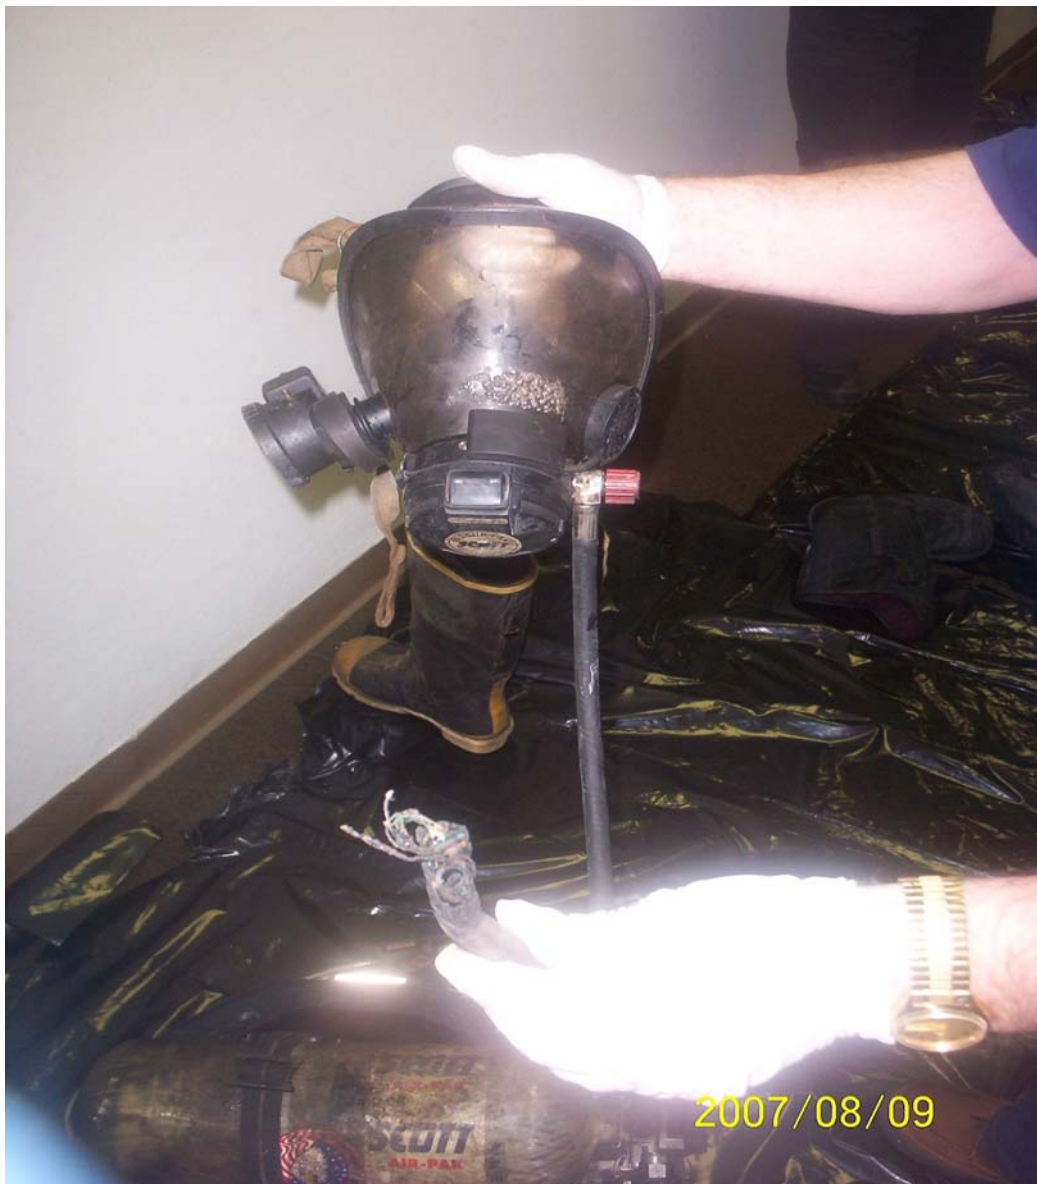
- a) The Luxor air cylinder with serial number E-10915-2216 exhibited signs of heat and smoke exposure. The cylinder pressure gauge was at zero.
- b) The face piece was found to have bubbling from exposure to heat.
