## Firefighter Fatality Investigation

**Investigation Number 06-139-11**

**Firefighter Clint Dewayne Rice**

Carlton Volunteer Fire Department

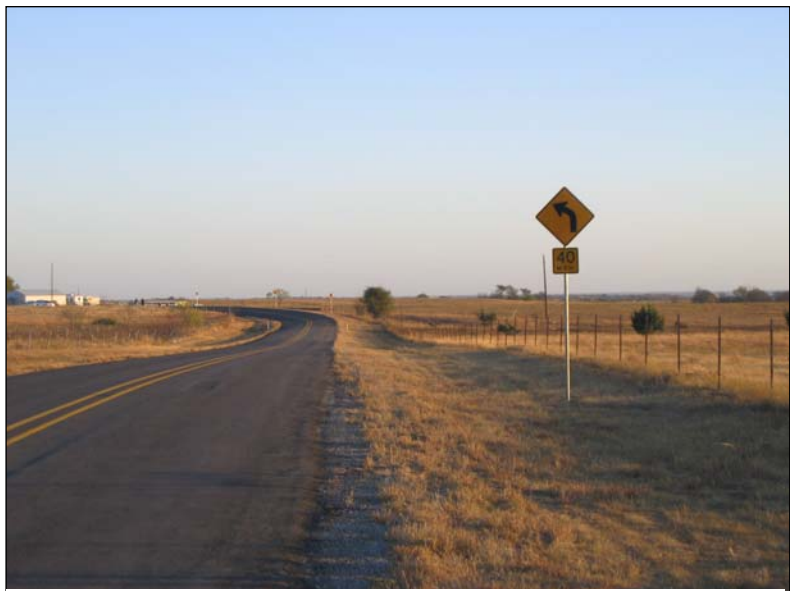
Approximately 2.5 miles from the CVFD station on Farm-to-Market Road 219, Unit 610 passed a diamond left curve sign with a 40 mph speed

**FM 219 approaching the incident scene in the direction of travel of Unit 610.**

Warning chevrons delineated the curve. The asphalt roadway was dry, in good condition, and had a slight downhill grade continuing into a banked left curve. The incident occurred during daylight hours.

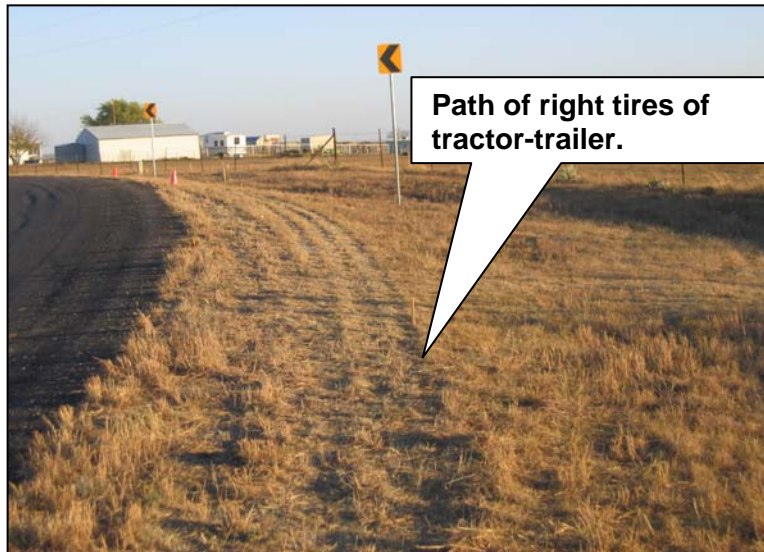
The right side tires of Unit 610 left the roadway at the transition of the straight road into the curve, .17 miles after passing the curve warning sign. Tire marks indicated that Firefighter Rice attempted to steer Unit 610 around the curve.

As Unit 610 approached the apex of the curve, the slope of the shoulder, combined with lateral movement of water in the cargo tank, began to lift the left side tires of the cargo tank off the pavement.

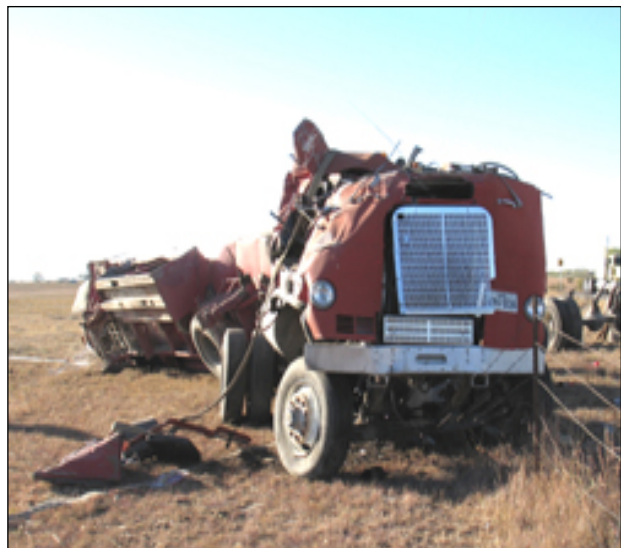
**Final resting position of tractor-trailer.  
Photo by Hamilton County JP Lively .**

As the tractor-trailer combination came to rest in a field, the truck tractor rolled back upright onto its wheels. The cargo tank

came to rest on its left side. The force of the rollover separated several tire/axle assemblies from the tractor-trailer water tender. The vehicle traveled approximately 330 feet from the point the first tire left the roadway.

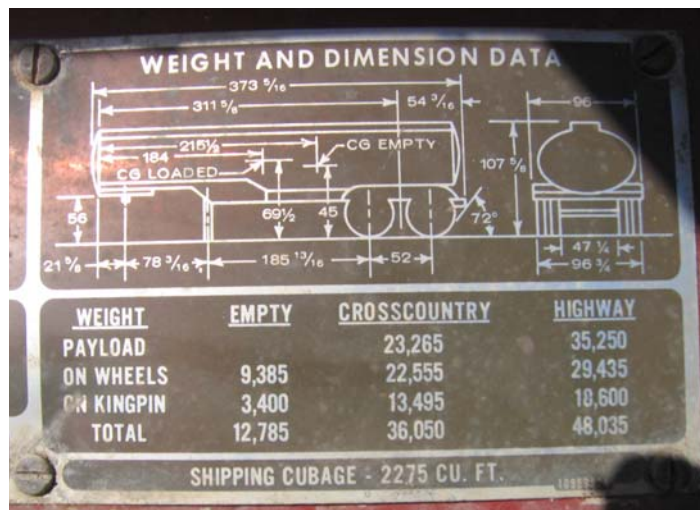
The military technical and maintenance manual for the M135A5 fuel tank trailer <http://www.tpub.com/content/semis/TM-9-2330-272-14P/index.htm> states hard surface road tire pressure should be 60 psi based on a 48,035 pound gross trailer weight. This gross trailer weight was based on a 5,000 gallon cargo of fuel weighing 35,250 pounds. Filling this trailer with 5,000 gallons of water weighing 41,700 pounds, (8.34 pounds/gallon) produces a gross trailer weight of 54,485 pounds.

This is 6,450 pounds over the maximum 48,035-pound gross weight listed on the information placard on the trailer frame. This does not take into account the weight of the water pump and any additional equipment installed by CVFD.

Exceeding the gross trailer weight may have an adverse effect on vehicle handling, braking, and performance and may violate state motor vehicle laws.

**Military data plate on frame of tank trailer**

**Recommendation:** Any fire department acquiring a vehicle, chassis, or trailer not originally designed as firefighting apparatus should proceed with caution when converting equipment for use in firefighting. Fire departments should take into account factors such as the weight of tank water and equipment, center of gravity, load distribution, capacity of the drivetrain, tires, steering, and braking systems during fire apparatus construction.

**Recommendation:** All fire departments acquiring vehicles, chassis, or trailers should refer to all available manuals or documentation prior to commencing conversion or modification operations. Water tanks should be clearly marked with the tank capacity and full gross weight. Fire departments should install positive physical safeguards, such as overflow vents, to prevent vehicles from exceeding maximum permissible gross weight when fully loaded.

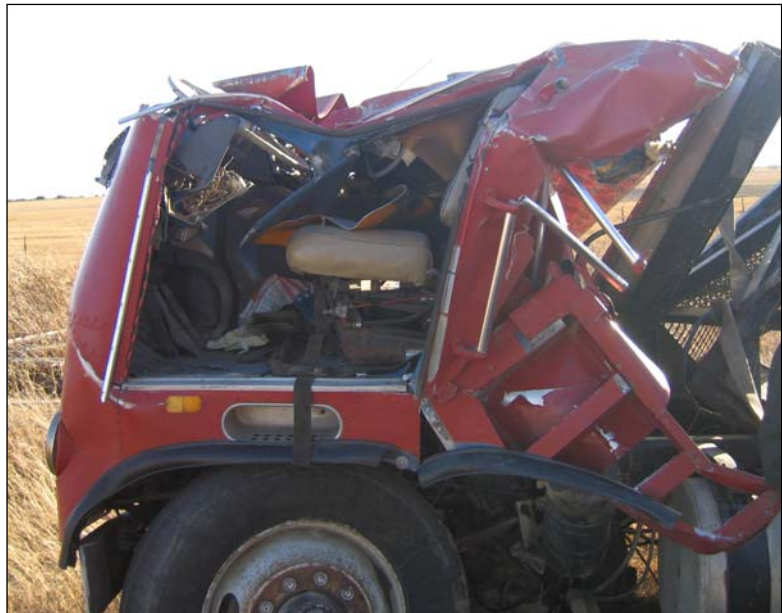
During the rollover, the truck cab roof was sheared away just above the dashboard. Firefighter Rice, who was not wearing the driver's seat safety belt, was ejected from the truck cab and landed on the right hand lane of the roadway, approximately 30 feet from the final resting point of the truck cab.

The driver's seat of the 1979 Freightliner cabover truck-tractor-owned by Carlton VFD is equipped with a lap type safety belt, but Firefighter Rice was not wearing it at the time of the motor vehicle incident. Due to the forces involved in this crash, it is not possible to determine if safety belt use would have prevented fatal injuries to Firefighter Rice.

**Left side view of truck cab of Unit 610**
