Line of Duty Death Investigation

Investigation Number 03-193-01

Firefighter Gary L. Staley

Texas Department of Insurance
Austin, Texas

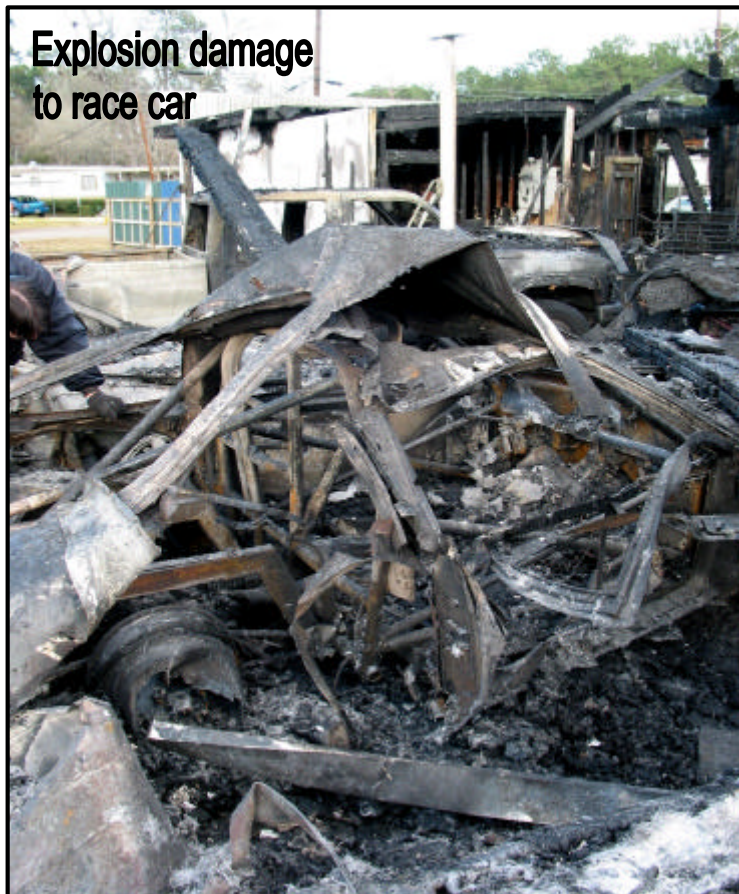
Investigators determined that approximately 5-10 gallons of flammable liquid (lacquer thinner) had been spread on the floor in the west end of the showroom area, allegedly to prepare the floor for applying ceramic tile. The tile worker claimed vapors from the liquid ignited when he plugged in a forced air space heater. The flaming liquid ignited the contents of the building, including boxes of auto parts, lubricating oil, classic and racing cars, personal watercraft, a boat and other vehicles. The building was destroyed by the fire.

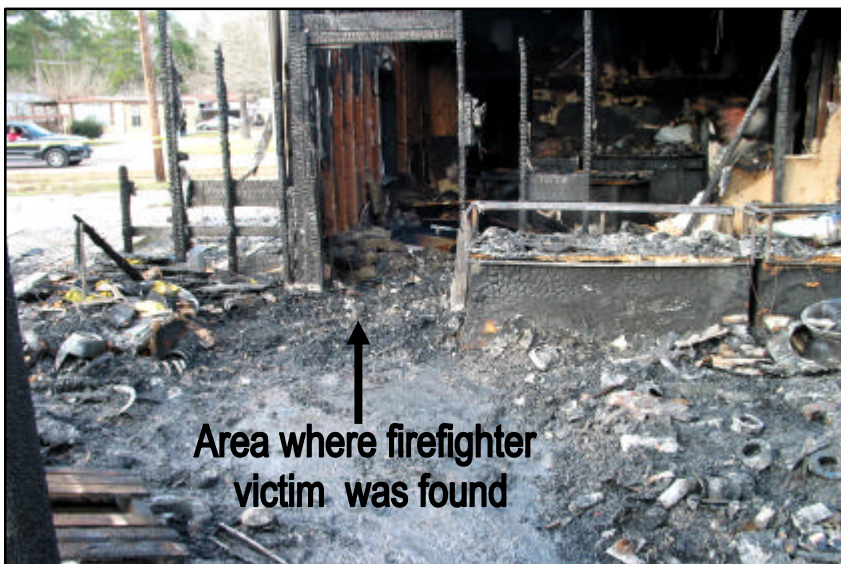
As the fire progressed, the metal roofing and wood rafters collapsed in the showroom area. None of the metal support posts failed. The area where the deceased firefighter was found had no significant structural failures.

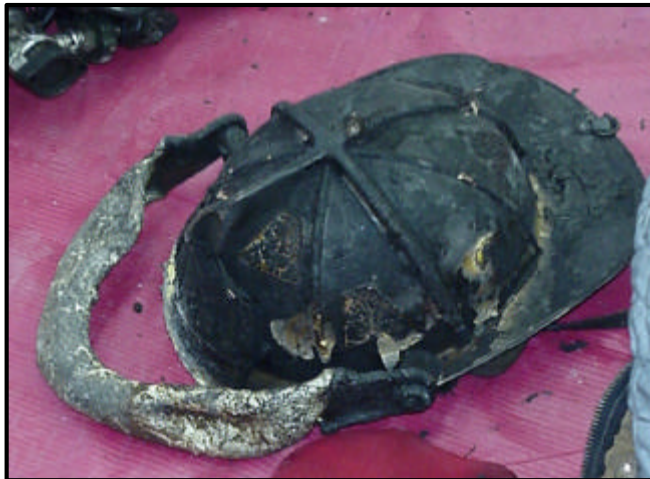
Firefighter Staley entered the building wearing full firefighter protective equipment, including a self-contained breathing apparatus (SCBA). When Staley's body was discovered he had his helmet, protective hood and SCBA face piece in place but his mask-mounted regulator was disconnected. Staley was wearing an SCBA with an integral chest-mounted PASS alarm device and the alarm was sounding when his body was discovered. Staley was found lying on top of his PASS device which muffled the alarm sound. There was evidence that the PASS device had been exposed to some heat and soot.

The protective visor on Staley's helmet was burned and melted but the helmet, although burned on the exterior, was intact.

Staley's protective clothing sustained extensive heat damage, burning completely away in the lower back, buttocks, and thigh areas. Damage to the bunker coat included a burned-through area on the upper right arm. Damage to the rest of the coat was limited to some moderate charring in the right hip area and melting/burning of reflective trim.

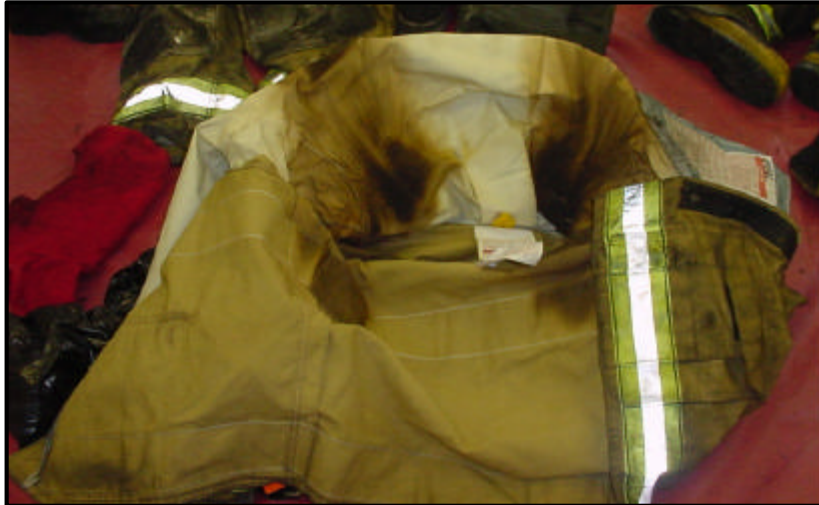
became disoriented and escaped the building with serious burns. All three were wearing full NFPA-compliant protective ensembles and SCBA. The helmets of the two most seriously burned firefighters, Chapa and Haynes, showed evidence of extreme heat exposure, with face shields burned and deformed, but helmet shells, although burned, were intact.

The fabric shells of Chapa's and Haynes' bunker gear showed extensive melting to reflective trim. Inner liner vapor barriers were scorched even though the fabric shells of the coats appeared undamaged other than damage to the reflective trim.

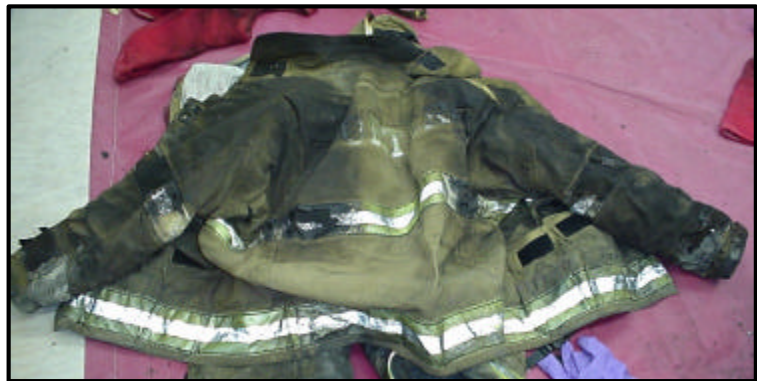
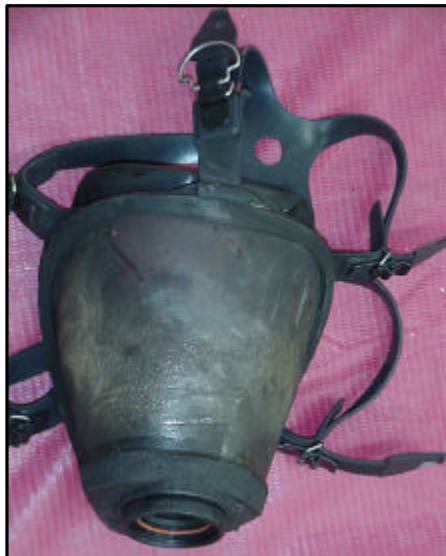
All SCBA masks were melted and opaque in some areas due to flame exposure. Some areas of the face pieces were undamaged because they were covered with portions of the firefighter

protective hood. Haynes sustained serious facial burns when he removed his face piece inside the building because he could not see. Haynes was the only injured firefighter that was wearing a "Reed Hood," a protective hood made of material similar to that used in bunker clothing and designed to be worn over a standard knit fabric fire resistant hood.
