# STATE FIRE MARSHAL'S OFFICE

## Line of Duty Death Investigation

**Investigation Number 03-194-01**

**Firefighter James Taylor**

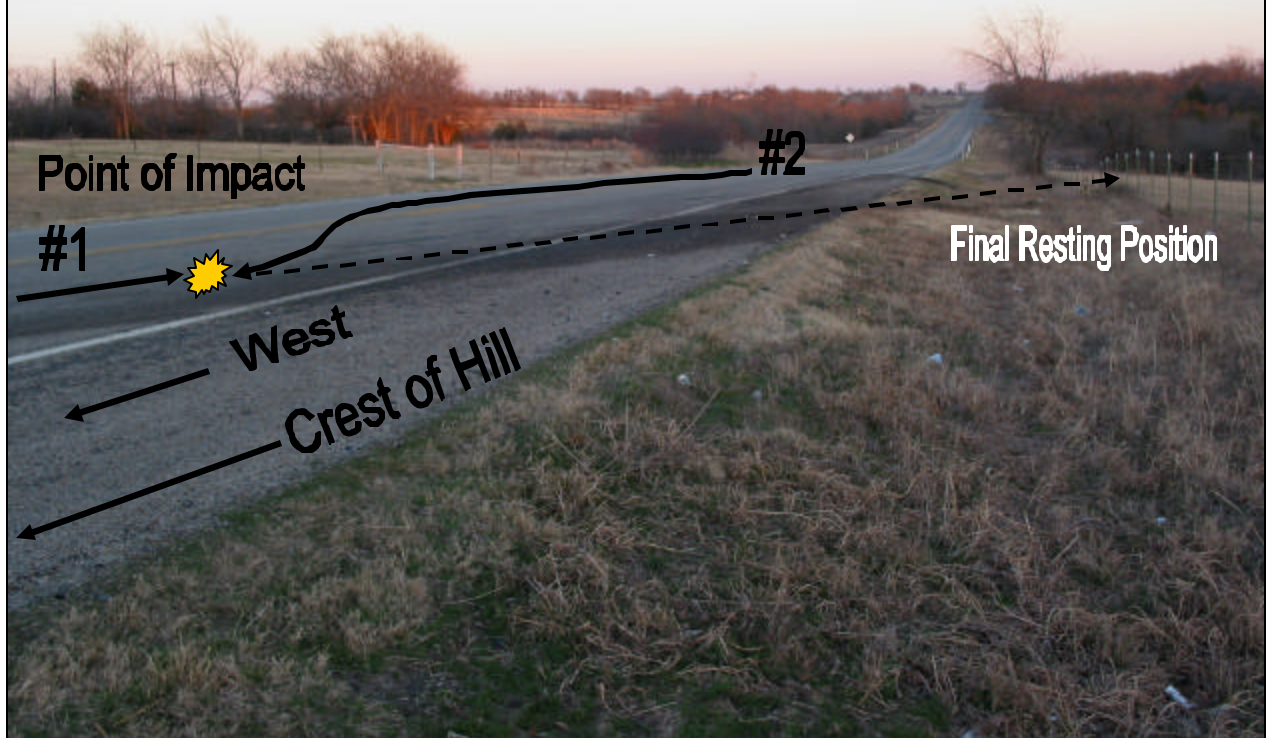
**ACCIDENT SCENE-STATE HIGHWAY 56-FANNIN COUNTY, TX**

After the collision, both vehicles came to rest on the grassy shoulder on the south side of SH 56. Vehicle #1 had damaged a barbed wire fence and came to rest facing southwest. Vehicle #2 came to rest approximately 75 feet from the rear of Vehicle #1 facing northeast. Both vehicles caught fire a short time after the impact. The fires were primarily concentrated in the engine compartment and front passenger areas.

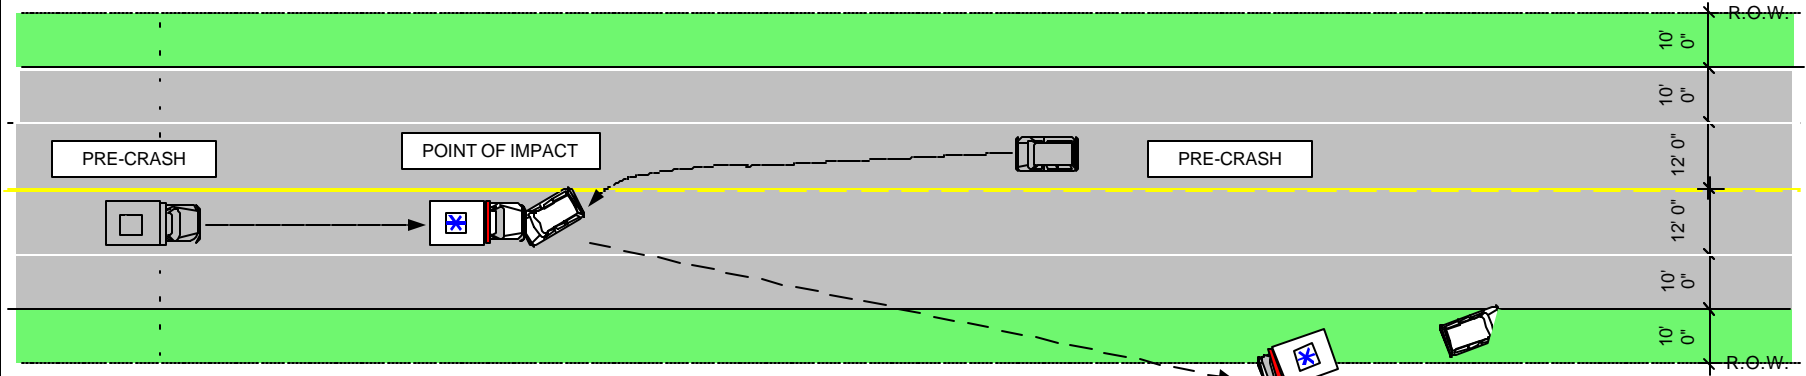
PRE-CRASH

POINT OF IMPACT

FINAL RESTING POSITION AFTER IMPACT

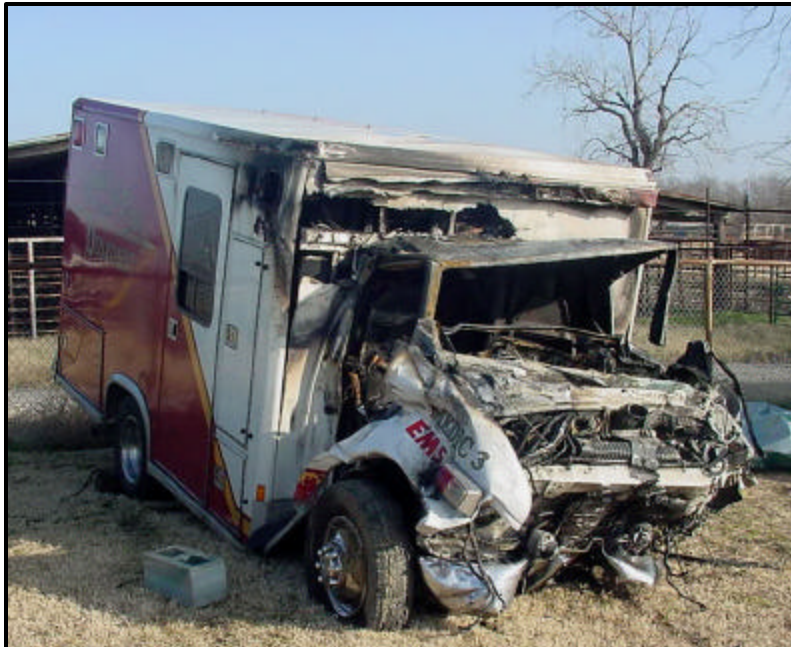
The gross vehicle weight listed for the vehicle was 10,500 pounds. The Texas Department of Public Safety weighed the vehicle after the accident and found that it weighed 11,800 pounds without crew or patients. It was not possible to determine the total mileage on the vehicle because of fire damage, but fire department records show Medic 3 had 312,657 total miles shortly before the accident in January 2003.

**Finding 1:** Overloading of the fire department ambulance by more than 1,300 pounds over Gross Vehicle Weight (GVW) combined with an estimated speed of 60-65 MPH created additional inertia which may have resulted in more vehicle damage than if the vehicle was at or below the correct GVW. Overloading may have affected vehicle handling, performance, and braking.

**Recommendation:** Fire departments should weigh all vehicles and compare weights to the Gross Vehicle Weight (GVW) listed on the federally required label. Equipment loads should be adjusted to bring weights to a level at or below GVW. Allowances should be made for the weight of the largest foreseeable number of crew and passengers aboard and a full fuel tank.

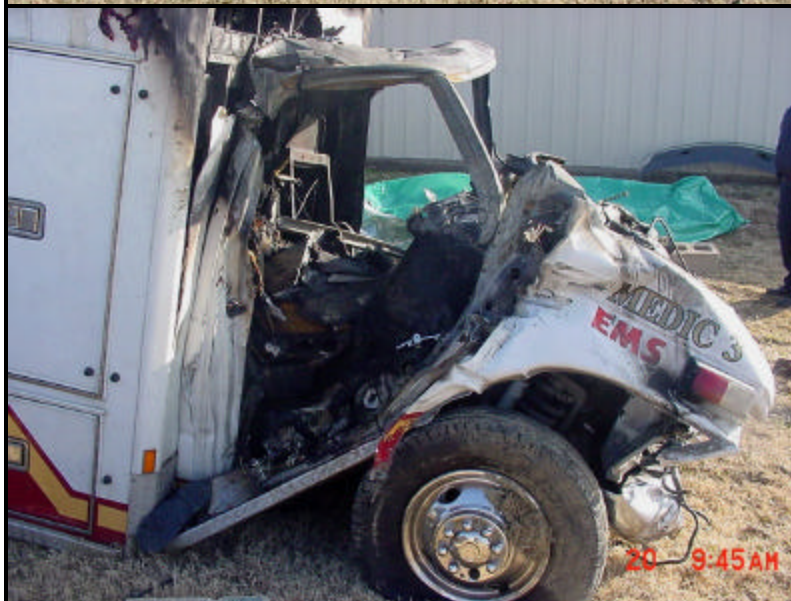
There was significant deformation of the vehicle and intrusion into the passenger space caused by the collision. The cab doors were removed with rescue tools when Taylor's body was removed from the vehicle. Other than fire damage, there was not significant damage to the ambulance box assembly.
