STATE FIRE MARSHAL'S OFFICE

Firefighter Fatality Investigation

Investigation Number FY 07-01

Firefighter Phillip Townsend

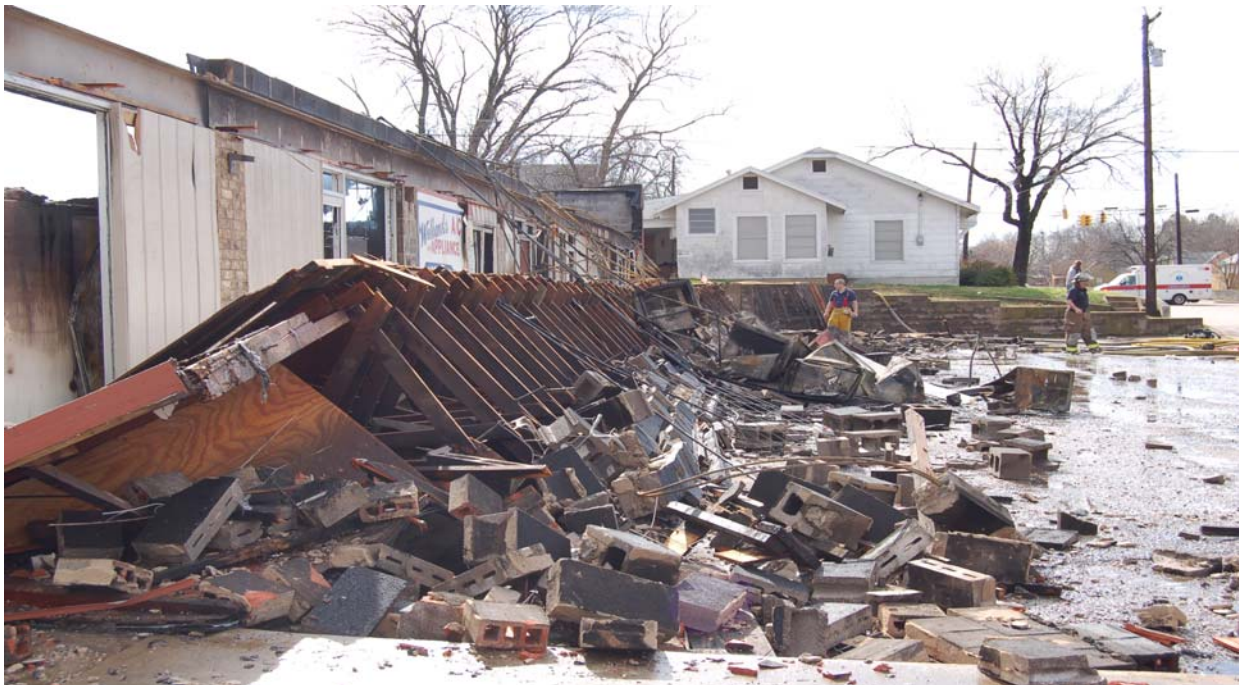
The front of the structure faced west toward South Crocket Avenue. The front wall was a combination steel I-beam, supported by steel pipe columns, masonry block, wood siding, aluminum frame windows, and glass doors. An awning over the sidewalk along the length of the front extended from the wall approximately 6 feet, 8 inches wide and 6 feet, 8 inches high, forming an open, triangular space. It was constructed of two-inch by six-inch (2 x 6) wood joists and two-inch by four-inch (2 x 4) wood framing. It was nailed to a 2 x 4 wood ledge that was bolted to the lower edge of the I-beam. The back of the awning assembly was attached to the concrete block wall above the I-beam with one-half inch diameter by 13 inch long steel bolts ($\frac{1}{2}$ " x 13"). The roof of the awning was curved with one-inch-thick plywood under composition shingle roofing and measured nine feet from the top to the front fascia. **(Figures 1 and 2)**

Figure 1. Collapsed awning (Photo by Denison FD)

Finding 8: The failure of the truss roof assembly in the building led to a partial building collapse, detaching the awning, which collapsed on firefighter Phillip Townsend and the Fire Chief.

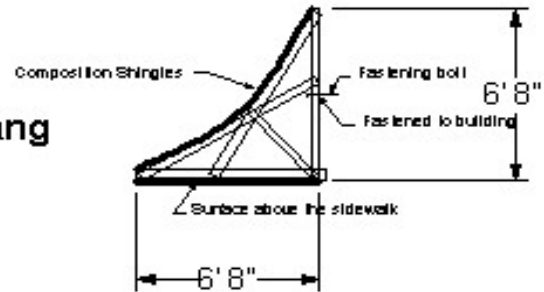
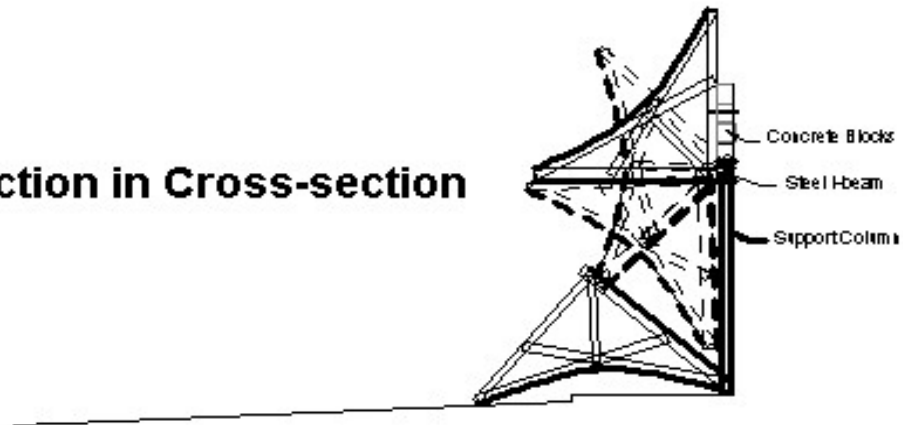
Figure 2. Awning construction (By DSFM E. Cheever)

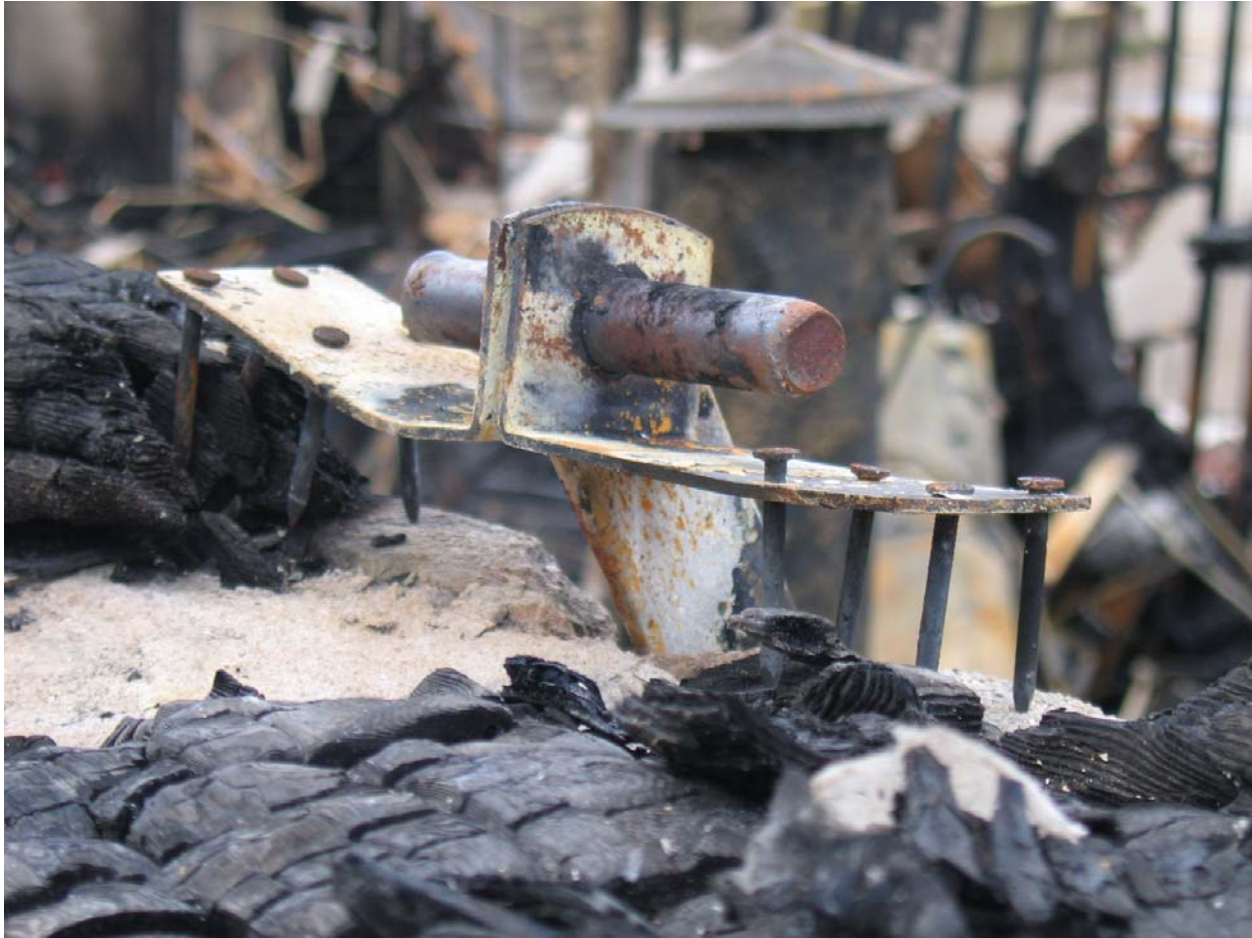
The truss system was attached to the masonry block at the east (rear) side by eight, two-inch nails per anchor assembly. Fire and collapse damage prevented inspection and determination of the method for attachment of the truss system to the west (front) side. The truss system extended from west to east in the attic space. **(Figure 3)**

Figure 3. Roof truss attachment to east wall (Photo by SFMO)

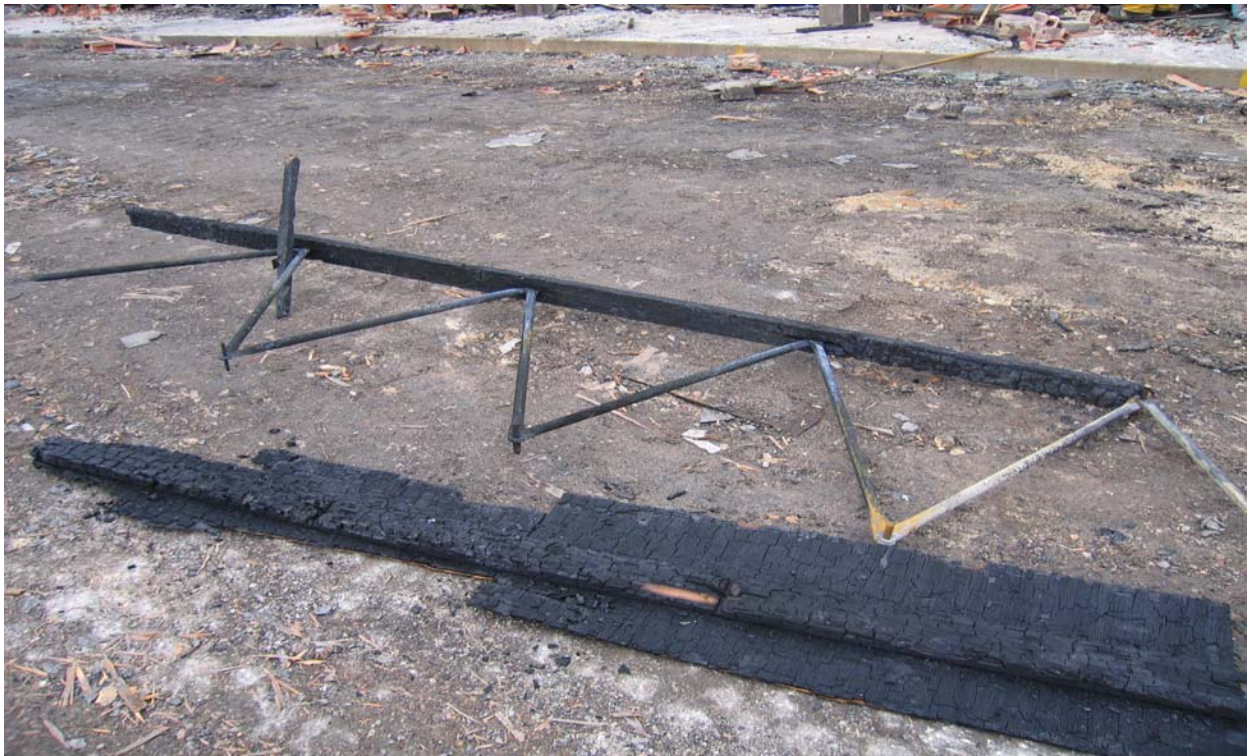
The building had a dropped ceiling, without fire separation between compartments to prevent heat and smoke spread. The exposed roof system was a pin-connected open web truss of tubular webbing and solid steel pins secured in unprotected two-inch by four-inch (2 x 4) wood chords. There were no indications that fire retardant or insulation was used on any of the exposed wood surfaces of the truss system or the roof decking. **(See Figure 4.)**

Figure 4. Remains of truss (Photo by SFMO)

The examination of the scene revealed that the roof structure collapsed and was consumed, leaving the tubular webbing of the truss system unsupported by the wood chords. This loss of the truss system allowed for the lateral movement of the front wall supporting the awning.

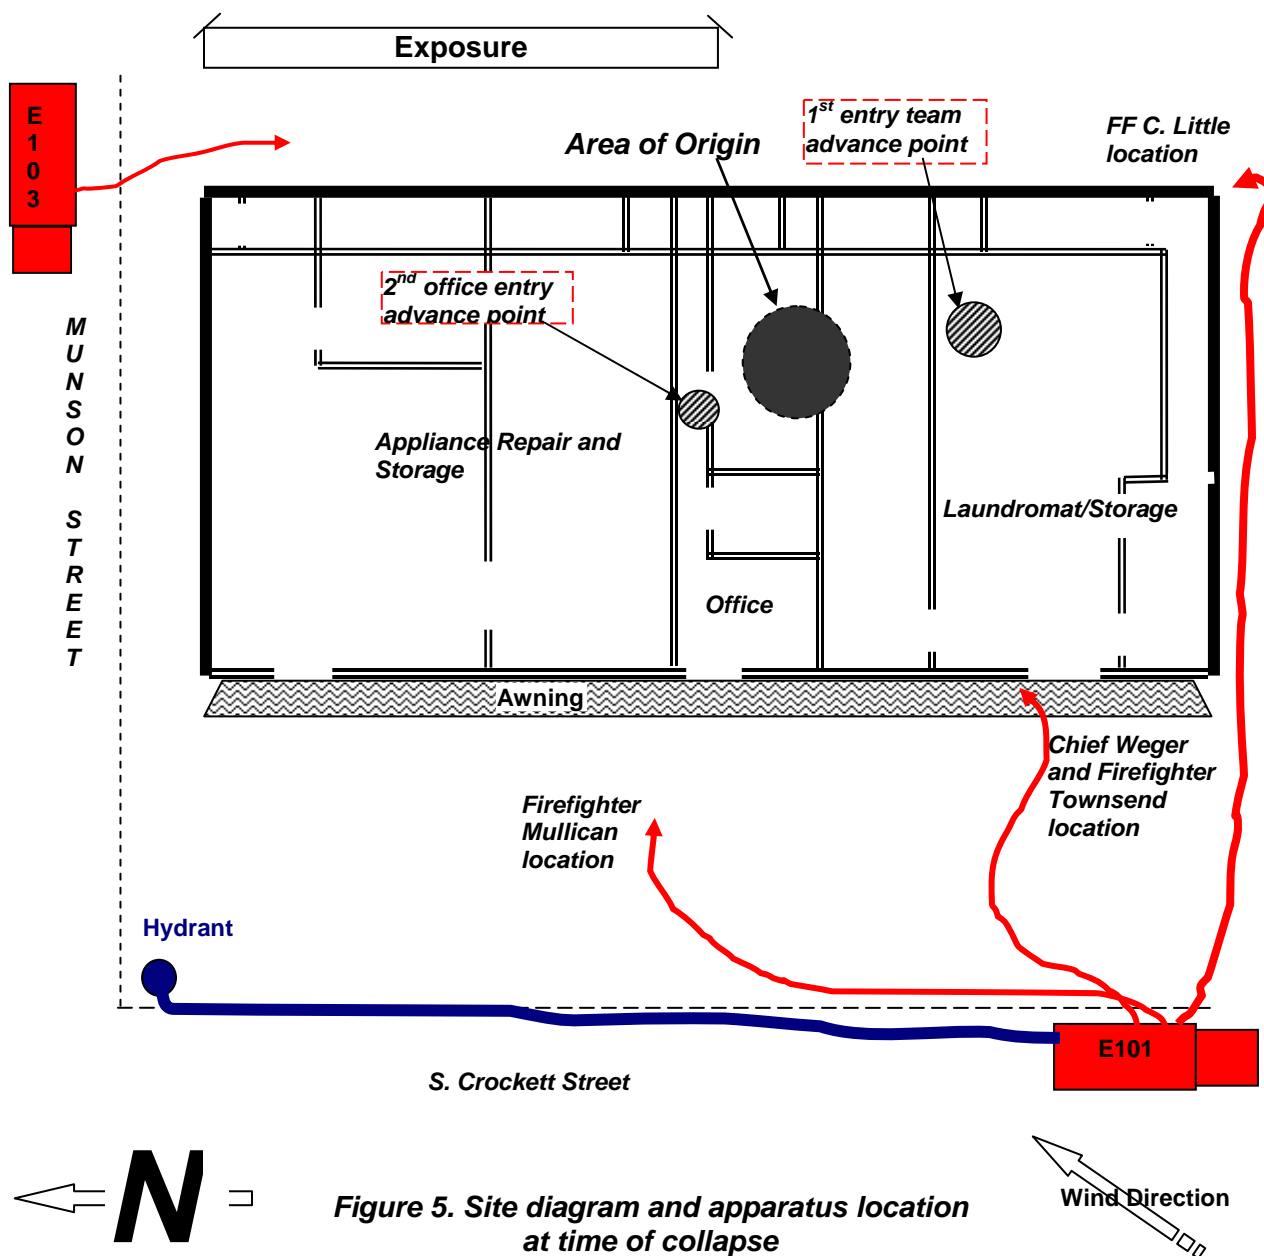
The fire investigation revealed that the fire originated above the concealed space of the owner's office and storage room near the center of the building. The undivided area of the roof system allowed for the development and spread of the fire, while remaining hidden. Forcible entry into the laundry at the south end of the building by the initial response team and the opening of the door into the center office area allowed the southwest wind of approximately seven mph to add air to the ventilation-starved fire, which aided rapid fire spread across the concealed area of the roof system. **(See Figure 5.)**

The extensive fire damage to the electrical circuits, junction boxes, and lighting fixtures mounted in the concealed space and above the dropped ceiling prevented identification of the initial ignition source or first material ignited. No other identifiable ignition source was found. The cause of this fire remains undetermined.

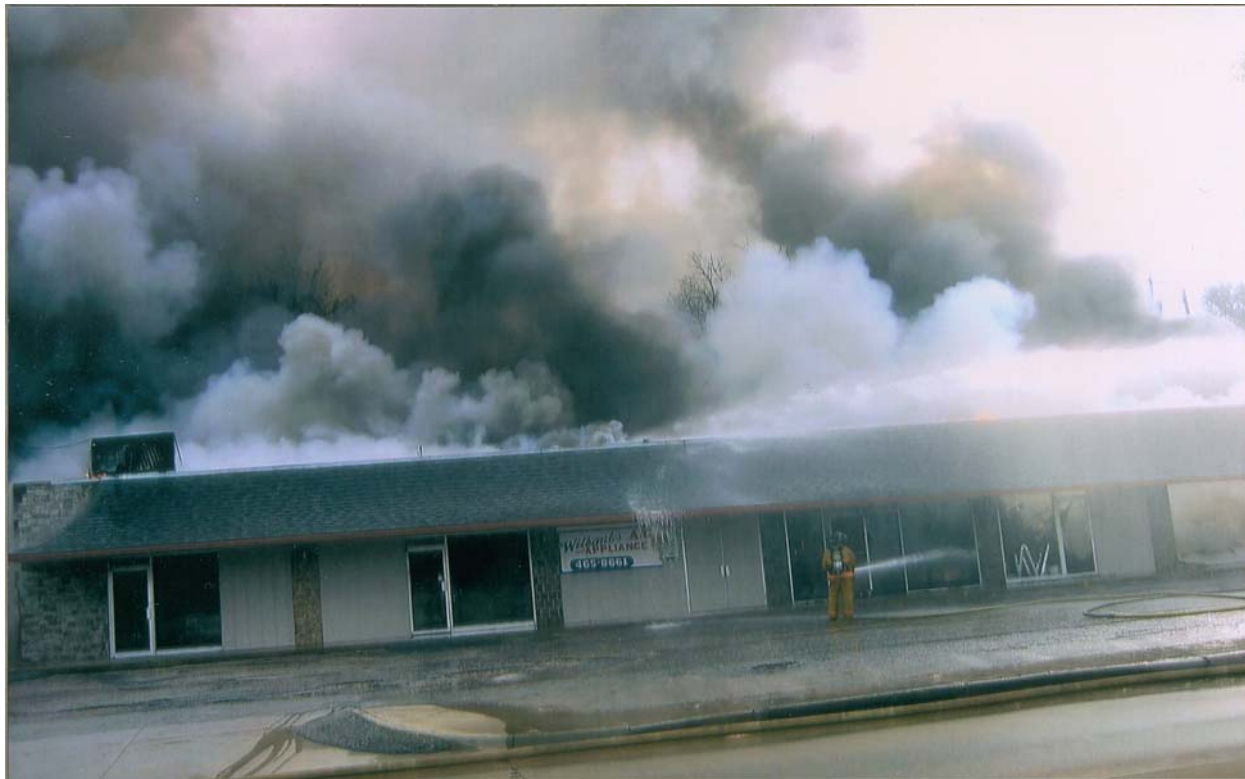
**Figure 6. Firefighter Mullican's position during defensive mode
(Photo from Denison FD)**

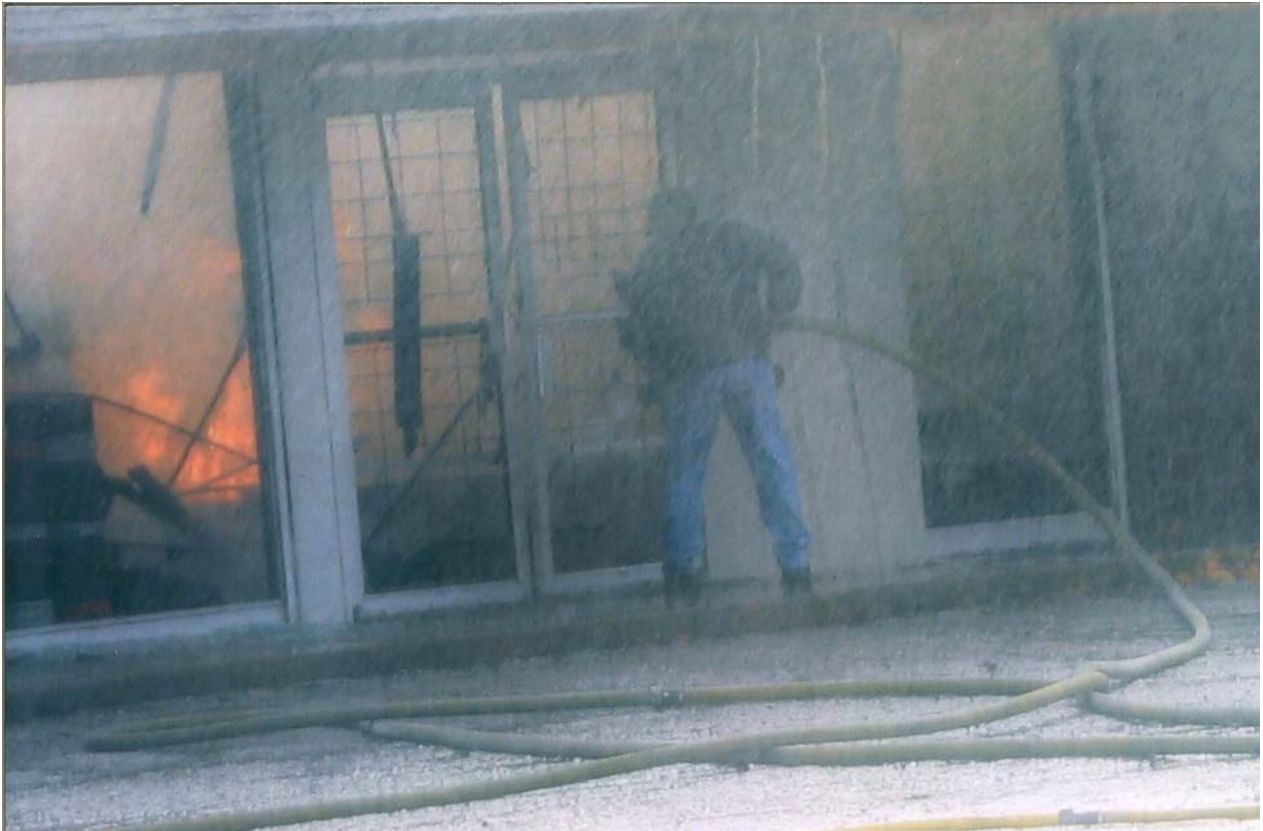
Figure 7. Chief Weger performing firefighting operations prior to the collapse. (Photo from Denison FD)

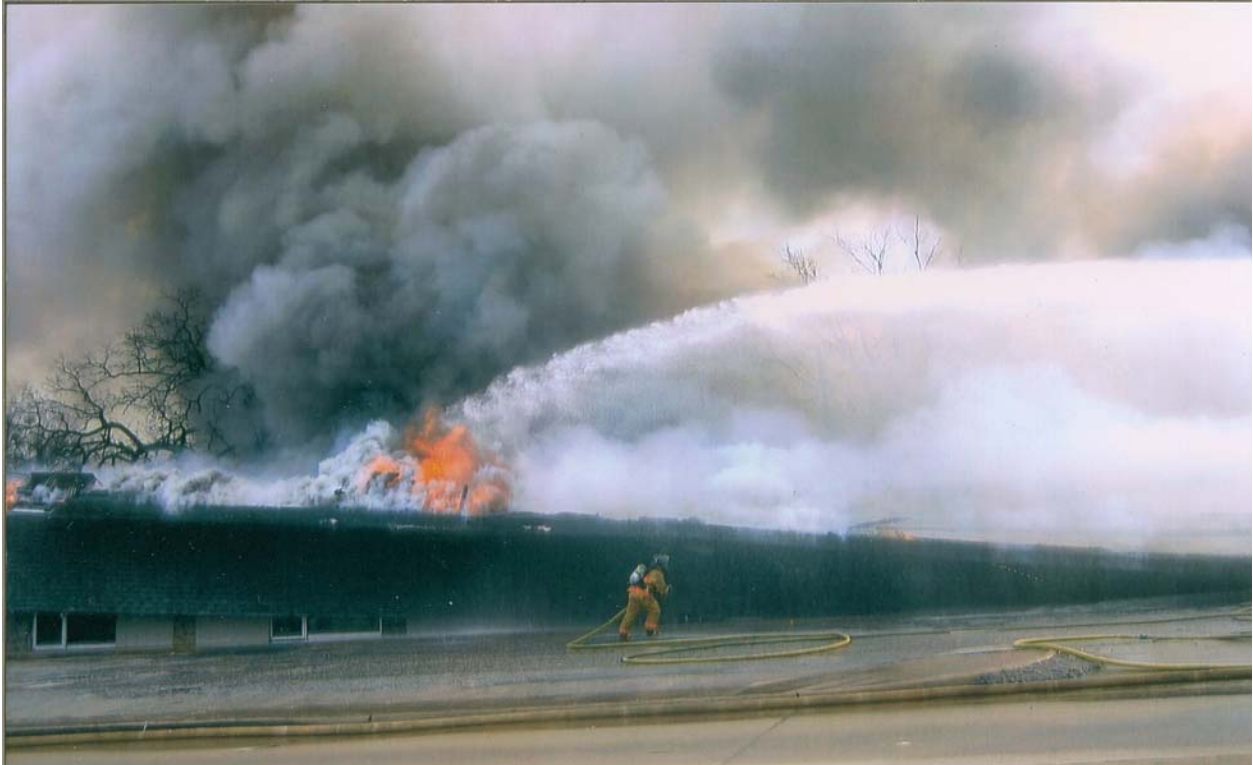
Figure 8. At the moment of collapse Firefighter Mullican starts toward Weger and Townsend's position. (Photo from Denison FD)

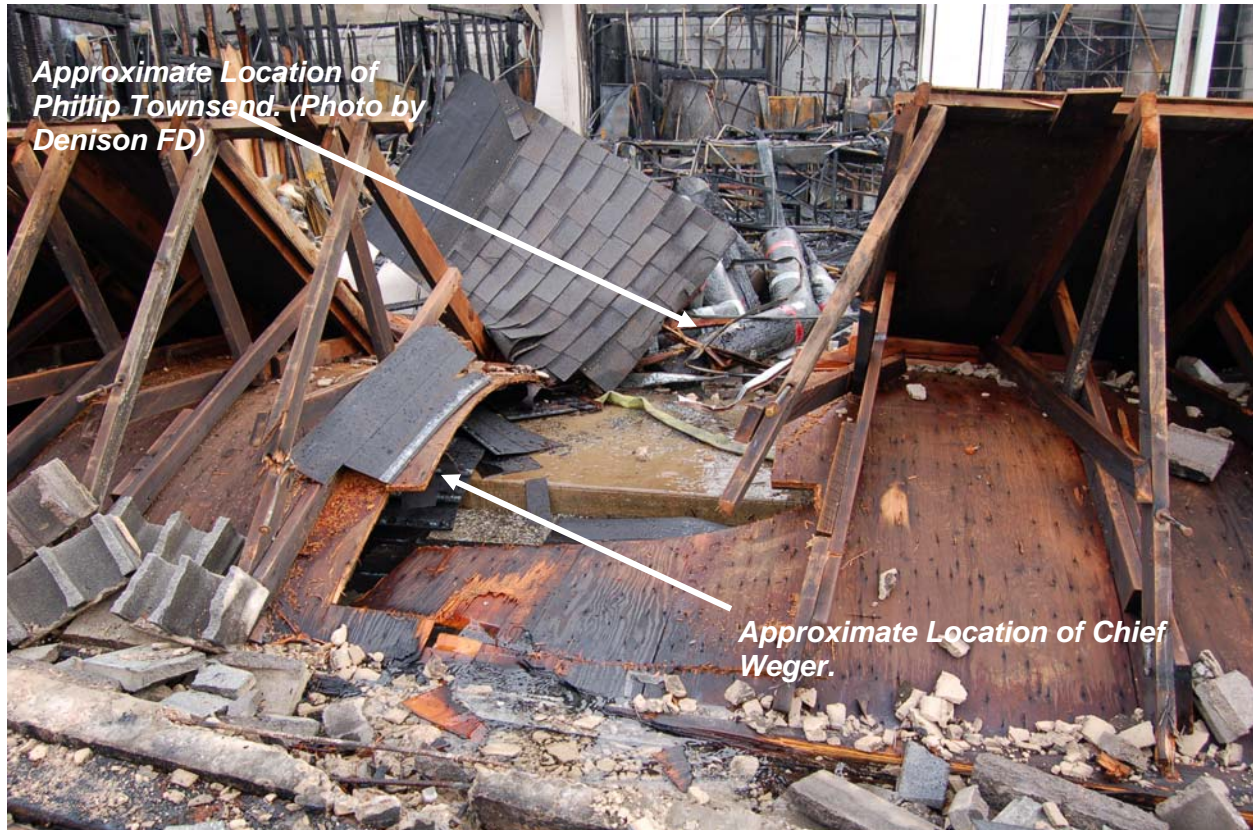
**Figure 9. Locations of Chief Weger and Phillip Townsend after collapse
(Photo by Denison FD)**

Firefighter Townsend was located near the wall of the building in a sitting position, pinned between the collapsed overhang and the masonry wall. Firefighters attempted to provide first air from his SCBA and later oxygen to him. He was unresponsive from the first time firefighters reached him. Firefighters Little, Mullican, Kuykendall, Flippo, Oates, Floyd, and Denison Police Officer Murrin all report hearing firefighter Townsend's PASS sounding when reaching him.

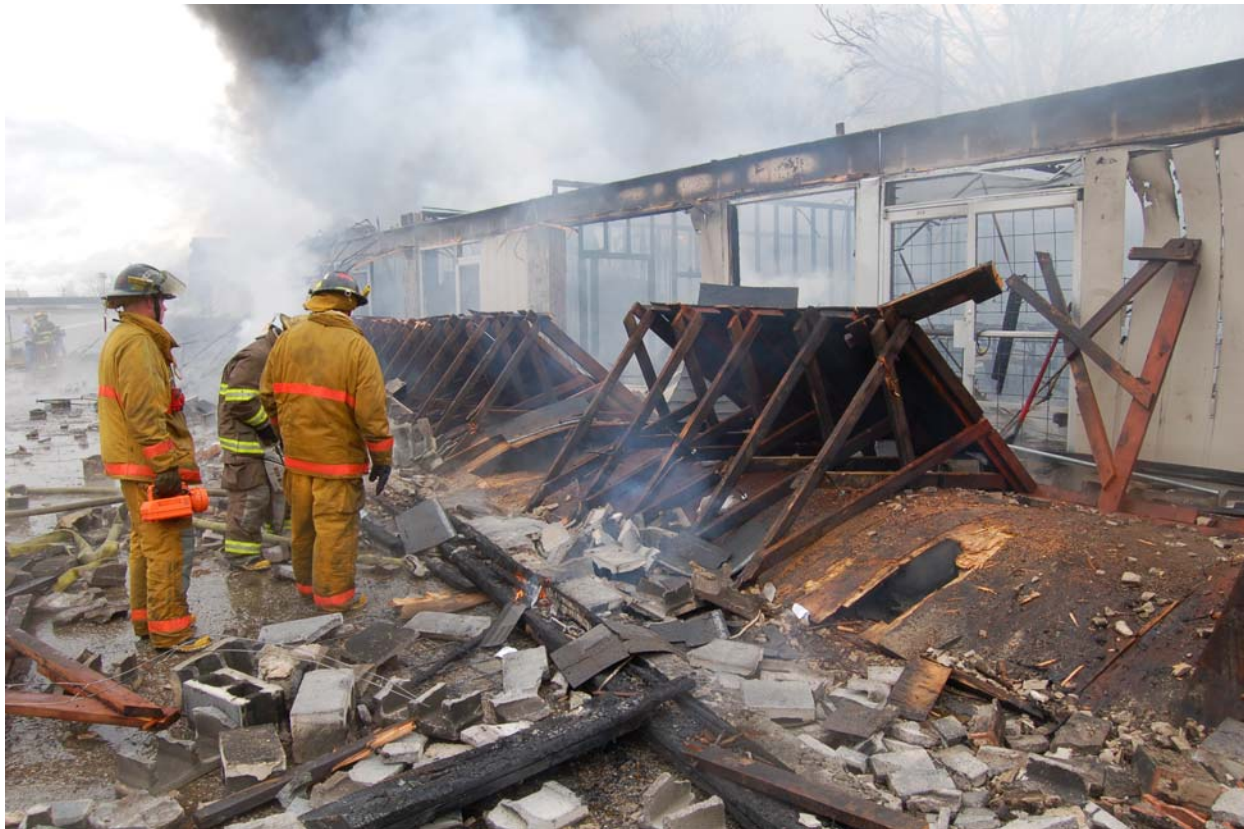
Figure 10. South view of collapse (Photo by Denison FD)

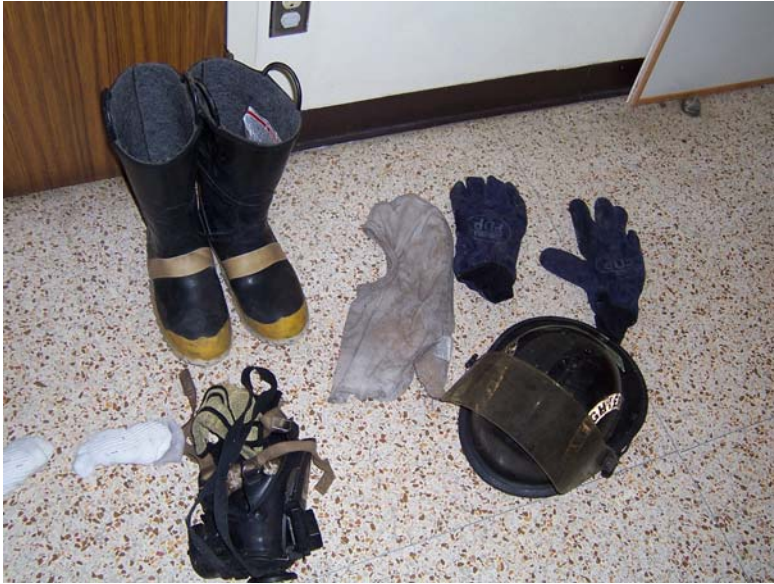
- Helmet – No apparent damage.
- Hood – No apparent damage.
- Self-Contained Breathing Apparatus – SCBA frame was damaged due to apparent impact of falling structural overhang.
- SCBA Mask – No apparent damage.
- Boots – No apparent damage.
- Structural Coat – The outer shell and liner of the coat were damaged due to removal by medical personnel. No apparent damage from fire or the collapse.
- Structural Pants – No apparent damage.
- Boots – No apparent damage.
- Gloves – No apparent damage.

Figure 11. Firefighter Townsend's PPE (Photo by TCFP)

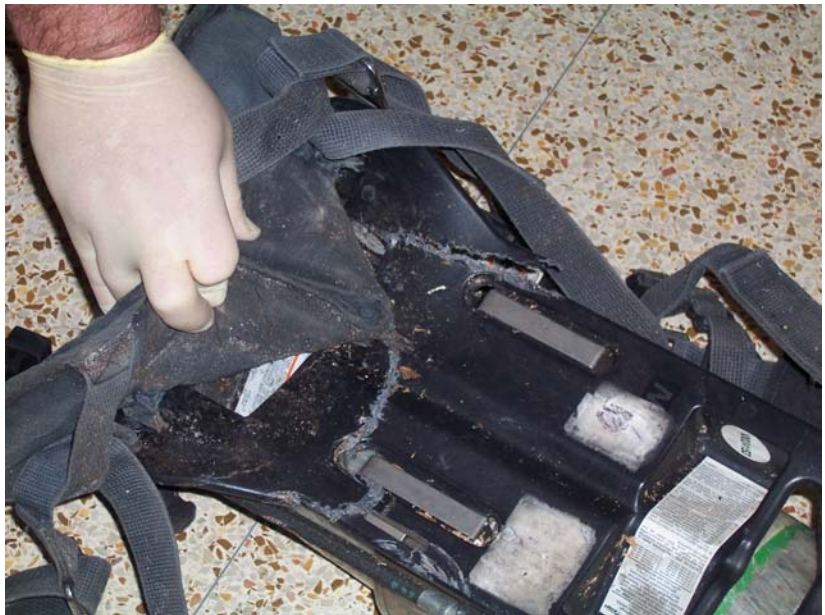
Figure 12. Photograph of the SCBA frame damage illustrating the cracked bracket (Photo by TCFP)
