# STATE FIRE MARSHAL'S OFFICE

## Firefighter Fatality Investigation

**Investigation Number 06-166-12**

### **Firefighter Chad Ernest Wessels**

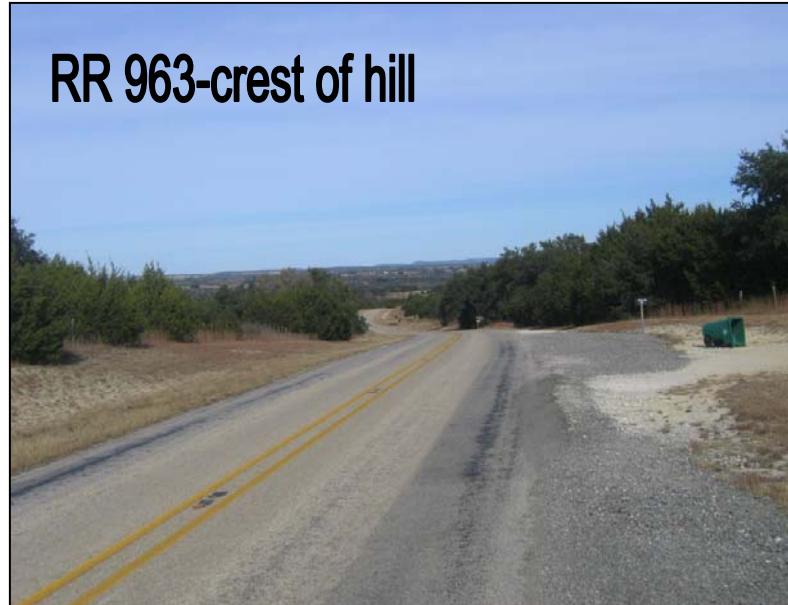
**RR 963-crest of hill**

Approximately 5 miles from the Wessels residence eastbound on Ranch Road 963, Briggs Unit 4240 passed a diamond left curve sign. No speed advisory sign is attached. (See attached diagram)

No warning chevrons delineated the curve. The asphalt roadway was dry, in good condition, and had a slight downhill grade transitioning from a slight left curve into a straight section. The roadway was marked with a double yellow centerline. The edges of the roadway are not marked with a white line, and loose asphalt and rock material is present at the edges of the roadway. The terrain of the shoulders and adjacent land is rocky and uneven.

After cresting the hill, the right front tire of Unit 4240 left the right hand side of the roadway at the exit of the left curve to the downhill straight section, after passing the curve warning sign. The Texas Department of Public Safety (DPS) report stated no tire marks were present that would have indicated that Firefighter Wessels applied heavy braking action.

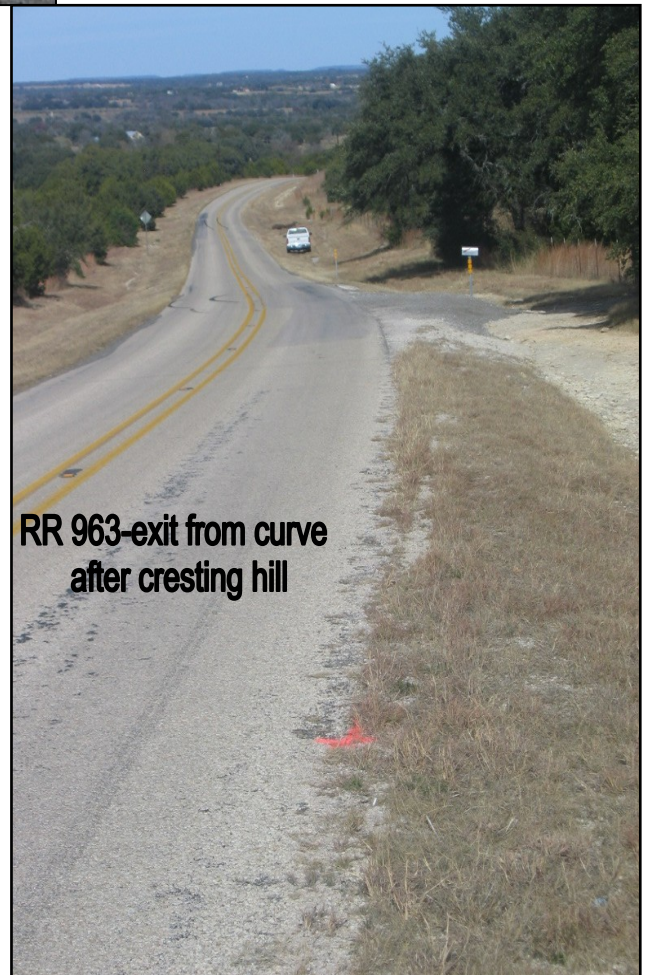
**RR 963-exit from curve after cresting hill**

Unit 4240 reentered the highway and veered left across the roadway at an angle and left the roadway on the left side. The water tender passed through a barbed wire fence and traveled parallel to the roadway approximately 600 feet before reentering the roadway, crossing it an angle and crashing through a barbed wire fence on the right side of the road. After traveling approximately 112 feet off road, Unit 4240 came to rest in a grove of cedar trees and brush.

A post-crash fire ignited and consumed the front and cab interior of Unit 4240. The investigating DPS trooper surmised that the movement of the truck through fences and across rocky terrain disrupted the fuel system of the Unit 4240, leading to the fire. The DPS report stated that it was believed that Firefighter Wessels, who was not wearing a safety belt, was thrown about and possibly rendered unconscious during the off-road excursion of the truck and was not able to respond and escape the burning truck. There was collision damage to the front bumper area of the truck, but none to the cab area.

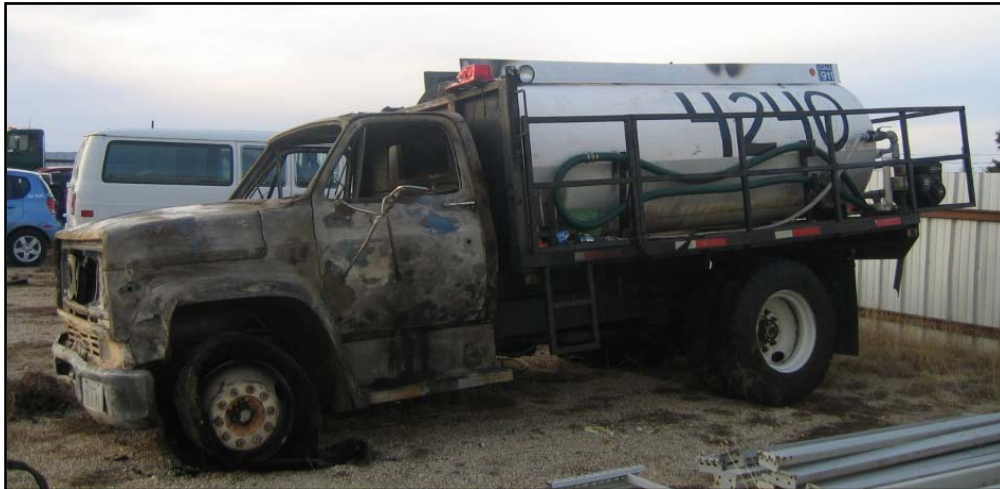
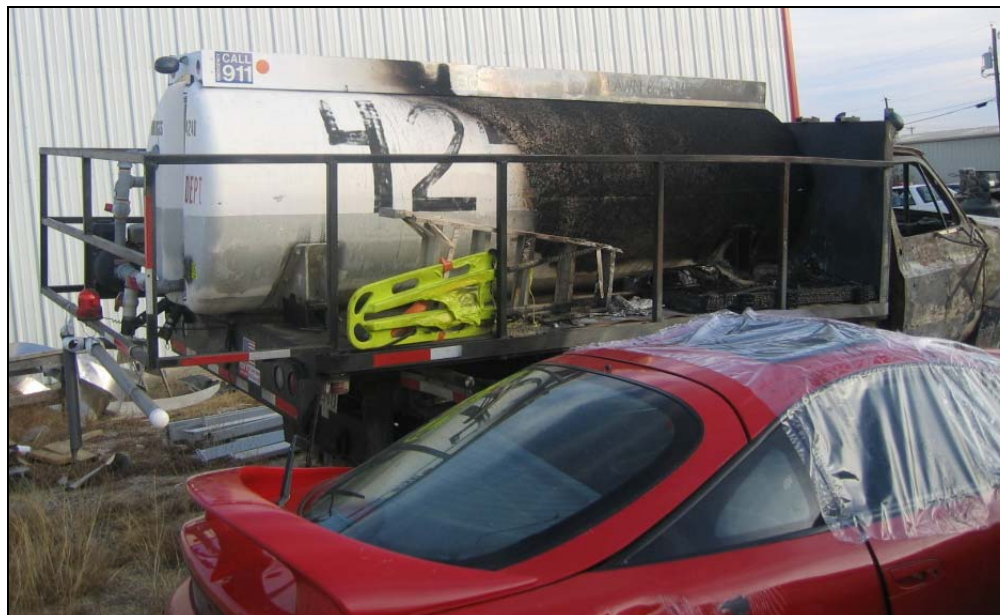
Texas Department of Public Safety trooper Ricky Mintz investigated the motor vehicle incident and cited “unsafe speed (below legal limit), and faulty evasive action” as contributing factors on his official report.
