STATE FIRE MARSHAL'S OFFICE

Line of Duty Death Investigation

Investigation Number 02-524-08

Firefighter Travis Wiens

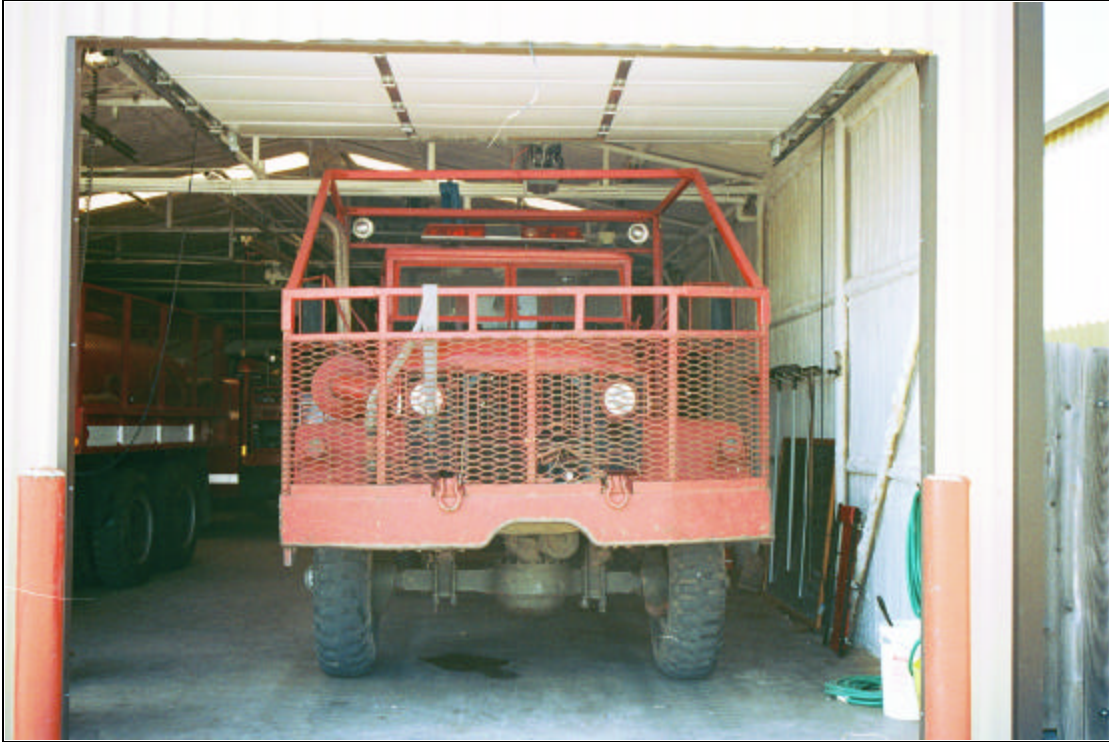
Wichita West Engine 720

The front bumper platform extended out approximately 36 inches. The bumper had an open frame that extended up to the cab and then down to the sides of the bumper. The lower front portion of the frame had mesh wire, which extended 39 inches from the top of the bumper to the cross member. The rest of the frame was completely open allowing uninhibited access from either side. There were no safety type harnesses or other safety devices for the front bumper platform.

The truck has been painted red. Four-inch-wide white reflective tape and reflective 911 emblems had been applied to both sides of the cargo bed. Red and white alternating reflective tape has been applied across the rear of the truck. The only warning lights on the vehicle are a full width red light bar mounted on top of the cab. The truck is also equipped with an electronic siren with the speaker mounted on the front bumper platform. Two high-mount white lights were installed for extra night visibility. There are no low-mounted or side-mounted warning lights.

There were no safety straps or harnesses installed on the front firefighting platform of the 5-ton brush truck.

- Personnel should not be allowed to ride on the front of wildfire firefighting apparatus at any time.

Accident prevention signs should be located on the vehicle at the rear step areas, and at front bumper extensions and cross walkways, if they exist. The signs should warn personnel that standing on these areas while the vehicle is in motion is prohibited.

- Firefighting should be limited to protected positions on the sides and rear of vehicles.

Firefighters in these positions should be protected by safety cages or belts that will prevent falls from vehicles. Rollover protection equipment should be considered for these types of vehicles.

Automatic nozzles may be installed on front bumpers to avoid placing firefighters at risk on an exposed position.
