DEFENSE NUCLEAR FACILITIES SAFETY BOARD

RECOMMENDATION 95-1 TO THE SECRETARY OF ENERGY
pursuant to 42 U.S.C. § 2286a(5)
Atomic Energy Act of 1954, as amended.

Technical Report

INTEGRITY OF URANIUM HEXAFLUORIDE CYLINDERS

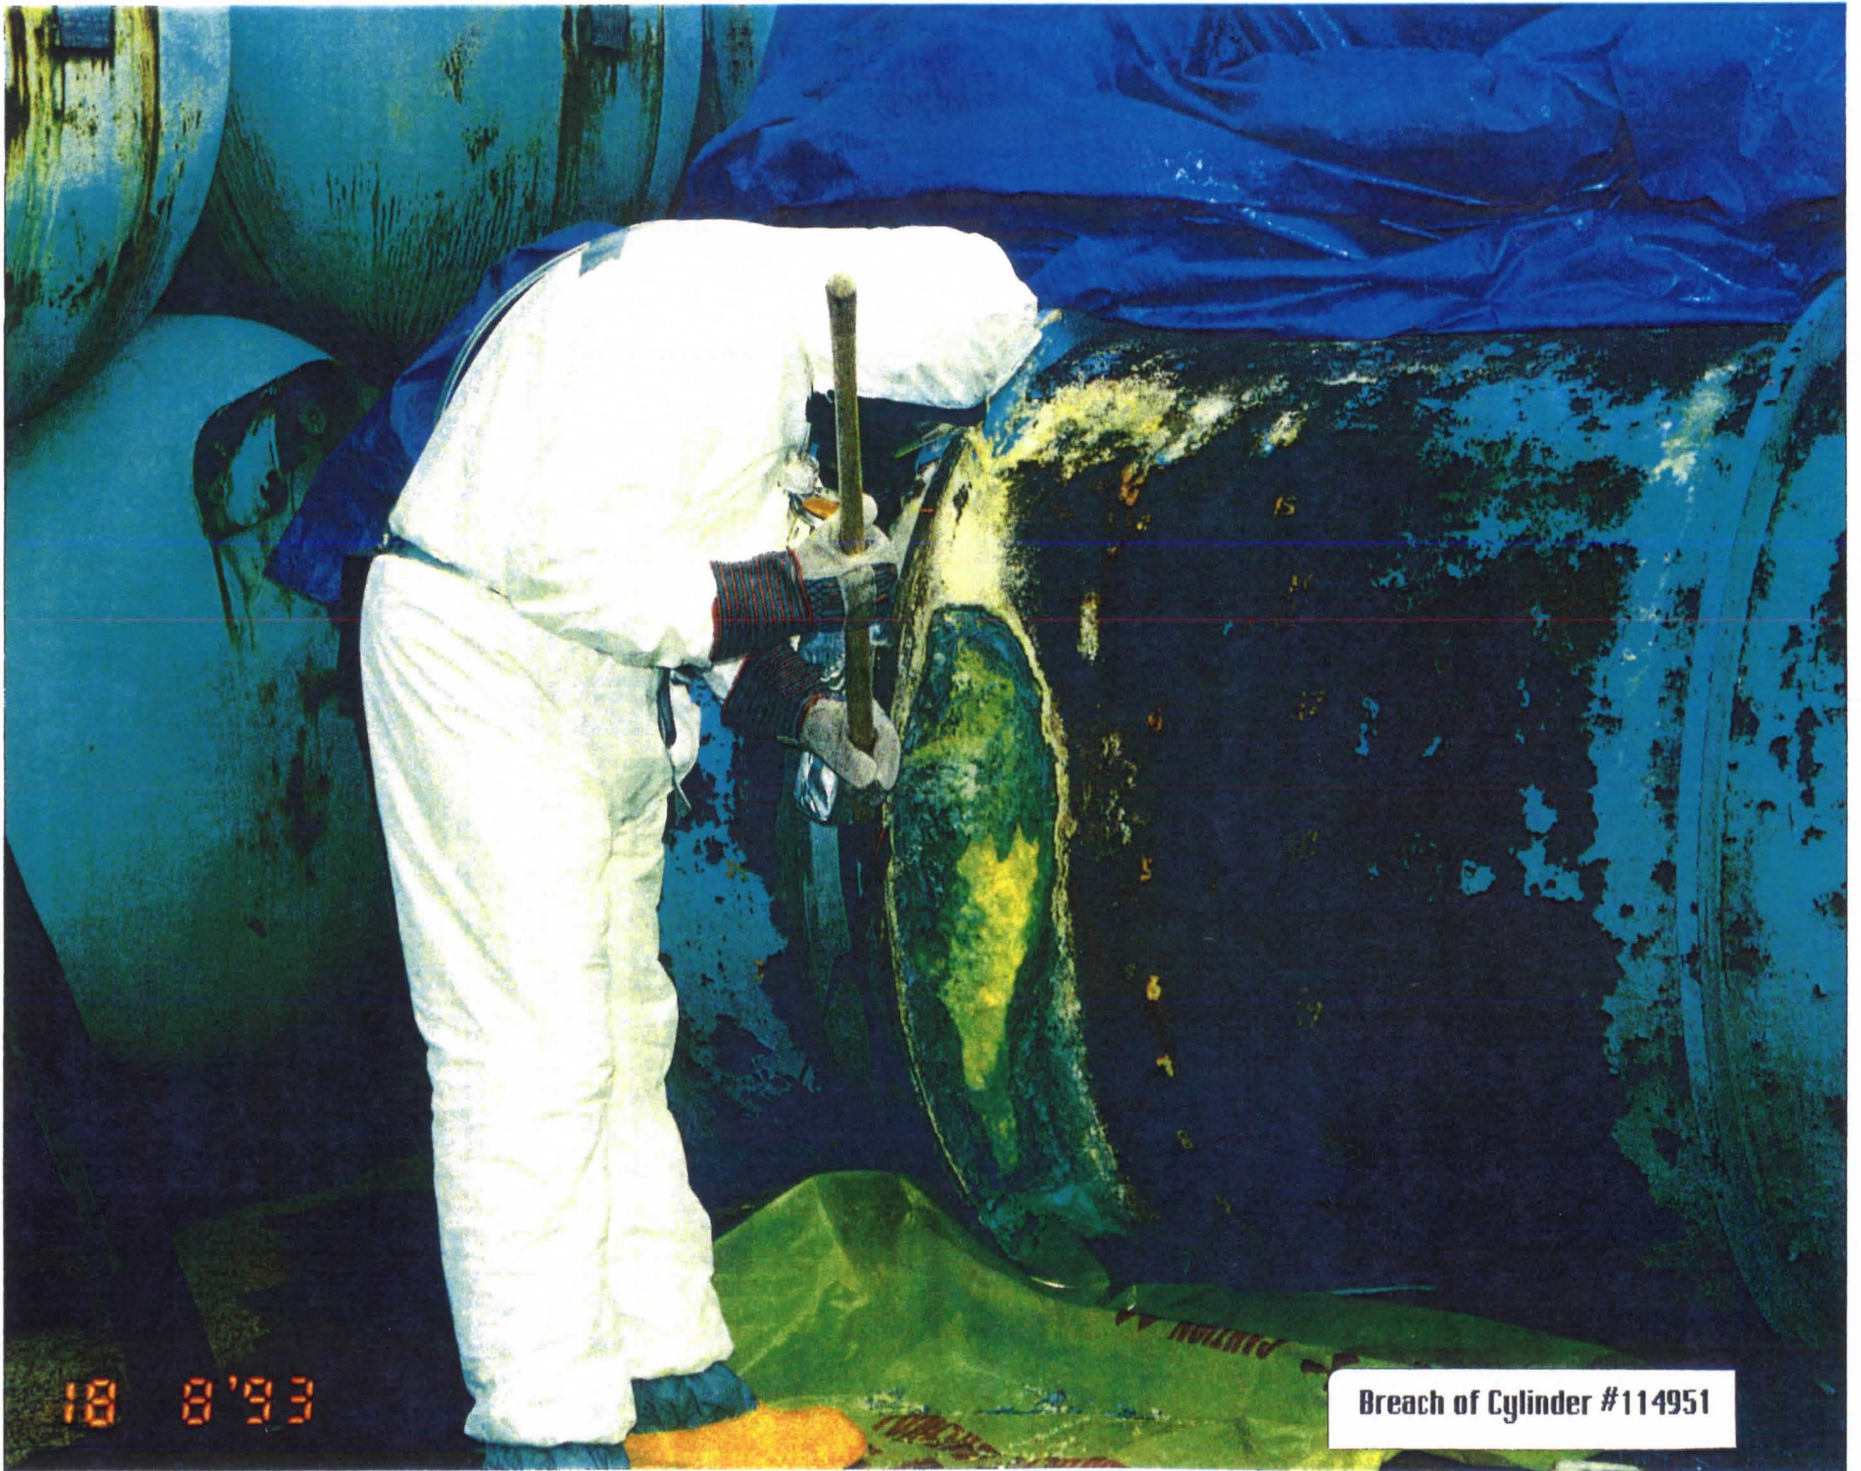
When released to the atmosphere, gaseous UF_6 reacts with water vapor to form a cloud of particulate UO_2F_2 and HF fumes. The reaction is fast, but is dependent on the availability of water. External contact with HF results in chemical burns of the skin, while exposure to airborne HF causes chemical burns/irritation of the eyes, nose, and throat. Because UF_6 reacts readily with water and organic materials, it must be handled in clean equipment and out of contact with moist air. A breach in a cylinder allows the external atmosphere to react slowly with the UF_6 . The solid reaction product tends to plug the breach; however, the HF formed releases slowly, attacks the metal cylinder, and enlarges the breach over time. The hole diameter is estimated to increase at a rate of approximately one inch per year. The reaction products, consisting of UF_4 , FeF_3 , and other iron oxides, fall to the ground or onto adjacent cylinders. The material released to the environment is HF and solvated uranyl fluoride $[H_3O]_2[U(OH)_4F_4]$, which is soluble in water. Figure 2. is a photograph of the largest breach discovered to-date.

Figure 2 Breached Cylinder at Oak Ridge K-25 Site
