Explosion and Aftermath: The Causes and Consequences of the Disaster

Chapter Four

The Macondo Well and the Blowout

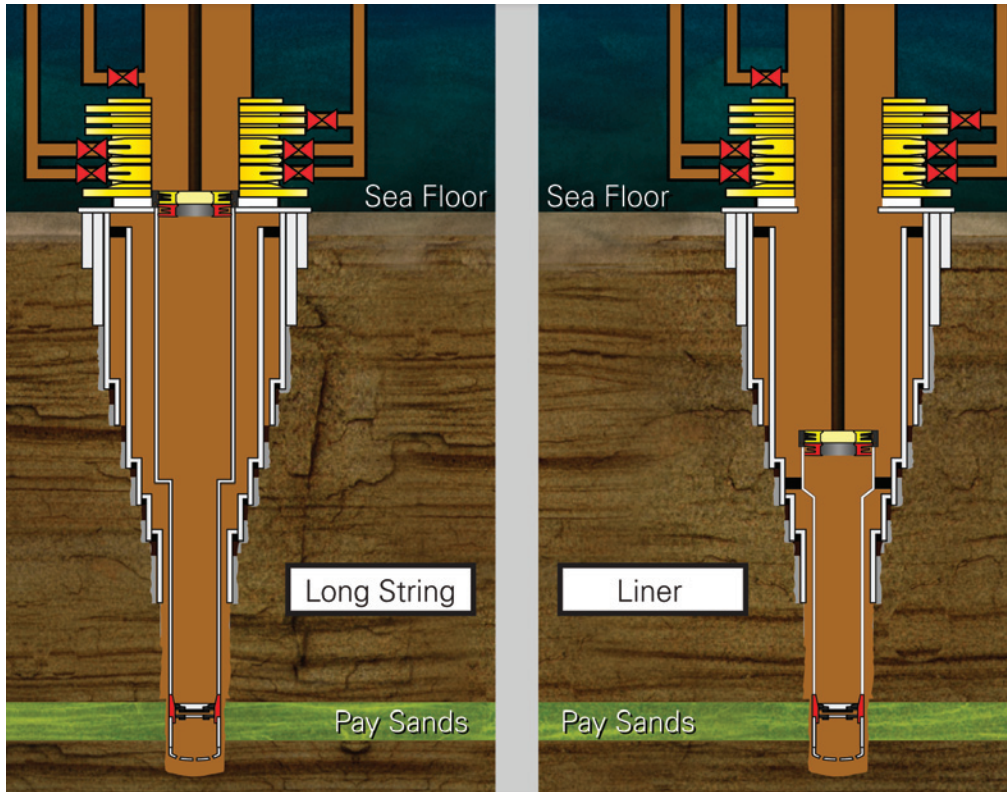
FIGURE 4.2: “Long String” vs. “Liner”

Two options for the Macondo production casing.

BP’s design team originally had planned to use a “long string” production casing—a single continuous wall of steel between the wellhead on the seafloor, and the oil and gas zone at the bottom of the well. But after the lost circulation event, they were forced to reconsider. As another option, they evaluated a “liner”—a shorter string of casing hung lower in the well and anchored to the next higher string. (Figure 4.2) A liner would result in a more complex—and theoretically more leak-prone—system over the life of the well. But it would be easier to cement into place at Macondo.

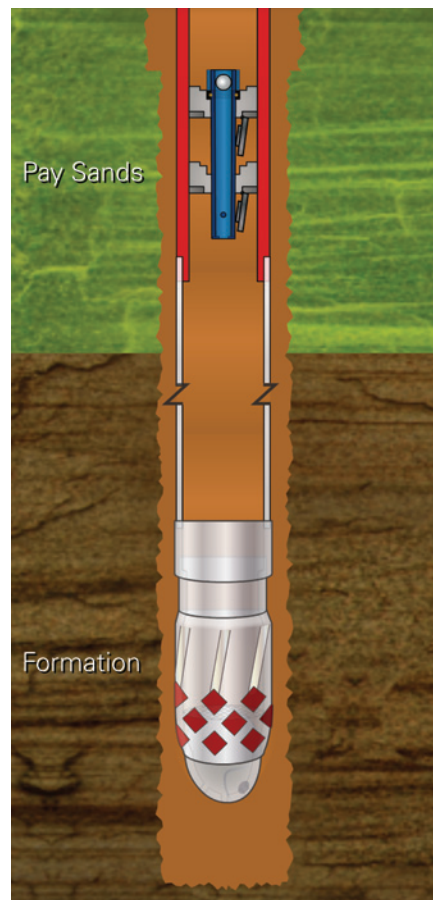
FIGURE 4.4: Shoe Track

The shoe track, showing the float collar assembly at the top and the reamer shoe at the bottom.

BP’s team concluded that the float valves had converted, but noted another anomaly. The drilling-mud subcontractor, M-I SWACO, had predicted that it would take a pressure of 570 psi to circulate mud after converting the float valves.²⁷ Instead, the rig crew reported that circulation pressure was much lower: only 340 psi. BP’s Well Site Leader Bob Kaluza expressed concern about low circulating pressure.²⁸ He and the Transocean crew switched circulating pumps to see if that made a difference, and eventually concluded that the pressure gauge they had been relying on was broken.²⁹ Believing they had converted the

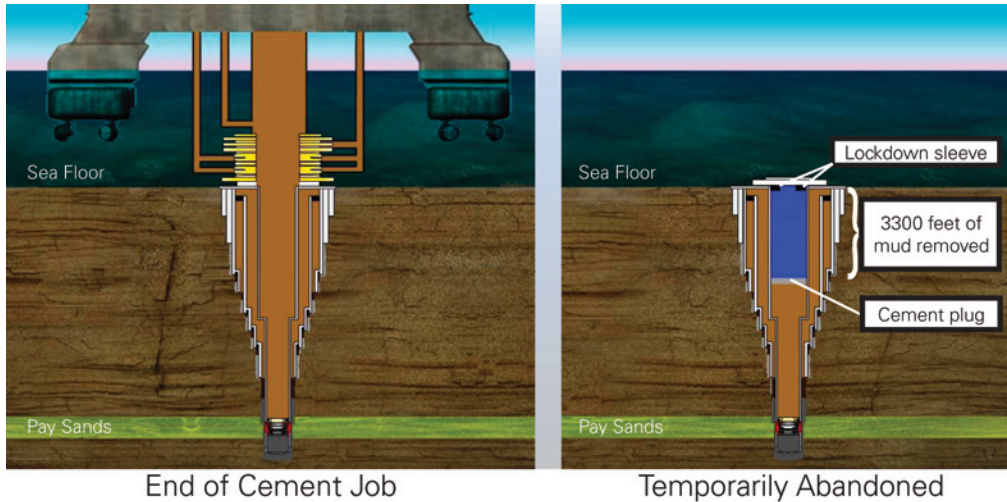
FIGURE 4.5: Temporary Abandonment

The status of the well before and after temporary abandonment.

Four features of the temporarily abandoned well are worth noting. First is the single 300-foot-long cement plug inside the wellbore. MMS regulations required BP to install a cement plug as a backup for the cement job at the bottom of the well. Second is the location of the cement plug: BP planned to put it 3,300 feet below the ocean floor, or “mud line” (which was deeper than MMS regulations allowed without dispensation, and deeper than usual).⁵⁸ Third is the presence of seawater in the well below the sea floor: BP planned to replace 3,000 feet of mud in the wellbore above the cement plug with much

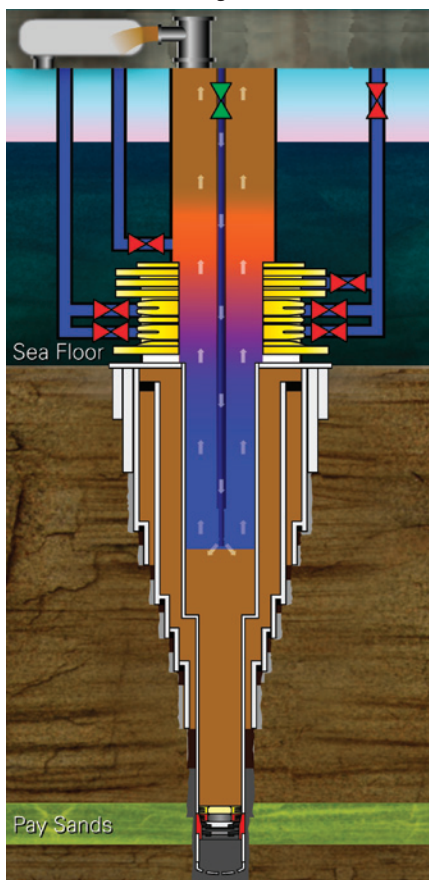
FIGURE 4.6: Displacing Mud With Spacer and Seawater Before the Negative Pressure Test

Seawater (blue) displaces mud (brown) from wellbore and riser, with spacer fluid separating the two.

While drilling crews routinely use water-based spacer fluids to separate oil-based drilling mud from seawater, the spacer BP chose to use during the negative pressure test was unusual. BP had directed M-I SWACO mud engineers on the rig to create a spacer out of two different lost-circulation materials left over on the rig—the heavy, viscous drilling fluids used to patch fractures in the formation when the crew experiences lost returns.⁷¹ M-I SWACO had previously mixed two different unused batches, or “pills,” of lost-circulation materials in case there were further lost returns.⁷² BP wanted to use these materials as spacer in order to avoid having to dispose of them onshore as hazardous waste pursuant to the Resource and Conservation Recovery Act, exploiting an exception that allows companies to dump water-based “drilling fluids” overboard if they have been circulated down through a well.⁷³ At BP’s direction, M-I SWACO combined the materials to create an unusually large volume of spacer that had never previously been used by anyone on the rig or by BP as a spacer, nor been thoroughly tested for that purpose.⁷⁴

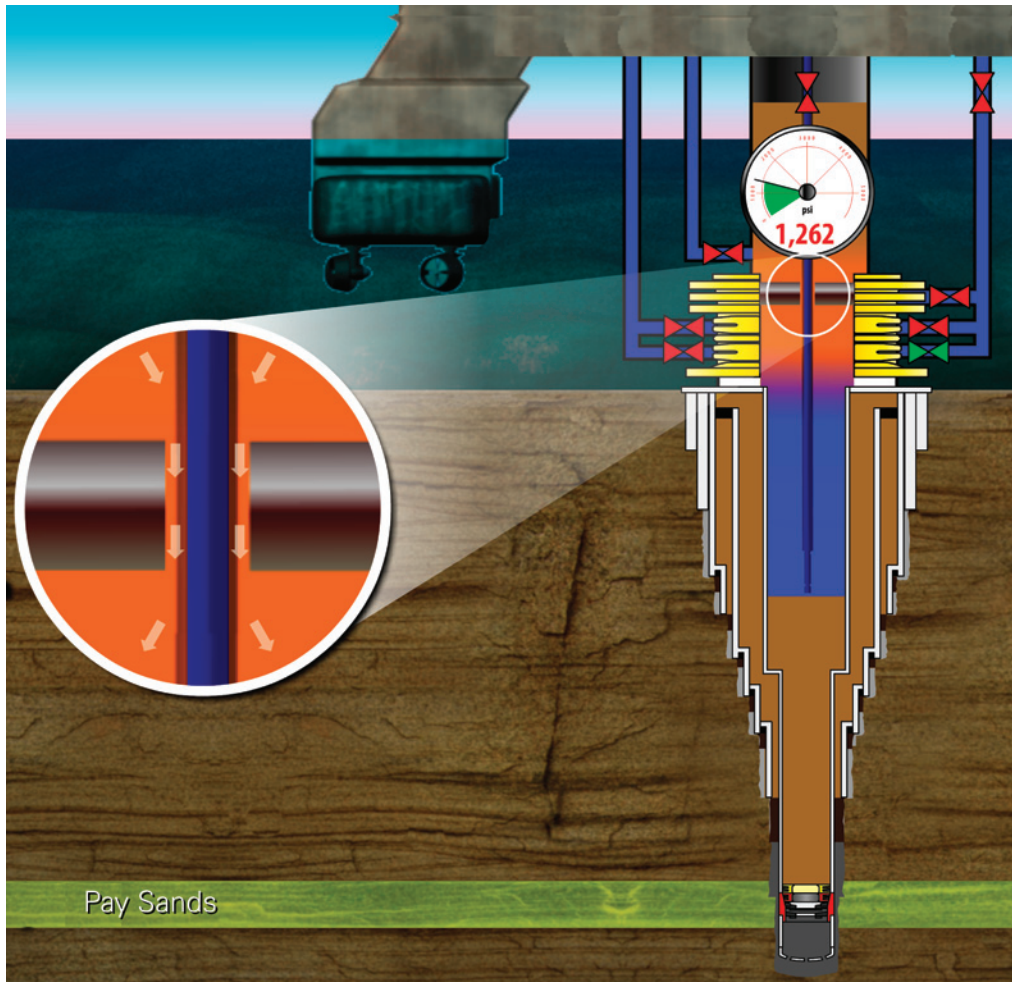
FIGURE 4.7: Fluids Leak Past Annular Preventer

The crew had noticed that the fluid level inside the riser was dropping, suggesting that spacer was leaking down past the annular preventer, out of the riser, and into the well (Figure 4.7). Harrell, who stayed behind in the drill shack as the tour continued, ordered the annular preventer closed more tightly to stop the leak.⁷⁷ Harrell then left the rig floor.

Spacer fluids (orange) leak past annular preventer.

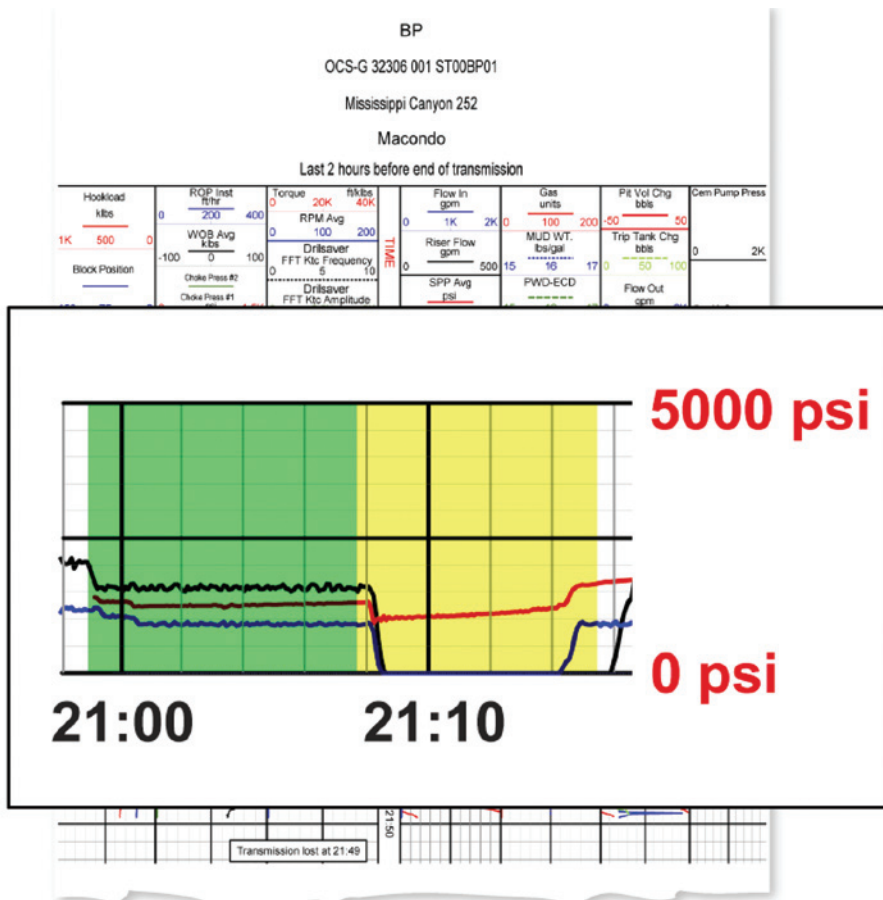
FIGURE 4.8: Increasing Drill-Pipe Pressure

Sperry Sun drill-pipe pressure data (in red).

magnitude of the increase may have appeared only as a subtle trend on the Sperry Sun display, the change in direction from decreasing to increasing was not.⁹¹
